APPENDIX B
Record Photographs

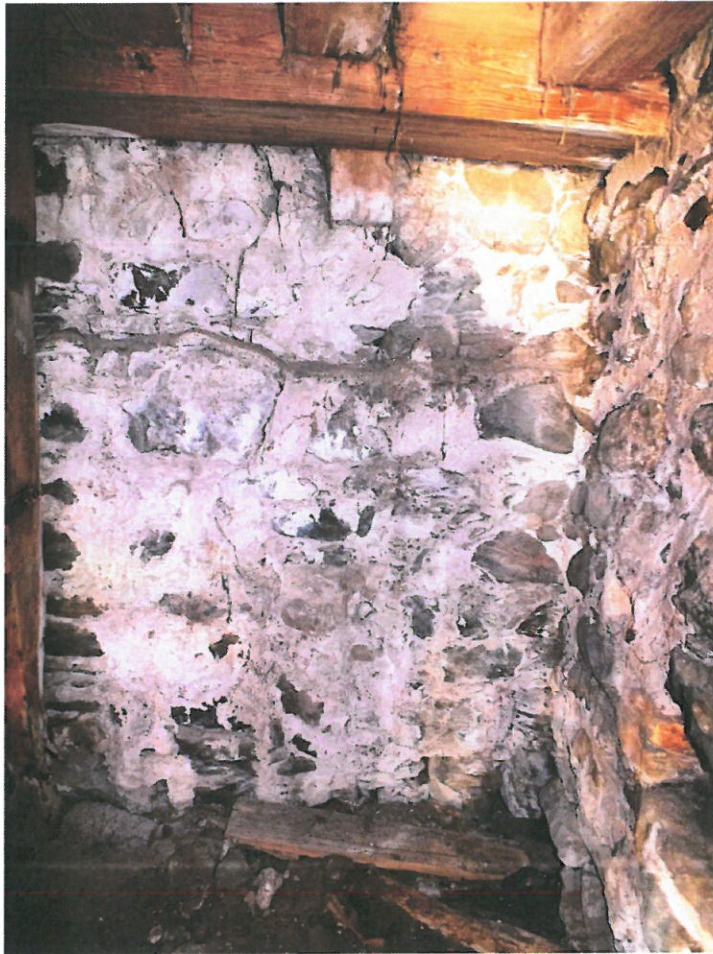
29

Area A – North-West Wall – Vertical Crack

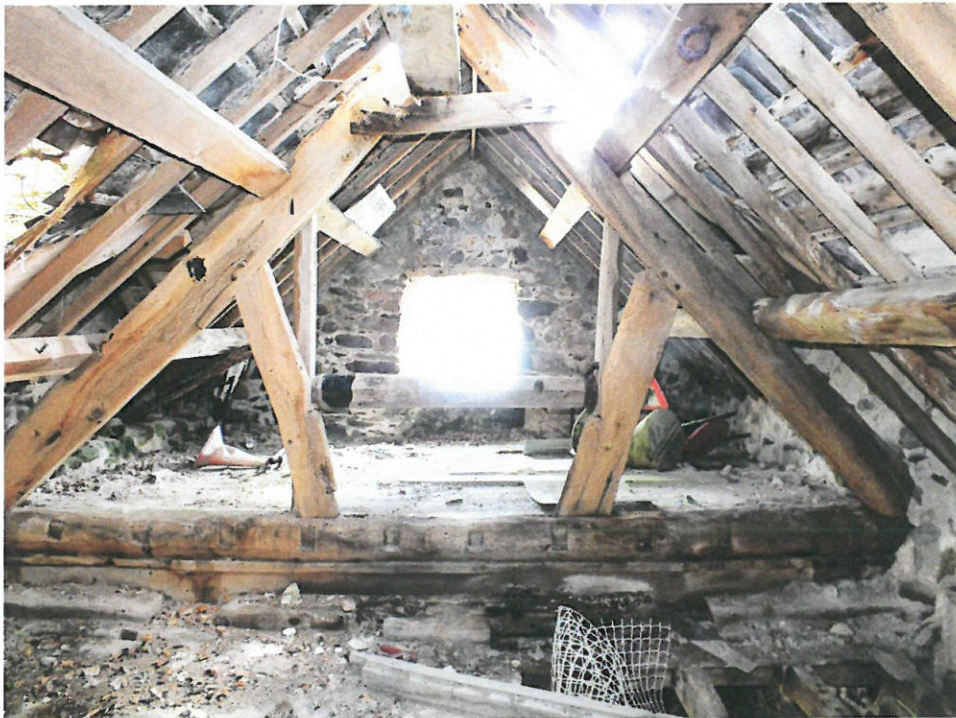
30

Area A – Truss 1

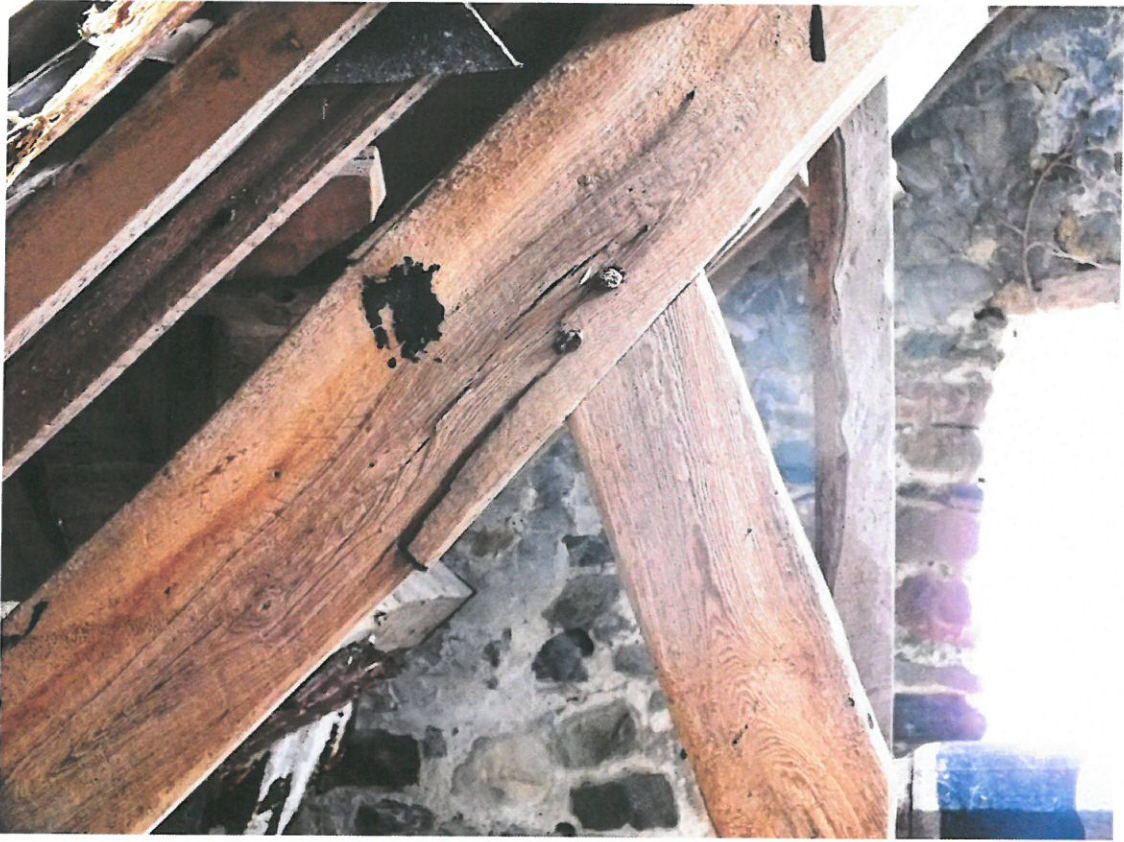
31
Area A – Truss 1

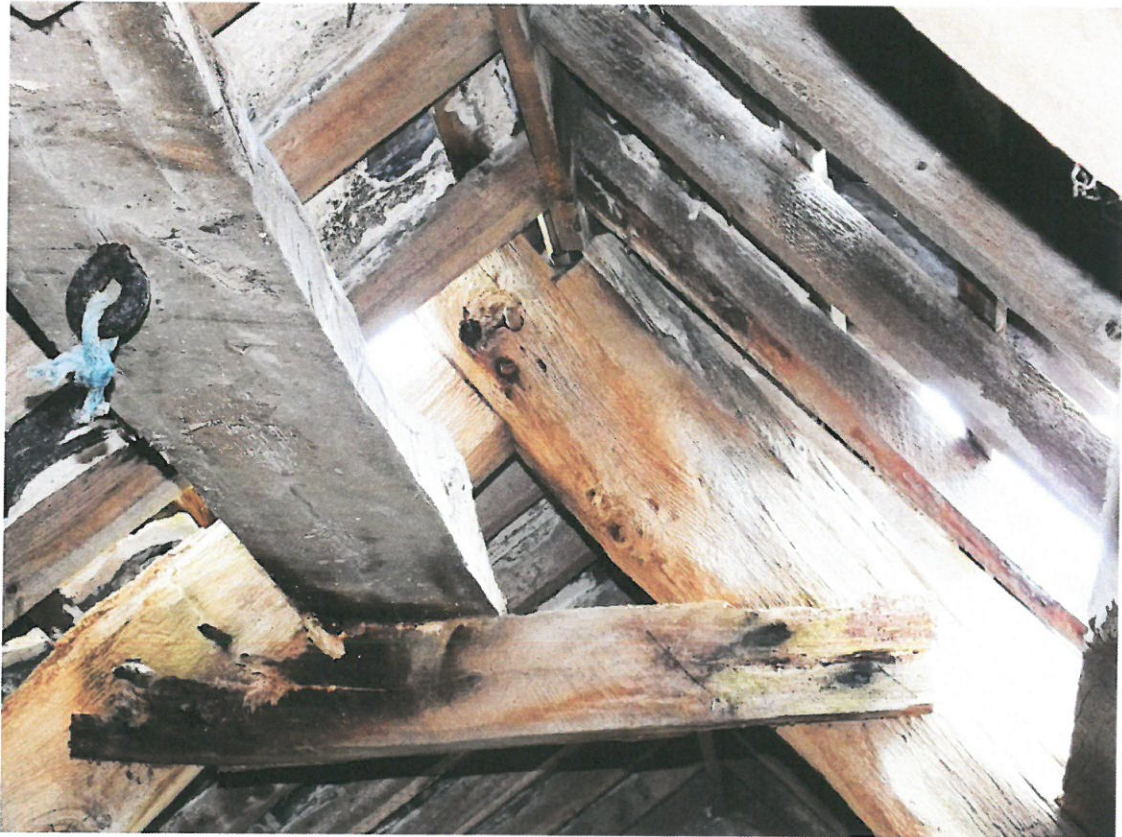
32
Area A – Truss 1

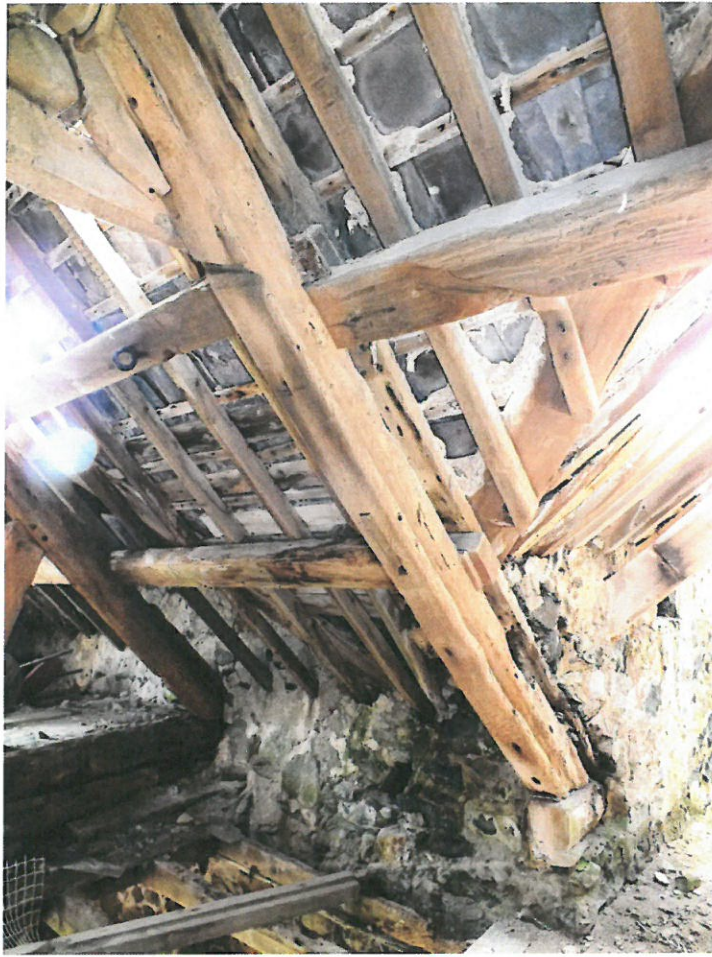
33
Area A – Truss 2

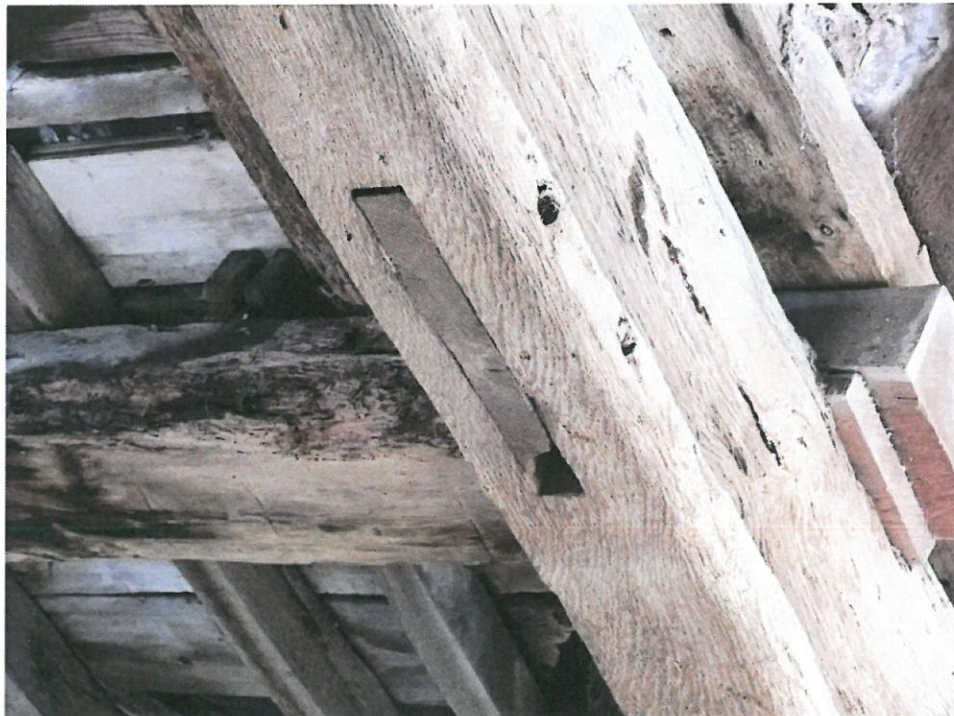
34
Area A – Truss 2 – Collar Removed

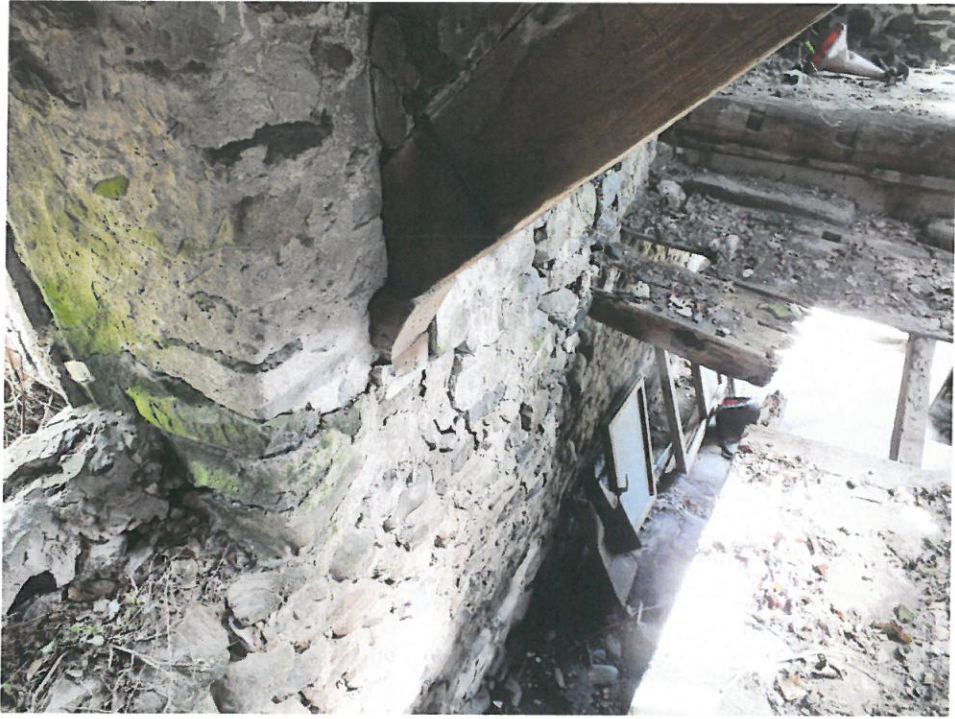
35

Area A – Truss 2 – Bottom Tie Cut Away

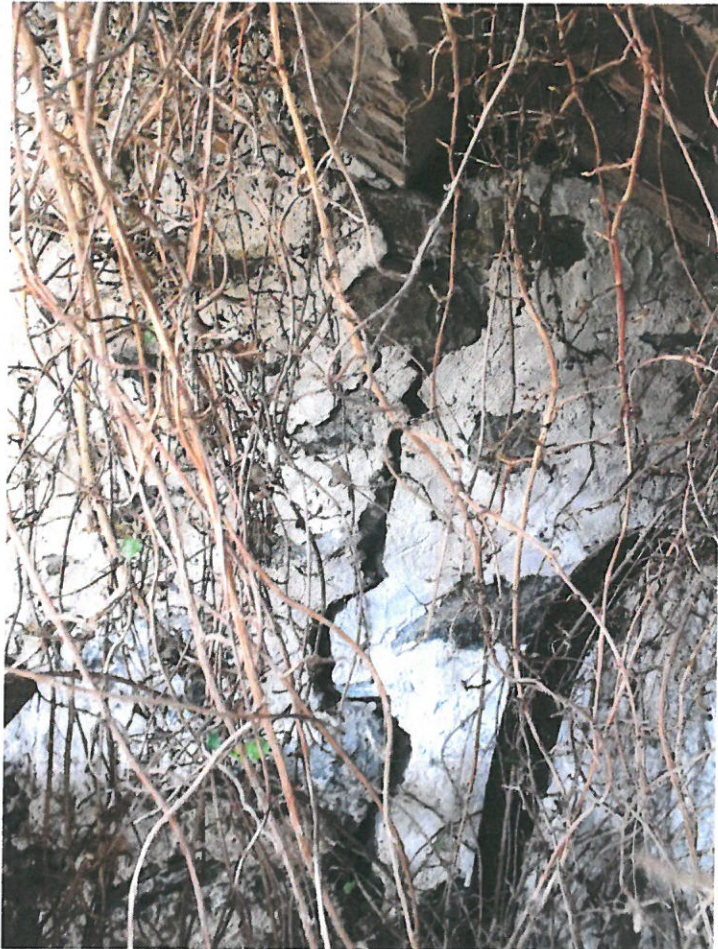
36

Area A – North-West Wall – Vertical Crack Near North Corner

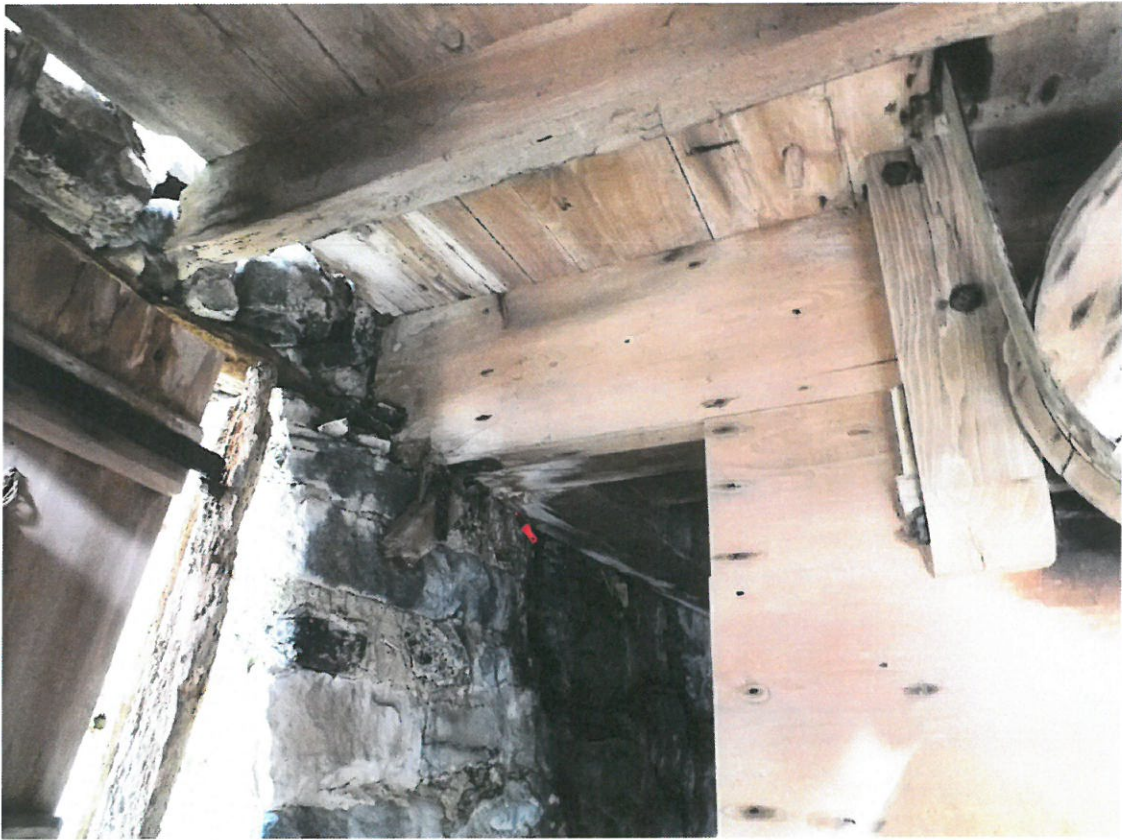
37

Area B – Beam to Machinery Frame into North-West wall

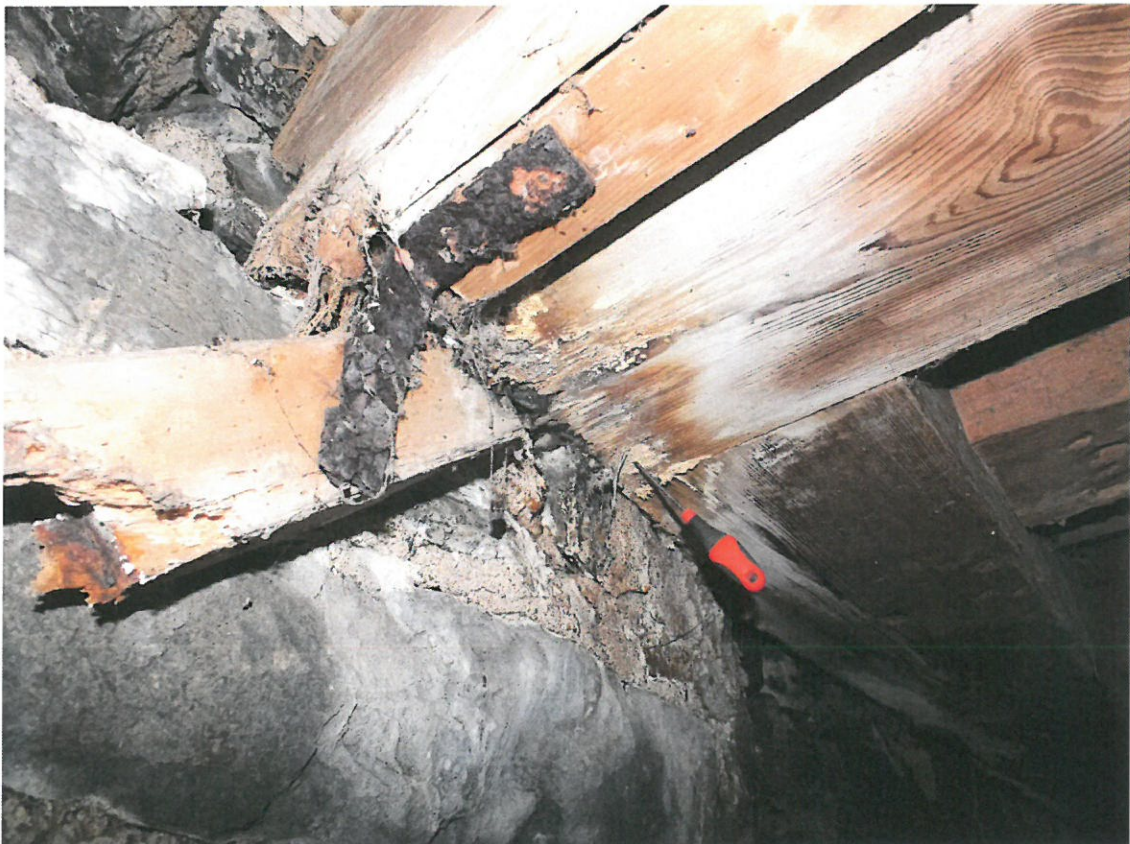
38

Area B – Rot in Beam End

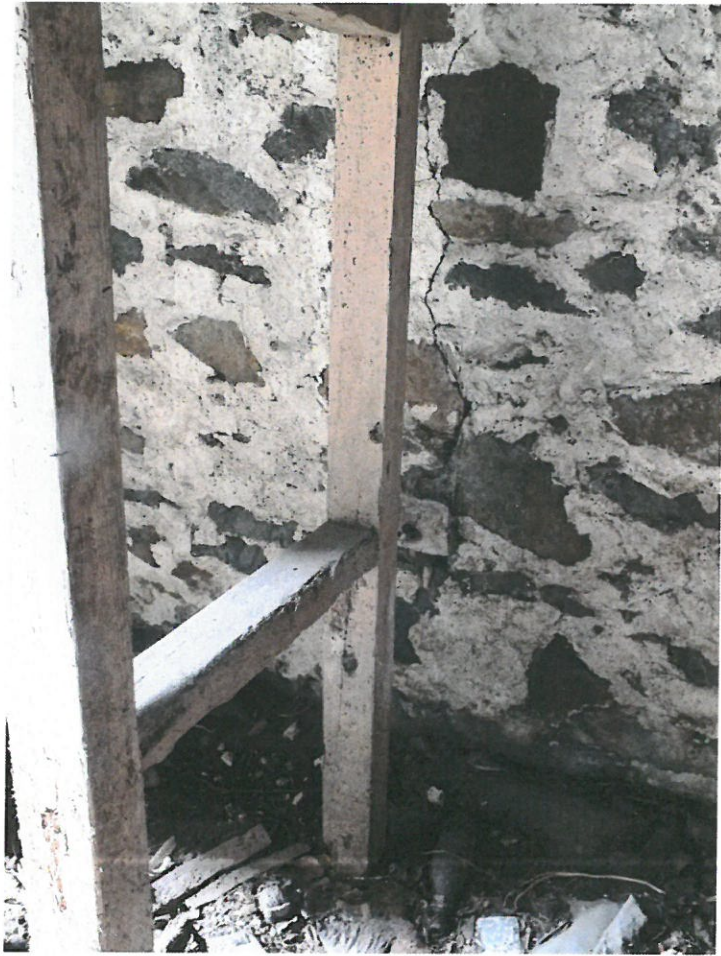
39

Area B – Vertical Crack in North-West Wall

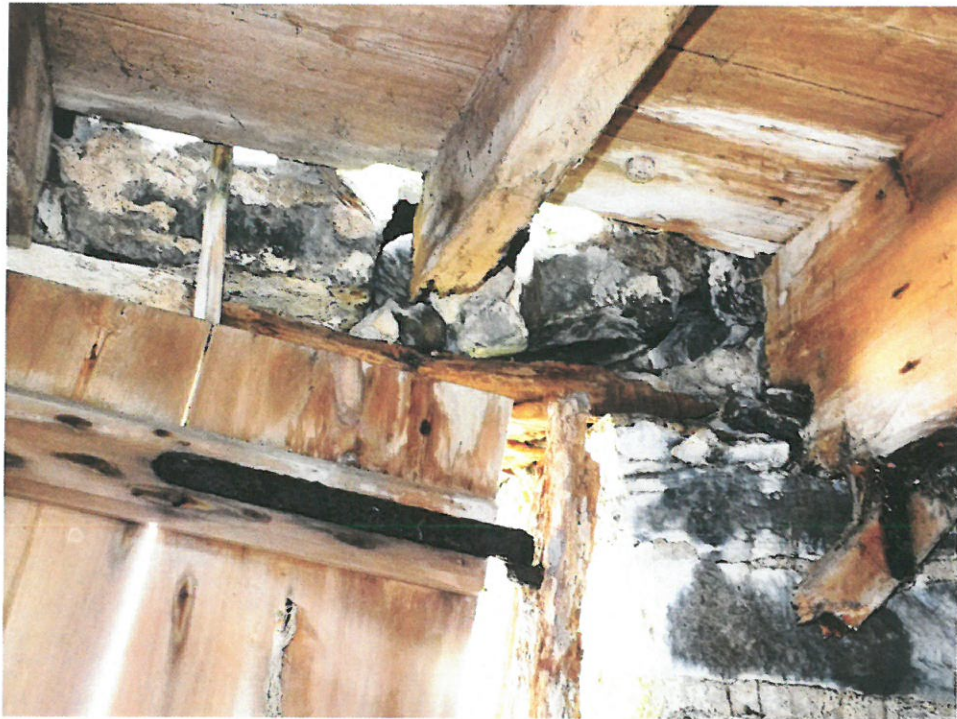
40

Area B – Lintel Failure to North-West Window

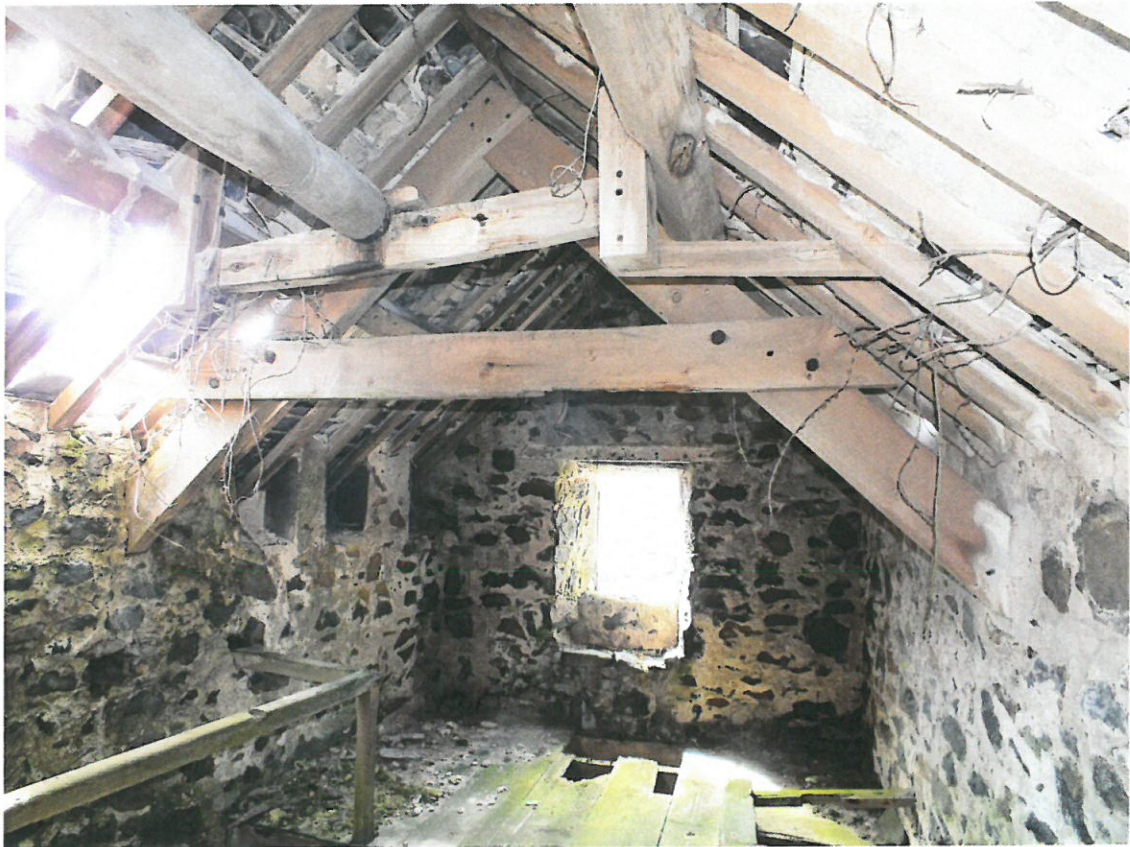
41
Area B – Truss 4

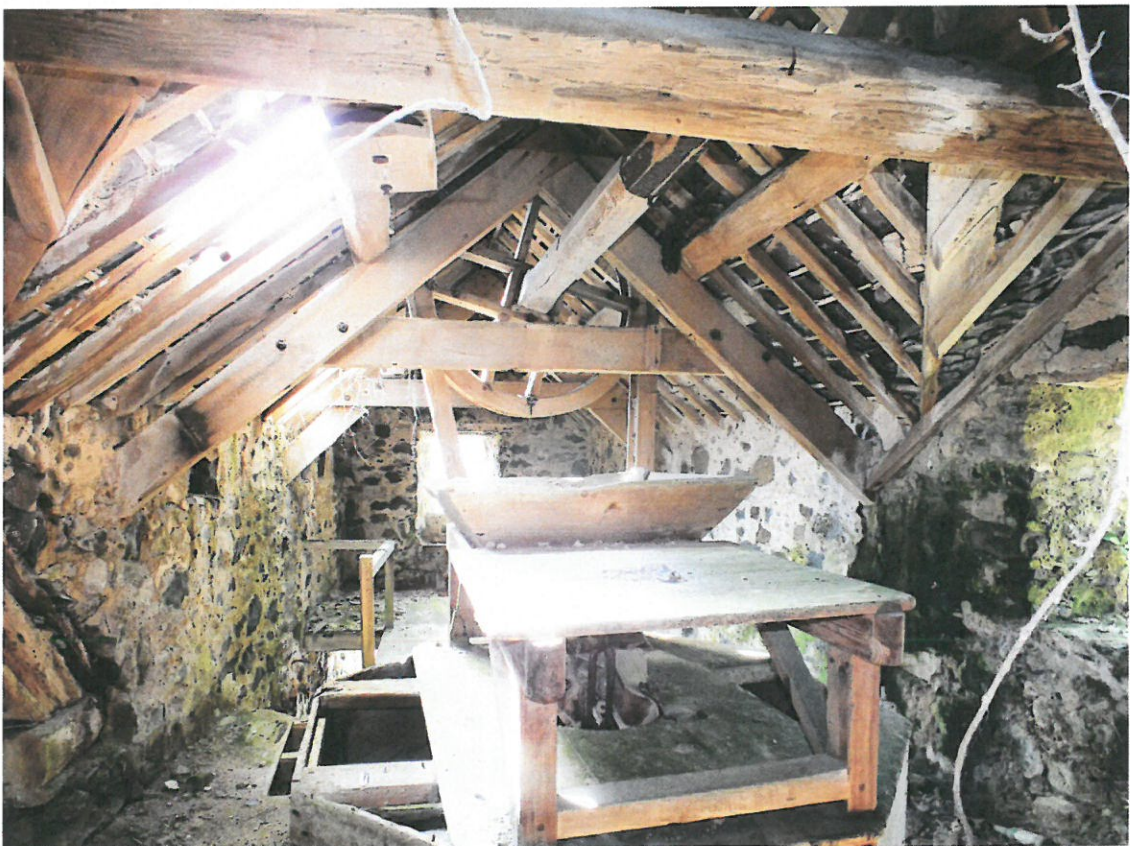
42
Area B – Truss 3

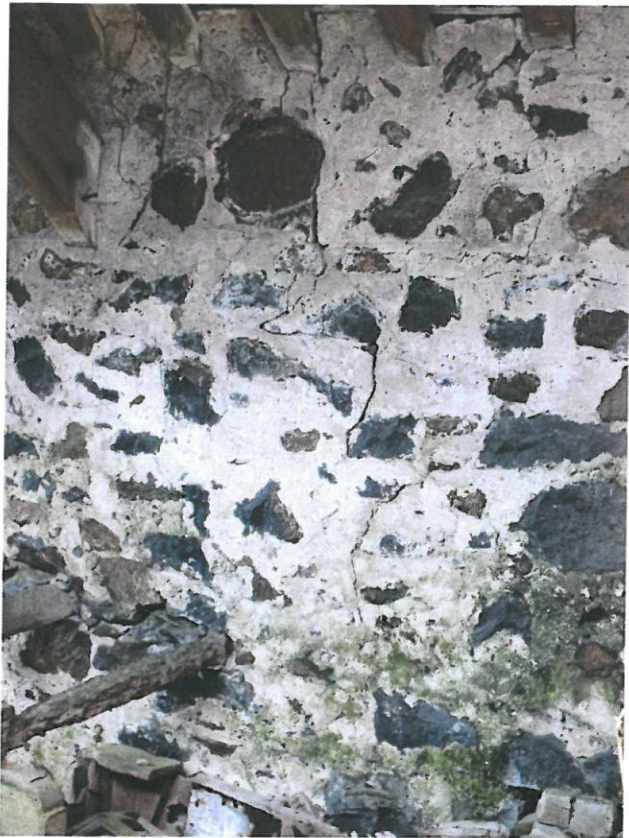
43

Area B – Vertical Crack in North-West Wall

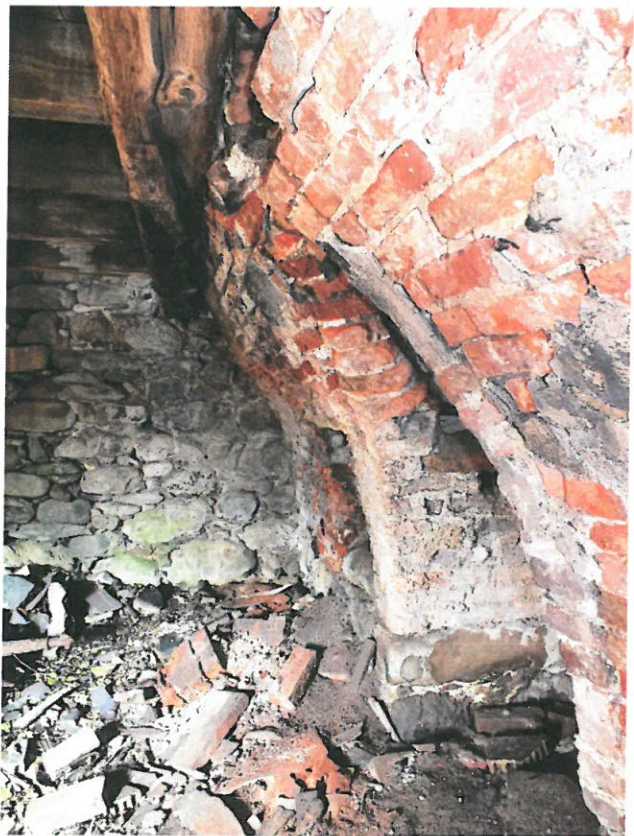
44

Area C – North-East Wall to Grain Dryer

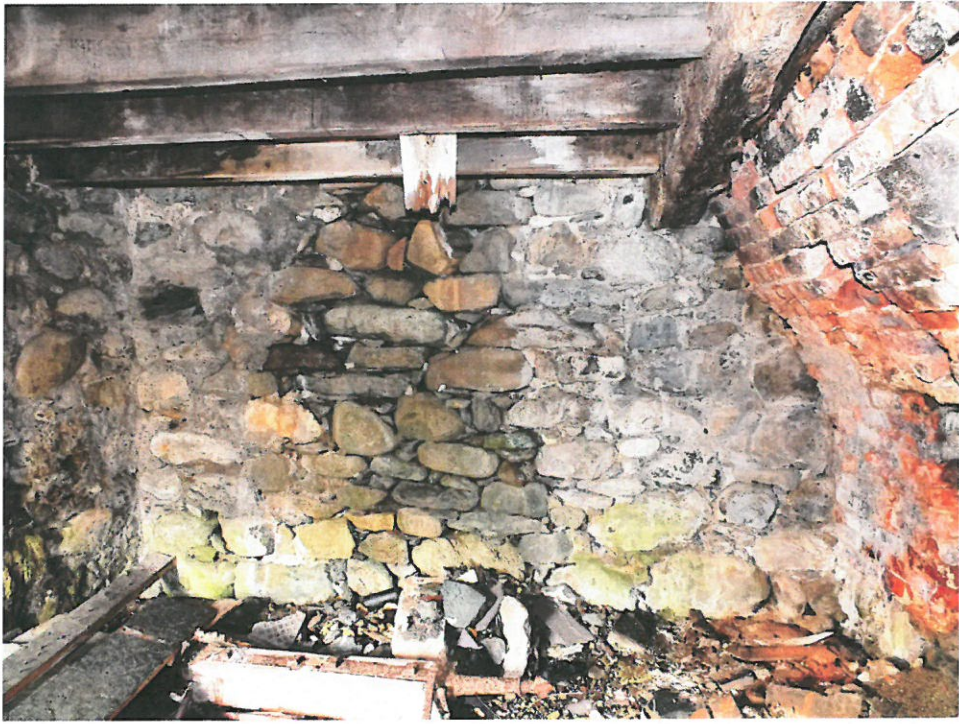
45

Area C – North-West Wall

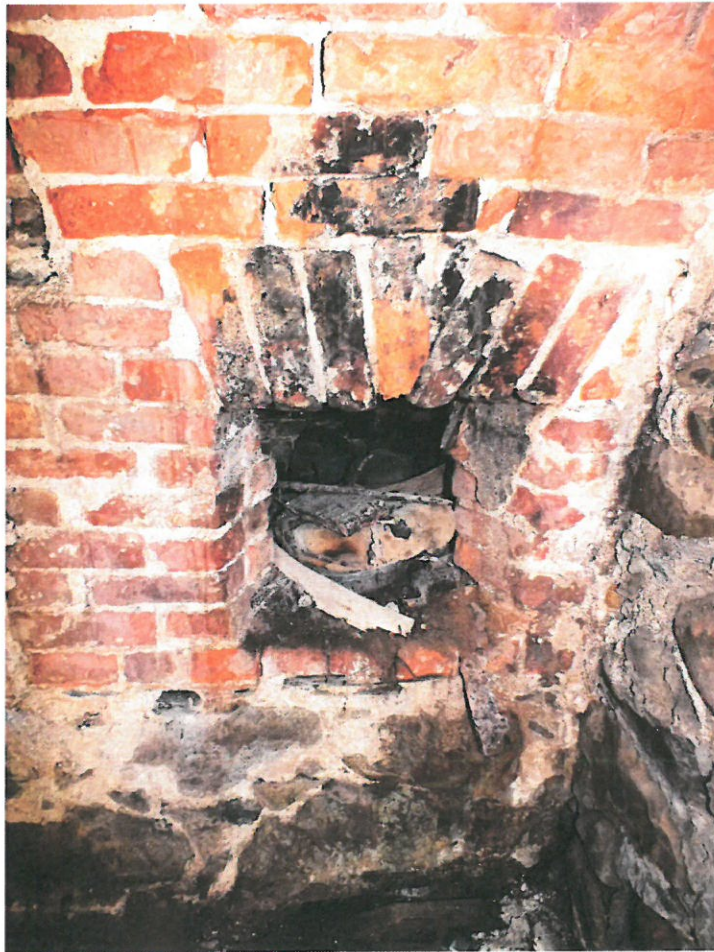
46

Area C – North-east Wall Opening

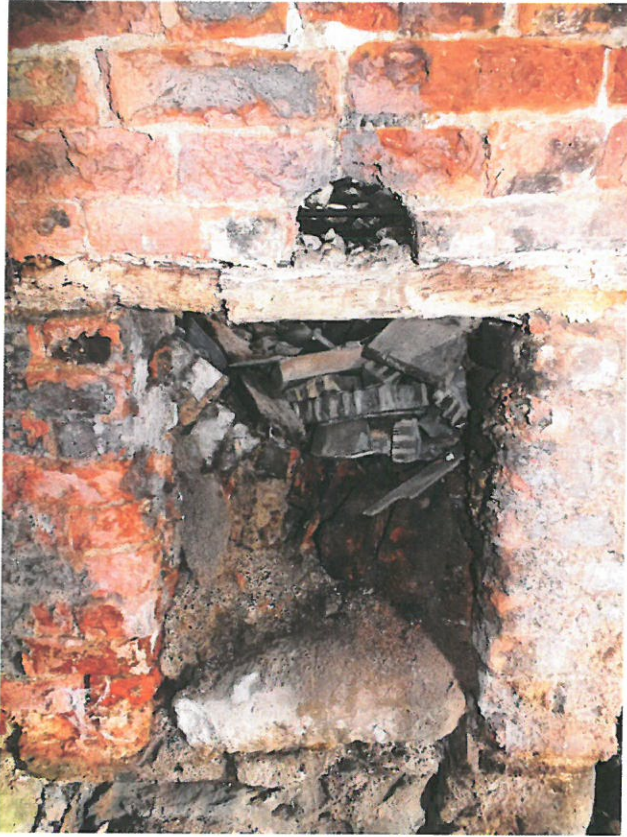
47

Area C – North-East Wall Opening

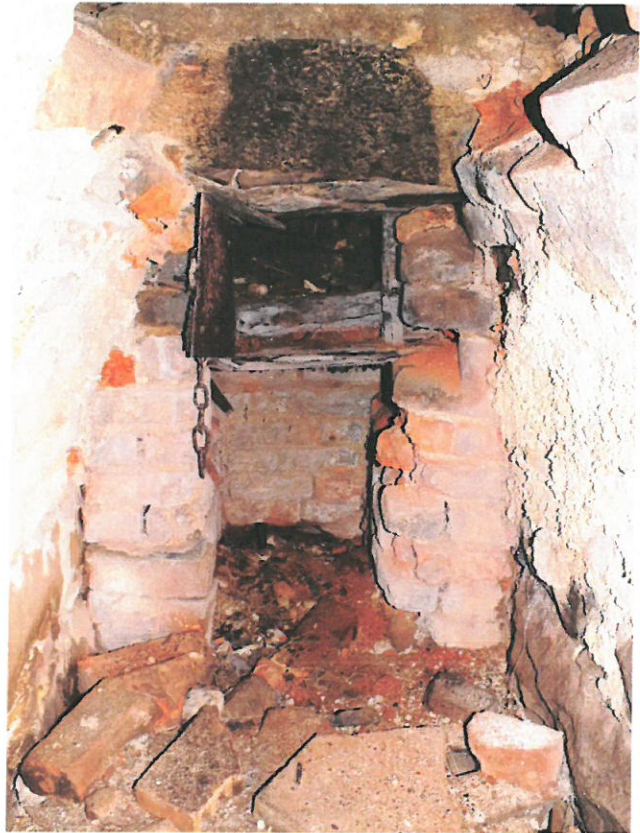
48

Area C – North-East Wall Opening

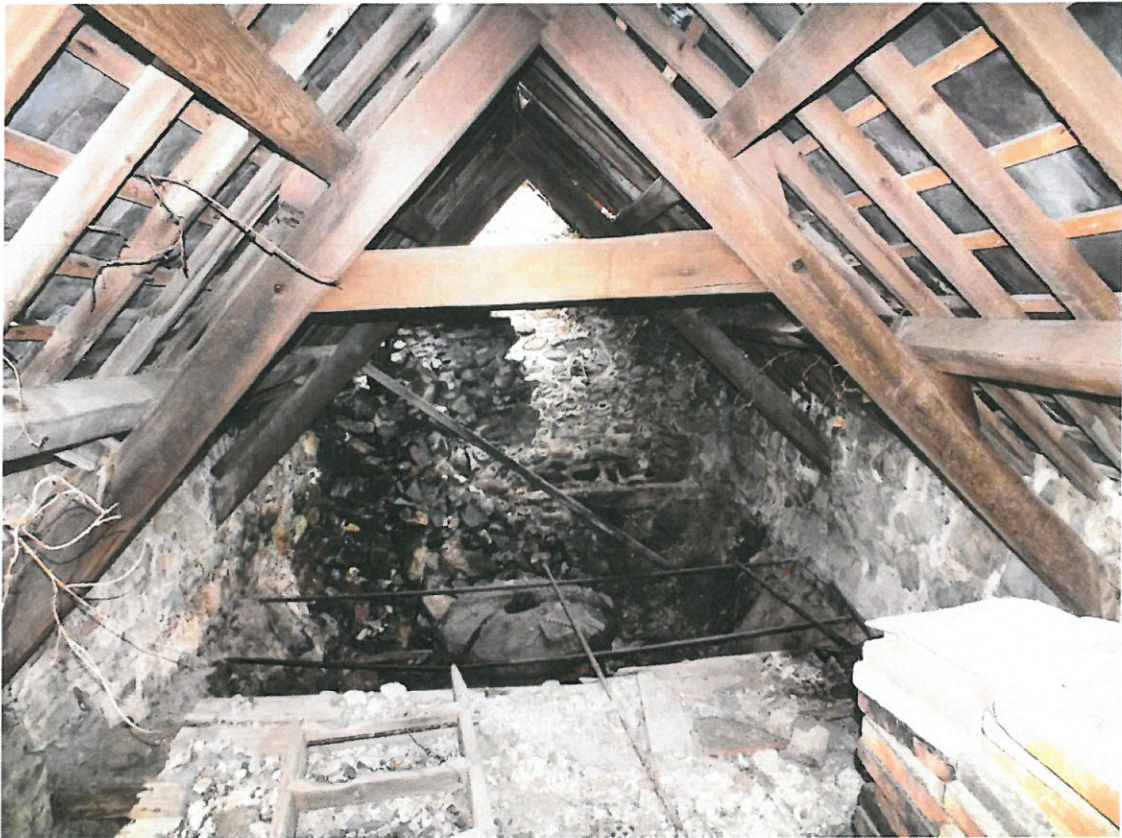
49
Area C – Roof Construction

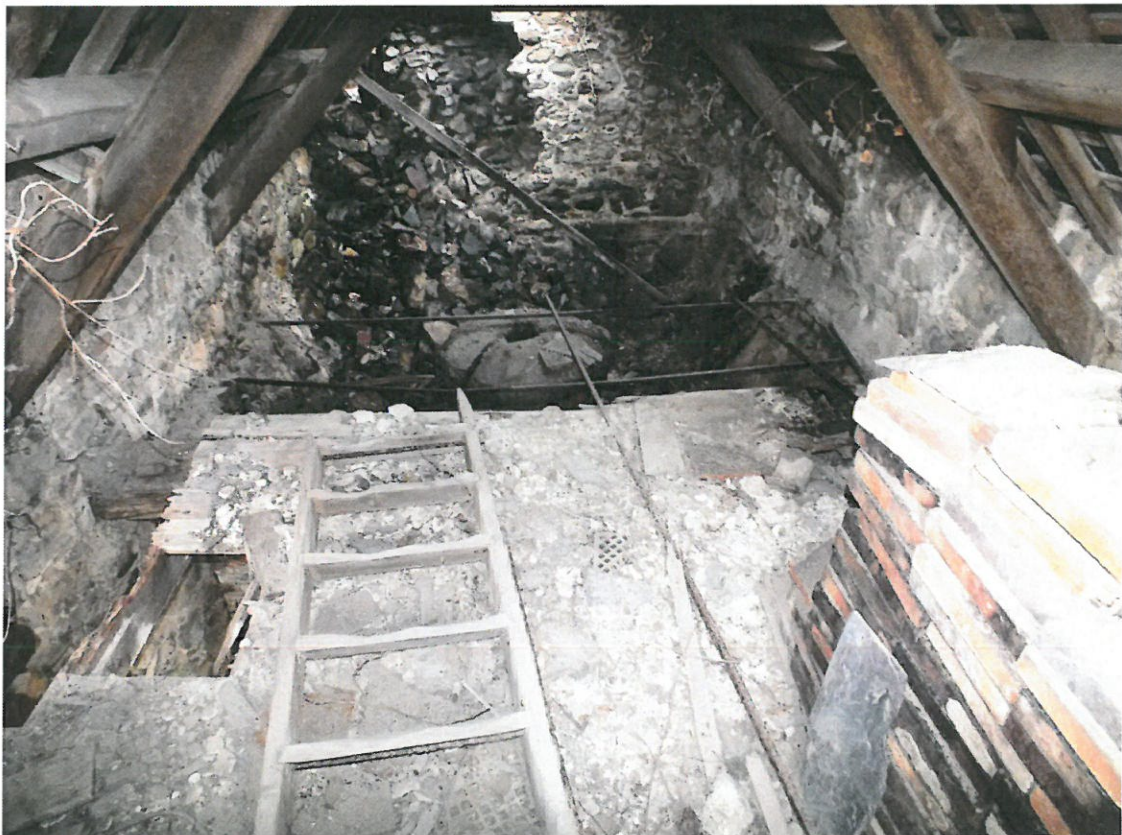
50
Area C – First Floor

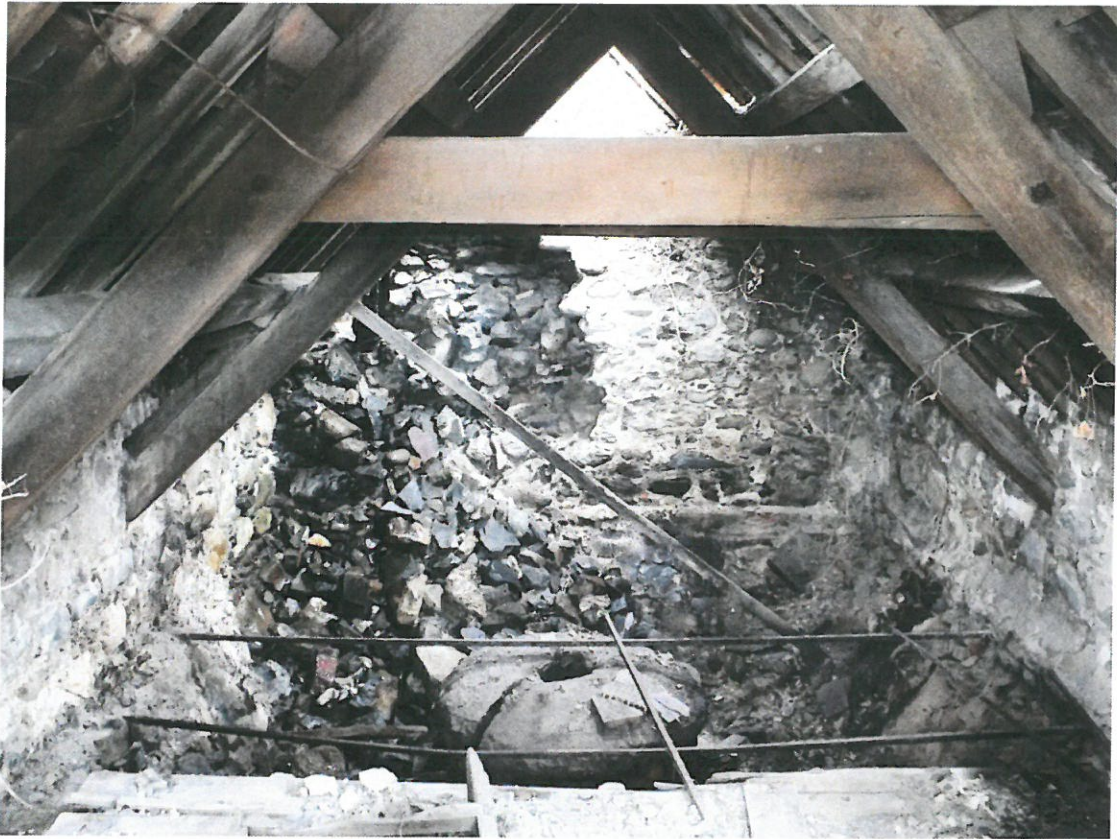
51

Area C – North-East Wall Collapse

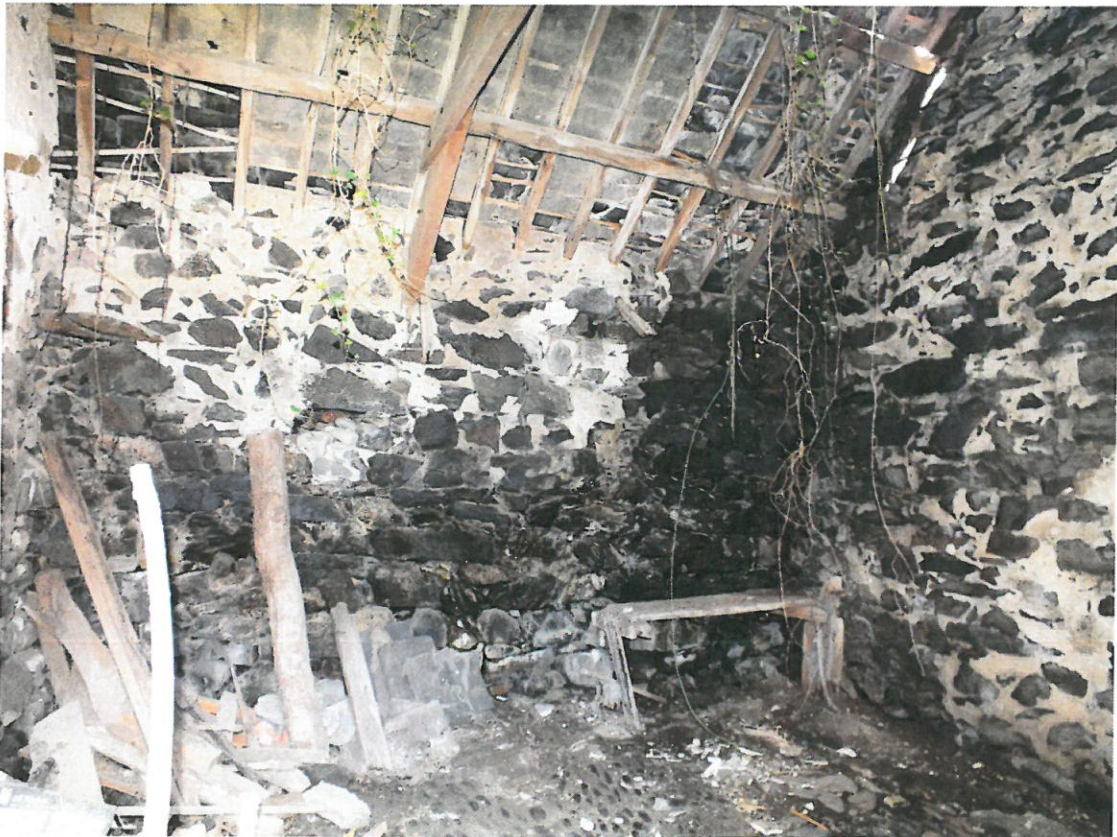
52

Stable – North-West Wall

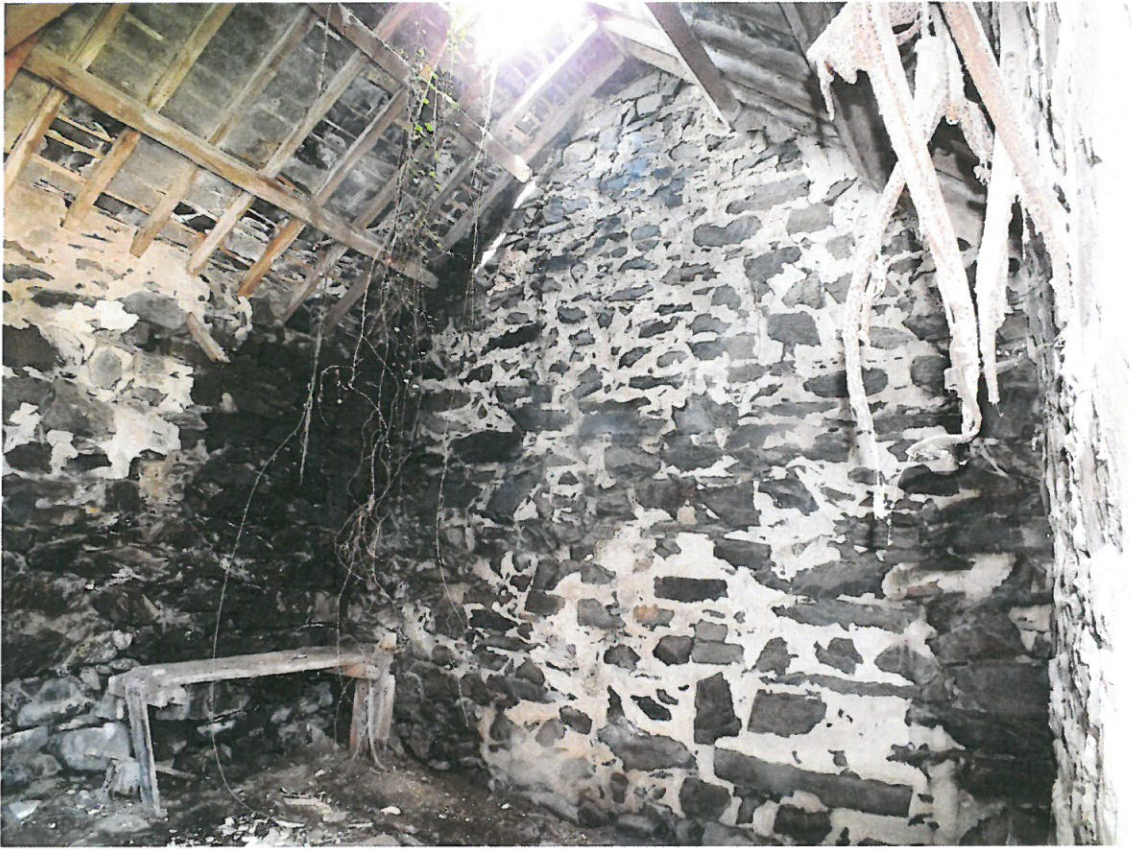
53

Stable - North-East Wall

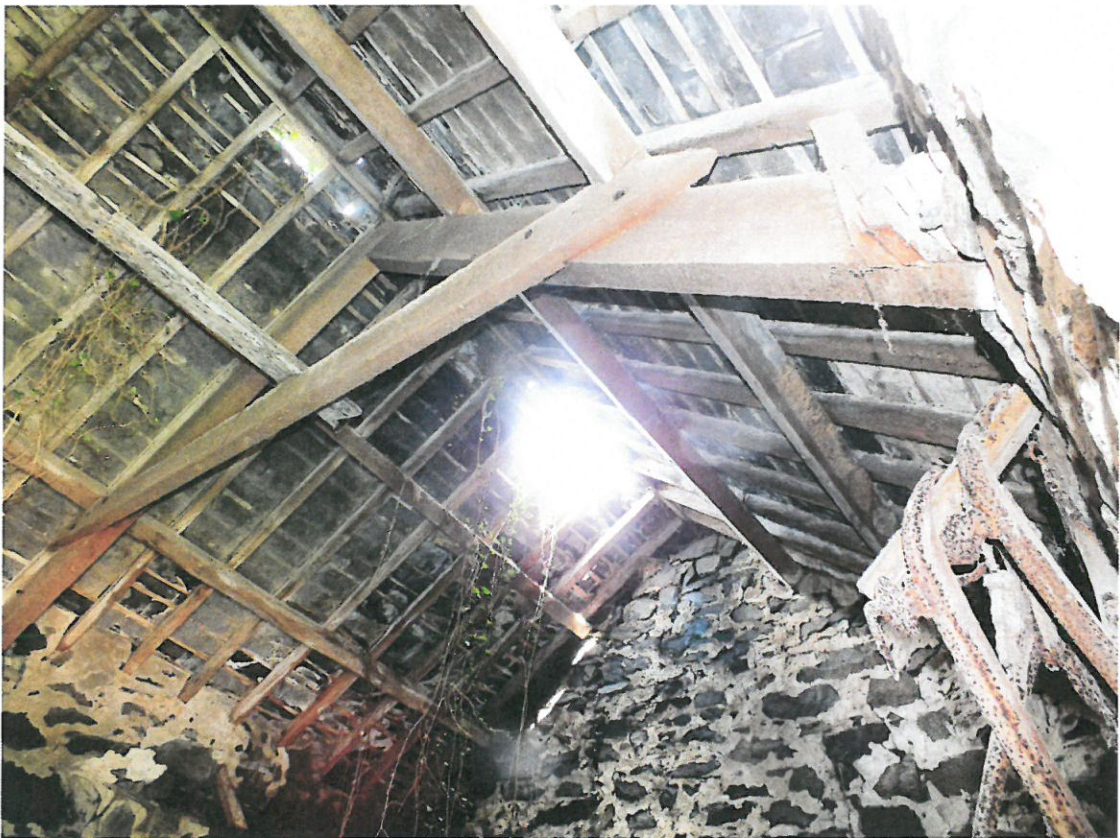
54

Stable - Roof

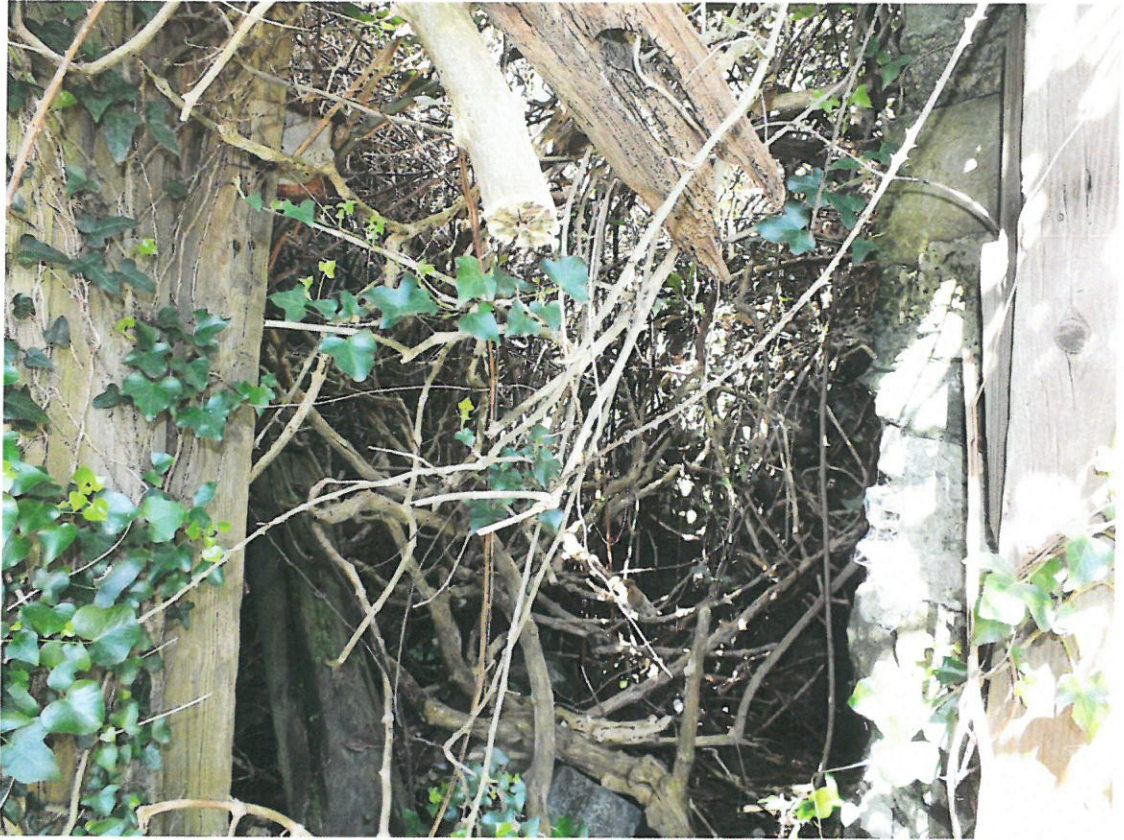
55

Store – Entrance Door
