Outline Condition Survey of Melin Daron, Aberdaron

Date of Inspection: 12 August 2020
Weather Conditions: Sunny, clear, dry 20°C

Issue date: September 2020

Prepared by: Gethin Roberts & Matt Osmont

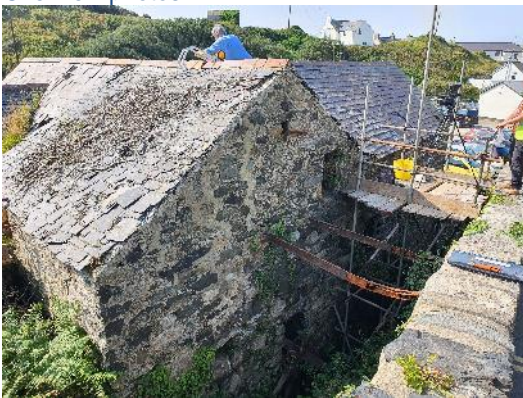
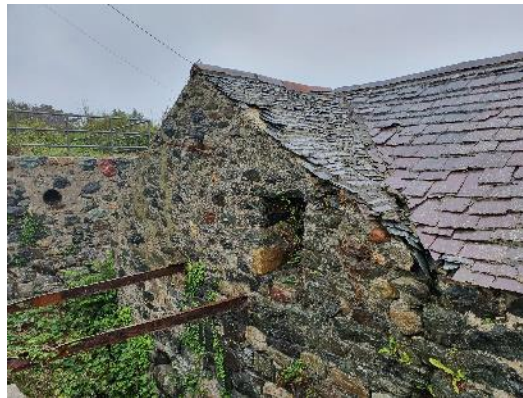
Missing stone to section of outer skin of wall at low level next to opening for water wheel shaft. The majority of the iron elements of the water wheel have rusted but potentially salvageable, however, the surviving spokes and the iron beams are heavily wasted and bowed. Lower section of gable obscured by vegetation and rubble with standing area quite spongy. Minimal mortar present to c.60%. Buttered pointing present to c.40%, generally in satisfactory condition. Evidence of past repair to 3no cracks with buttered pointing with cementitious mortar.

- Renew 3no Launder support "I" beams to match existing (6" x 3").
- All ironwork associated with machinery to be de-greased, de-rusted, cleaned and stabilised. Work to include renewal of the hub fixings.

- De rust shaft and hub ironwork, paint.
- Design and build new 16ft water wheel with cast iron shrouds and timber buckets.

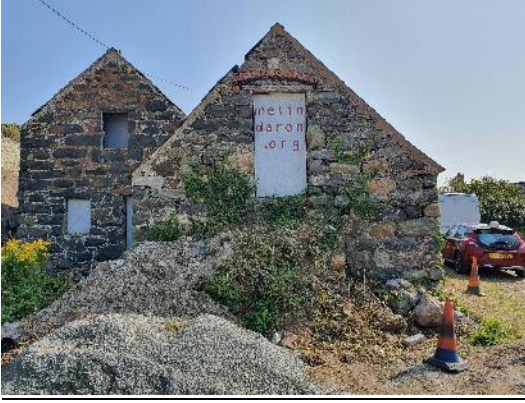
Localised areas to outer skin of stonework and apex of gable wall in poor condition with majority of mortar perished. Unable to assess condition of walls that were obscured by vegetation. External staircase has largely deteriorated and collapsed in areas with the majority under a pile of rubble and masked by vegetation.

- Rebuild external staircase with salvaged stone on site in a roughly coursed method, pointed with hot mix lime mortar. Allow for 25% matching stonework for any shortfall.
- Provide new balustrade to rebuilt stone steps. Allow for 40mm stainless steel handrails and stainless steel spindles welded into stone treads and landing.
- Provide new boarded and ledged timber stable door with new hook and pin strap hinges and locks.

- Allow to replace all ferrous metal work to lintel with new.

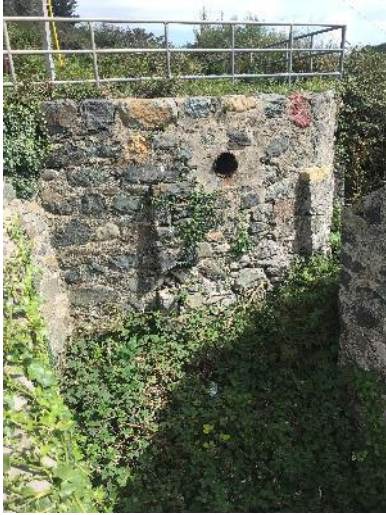
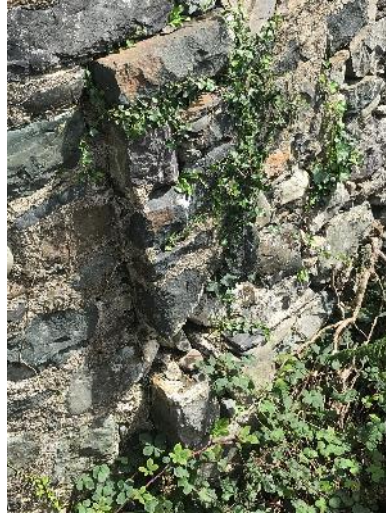
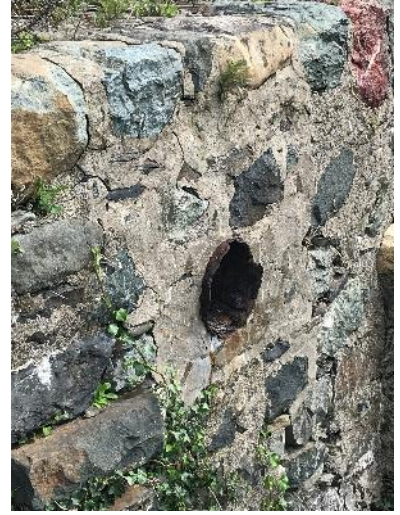
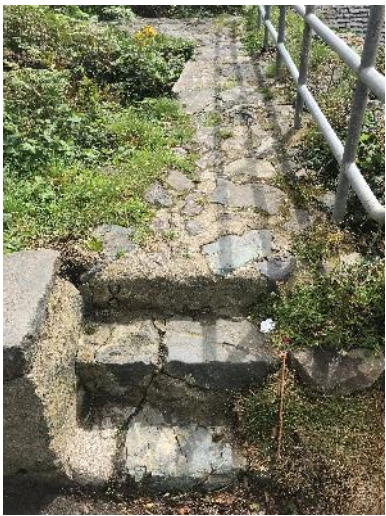
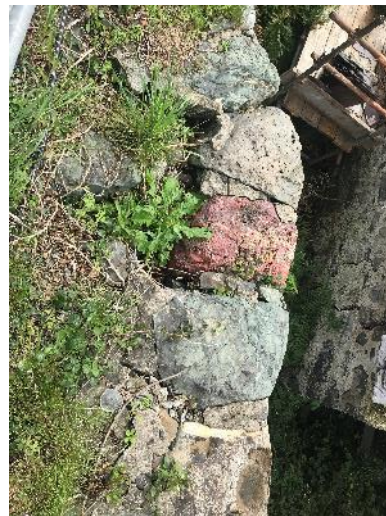
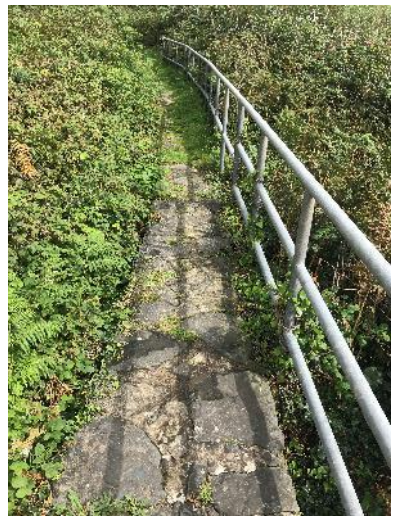
Buttered pointing generally satisfactory. 1no buttress to west wall damaged with missing stone at mid-point. 3no cracks visible to west wall. Wrought iron outlet pipe has entirely rusted and wasted. Steel railings in good condition.

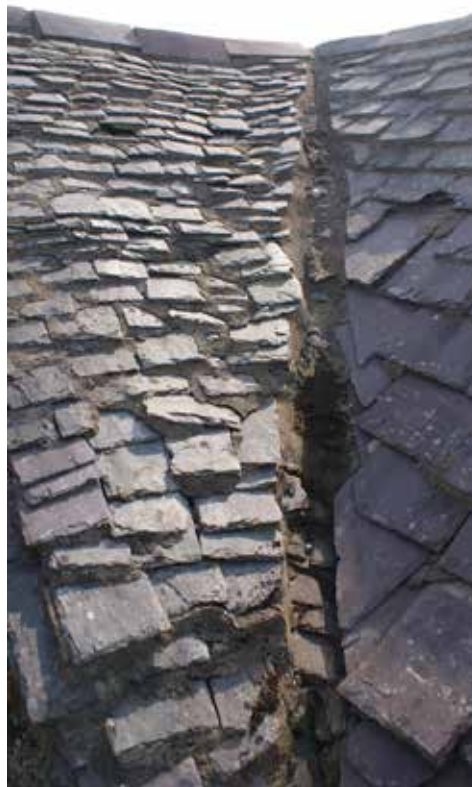
Figure 2. Area 2. The earliest Ordovician age slating from the Blaenau Ffestiniog to Cricieth area. Small random sized slates and the Welsh valley showing the mortar in-fill which is partially removed in the lower section

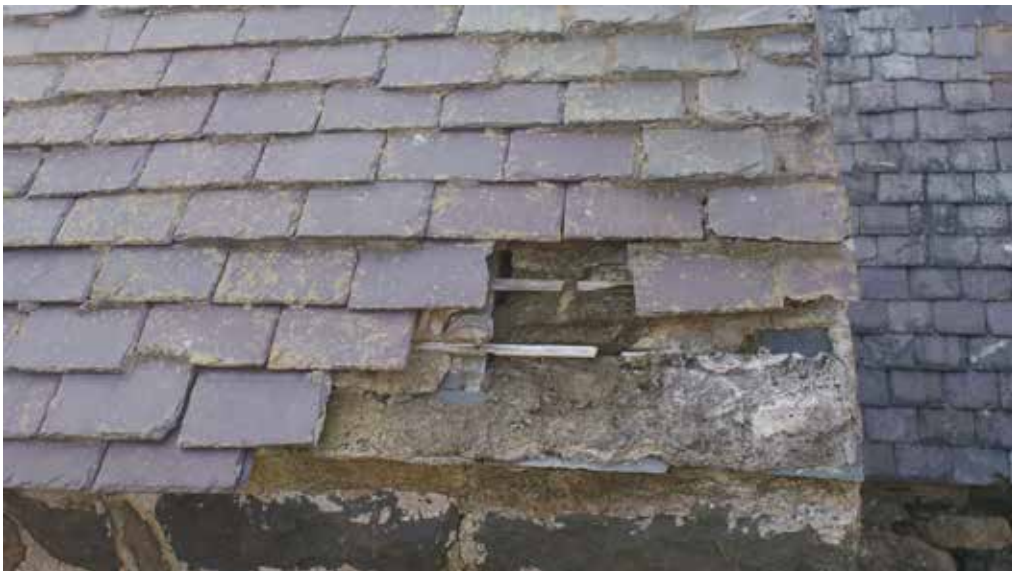
Figure 4. Area 1. Talley slating and mortar bedding of the eaves slates.

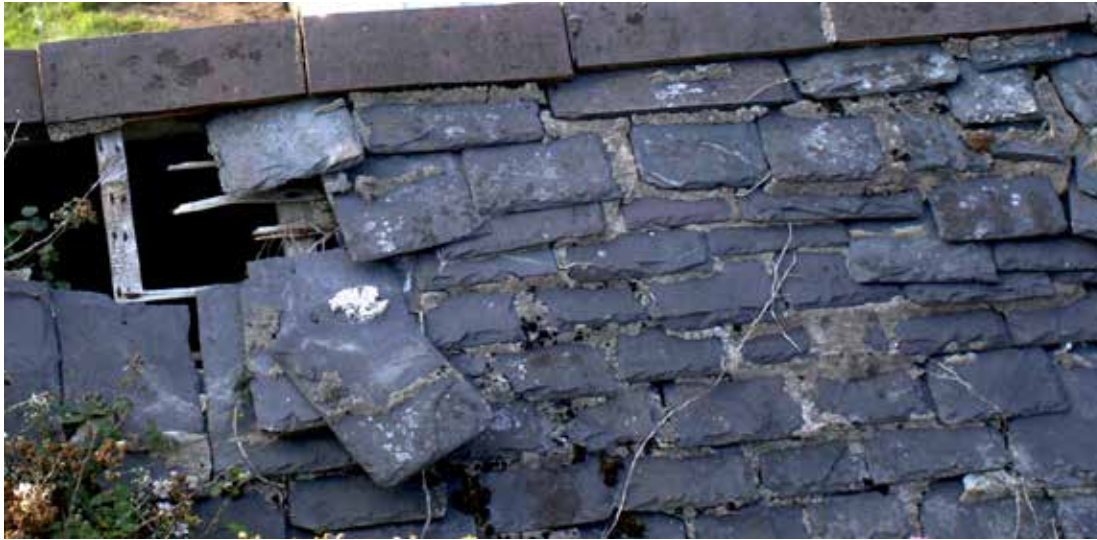
Figure 7. Area 4. Mortar grouting applied to secure failing slating.

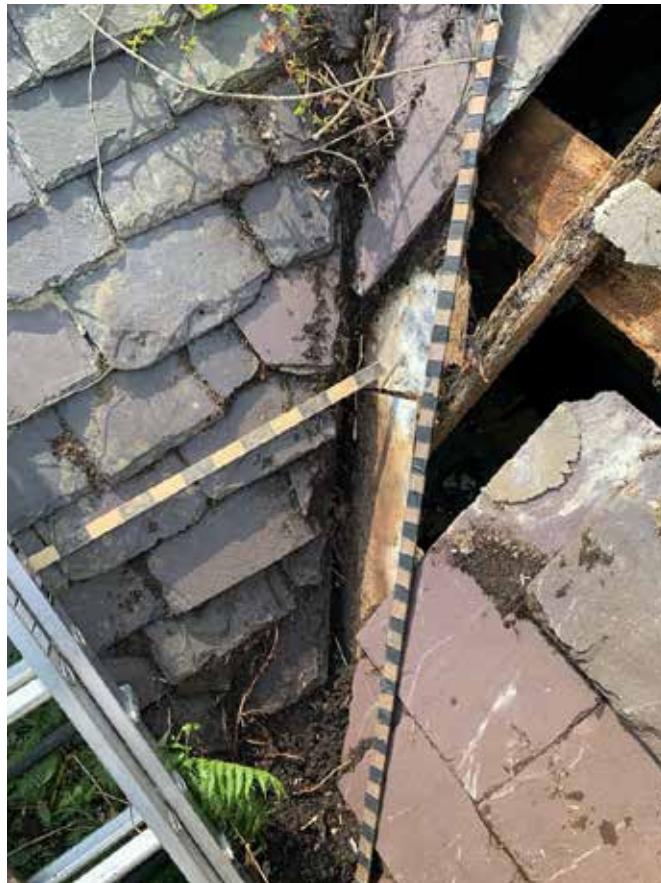
Figure 8. The (split) metal lined valley between areas 4 and 5.

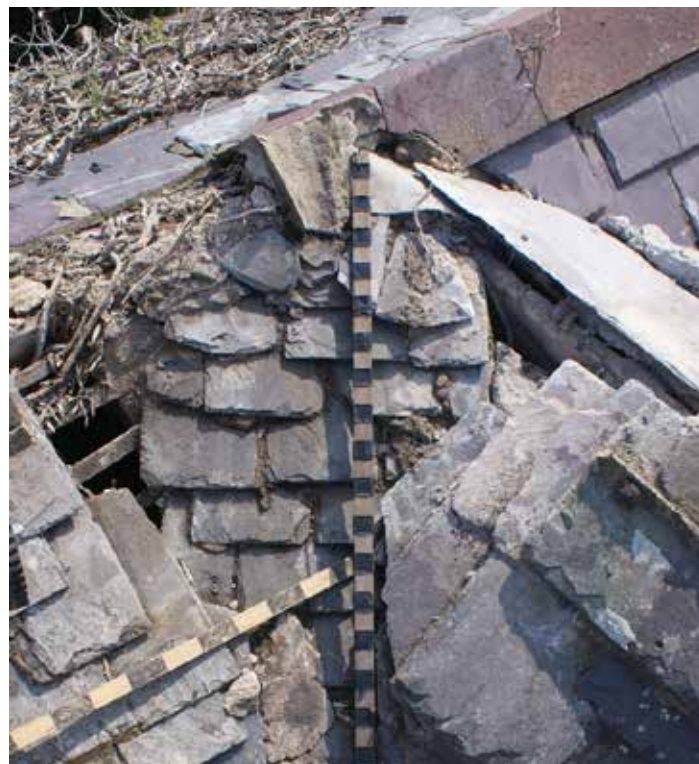
In essence, a Welsh valley is three slate roofs: one forming the lining, approximately 8 inches wide, and overlain by the areas on either side by about 7 inches (Fig 9). The valley slating carries the most rainwater so the slates are longer than the overlying areas giving a larger head lap to prevent leaks. The overlying slates have been bedded onto the valley. The whole valley has been mortar filled presumably to try to deal with a leak.

Figure 9. The Welsh valley showing the slating from areas 1 and 2 overlying the valley slates.

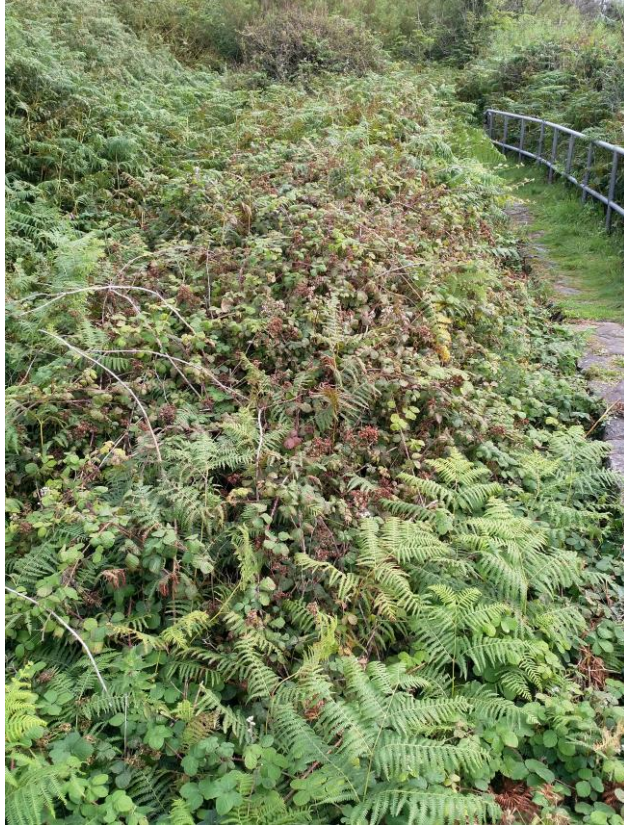
The pond behind the mill is completely overgrown, but the side walls are in evidence showing where the boundary to the pond was.

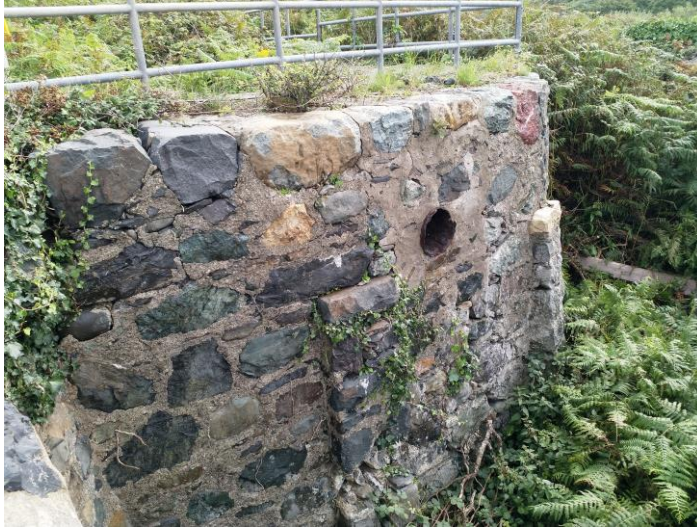
Water from the mill pond is transferred through the end wall via a 12" diameter iron pipe. This is significantly rusted and wasted.

This pipe will either require replacement or conserving where it is and a new sleeve place inside. At present there is no way of controlling the water flow from the mill pond through the pipe and ultimately into the launder. It is suggested that a modern butterfly or gate valve be installed on the pond side of the pipe to provide control. The only real way to control the speed and operation of the mill is by regulating the water supply. In an emergency it is vital that the water can be turned off quickly, so a substantial and easily maintainable closing valve is essential. Historically this would have been a timber sluice gate at the head of the mill pond where the river fed into it.

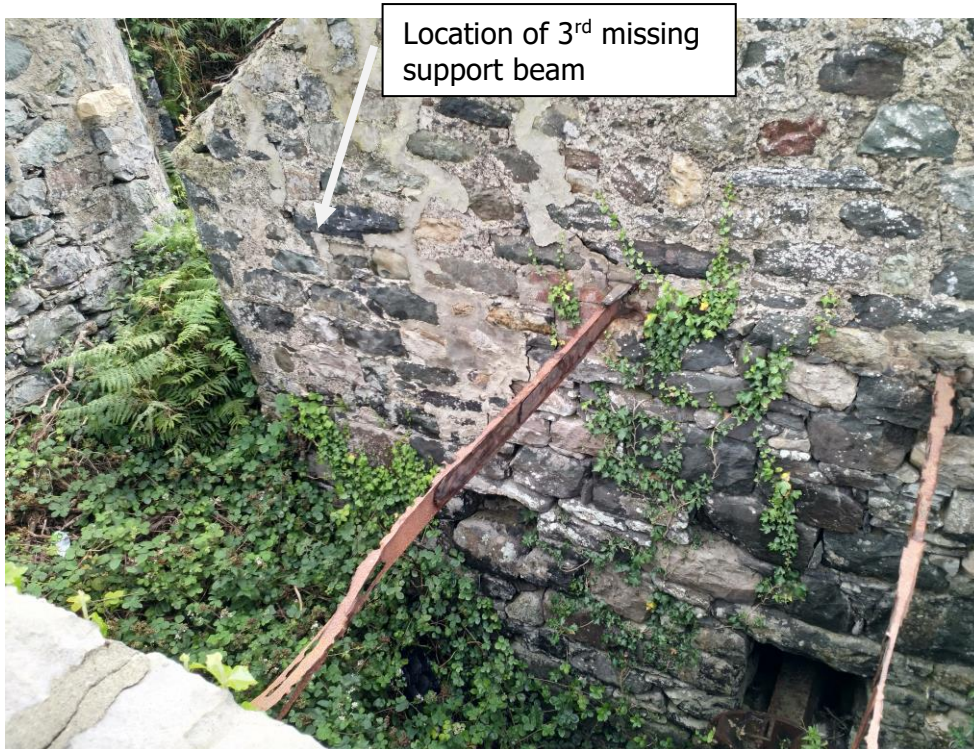
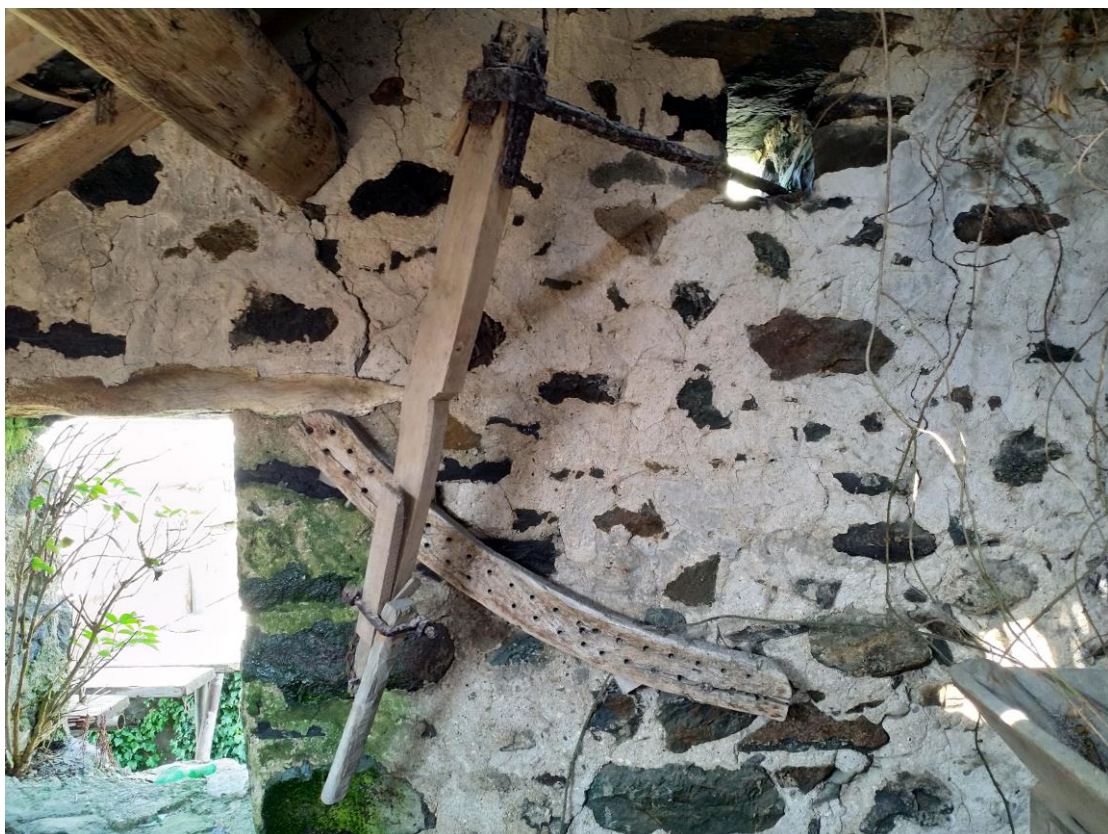
Internal peg board and control arm for the external launder water flap. All ironwork requires de rusting and treating with a suitable oil or paint system for protection. The peg board requires re attaching to the wall in the correct place and the iron rod passing through the wall requires 2 new plain bearings to support it. Fixing of the control rod to the end of the timber control arm should be re wedged.

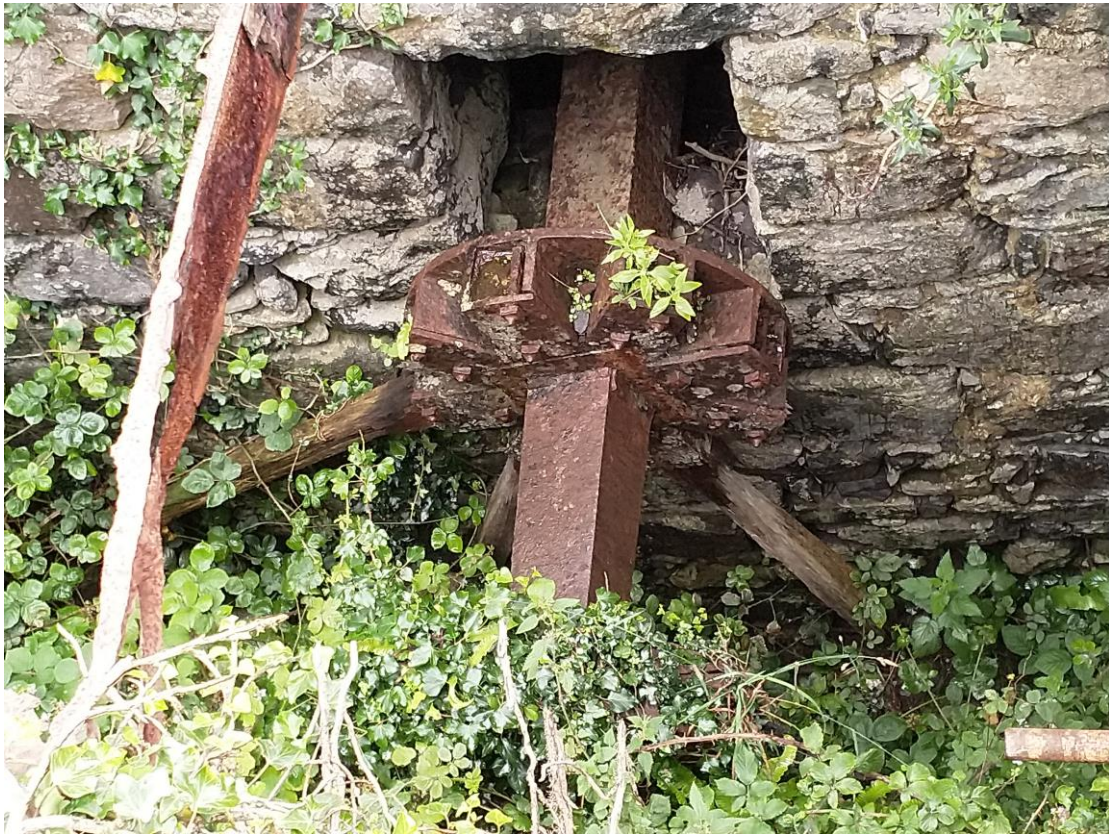
Remains of the waterwheel exist giving evidence of what might have been there. In the "Engineers design brief" there is reference to a 4.8m diameter wheel. It is likely the wheel would have been to the nearest imperial equivalent which would have been 15 ½ ft, although most are to whole imperial measurement so either 15 or 16 ft. A forged wrought iron shaft remains (7" sq) with two cast iron hubs and cover plates.

These can all be reclaimed. They require removal of the rust, painting and renewal of the hub fixings. External shaft bearing was just visible through the undergrowth, its cast iron plumber block can be refurbished but will require a new internal plain bronze bearing. The whole assembly will need re bedding on new timbers fixed down to the wall. There are 16 spokes (8 per side) 4.5" sq all need renewing. The wheel is completely missing and no evidence remains as to what the shrouds or buckets were made from. Based on the amount of other iron components i.e shaft and hub it is reasonable to assume that the shroud was manufactured from cast iron in sections with either timber or iron buckets. For pricing purposes, we will assume cast iron shroud with timber buckets.

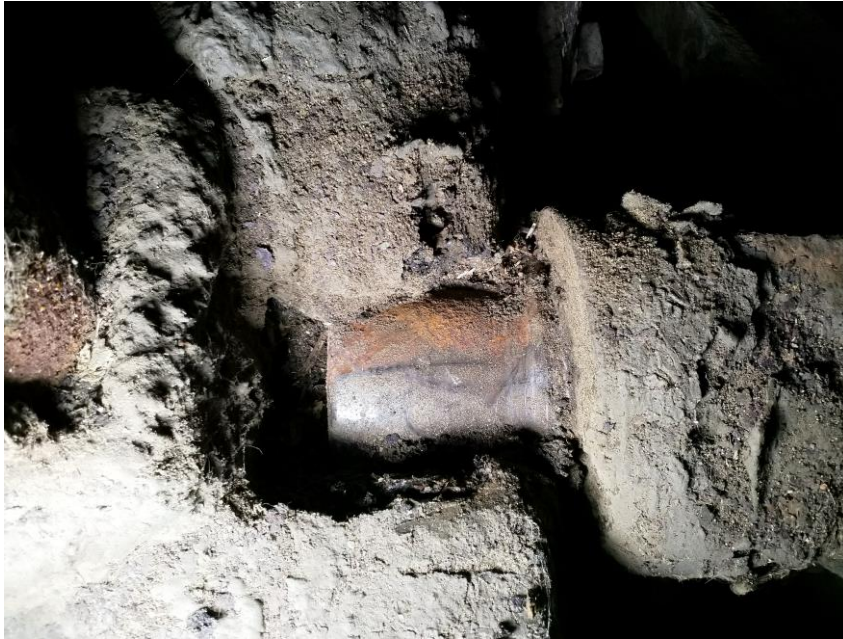
Internal shaft bearing journal is smooth and the cast iron plumber block remains. It will require a new plain bronze bearing to match the ware on the shaft journal.

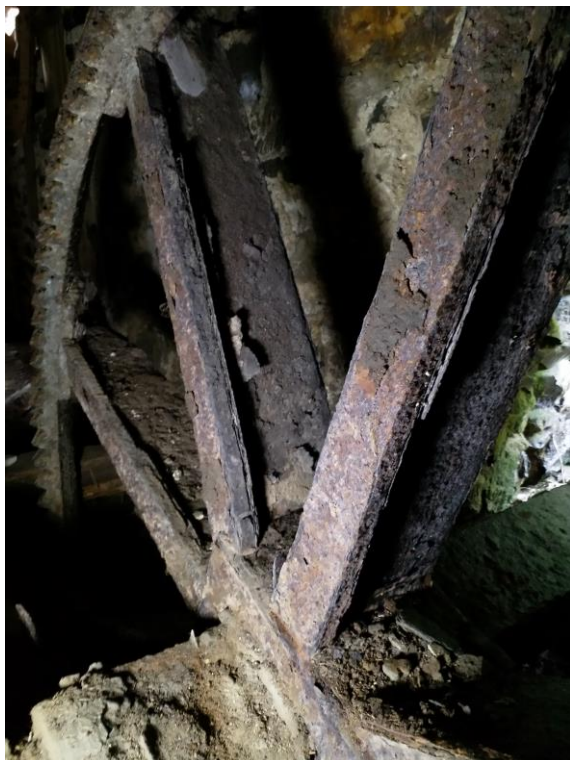
The Pit wheel is cast as a single grey iron casting with separate castings for the teeth. These appear to be split into segments meaning they can be replaced when worn. The pit wheel is wedged onto the shaft and appears secure. It is heavily rusted but there is minimal section loss on the main spokes so is serviceable. The wheel measures 88" diameter and comprises 112 teeth with a pitch between them of 2".

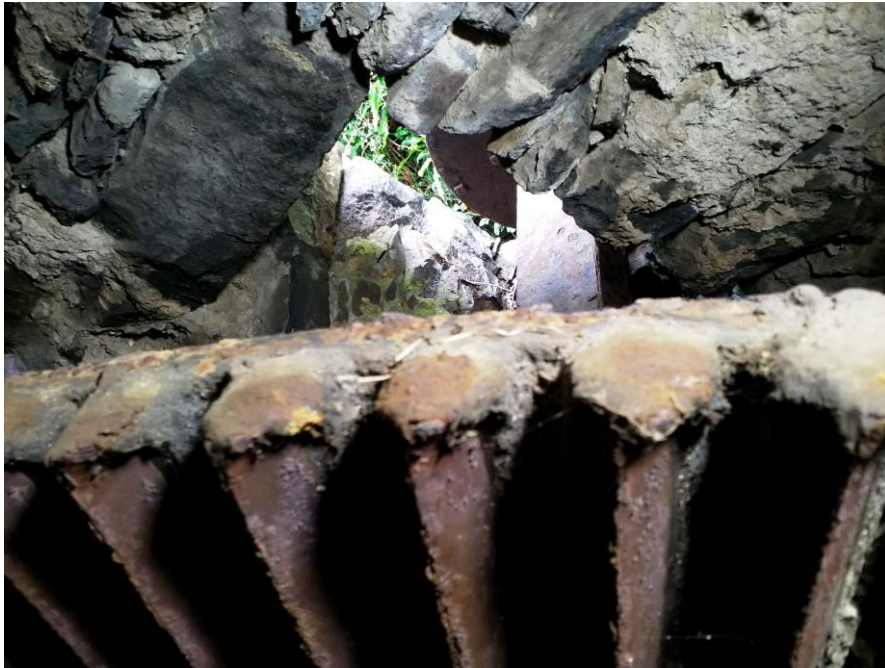
The teeth are heavily worn, if the mill was just going to rotate without having a load put on it (i.e. by milling) then the teeth would operate. As the plan is to mill these teeth will need to be replaced to prevent the risk of failure in the future.

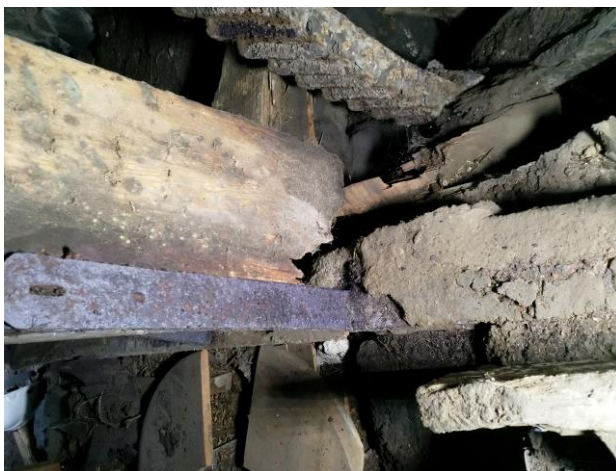
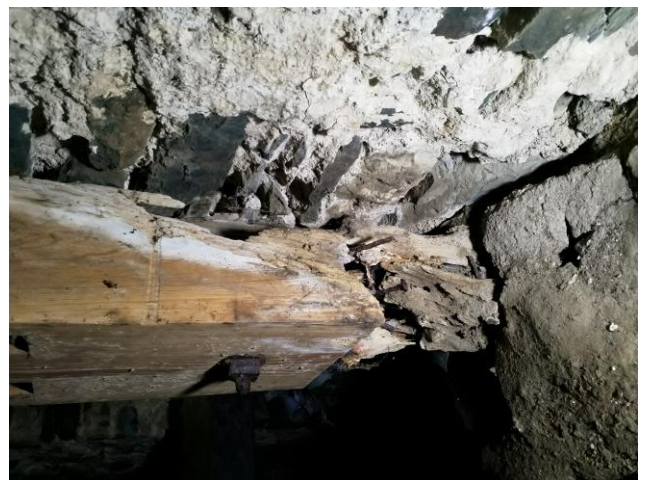
The hurst frame provides support for the millstones, upright shaft, some ancillary drives and stone nuts. It is manufactured in general from 12" x 7 1/2" timbers and is generally sound apart from where two vertical sections meet the floor and are significantly rotten. West upright (to the Left of the pit wheel when looking from the inside out) requires a replacement section to be scarfed in 12"x 9.5" x 1ft long. East upright (to the right of the pit wheel) requires a new section scarfed in 12" x 7.5" x 22" long

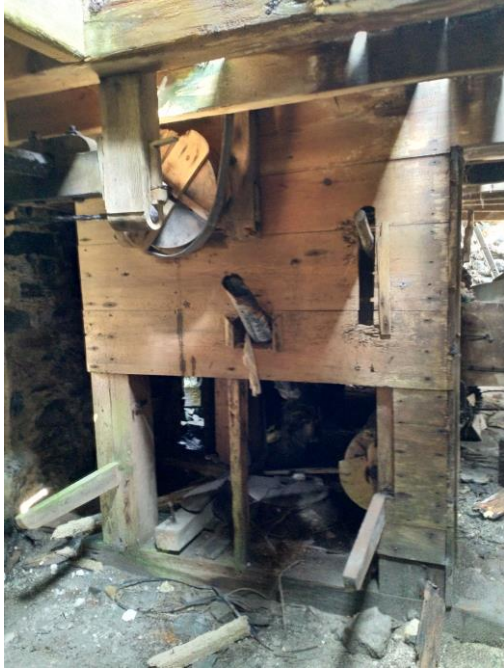
Panelling to the outside of the hurst frame is missing in one area and should be replaced using 16" x1" boards of the same timber

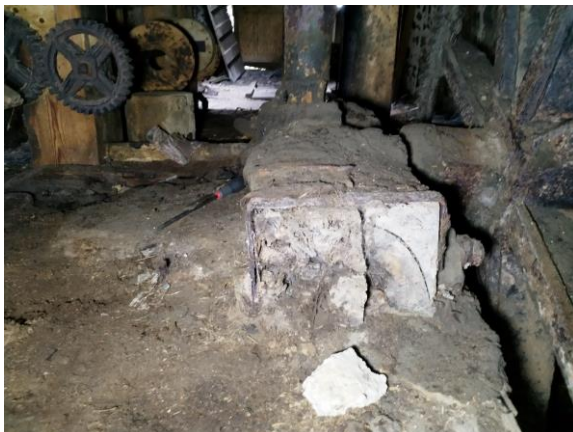
- 1- Upright shaft is driven from the pitwheel through the wallower. At the base is a cast iron adjustable block with a plain bronze bearing (foot bearing) Both appear serviceable although the thickness of the foot bearing was not checked. Top bearing cast iron block is reusable, requires cleaning and will need new bronzes as these are visibly worn. There is significant old grease and debris build up around the bottom of the shaft that will need removing. Foot bearing support timbers have significantly rotted and will require replacement. These are 7.5"x8.5" 34" long 2nr required.

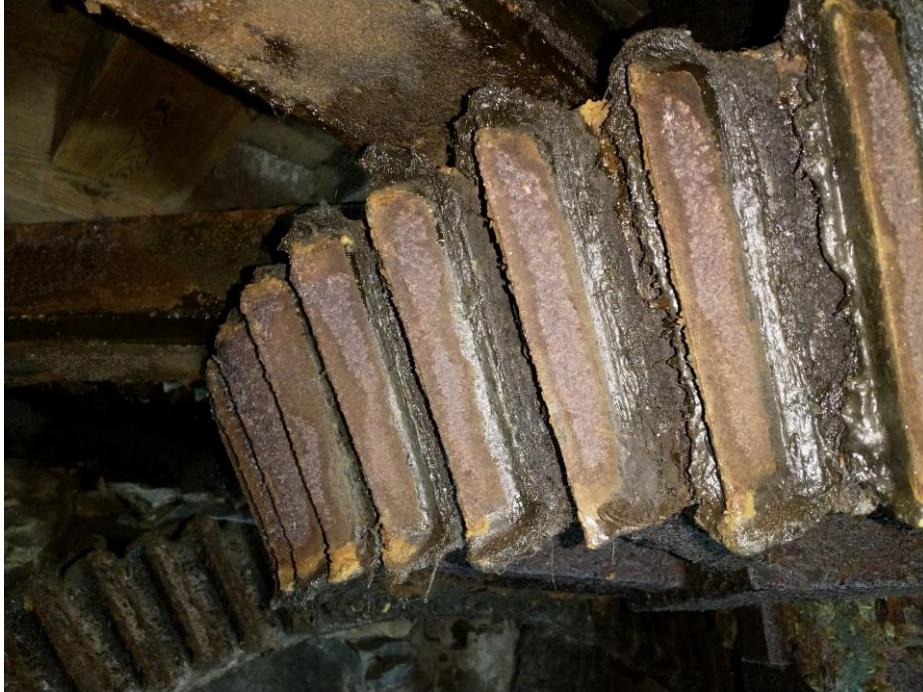
- 2- Wallower – driven by the pit wheel. This is 40" diameter with a 2" pitch between teeth (to match the pit wheel). The teeth are worn to match the pitwheel. The teeth are serviceable but if the pitwheel teeth are being renewed then the wallower should also be renewed to match.

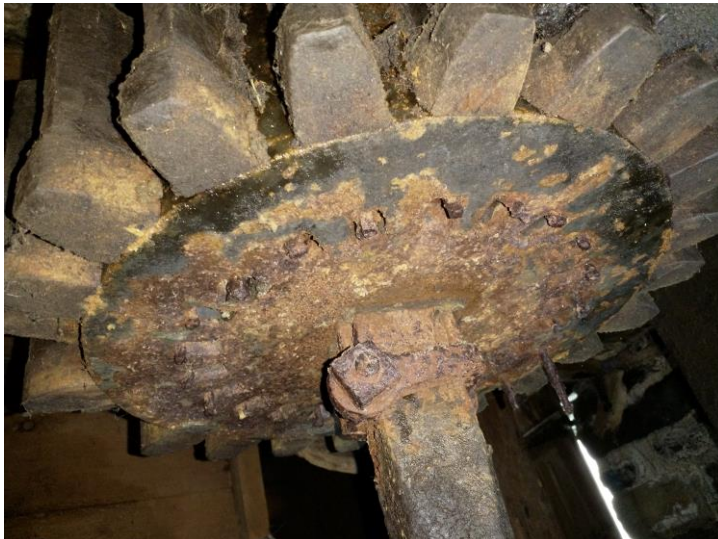
- 4 – West stone nut (nearest carpark) This is a cast iron hub with timber teeth set into it. 20" diameter wedged onto a wrought iron 2.5" sq shaft. This sits in a plain bronze foot bearing. There is excessive grease around the bearing and this will need cleaning. Teeth are held into the gear by iron pins, 6 of these require replacement. The teeth are worn but serviceable.

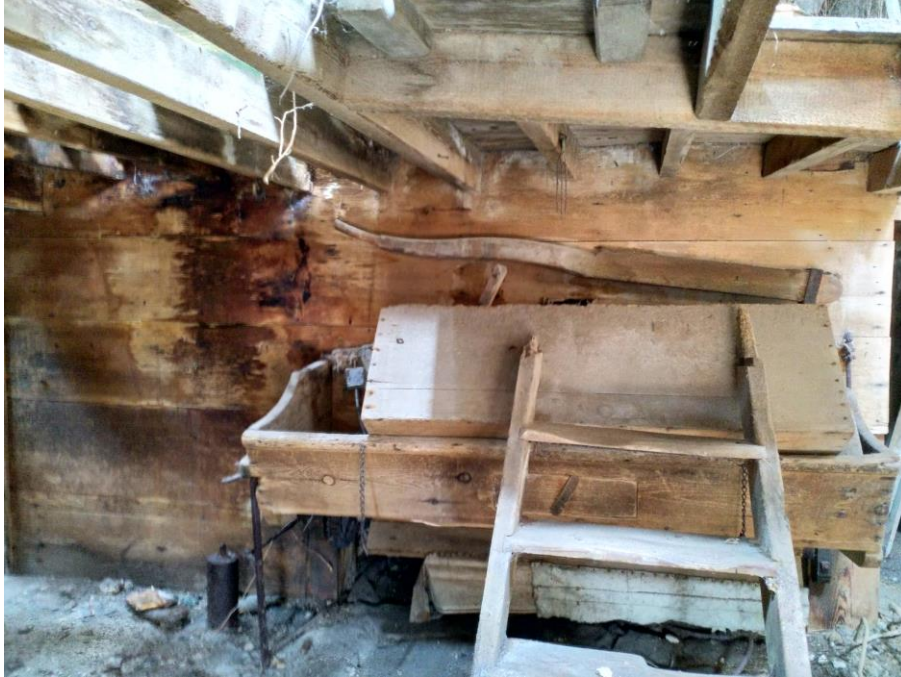
6 – Controls. The stone nuts sit on the hurst frame and this section can be raised or lowered by handles to provide adjustment to the millstones (known as tentering). Both handles are in existence and once freed would operate again.

All ironwork to the above items require de rusting, cleaning and either painting or oiling.

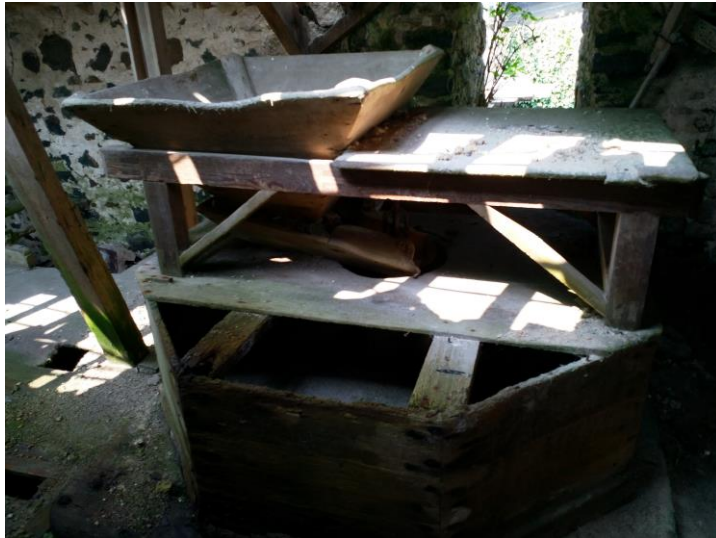
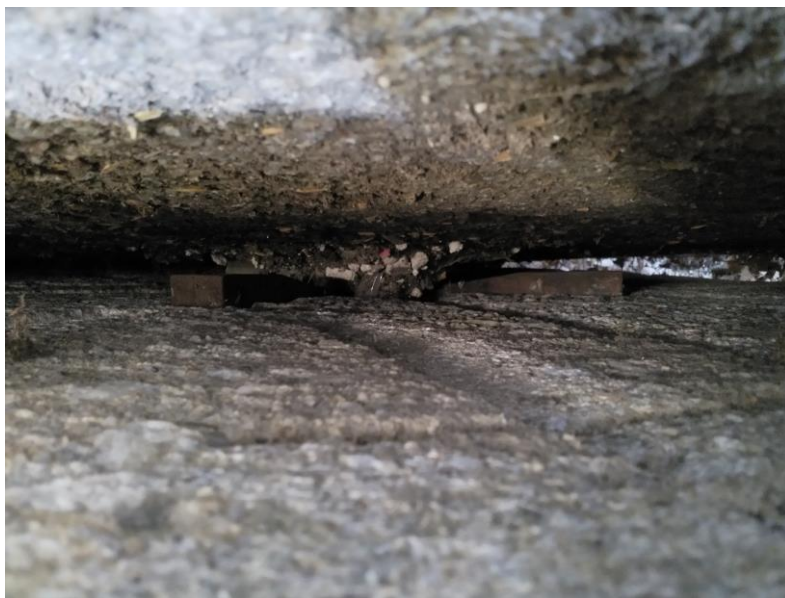
This set of stones was lifted to view the stone faces

One set of new stones will be required if milling is required. These can either be another set of monolithic stones, French Burr or a composite set (man-made). French burr are known as the best type for good quality flour production so it would be preferable to try and source this type if possible.

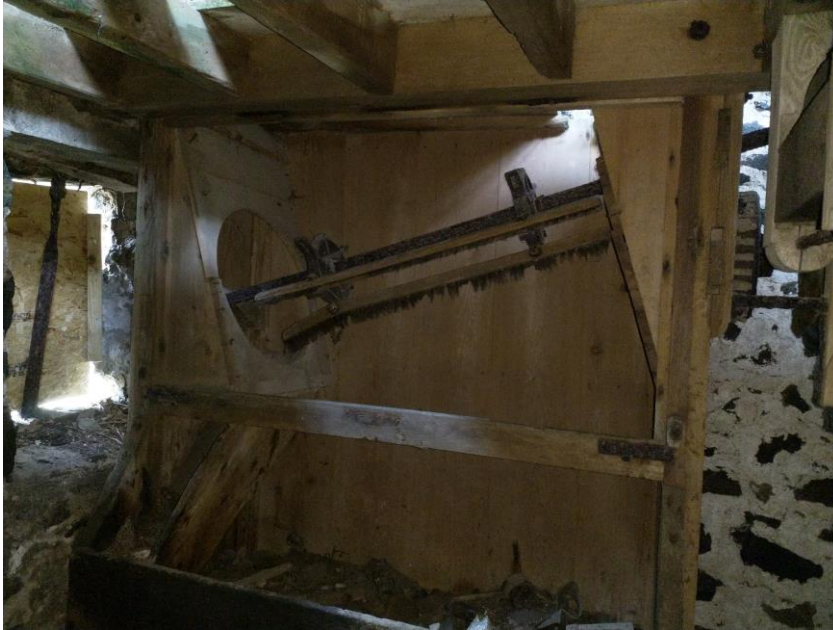
To the west corner of the mill (carpark side) there are two dressing machines. Both appear to be of similar design so were either both used to sift flour or one may have been adapted to enable it to sift the incoming grain and remove any debris before milling. The far left machine only has its outer casing and Central armature remaining.

The central armature is missing its drive gear teeth, all wiping brushes, external timber surround and sifting mesh grill.

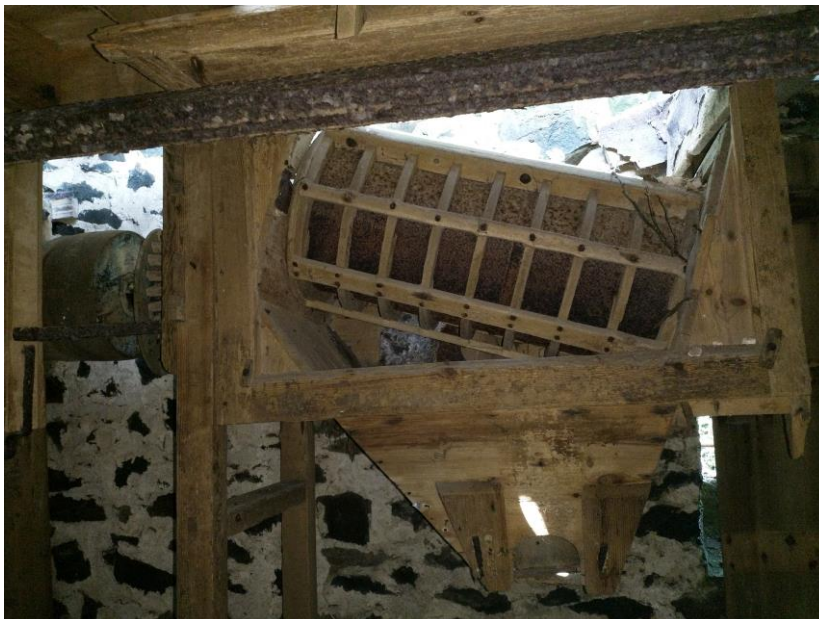
The second dressing machine is more complete. There is evidence of the internal wiping brushes, mesh surround (although top half is missing) and the external case is largely complete.

The main structure is missing the two rear legs which should be replaced.

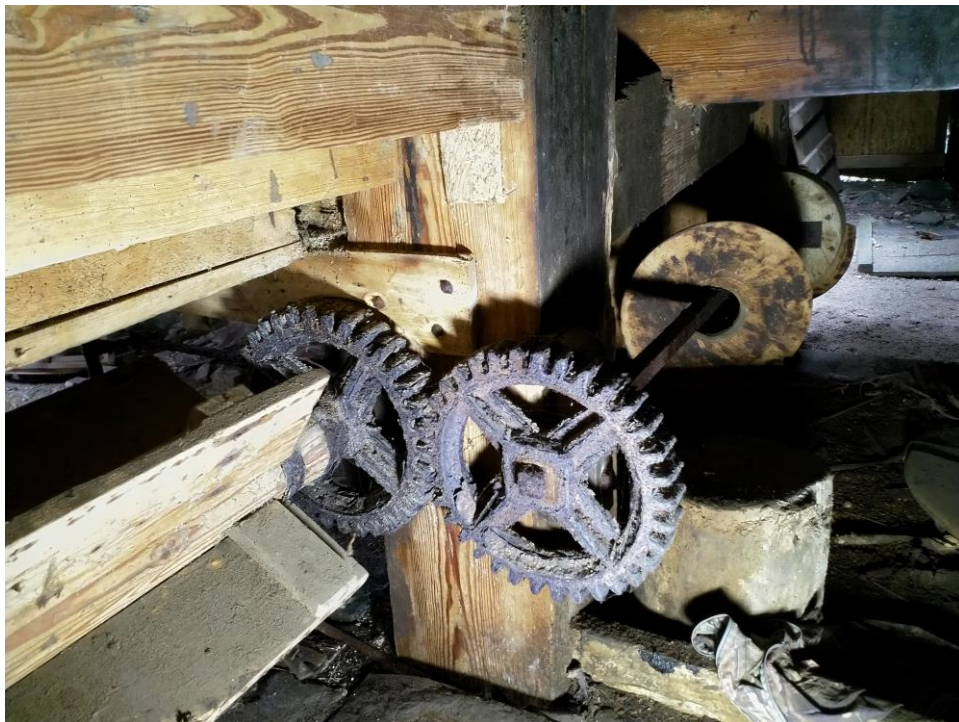
Line shaft running under the hurst frame. This appears to drive what may have been a dust extractor or a fan to circulate air around the mill. The drive shaft is complete and the gears although heavily rusted could be serviced and used. There is no evidence of a case or box around this element so more research may be required if this is to become operational. Wooden drive drum requires a new rear flange where broken and a drive belt. We would suggest that this element is conserved and stabilised but remains as a static object.

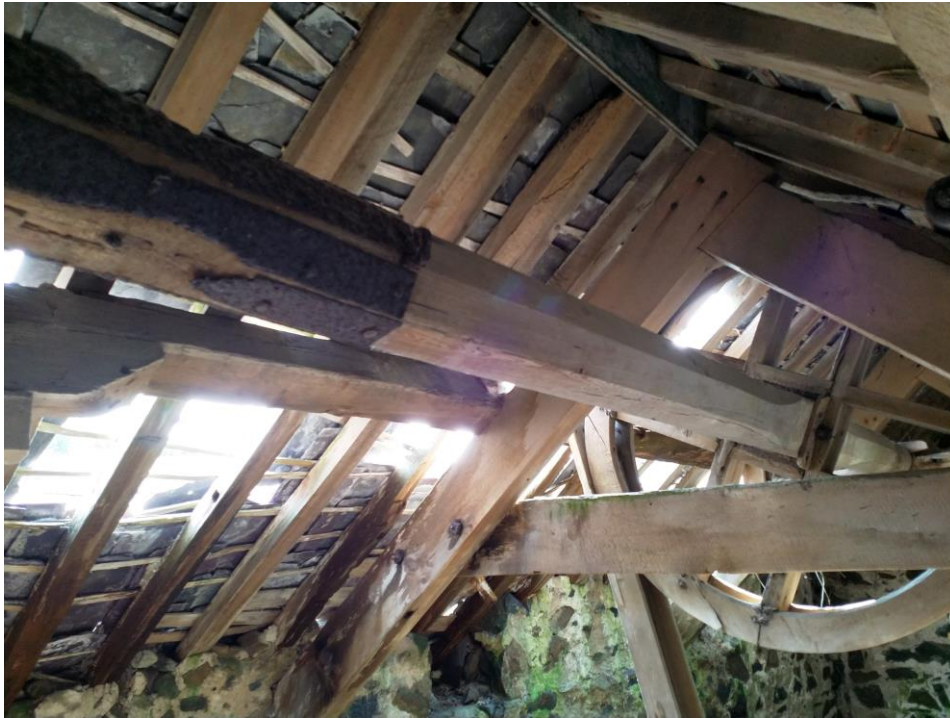
Second floor line shaft. This is for the sack hoist and is driven from the line shaft on the ground floor. The main timber drive wheel is complete apart from some of the internal running surface which should be replaced. The shaft is complete and rotates. Bearing over the west millstones should be replaced as it is significantly worn. The pivot pin to enable the sack hoist to be engaged and disengaged is missing and would require replacement. To enable this to operate a new chain would be need, guide pulley in the roof which is missing and the trap doors reinstated.
