BendPak two post vehicle lifts – safety issues relating to locking mechanisms

Health and Safety Executive - Safety alert	
Department Name:	Field Operations Division
Bulletin No:	FOD1-2018
Issue Date:	28 November 2018
Target Audience:	All users of BendPak two-post vehicle lifts, Motor vehicle repair and associated industries, Suppliers
Key Issues:	<ul style="list-style-type: none"> • There are up to 1700 or more BendPak two post vehicle lifts in use throughout Britain with potential faults • The lifts present a serious risk of a vehicle falling from the hoist with the potential of causing death or serious injury • Evidence obtained during an on-going investigation of a fatal incident has revealed concerns with the design, manufacture and supply of the BendPak two-post lifts • All users of BendPak two-post vehicle lifts should check the arm restraint gear on their lift and, if affected, take immediate action to replace
Health and Safety Executive - Safety alert

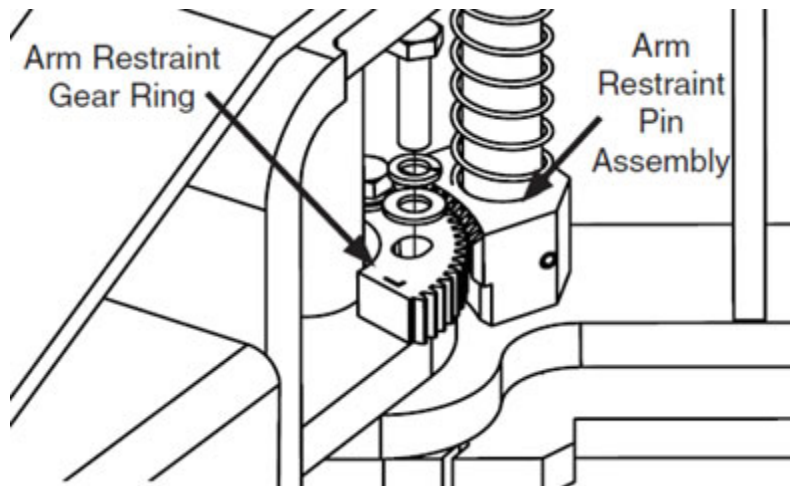
An unknown number of BendPak two-post vehicle lifts have been supplied with arm restraint gears which allow complete disengagement from the arm locking mechanism, located on the carriage of the vehicle lift.

Also, in some of the lifts, the arm restraint gears are manufactured from a material that is insufficient to withstand the forces which satisfies the testing required by the harmonised standards relating to vehicle lifts. The current standard is BS EN 1493:2010.

The manufacturer has now redesigned the arm restraint gear. The new design is a machined part using a grade of steel which was found to be suitable when tested by the manufacturer. The gears now have circular rather than oval holes and a wider cross section which prevents disengagement.

Lifts which have not been supplied with this re-designed part still present a serious risk.

If the lift does not have the newly designed arm restraint gear **take immediate action to replace** it. Users should contact their supplier, or the manufacturer, to get replacement parts. The gears should be steel, machined with circular holes. They should sit properly against the pin that the arm swings on without visible clearance.
