POTENTIAL OBSTRUCTION TO COOLANT FLOW

Timing Chain Cover

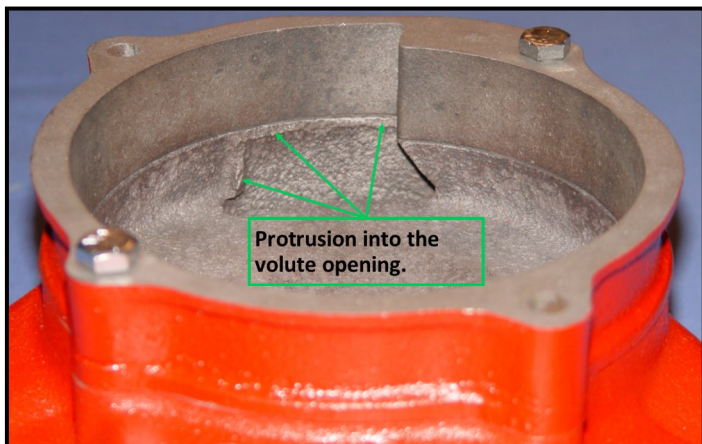
This article discusses a potential issue that may hurt the coolant flow in your Y-Block engine's cooling system. It resulted from a "bad" break during manufacturing at the Cleveland Foundry 60 plus years ago. Upon close inspection of the volute opening in the timing chain cover, it appears in the manufacturing process that part of the casting was broken away to make the volute opening. Unfortunately, the breaks vary in how clean the result was.

Figure 1 shows a timing chain cover with an example of a casting protrusion into the volute opening. When the timing chain cover is installed on the engine, a casting protrusion is not something you would see unless you were specifically looking for it.

I had removed and reinstalled my water pump and various spacers several times during flow testing and never saw the protrusion. After I became aware of this potential problem, I removed the water pump just to check. I found a protrusion close in size to the one pictured in Figure 1. I used an angle drill with a 1½ inch sanding drum with number 80 abrasive to remove the most significant part of the protrusion, then stepped down to 1 inch, ¾ inch, and finally a ½ inch drum to get as close to the offset as possible. Cast iron is relatively soft, so check your progress frequently during grinding. After the grinding is complete, the water jacket will need to be thoroughly

flushed to remove all grinding debris.

Because this issue has only recently come to light, most of us have no idea how good the break on our timing chain cover was when manufactured. I suggest you make a note to check it the next time the water pump is removed. There is no better time to check for and remove any protrusion that exists than when the timing chain cover is uninstalled. So don't miss this when you are rebuilding your engine.

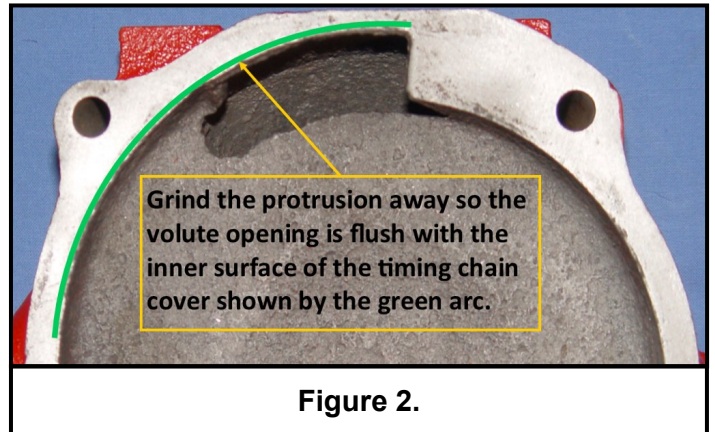
Figure 2.

Figure 2 shows the inner surface of the timing chain cover with which the volute opening should be flush.
