# POTENTIAL OBSTRUCTION TO COOLANT FLOW

## Timing Chain Cover

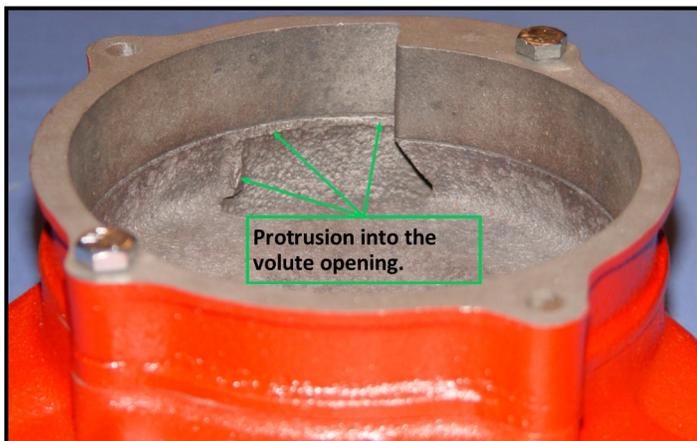
**Figure 1.**

This article discusses a potential issue that may hurt the coolant flow in your Y-Block engine's cooling system. It resulted from a "bad" break during manufacturing at the Cleveland Foundry 60 plus years ago. Upon close inspection of the volute opening in the timing chain cover, it appears in the manufacturing process that part of the casting was broken away to make the volute opening. Unfortunately, the breaks vary in how clean the result was.

Figure 1 shows a timing chain cover with an example of a casting protrusion into the volute opening. When the timing chain cover is installed on the engine, a casting protrusion is not something you would see unless you were specifically looking for it.

I had removed and reinstalled my water pump and various spacers several times during flow testing and never saw the protrusion. After I became aware of this potential problem, I removed the water pump just to check. I found a protrusion close in size to the one pictured in Figure 1. I used an angle drill with a 1½ inch sanding drum with number 80 abrasive to remove the most significant part of the protrusion, then stepped down to 1 inch, ¾ inch, and finally a ½ inch drum to get as close to the offset as possible. Cast iron is relatively soft, so check your progress frequently during grinding. After the grinding is complete, the water jacket will need to be thoroughly

flushed to remove all grinding debris.

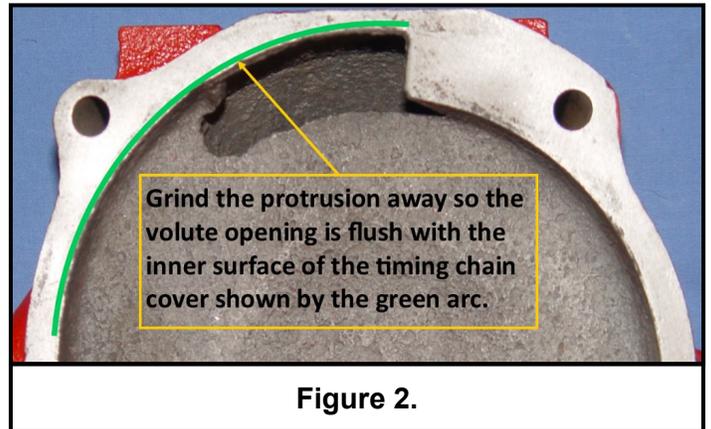
**Figure 2.**

Figure 2 shows the inner surface of the timing chain cover with which the volute opening should be flush.

Because this issue has only recently come to light, most of us have no idea how good the break on our timing chain cover was when manufactured. I suggest you make a note to check it the next time the water pump is removed. There is no better time to check for and remove any protrusion that exists than when the timing chain cover is uninstalled. So don't miss this when you are rebuilding your engine.
