POTENTIAL OBSTRUCTION TO COOLANT FLOW IN Y-BLOCK TIMING CHAIN COVER

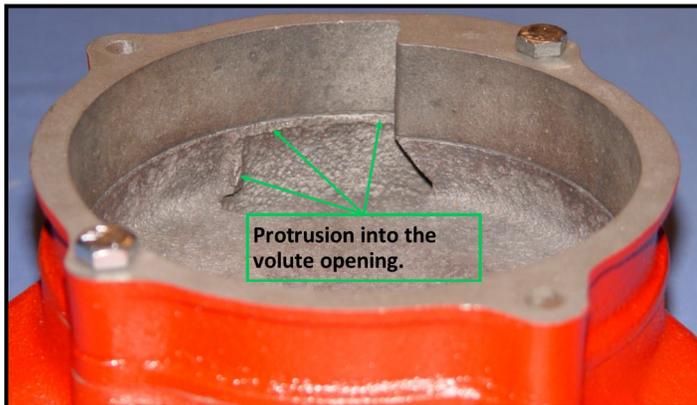
This article discusses a potential casting protrusion that may slow coolant flow in your Y-Block engine. It appears that part of the timing chain cover casting was broken away in the manufacturing process to form the volute opening. Unfortunately, some of the breaks were not as clean as intended and resulted in some of the casting protruding into the volute opening. Figure 1 shows a timing chain cover with an example of a casting protrusion into the volute opening. With the timing chain cover installed on the engine, a casting protrusion is not something you would see unless you were specifically looking for it.

I had removed and reinstalled my water pump several times with various spacers during flow testing and never saw the protrusion. After I became aware of this potential problem, I removed the water pump to check and found a protrusion close in size to the one pictured in Figure 1.

An angle drill with a 1/2 inch rotary file as shown in Figure 2 is an excellent tool to grind the protrusion away. The one shown is from NAPA, item number 7771619. After the grinding is complete, the water jacket must be thoroughly flushed to remove all grinding debris.

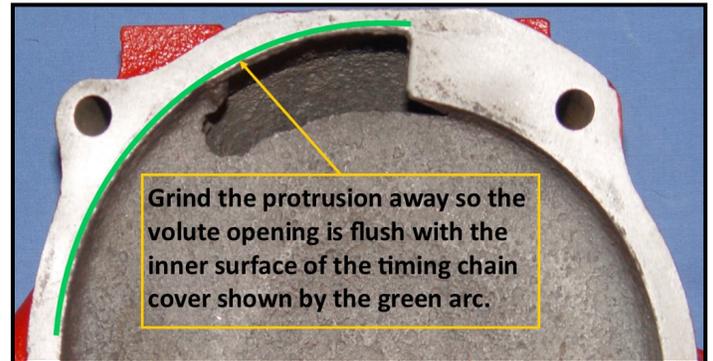
Figure 3.

Figure 3 shows the inner surface of the timing chain cover with which the volute opening should be flush.

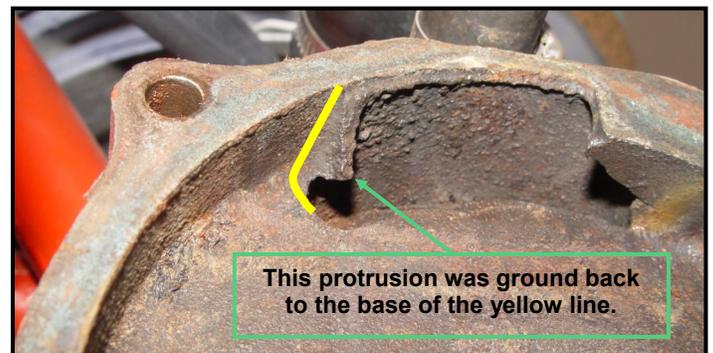
Figure 4.

The protrusion shown in Figure 4 is the worst I have seen to date and had gone unnoticed for over 60 years. Because this issue has only recently come to light, most of us have no idea how clean the break on our timing chain cover is. I suggest you make a note to check the next time you remove the water pump. Also, there is no better time to check for and remove any protrusion that exists than when the timing chain cover is uninstalled. So don't miss this opportunity when you are rebuilding your engine.
