POTENTIAL OBSTRUCTION TO COOLANT FLOW IN Y-BLOCK TIMING CHAIN COVER

This article discusses a potential casting protrusion that may slow coolant flow in your Y-Block engine. It appears the volute opening was cast closed with a thin perimeter and then broken out of the timing chain cover later in the manufacturing process. The intent was for the volute opening to break flush with the inner surface of the timing chain cover to provide smooth coolant flow. Unfortunately, some of the breaks were not as clean as intended and resulted in part of the casting protruding into the volute opening, as shown by the green pointers in Figure 1.

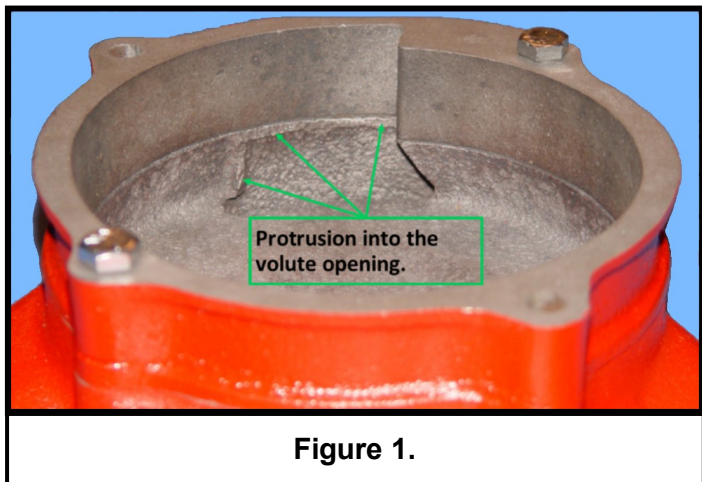
So, after becoming aware of the potential problem, I removed our water pump and spacer and discovered a protrusion approximately the size of the one pictured in Figure 1.

The good news is that the protrusion can be carefully ground away to make the opening flush with the inner surface of the timing chain cover in the area shown by the green reference line in figure 2. After the grinding is complete, you must thoroughly flush the water jacket to remove all grinding debris.

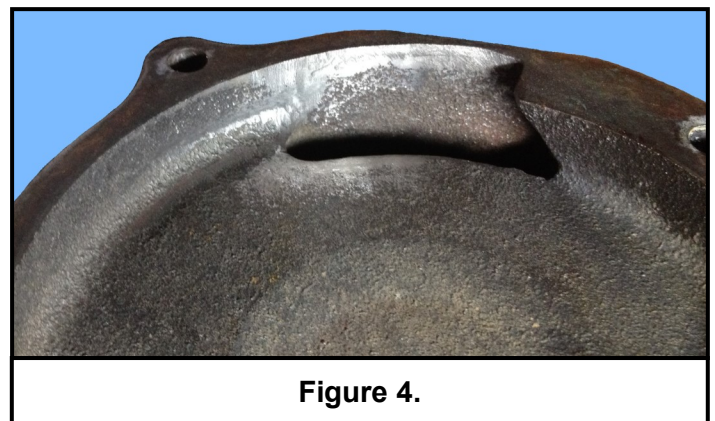
Figure 4 shows our volute opening after I ground off the protrusion and smoothed the edges of the volute opening.

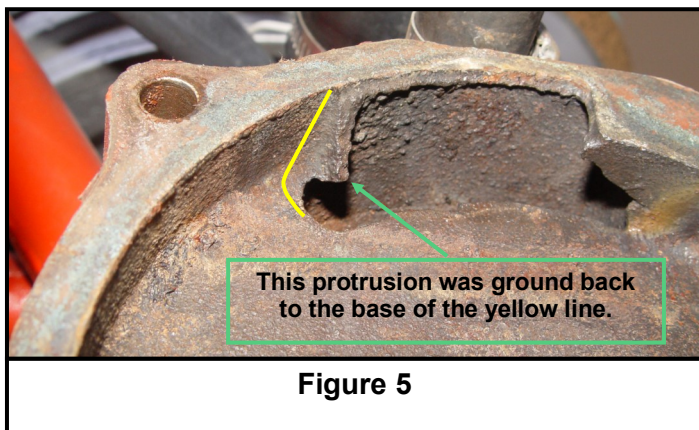
The *Arizona Classic Thunderbird Club* does a Tech Day each year, and at the 2018 session, I showed the redesigned water pump spacer and the example of a protrusion on the timing chain cover shown in Figure 1. After the presentation, one of the first Club Members to install the A-432 said that because this problem was not known when he had his spacer installed, he did not have the timing chain cover checked and was concerned about the possibility of a protrusion. I offered to help him pull the water pump and spacer to check. A couple of days later, he brought his Thunderbird over, and we removed the water pump and spacer and discovered the worst protrusion I have seen to date! And the chunk of casting in the volute opening shown in Figure 5 had gone unnoticed for over 62 years!

Because this issue has only recently come to light, most Thunderbird owners have no idea if their volute opening is the result of a clean break or not. If you don't know the condition of yours, I suggest you make a note to check it the next time your water pump is removed. And if you are having your timing chain cover removed from the engine, do not miss the opportunity to check for and remove any protrusion.
