POTENTIAL OBSTRUCTION TO COOLANT FLOW IN Y-BLOCK TIMING CHAIN COVER

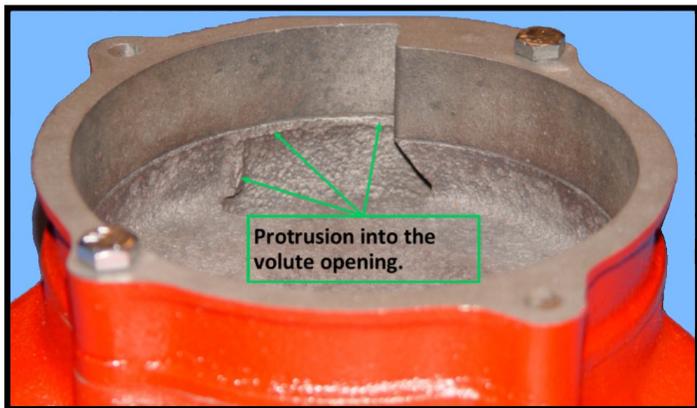
This article discusses a potential casting protrusion that may slow coolant flow in your Y-Block engine. It appears the volute opening was cast with a thin perimeter and then broken out of the timing chain cover later in the manufacturing process. Unfortunately, some of the breaks were not as clean as intended and resulted in part of the casting protruding into the volute opening. I first observed this when I was sandblasting a timing chain cover to clean it up to serve as a mounting point to show the difference between the original and the A-432 water pump spacers. That first observed protrusion is called out in Figure 1.

While this protrusion is visible when photographed with good lighting and from this angle, it is not visible when the timing chain cover is attached to the engine. In fact, during flow testing of the various prototypes of the redesigned water pump spacer, I had removed and reinstalled the water pump spacer several times and never noticed whether or not our timing chain cover had a protrusion.

It was not until after becoming aware of this potential protrusion problem that I realized that I did not know the status of our volute opening. So I removed the water pump spacer to check for a protrusion and found one approximately the size of the one pictured in Figure 1.

The volute opening should be ground flush with the inner surface of the timing chain cover as shown by the green reference lines in figure 2 to minimize obstruction to coolant flow.

An angle drill with a 1/2 inch rotary file as shown in Figure 3 is an excellent tool to grind the protrusion away. The one shown is from NAPA, item number 7771619. After the grinding is complete, the water jacket must be thoroughly flushed to remove all grinding debris.

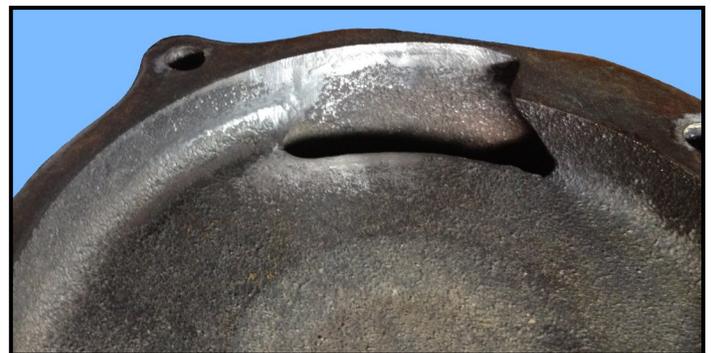
Figure 4.

In Figure 4 the timing chain cover is shown after I ground off the protrusion and smoothed the edges of the volute opening.

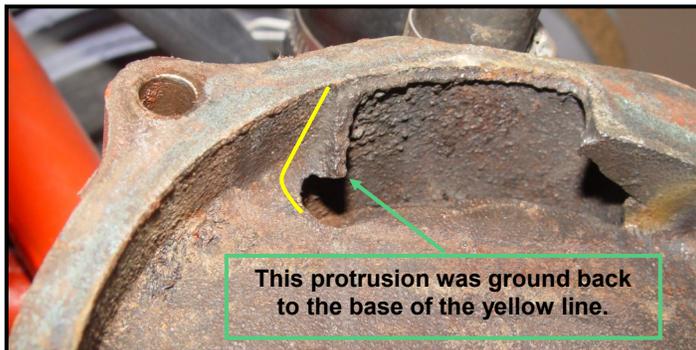
Figure 5.

The *Arizona Classic Thunderbird Club* does a Tech Day each year, and at the 2018 session, I showed the redesigned water pump spacer and the example of a protrusion on the timing chain cover shown in Figure 1. After the presentation, one of the first Club Members to install the A-432 said that because this problem was not known when he had his spacer installed, he did not have the timing chain cover checked, and was concerned about the possibility of a protrusion. I offered to help him pull the water pump and spacer to check. A couple of days later, he brought his Thunderbird over, and we removed the water pump spacer and discovered the worst protrusion I have seen to date. And the chunk of casting in the volute opening shown in Figure 5 has gone unnoticed for over 60 years! You are not likely to notice casting protrusion unless you were specifically looking for it.

Because this issue has only recently come to light, most Thunderbird owners have no idea if their volute opening is the result of a clean break or not. If you don't know the condition of yours, I suggest you make a note to check it the next time you remove the water pump. And if you are having your engine rebuilt, do not miss the opportunity to check for and remove any protrusion that exists when the timing chain cover is off the engine.
