TRI-COM BOARD OF DIRECTORS SPECIAL MEETING
Special Meeting Agenda
Friday, September 20, 2019

Project Name: STARCOM21 Conversion Project

Customer Name:	Tri-Com Central Dispatch						
Equipment Location	3823 Karl Madsen Drive, St. Charles, IL 60175						
Requestor:	Debra Brown			Project #:		TBD	
Inspector's Name:	Michael Barton			Audit Date:		August 5th, 2019	
Site Name:	Central Dispatch						
Motorola Pass/Fail	Pass	33	Fail	12	N/A	95

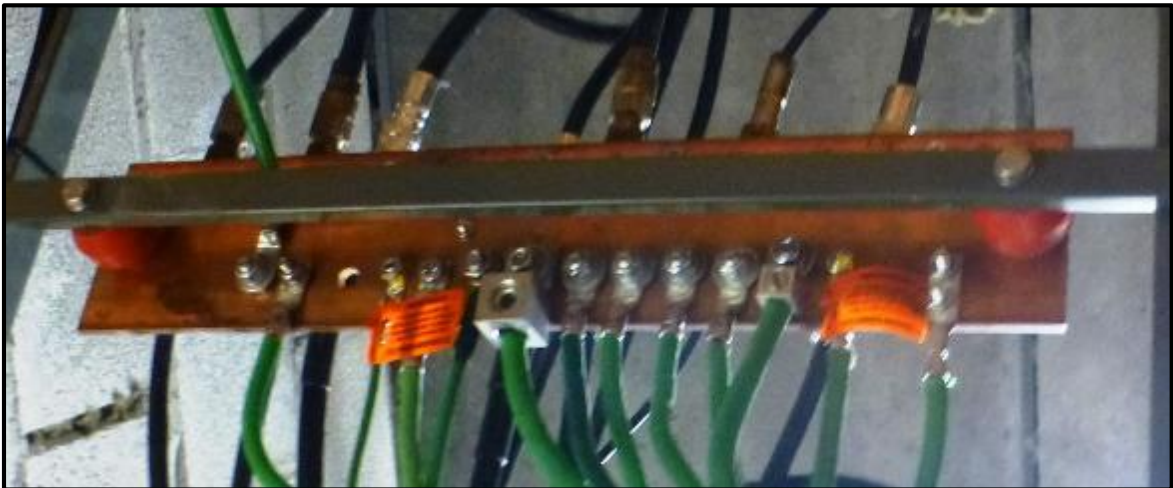
PBB in equipment room.

- 4.a: A properly sized Primary Bonding Bar (PBB) is not installed as required. The current bus bar in the equipment room does not meet sizing requirements. Minimum dimensions in height is 4 inches, length-variable to meet the application requirements and allow for future growth, 12 inches is recommended as the minimum length. Holes should be 7/16 inches on 3/4 inch or 1-inch centers to permit the convenient use of two-hole lugs. *Reference R56, Paragraph 5.6.1.*

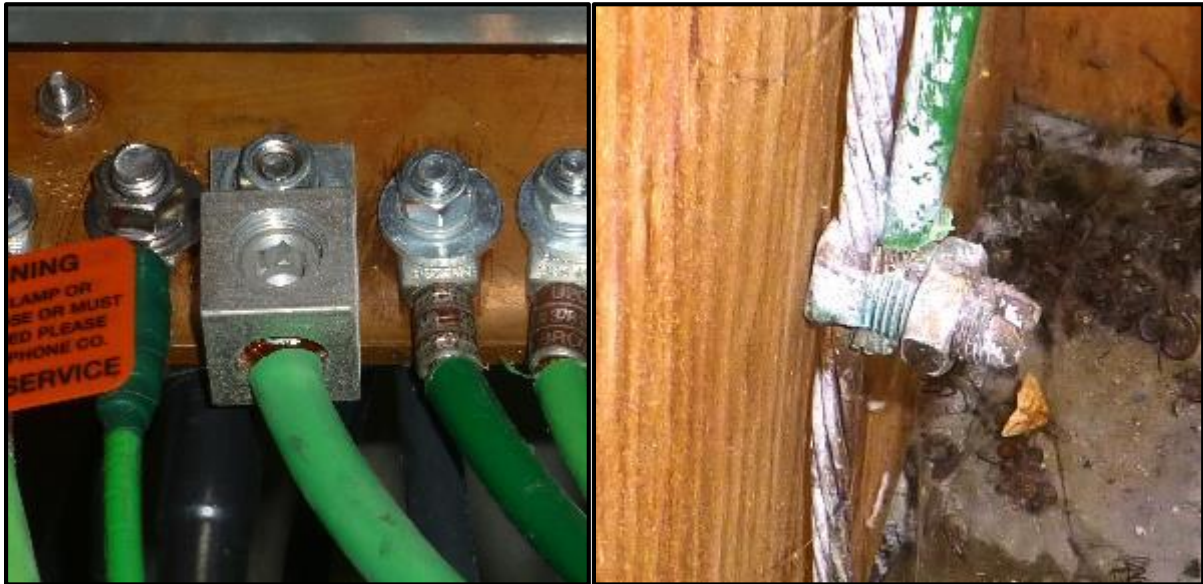
PBB earth grounding connection.

- 4.b: The PBB grounding electrode conductor has not been properly bonded by approved connection methods. It is attached to the PBB with a mechanical lug. Lugs equipped with mechanical set screw securing hardware for conductor connection shall not be used on bonding/grounding conductors. Single hole lugs are not permitted. The PBB grounding conductor shall be secured to the PBB by exothermic welding, listed compression two-hole lug, or irreversible compression-type connection device. The earth grounding conductor is attached to the earth grounding conductor with a split bolt. Split Bolt connection devices shall not be used to bond ground conductors. The PBB grounding electrode conductor shall be free of splices. Should a splice become necessary, splicing shall be permitted only by exothermic weld or listed irreversible compression-type connection. Grounding electrode system connections shall be joined using exothermic welding or listed irreversible high-compression fittings *Reference R56, Paragraphs 5.6.1.4 & 5.6.1.6.*

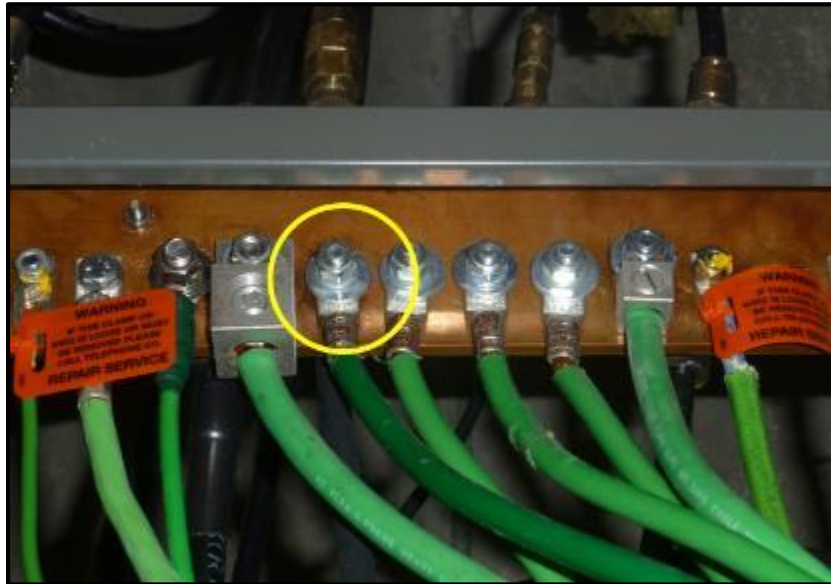
Connections to the equipment room PBB.

- 4.c: Not all conductor connections to the PBB follow the approved connection methods. Ground bus conductors are secured with single hole lugs. The lug circled in the picture is the conductor to the RBB in the rack with the new APX Consolettes. Single-hole lugs or mechanical set screw securing hardware for conductor connections shall not be used on bonding/grounding conductors. Connections to the Primary Bonding Bar (PBB) shall utilize exothermic welding, irreversible high-compression connection, listed irreversible compression two-hole lugs or listed exothermic two-hole lugs. Bus bonding conductors shall be bonded to the PBB by exothermic weld, listed irreversible compression two-hole lug, two-hole exothermic lug or irreversible high compression-type connection. Single-hole lugs are not permitted. *Reference R56, Paragraphs 5.8.1 & 5.8.9.1*

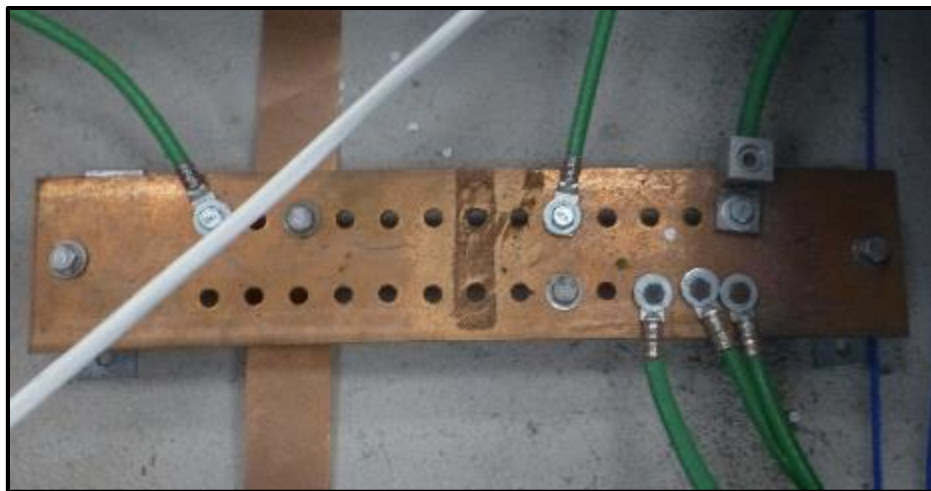
SBB in dispatch area.

- 4.d: The Secondary Bonding Bar (SBB) in the dispatch area has not been properly installed. The SBB is not secured. The SBB shall be secured to the structure using brackets suitable for the application and shall be insulated from its support structure using listed insulators. *Reference R56, Paragraph 5.6.3.*

- 4.f: Not all conductor connections to the SBB follow the approved connection methods. The bonding conductors on the SBB in the dispatch area going to the individual dispatch positions are secured to the SBB with single hole lugs. Bus bonding conductors shall be bonded to the SBB by exothermic weld, listed irreversible compression two-hole lug, two-hole exothermic lug or irreversible high compression-type connection. Single-hole lugs are not permitted. The SBB grounding conductor to the equipment room is secured with a mechanical connection. Lugs equipped with mechanical set screw securing hardware for conductor connection shall not be used on bonding/grounding conductors. *Reference R56, Paragraph 5.6.3.5.*

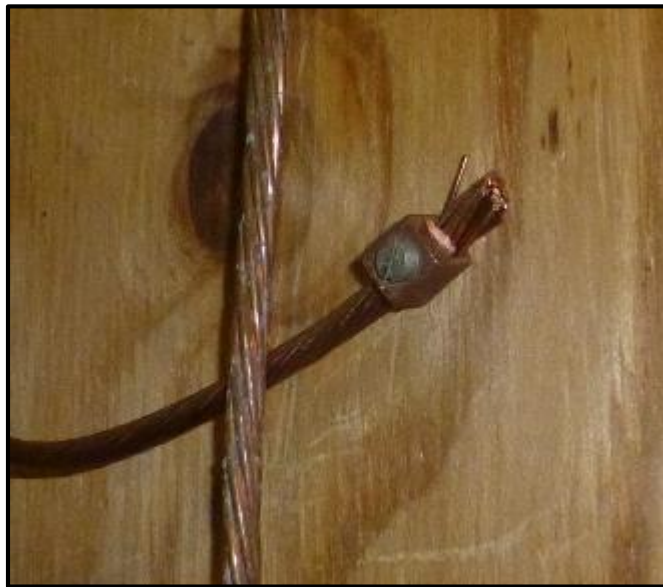
Example of ancillary equipment not bonded.

- 4.i: Each ancillary support apparatus is not properly bonded to the IPBB, PBB, or SBB. All ancillary support apparatus within an equipment shelter, room or specific equipment area shall be bonded to the PBB, SBB or IPBB. In areas other than where the PBB is installed, ancillary support apparatus shall be bonded to the SBB, or to the internal perimeter bonding bus conductor (IPBB), using an equipment grounding conductor. *Reference R56, Paragraph 5.9.1.8.*

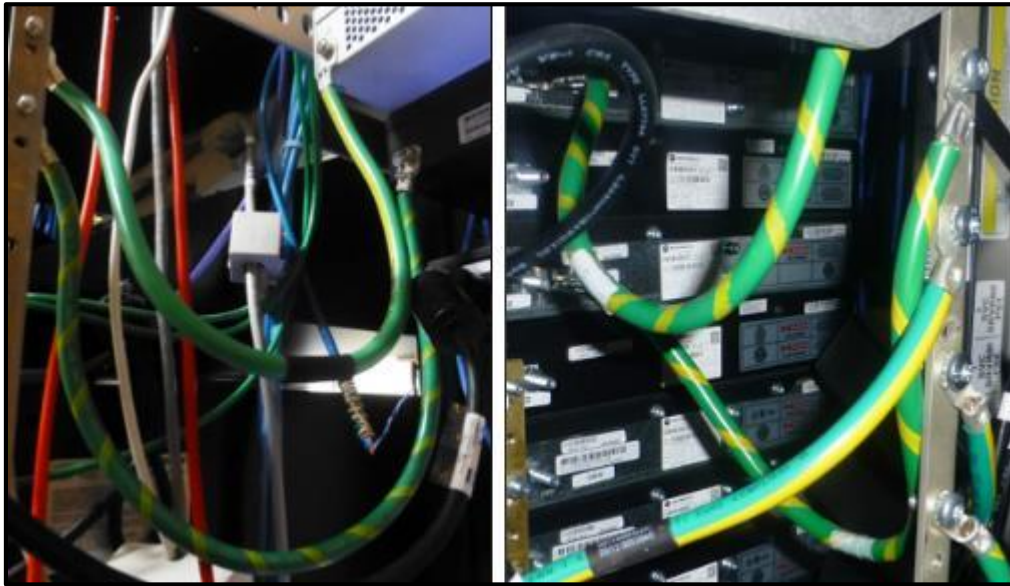
Bonding jumpers exceed minimum bending and routing requirements.

- 4.r: Not all ground bus conductors, ground bus extensions and equipment grounding conductors are routed towards the PBB, RBB or SBB as required. Grounding conductors shall be run as short, straight, and smoothly as possible, with the fewest possible number of bends and curves. All bends and curves shall be made toward the ground location. Ground conductors of all sizes shall maintain a minimum bending radius of 8 inches. The angle of any bend shall not be less than 90 degrees. (The FortiGate, HP 2620, GGM 8000s (top and 3rd units), and bottom SDM are shown.) *Reference R56, Paragraph 5.6.6.3.*

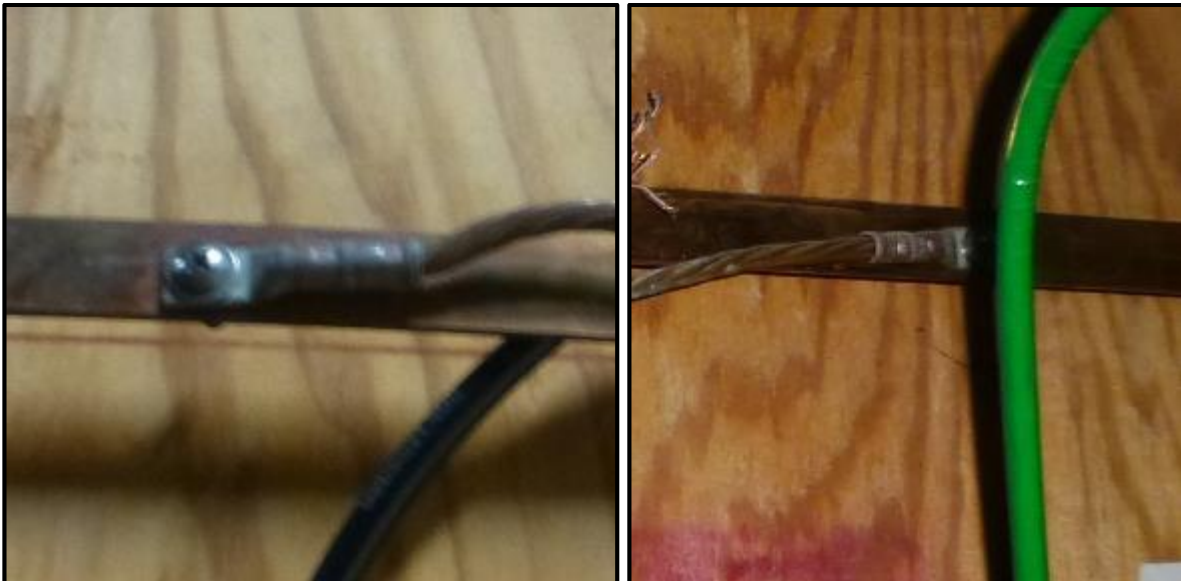
Examples of ancillary secured to the perimeter bus in the wrong direction.

- 4.r: Not all ground bus conductors, ground bus extensions and equipment grounding conductors are routed towards the PBB, RBB or SBB as required. Multiple pieces of ancillary equipment is secured to the perimeter bus conductor in the wrong direction - flowing away from the ground source. Grounding conductors shall be run as short, straight, and smoothly as possible, with the fewest possible number of bends and curves. All bends and curves shall be made toward the ground location. The main reason is because the perimeter bus is bonded to ground with multiple down conductors. *Reference R56, Paragraph 5.6.6.3.*

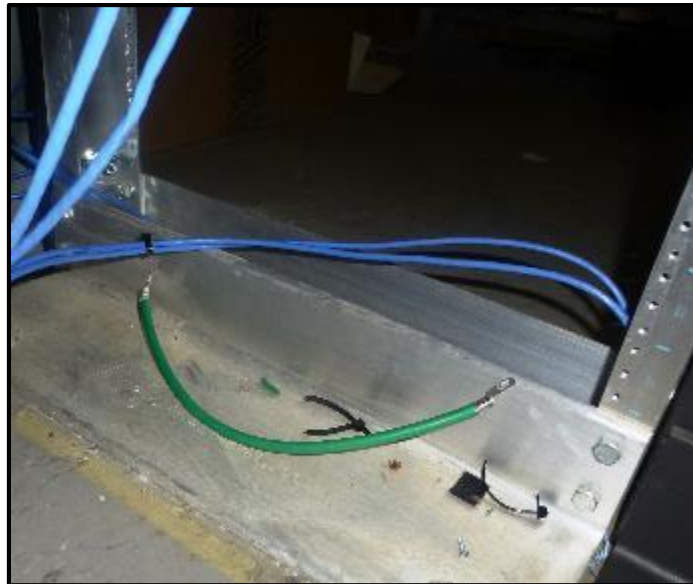
APX radio rack not bonded to ground

- 4.u: Racks have not been properly bonded back to the PBB, SBB or ground bus by approved methods. The existing rack used to for the new APX Consolettes is not bonded to ground. Racks or cabinets equipped with a Rack Bonding Bar (RBB) shall have an independent bonding jumper installed between the rack or cabinet grounding connection point and the RBB. Conductor connections to racks and cabinets shall be made at the designated ground (earth) connection point or ground "pad." *Reference R56, Paragraph 5.9.1.6.*

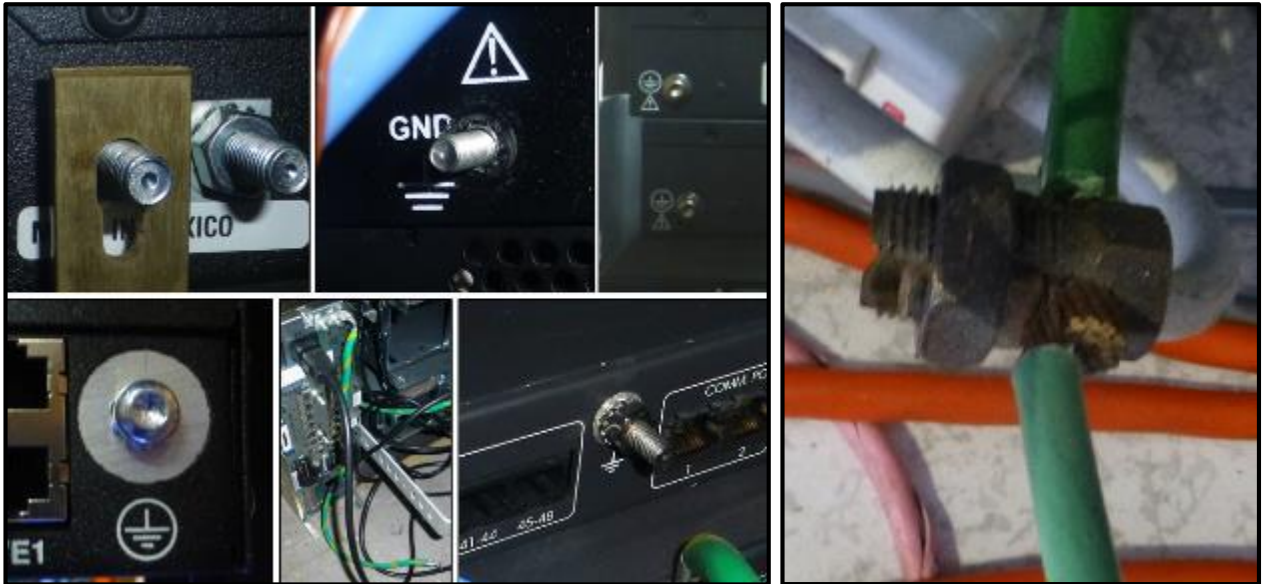
Individual chassis equipment not bonded.

- 4.w: Individual system component chassis equipment is not properly bonded as required. On equipment where a ground stud or connection point is provided by the manufacturer a #6 AWG or coarser equipment grounding conductor shall be attached to this attachment point and bonded to the RBB, equipment grounding bus conductor or other suitable grounding point. The NBB shall be attached directly to each equipment chassis with suitable stainless-steel hardware. (Shown are an improperly attached NBB, existing APX installed in rack with new APX Consolettes, LAN switches, GGM 8000, SDM and GCP 8000.) There is other existing/older equipment not properly bonded. The VPMs at the dispatch positions are secured to bonding conductor with split bolts. Split bolts are not permitted. Some of the above was existing and some will be replaced. *Reference R56, Paragraphs 5.6.6.8 & 5.9.1.5.*

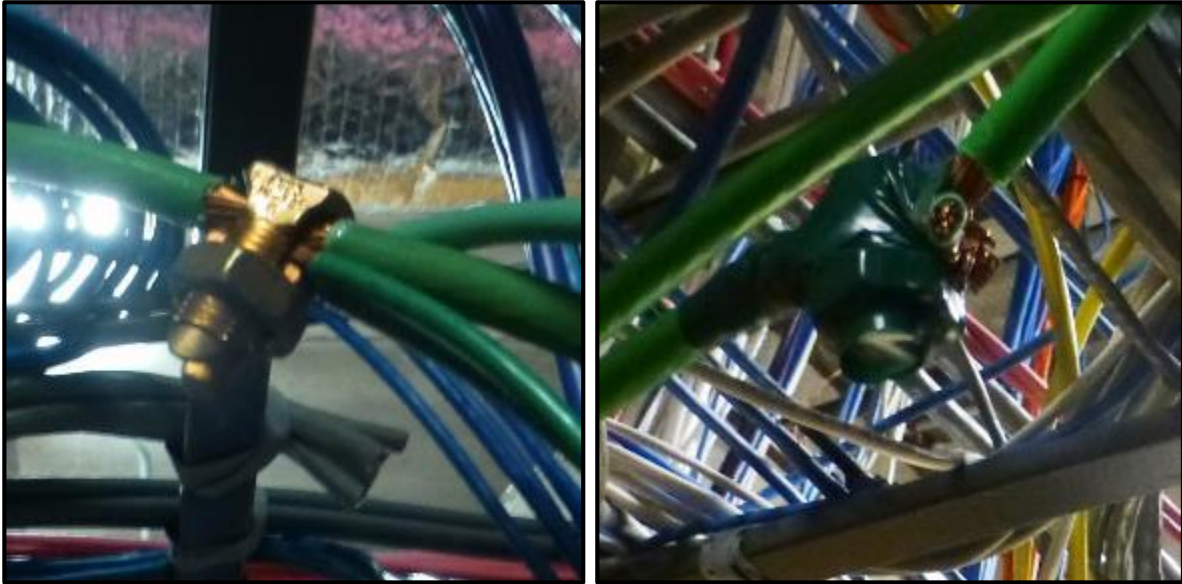
Multiple pieces of existing equipment secured to bus conductors with split bolts.

- 4.w: Individual system component chassis equipment is not properly bonded as required. Split bolt connection devices are not permitted. Bonding bus branch conductors and equipment bonding jumpers shall be connected to the main bonding bus conductor using exothermic welding or listed irreversible compression-type connectors. Multiple connections shall not be made to one attachment point on the bonding bus conductor unless this connection is made using exothermic welding or listed irreversible compression-type connector listed for multiple conductors. In all cases the connection means shall be listed for the size and number of conductors to be connected. *Reference R56, Paragraphs 5.8.8 & 5.9.1.*

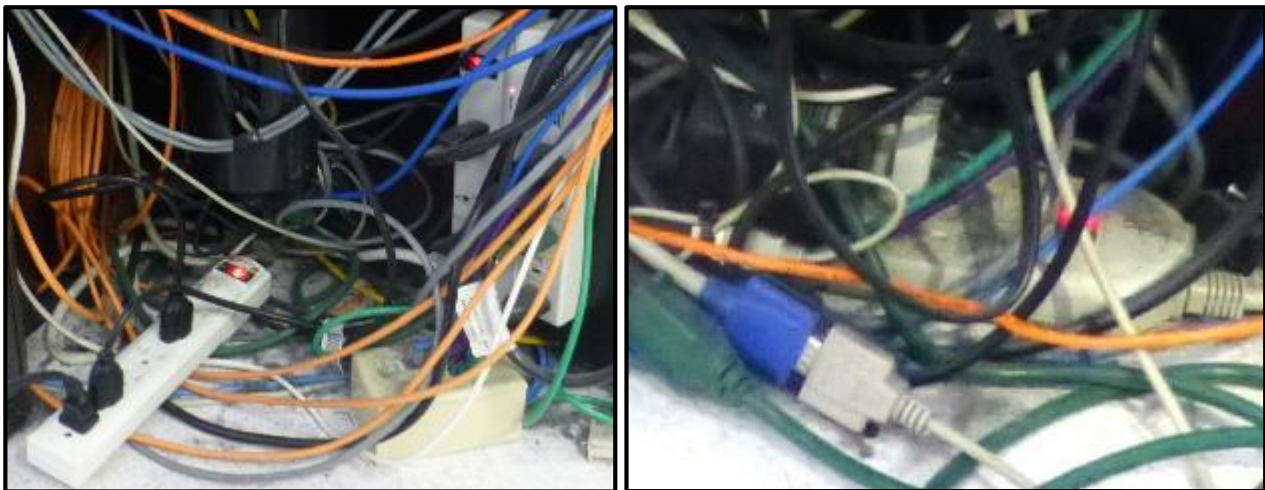
Receptable strips do not installation requirements.

- 5.j: AC power receptacle outlets and strips are not of the proper type and not securely mounted off the floor. Receptacle strips at the dispatch positions do not meet requirements. (Not shown are receptacle strips in the equipment room that are of same type and plugged into the same circuits. They are not used on the new equipment.) Receptacle strip shall be securely mounted to the supporting structure using intended bolt mounting and shall not be secured by being tie-wrapped. Receptacle strips shall not include ON/OFF switches unless the ON/OFF switch is covered to help prevent the switches from being inadvertently switched off. Consumer-grade surge-protected or locally fused receptacle strips shall not be used. No more than one receptacle strip shall be connected to the same branch circuit. Redundant equipment pairs shall not be connected to the same receptacle strip. If multiple receptacle strips are used, they shall be plugged into dedicated simplex receptacles on individual branch circuits. *Reference R56, Paragraph 6.2.13.*

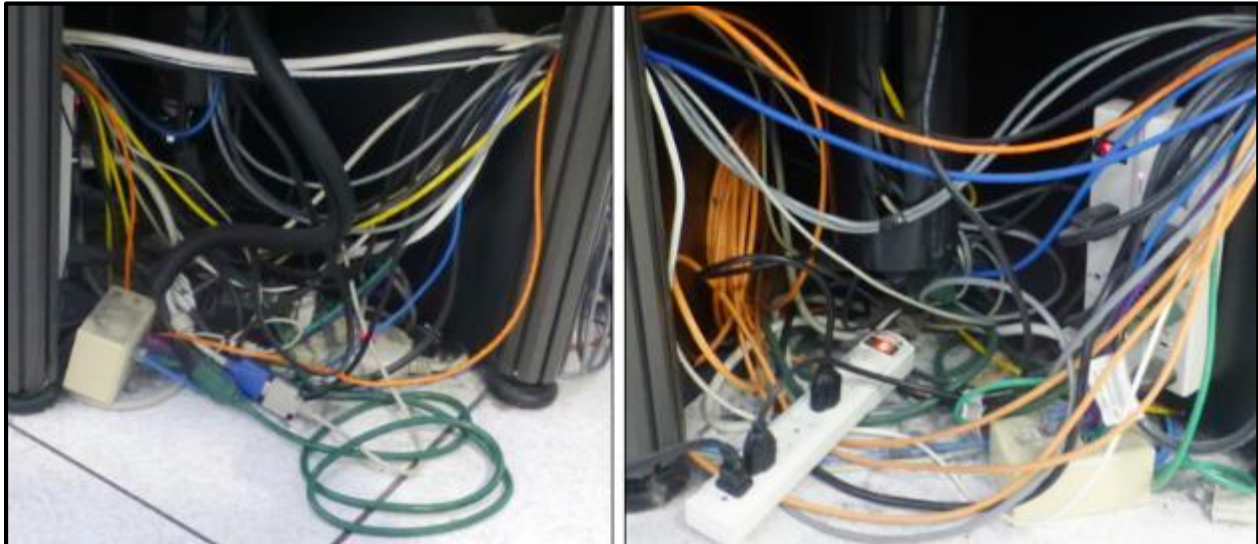
Cabling not installed to standards.

- 7.f: Cables and cable groups of different function do not maintain a minimum 2-inch separation as required. Cable groups shall be separated by 2 inches from other cable groups. All ground conductors shall be separated a minimum of 2 inches from conductors of other cable groups. Transmission lines (coax) for transmitting stations shall be separated a minimum of 4 inches from electrical lights, power, and signaling circuits. *Reference R56, Paragraphs 9.9.1.5 & 9.9.3.2.*

- 7.n: CAT-5 cables do not maintain the proper separation from AC power cables. Avoid routing CAT 5 cable near sources of EMI/RFI. Routing cables near sources of EMI/RFI can cause data errors and degraded system performance. Cables shall be separated by at least 2 inches from AC power conductors. Such noise sources may be electrical power wiring, dimmer switches, radio frequency transmitters, motors, generators, and fluorescent lights. Doing so can be unsafe and is likely to cause EMI onto the CAT 5 cable, causing network errors. *Reference R56, Paragraph 9.9.6.4.*
