Inspection report for the property at  
99 Big Tree Lane, Jackson, TN 38301

This report is prepared exclusively for **John Smith**  
Inspected On: **04-16-2026**

Inside Out Home Inspections  
(731) 410-7111

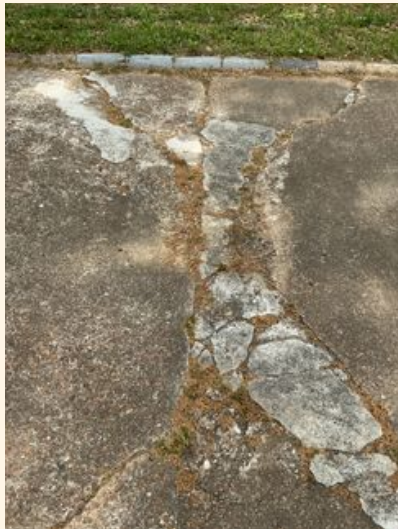
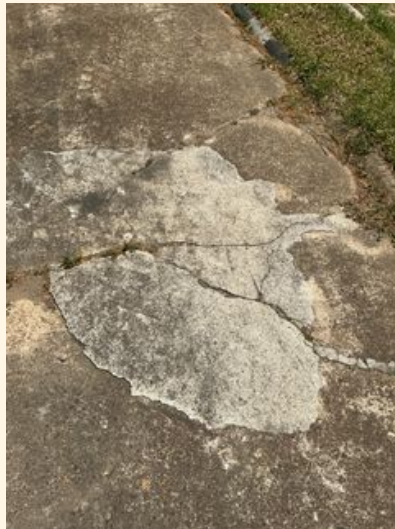
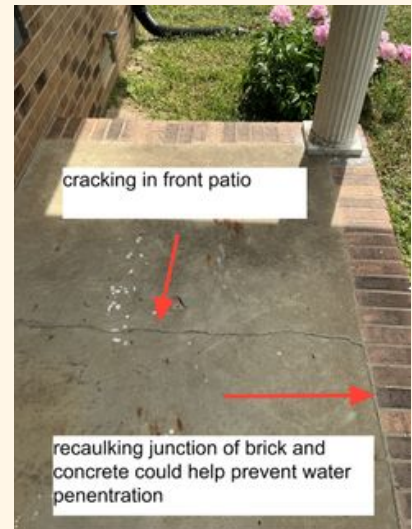
**Cracks** were noted in the driveway and patio flatwork. This is common in flatwork, especially as it ages. Regular sealing of small to moderate cracks with a quality exterior flexible sealant can minimize water penetration and prolong the life of the flatwork. Large cracks can present a more urgent need for repair, especially if the cracks lead to displacement and trip hazards. Previous repairs in the driveway that are now failing were noted.

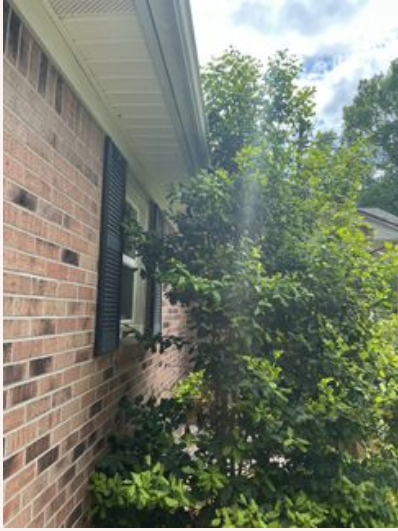
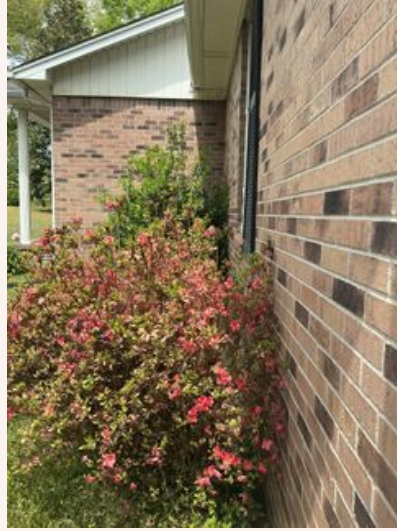
Pruning trees, branches, and vegetation away from the building is recommended. Where trees, branches, and large shrubs can provide rodent access to the roof, a minimum 6-foot clearance is recommended. All vegetation, including smaller landscaping such as grasses, flowers, and shrubs should be kept 1 foot off the house to eliminate contact which could trap moisture against the building.

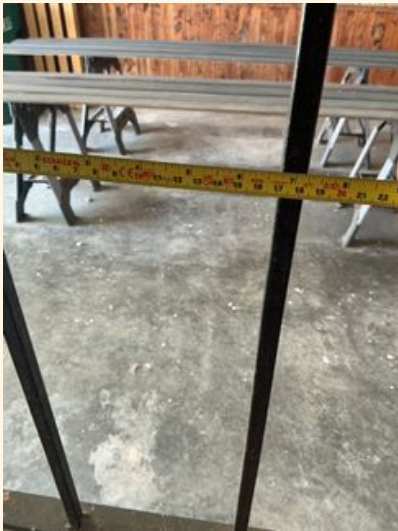
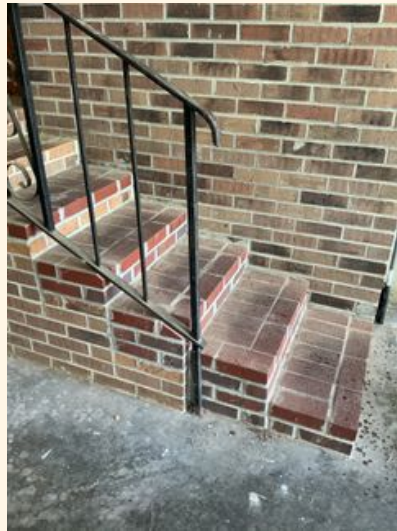
An older style of guardrail was noted with openings between balusters larger than 4 inches. Openings no larger than 4-inches are recommended especially for child safety. Hire a qualified contractor to repair / update as needed.

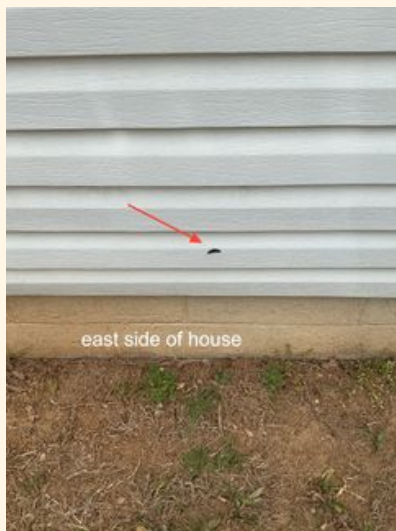
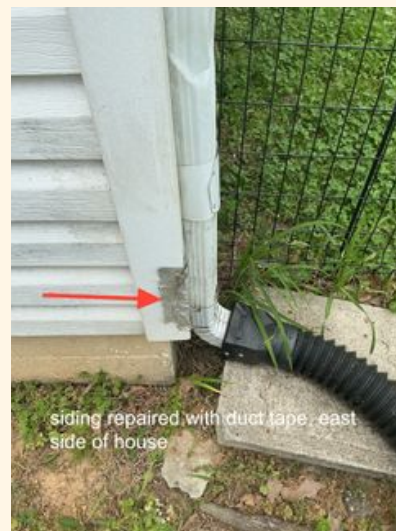
A few areas of vinyl siding damage were noted on the east side of the house. These should be repaired to prevent water intrusion.

Have the siding further evaluated and repaired as recommended by a qualified contractor.

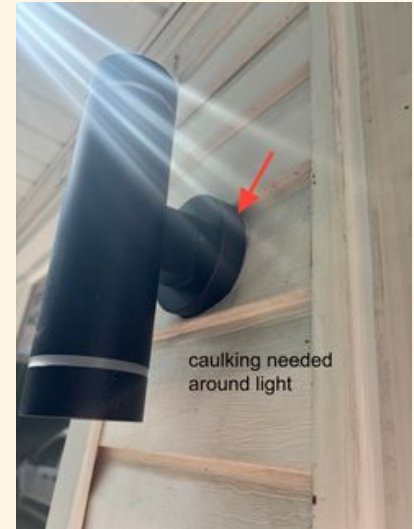
Caulking needed around light to protect electrical wires from moisture exposure.

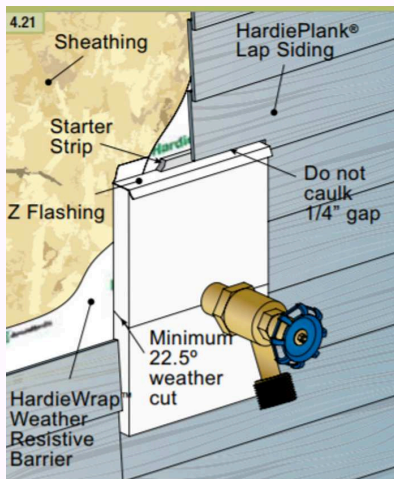
Some of the penetrations in the siding lack adequate mounting blocks. For penetrations in the building envelope such as hose bibs and holes with a 1½ inch diameter or larger, such as dryer vents, a block shall be installed around the point of penetration. Blocking should be a minimum 3 in. radius greater than the radius of the penetration. The main purpose of mounting blocks is so that if termination covers, such as a fan cover, are broken or damaged, they can be replaced without needing to dismantle the exterior siding system.

A section of siding on the south side of the house that appeared to be newer had appropriate blocking for the exterior light.

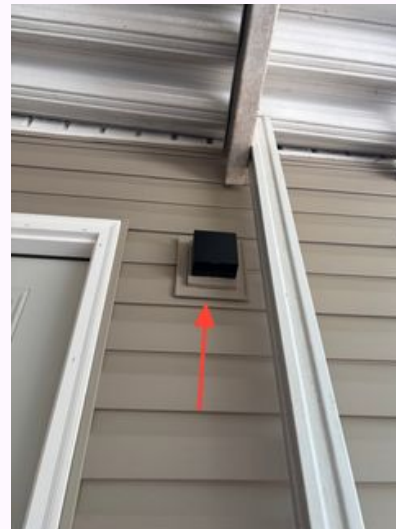
*Penetrations in siding greater than 1.5 inches should have a flashed mounting block*

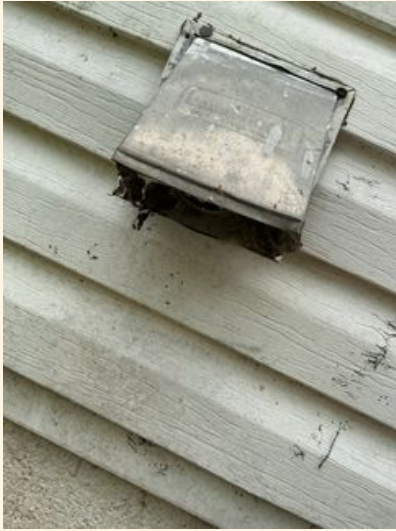
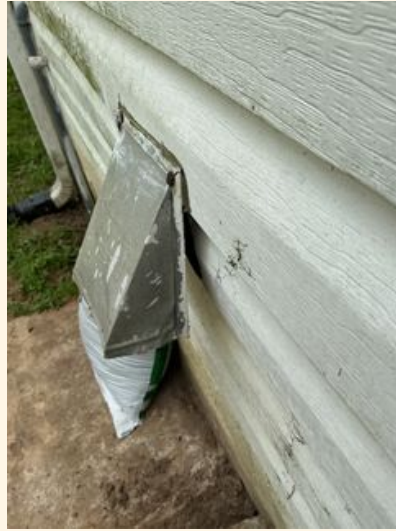
🔧 **(E-4) Repair:** The dryer vent on the side of the house was not attached to the siding and does not have a backdraft damper. Repair is recommended to keep cold air, insects and vermin from entering the house through the vent.

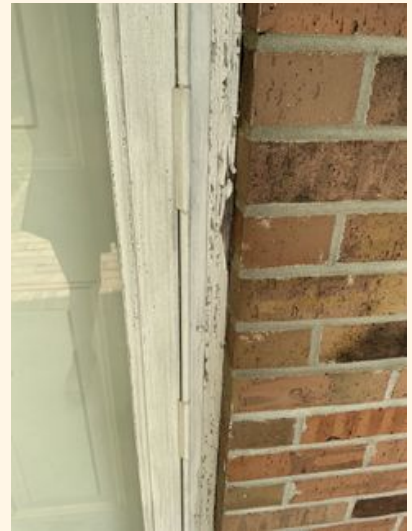
Peeling paint around the wood front door frame was noted. Repair is recommended to keep wood from being compromised by sun and moisture.

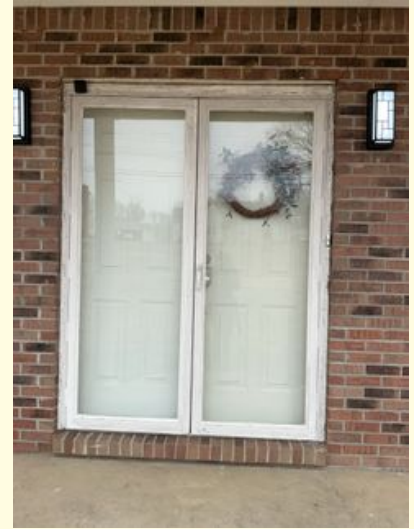
The door glazing did not appear to be safety glass. No logo or tempered bug was visible. All glazing greater than 3 inches in exterior doors should be safety glass. Updating with tempered or laminated glass is recommended for improved safety.

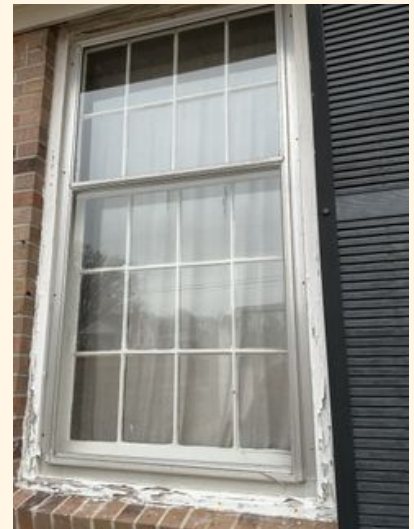
All windows appeared to be newer vinyl windows with the exception of the window on the front of the house for the carport. This carport window had paint peeling. Repair is recommended to prevent the wood window frame from being compromised by moisture.

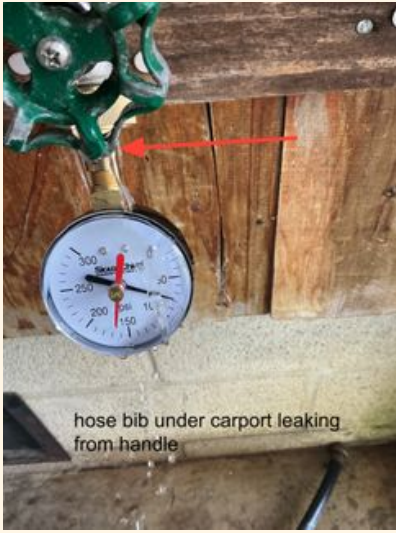
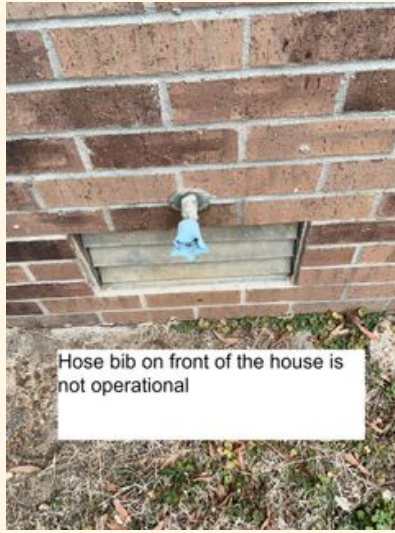
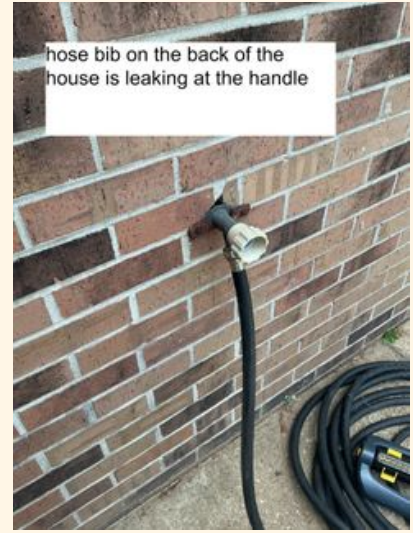
- Hose bibs leak from the handle when turned on and under pressure. Tightening the packing often fixes this.

Repair exterior hose bibs as needed.

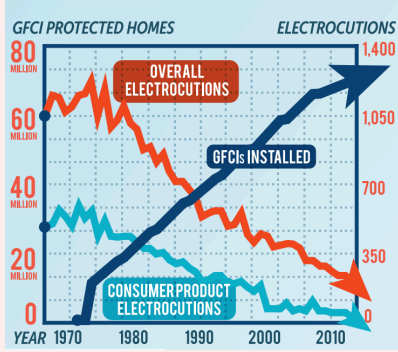
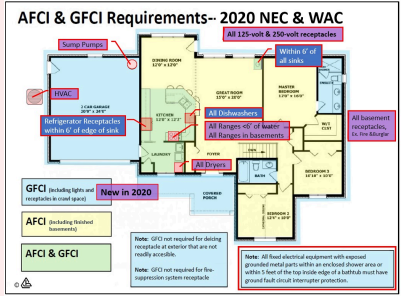
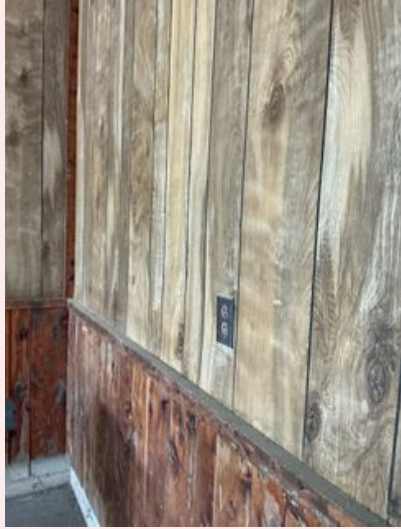
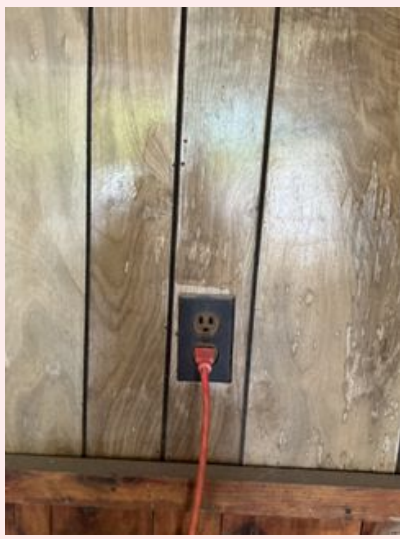
Since the 1970s, requirements for GFCI (Ground Fault Circuit Interruption) protection have changed, and locations requiring GFCI protection seem to get added with every code cycle. It is common for older residential buildings to have some or even many electric receptacles that do not meet modern safety standards. GFCIs have proven successful at reducing electrocutions, and it seems likely that someday, every circuit, receptacle, and appliance in the building will require GFCI protection. The first chart below shows how successful GFCIs have been at reducing risks from electrocution. The second illustration shows where GFCI protection is required as of the 2020 NEC and WAC. As a general best practice for safety. For improved safety, I always recommend bringing GFCI protection up to modern safety standards.

**During inspection today, I noted that GFCI protection is inconsistent with modern minimum standards for safety in the following locations: carport**

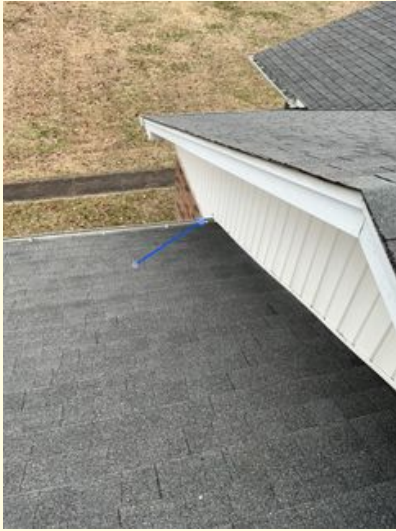
**(RCG-1) Improve or Upgrade:** Inadequate kick-out flashings noted at roof / wall juncture. Kick out flashing is installed at the intersection where a sloped roof meets a vertical wall, directing rainwater away from the exterior walls and into gutter.

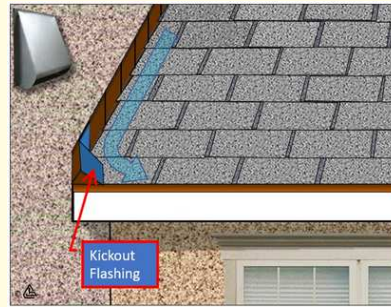
*Missing kick out flashing*

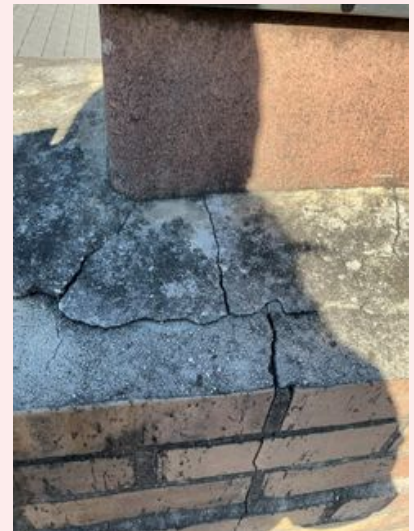
Repairs are needed to the masonry chimney cap. The cracks noted here could increase the risk of moisture control problems related to the chimney. Neglecting maintenance on masonry chimneys can also lead to loose or damaged bricks and eventually a failing masonry system.

Hire a licensed masonry contractor to further evaluate and repair the masonry chimney as recommended.

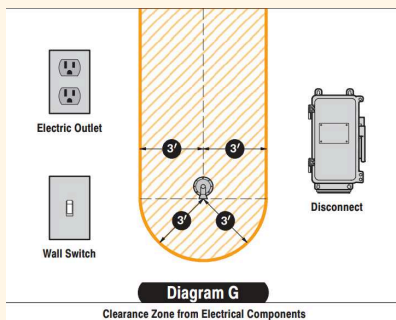
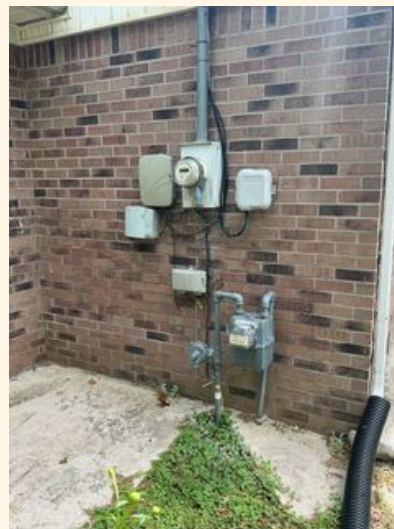
✂️ **(FSD-1) Repair:** The gas meter is too close to the electric meter. It must be 3 feet to the side or 3 feet above. Consult with your gas provider to further evaluate and repair.

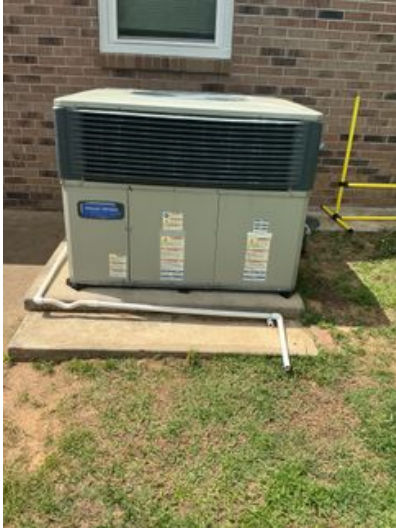
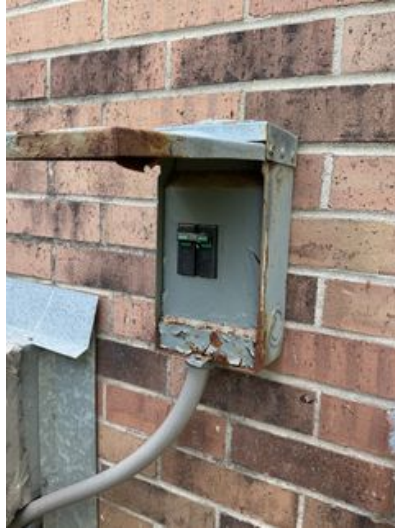
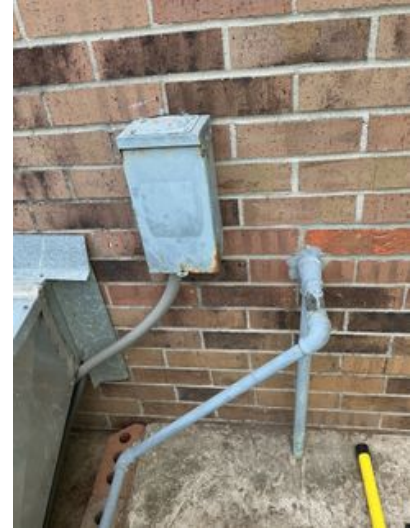
Annual servicing of gas forced air furnaces is recommended for safe and reliable heat. I could not find recent service records on the furnace. A servicing is recommended if one has not been done in the last year. The furnace was tested during the inspection and was operational.

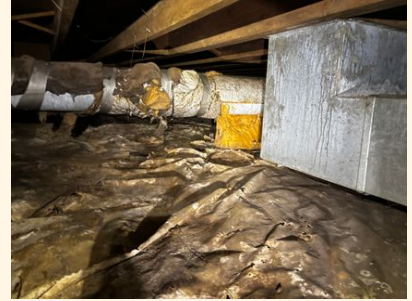
- The ductwork is not well-supported in the crawl space – additional support is needed.
- The ductwork insulation is damaged and requires repair

I recommend additional inspection and repair of the heating ductwork system by a qualified heating and cooling contractor. Implement repairs as recommended to ensure reliable performance.

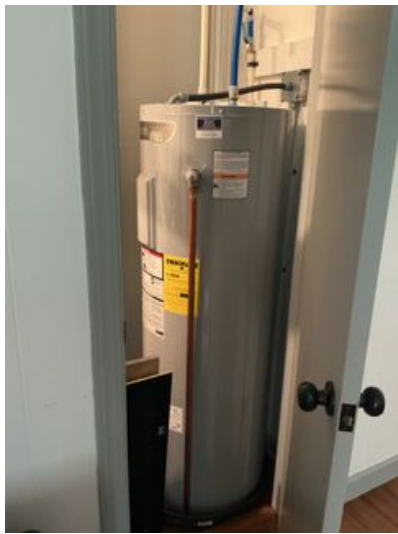
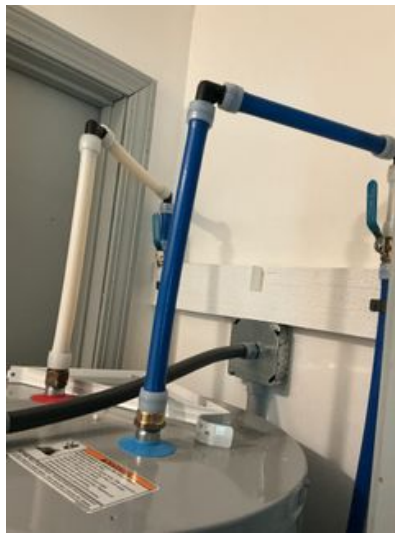
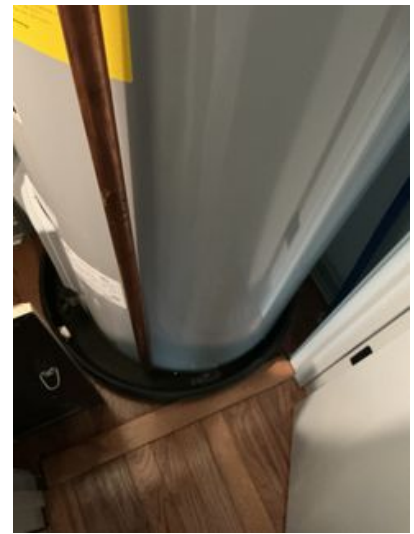
Install listed seismic straps to restrain the water heater in the event of an earthquake; none were noted during inspection. Two straps should be located on the water heater: one on upper 1/3rd of tank and one at the lower 1/3rd.

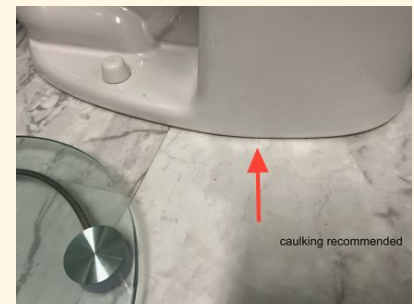
The toilet in the upstairs bath has not been caulked to the floor. Caulking the toilet to the floor is recommended and even required though opinions on this can vary. I prefer caulking the toilet to the floor, but leaving a gap on the back of the toilet that remains uncaulked so if the toilet leaks, water has an escape route. The biggest risk of not caulking the toilet to the floor is that the toilet can become loose which is the biggest problem here. Repair as recommended by a licensed plumber.

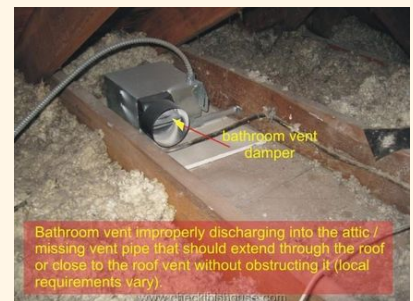
The exhaust ductwork for the bathroom fans are disconnected in the attic. This can lead to seasonal condensation and moisture control problems.

Repair to ensure proper discharge of air to the exterior, and ensure exhaust ductwork is insulated to R-8 or better to reduce risks of seasonal condensation.
