AMEA Services UK Completes Fire Damper System Repairs and System Upgrade

Introduction

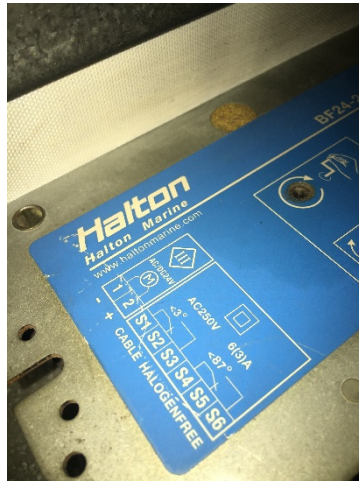
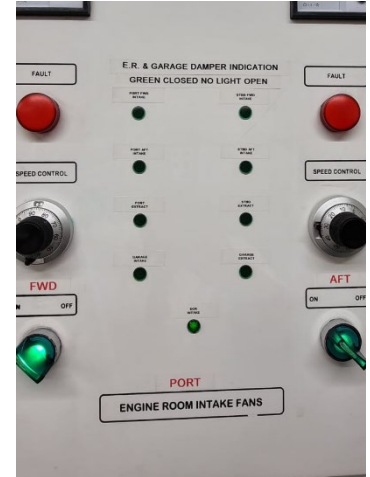
A client had an issue with their fire damper operation within their engine room and lazarette areas.

A number of intake and extract variable speed drive driven fans were not operating the dampers when instructed to do so. There was also no remote indication of damper position within the ECR.

Bridge indication had failed showing continually that dampers were permanently open, regardless of position.

- Full survey conducted into damper operational issues.
- Some were replaced with replacements sourced and delivered to site. One damper required a replacement thermal fuse only.
- Replacement controls fitted for one damper where it could not be ascertained where control was derived from.
- Additional damper indication fitted within ECR. This involved new cabling being installed and the use of MCT Brattberg class approved penetrations.
- Bridge indication repaired. With fault located to short circuited diode within lamp test circuit.
