AMEA Services UK Completes Underwater Lights Repairs

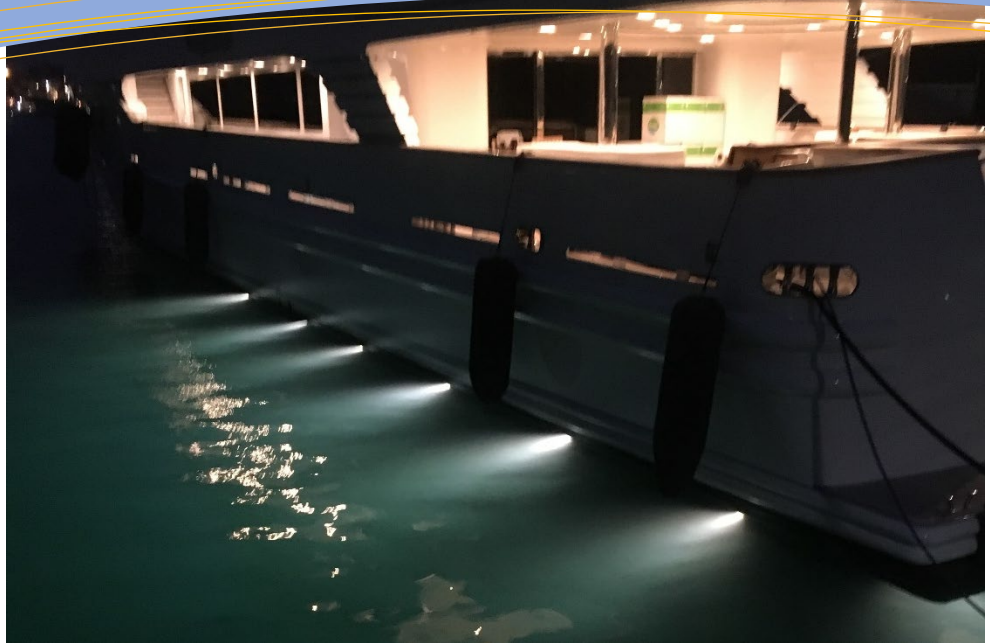
A client had an issue with their metal halide underwater lights whereby many were inoperable, had low earth readings and some displayed signs of heat damage on connecting cables.

It was found that the ballasts for controlling the lamps were all located remotely in a central position, in some cases over 20 metres away from lamps.

- Full survey conducted into underwater lights operational issues.
- Existing light housings were maintained with a full blanket change of lamps and lamp holders internally implemented.
- The final length of damaged cable to each luminaire was pulled back and replaced utilising heat resistant sleeving for additional protection.
- Replacement ballasts fitted locally to lamps. It was a requirement of the lamp manufacturer that the ballasts are sited locally (within 2 metres) of the light fitting.
- Soak test implemented over many evenings without failure.
