Honest Neighbor Inspections

Detailed HNI Home Inspection Report

5555 1st Street

Inspected on Wed, Feb 19 2020 at 10:20 AM

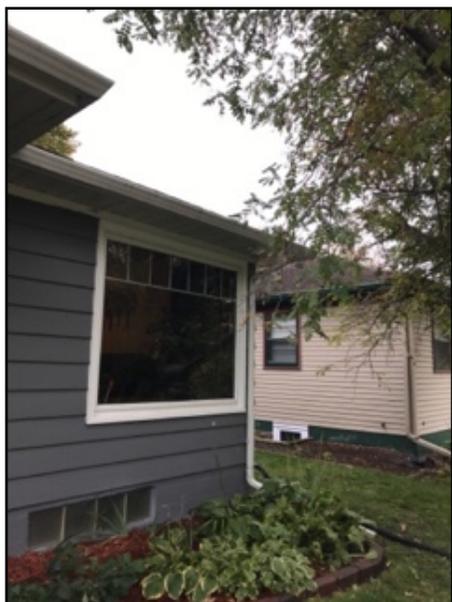
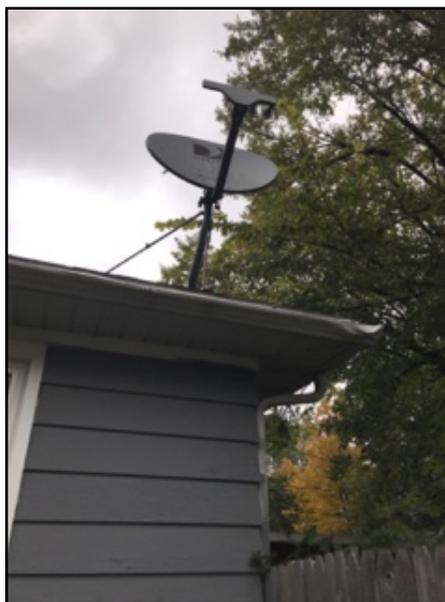
Vegetation should be trimmed back 10' from building roof to prevent moss and gutter buildup and falling branch damage .

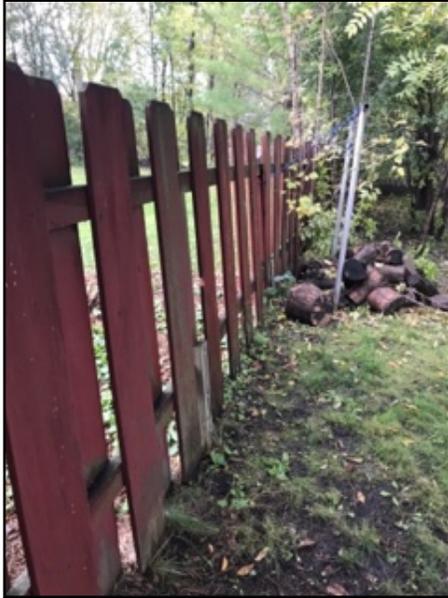
Figure 2-1

Posts seem to be loosely attached to the ground. Some rail sections are weak when pushed.

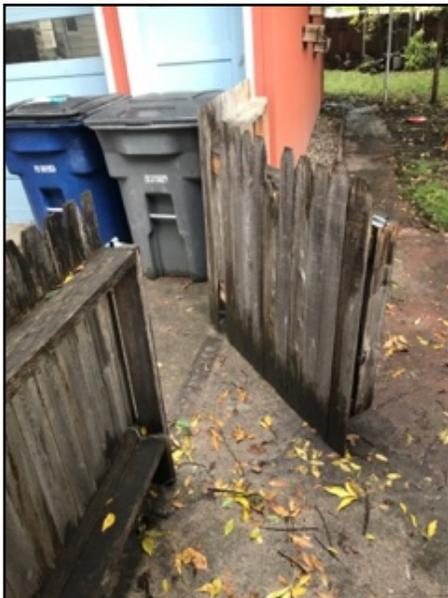
Figure 3-1

Back yard entrance fence is weak and leans when pressed. Gate is hard to operate.

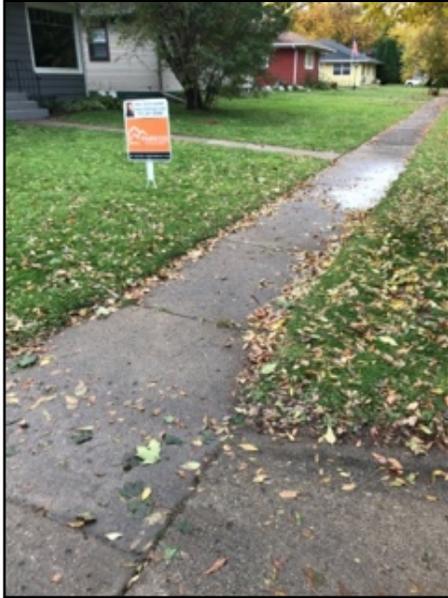
Figure 5-1

Comment 5:
Some standing water and some cracks.

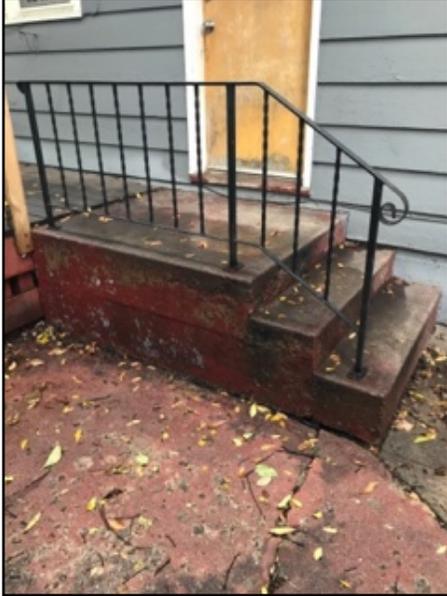
Figure 6-1

Iron railing has missing bolt/anchor. Recommend fastening for safety.

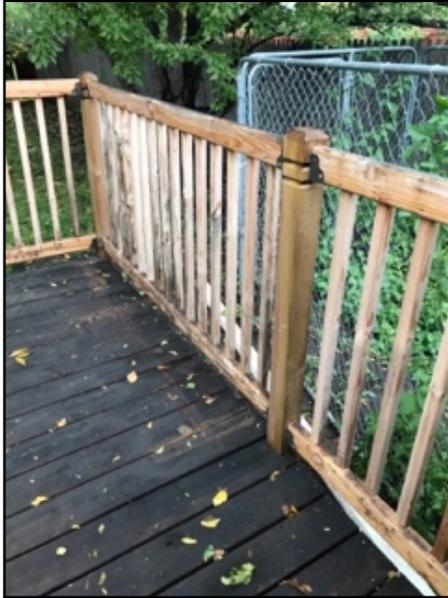
Figure 7-1

Comment 7:
Wood railing feels weak. May need additional bracing.

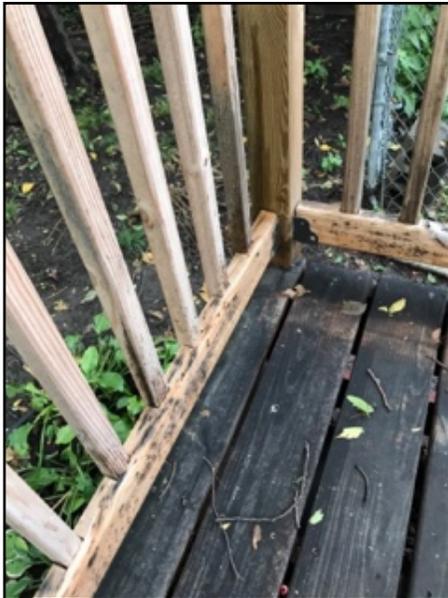
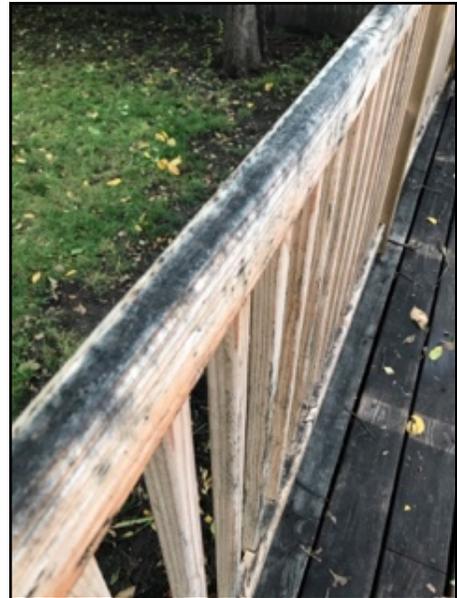
Comment 8:
Wood railing and deck were not properly sealed or treated. Future maintenance won't be possible as the wood is stained.

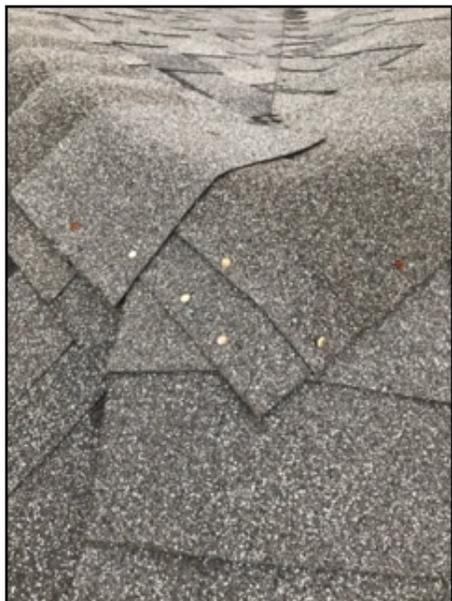
Figure 9-1

Final nail heads need sealant. Heads are rusting

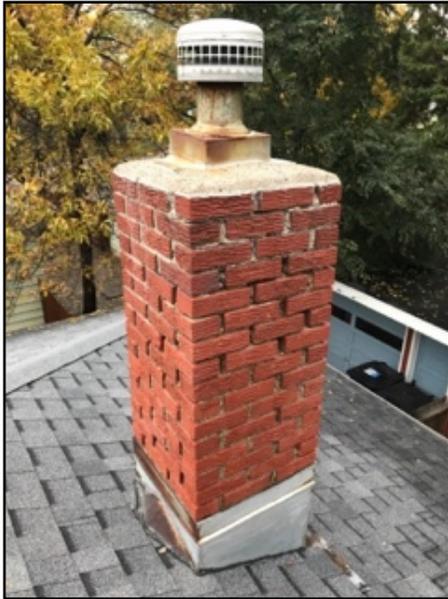
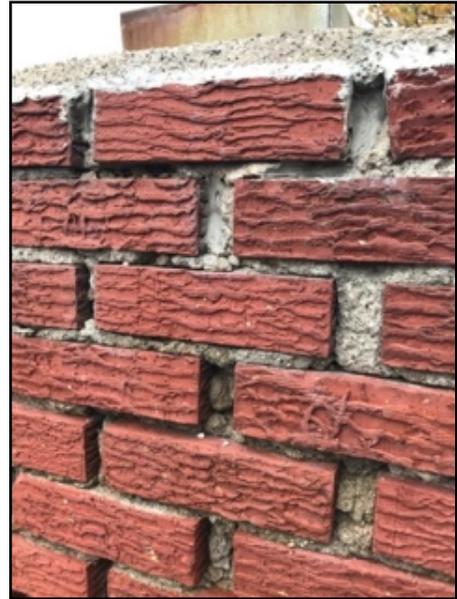
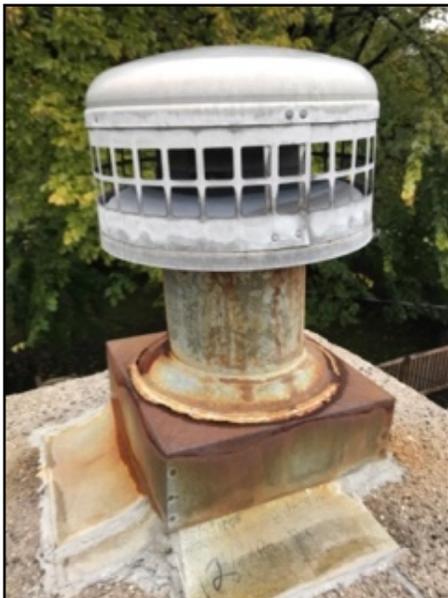
Comment 10:
Chimney mortar needs replacing. Integrity appears good. Improper mortar repair. Chimney cap in need of new sealant and rusted. May need replacement in near future.

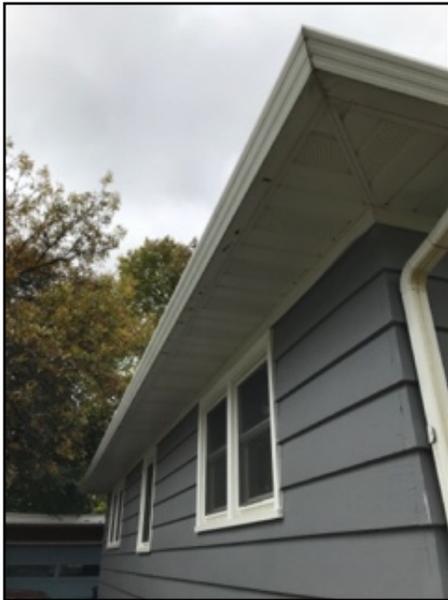
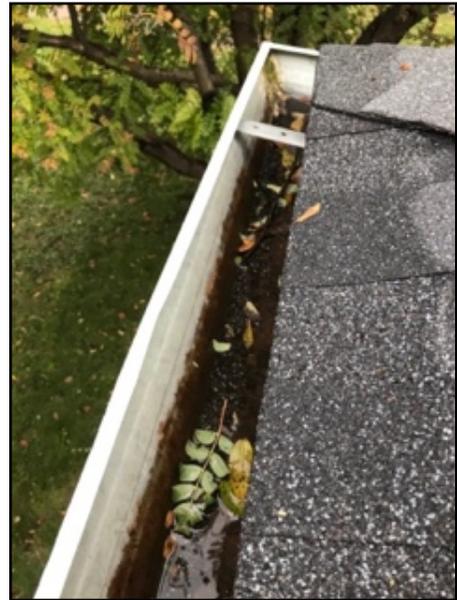
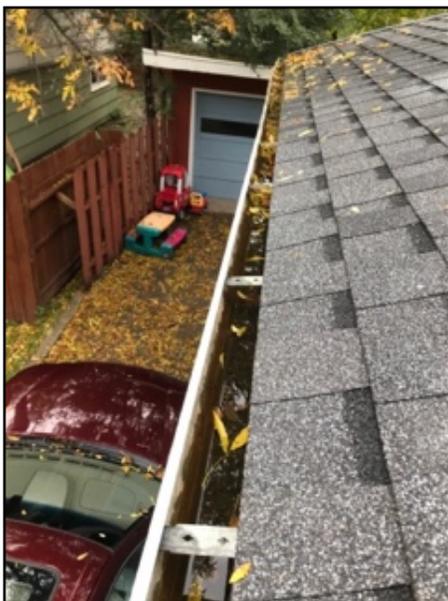
Comment 11:
Active gutter leaks. Apparent rusting occurring. Gutters have standing water.
Recommend replacing.

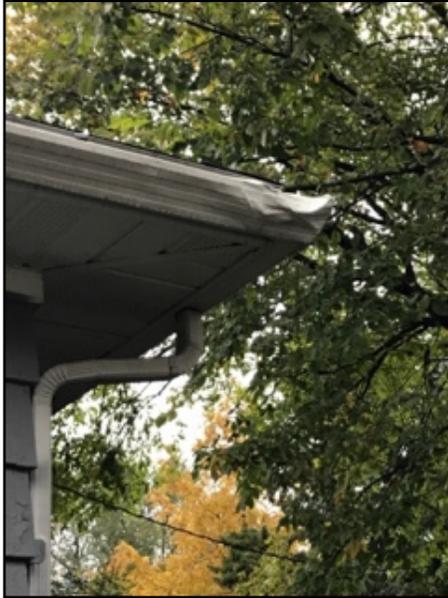
Figure 12-1

Comment 12:
Damaged possibly by branches.

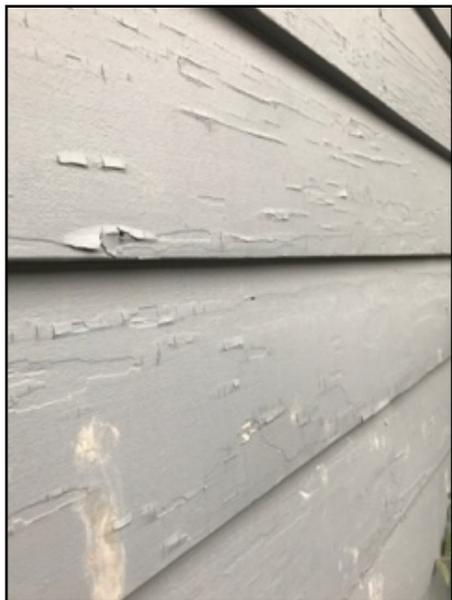
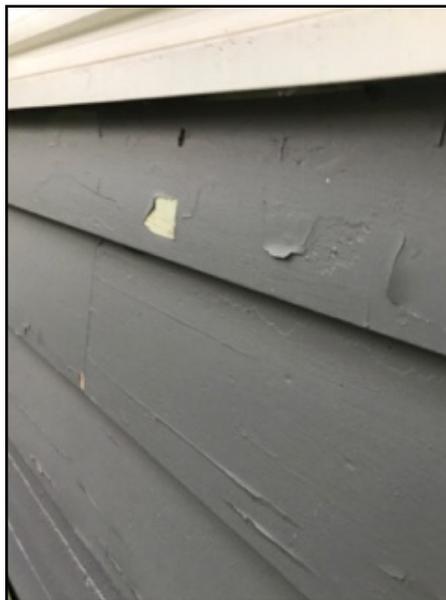
Comment 13:
All areas of siding have been painted and were not properly scrapped and will need to be redone within a year or 2.

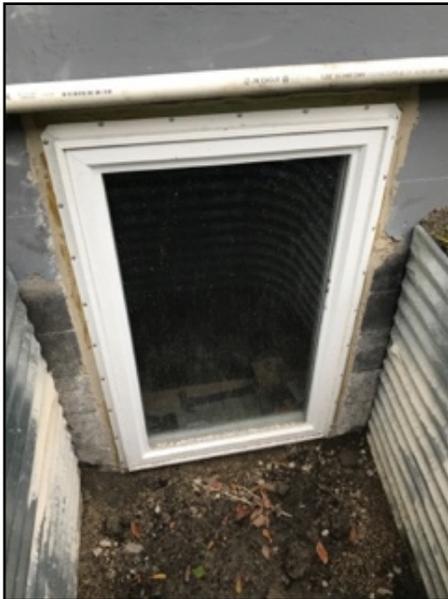
Figure 14-1

Basement egress window is missing proper flashing and weather protection.

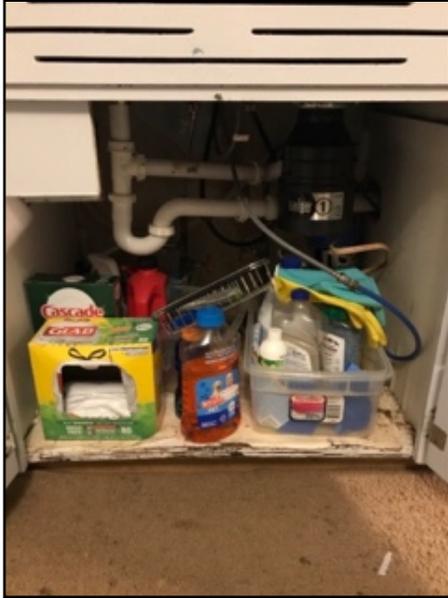
Figure 18-1

Sludge will build up in discharge from garbage disposal. Should have proper slope.

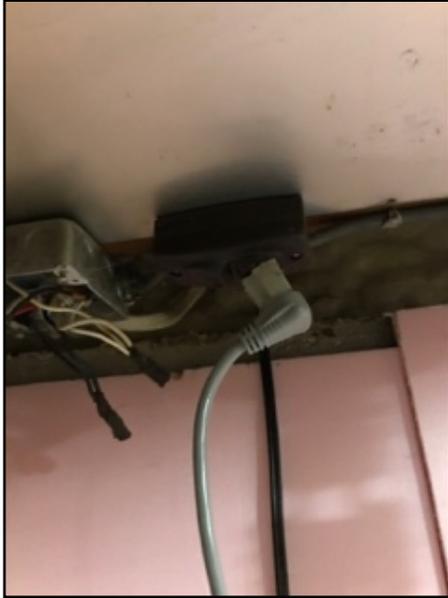
Figure 20-1

Laundry outlet should be replaced with a grounded receptical. Nehiboring box should have box covered.

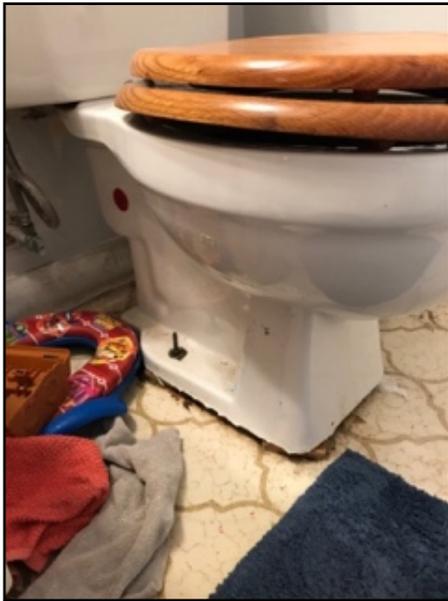
Figure 21-1

Comment 21:
Handyman shim used to prop up. Not properly set.

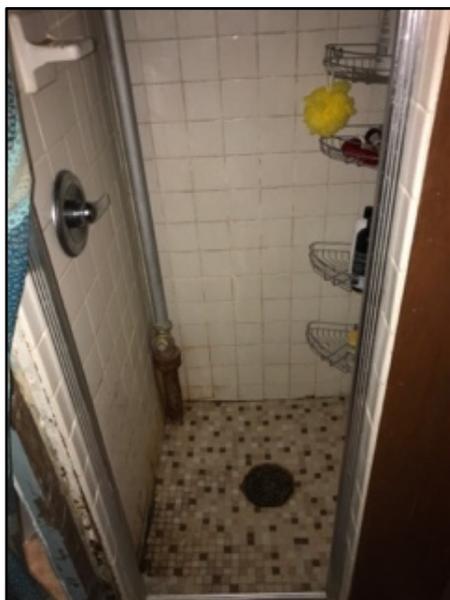
Figure 24-1

Tile may need replacing in near future. No light fixture and missing ventilator.

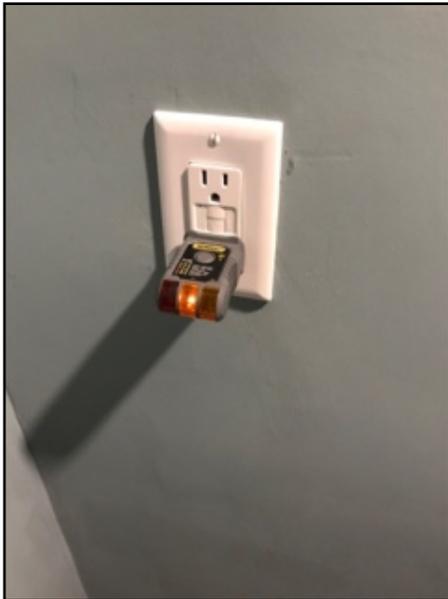
Figure 25-1

Comment 25:
Basement bathroom open ground.

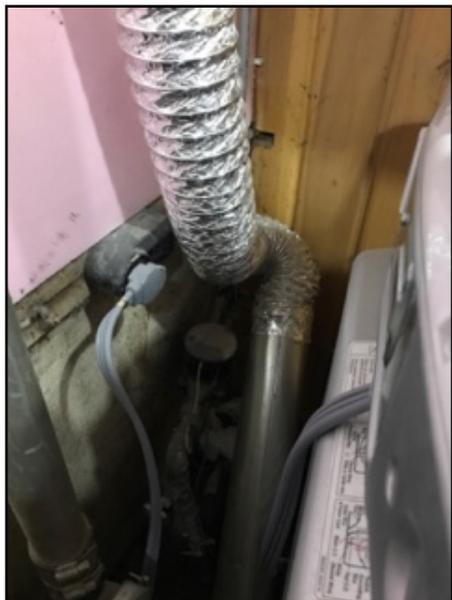
Figure 28-1

Comment 28:
Supply line is reduced to smaller 1/2" supply for whole house. May need to be replaced for added bathroom.

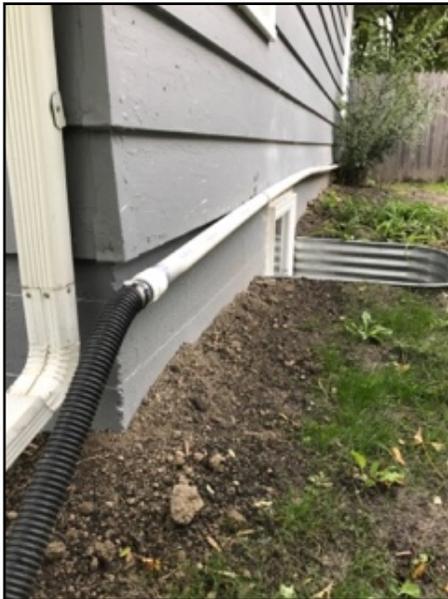
Figure 29-1

Comment 29:
Sump line slopes up. Needs to slope down in case of clogging or freezing.

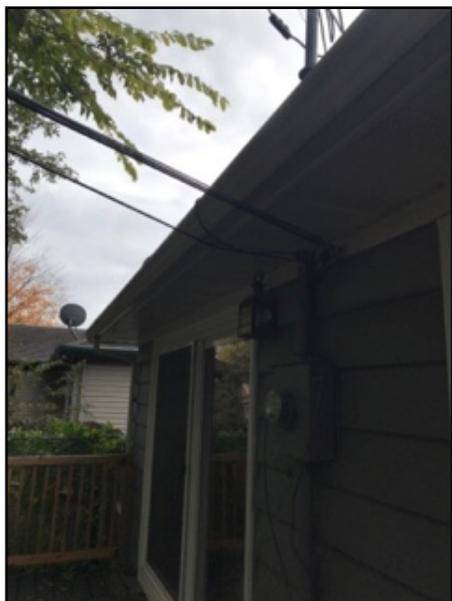
Figure 31-1

Additional cable should be removed if abandon. Recommend they be removed.

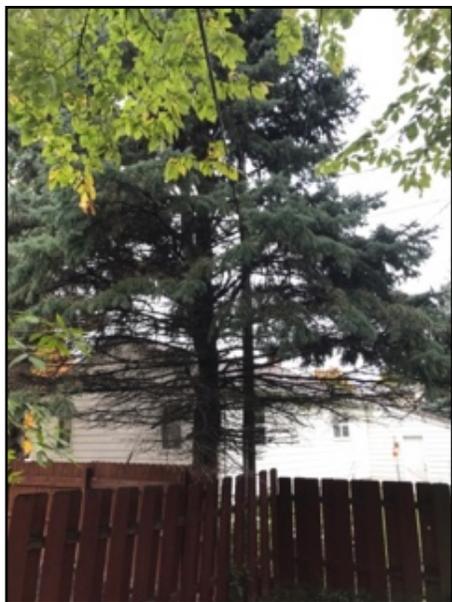
Figure 32-1

Overhead service line needs trees to be removed. Further evaluation required and may inquire large expense.

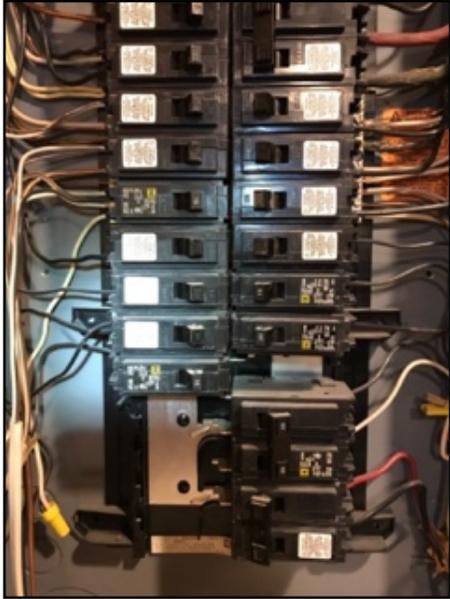
Figure 33-1

Comment 33:
Found 2 breakers are too large 20 amp for 14 ga wire.

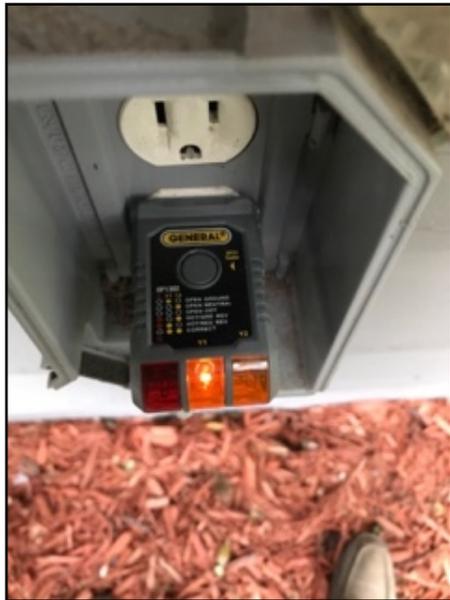
Figure 34-1

Comment 34:
Outdoor receptical has open ground. Neither gfci. Recommend replacement with gfci receptical.

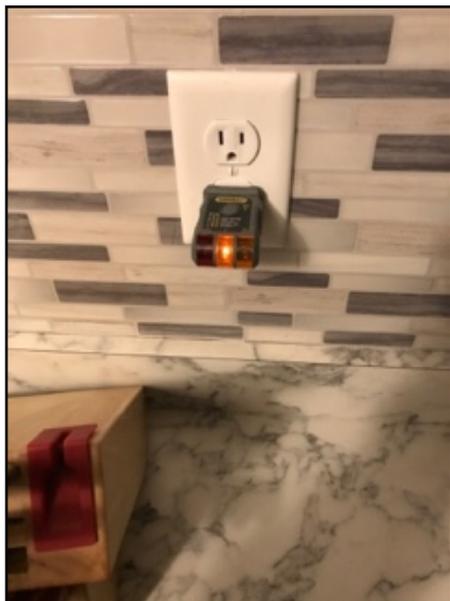
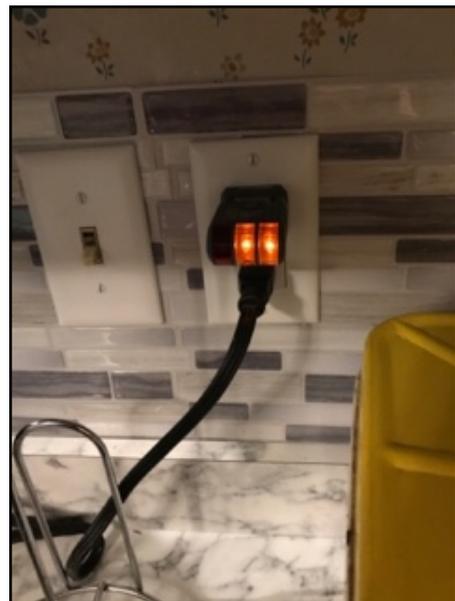
Open ground in kitchen. Gfci recepticals needed in kitchen. Did not trip when tested.
