Pre-Purchase Building and Pest Inspection Report (PPBPIR)

23 Marathon Street, Aspley Qld 4034

Wednesday, 31 August 2022

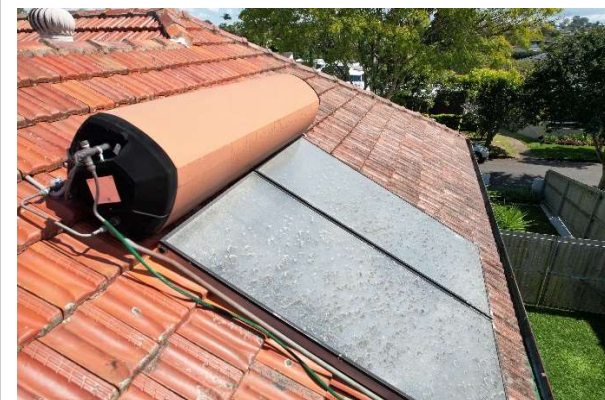
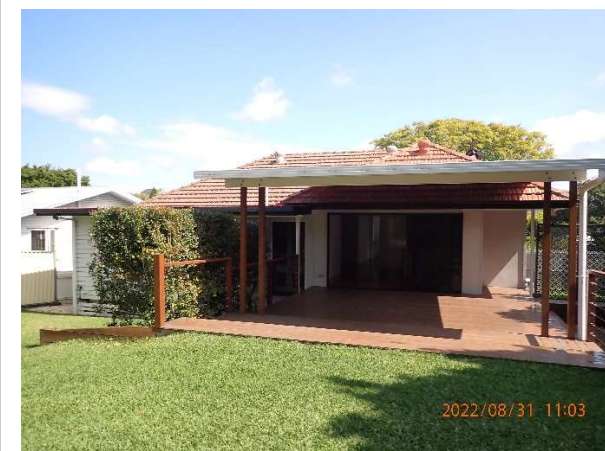
Slight wood decay was observed to the fascia boards. Repair recommended.

Paint delamination was observed to the eave. This is caused when paint has an adhesion problem it is commonly prepped incorrectly or not prepared for painting at all. Repairs recommended.

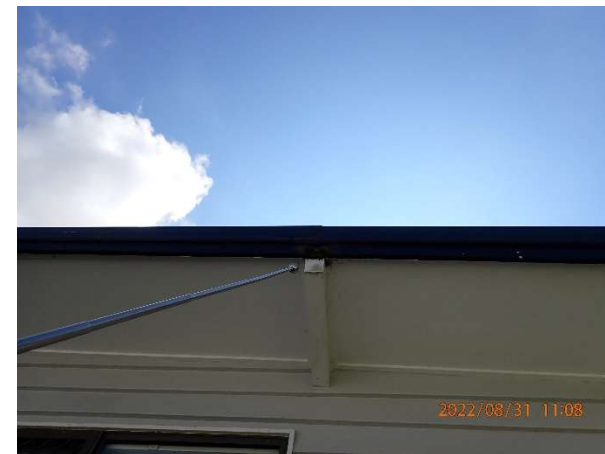
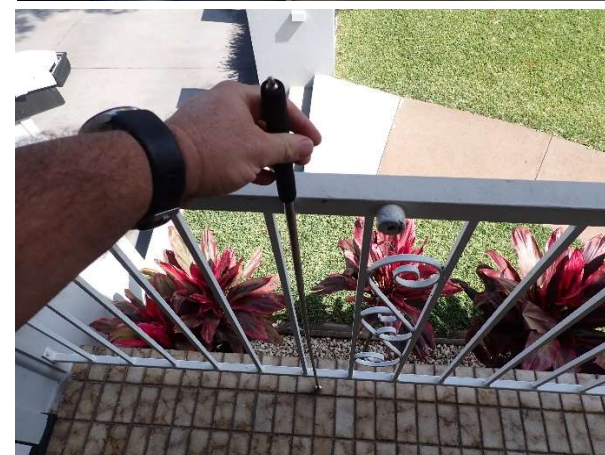
The front entry handrail balustrade is less than one meter high. Repairs recommended

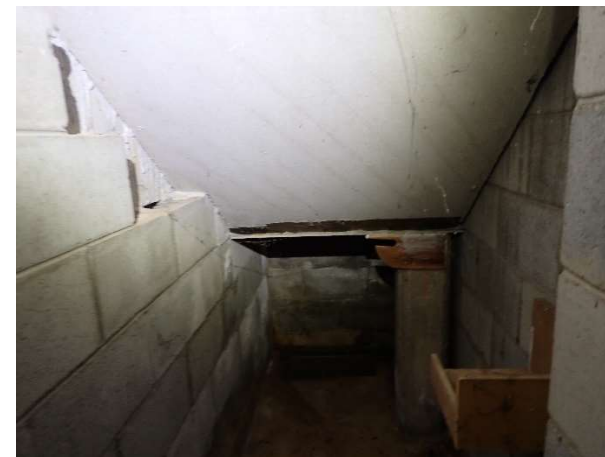
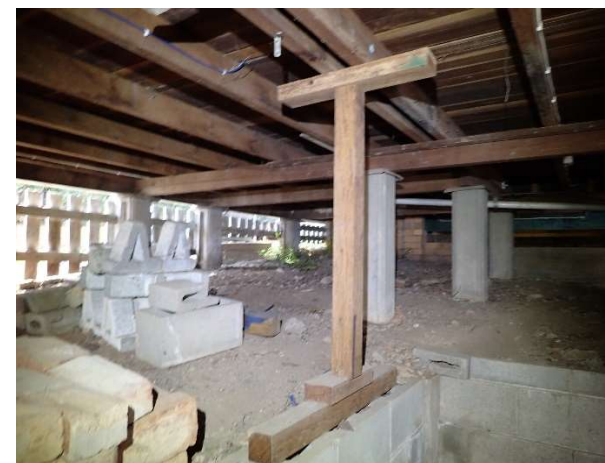
The inspector observed alteration to the house subfloor. It is recommended to obtain all information for the service provided.
