Sample Condo

PROPERTY INSPECTION REPORT

Concerning: Sample-Condo

By: Jeffrey Kent Prokaski TREC #9866

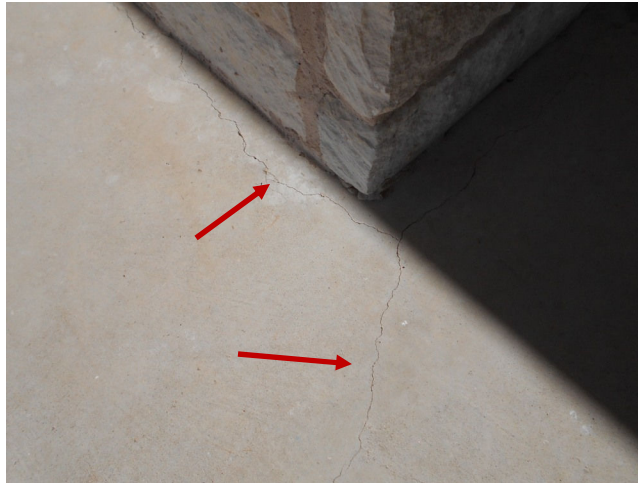
Minor cracking was observed in the foundation at the front of the house. This type of cracking is usually the result of shrinkage of the concrete as it cures. Shrinkage cracks are very common and should not be cause for alarm. This area of course, should be monitored.

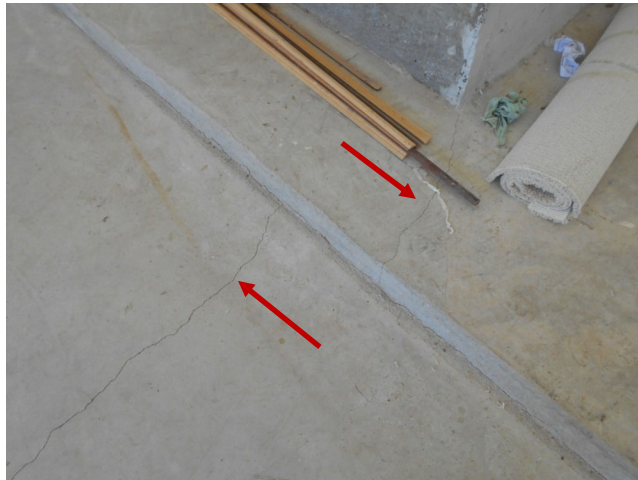
Minor cracking was observed in the foundation in the garage. This type of cracking is usually the result of shrinkage of the concrete as it cures. Shrinkage cracks are very common and should not be cause for alarm. This area of course, should be monitored.

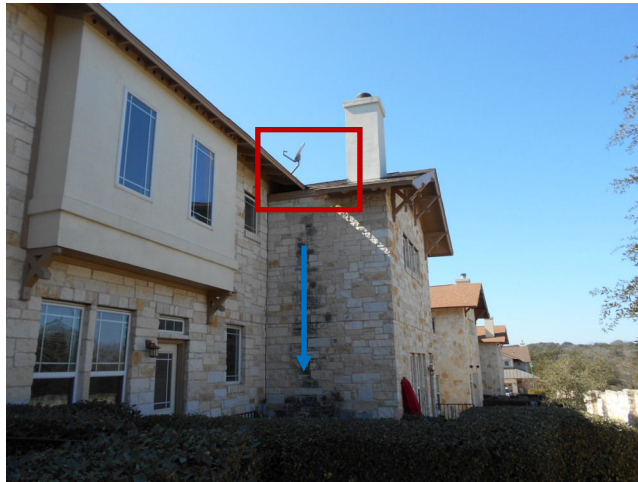
The design of the roofing system on the north side of the home discharges heavy amounts of water onto the condenser below. It is recommended that a gutter be installed in this area to divert water runoff. At a minimum, a rain diverter is required at this location.

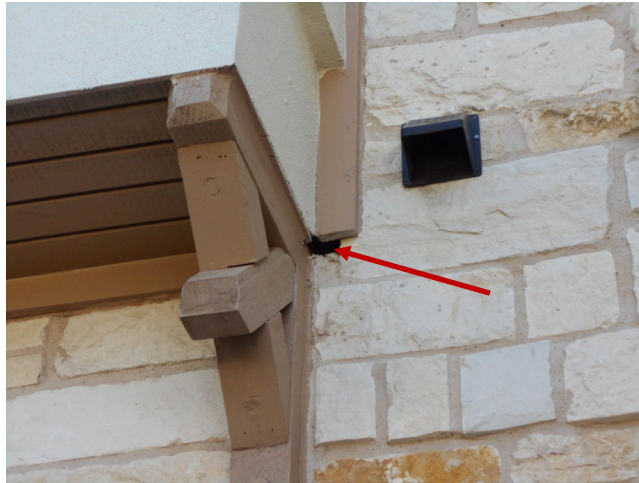
An opening in the wall was observed along the north side of the house. This area should be sealed as needed to prevent water penetration.

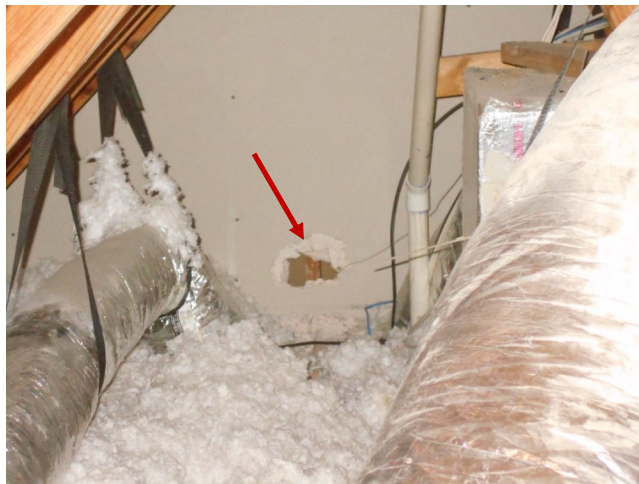
The separating wall (common wall) in the attic space is damaged and should be repaired.

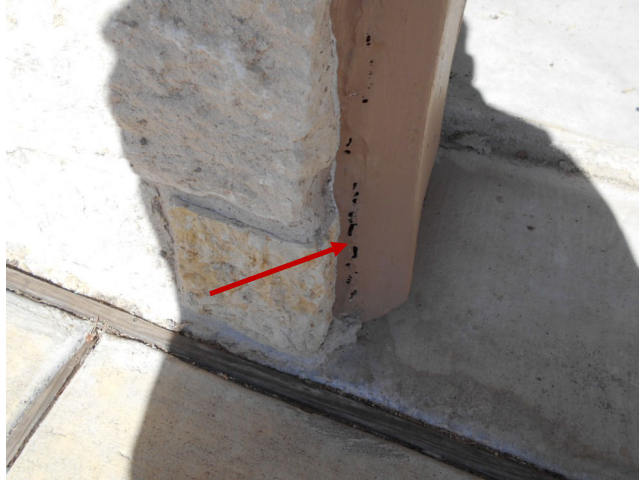
The wood casing for the garage door should be better sealed to the structure to prevent water penetration and possible wood rot.

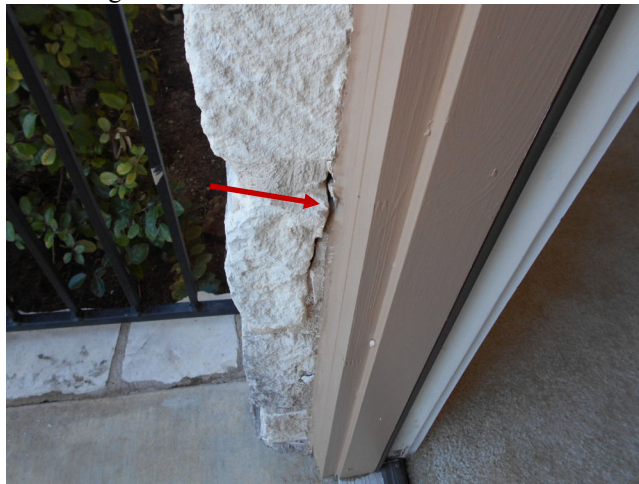
The casing for the door at the rear of the house should be sealed to prevent water and air penetration.

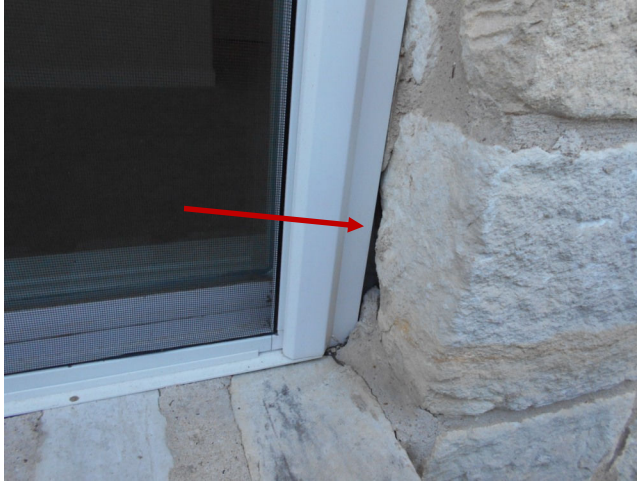
The windows and window sills on the exterior of the house are in need of re-caulking or re-pointing to avoid water penetration.

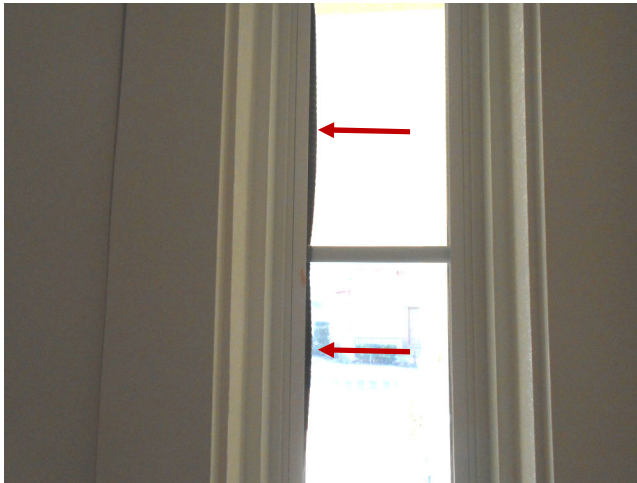
The seals for the side light windows at the front of the home were damaged and should be repaired.

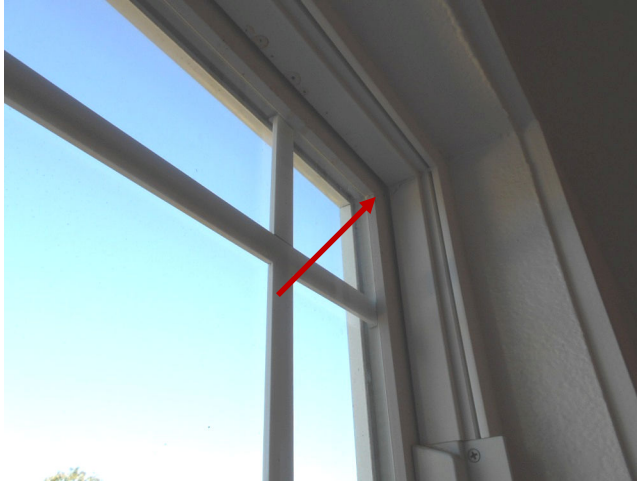
Two windows in the master bedroom are not sealing properly and are letting water penetrate. Improvement is recommended.

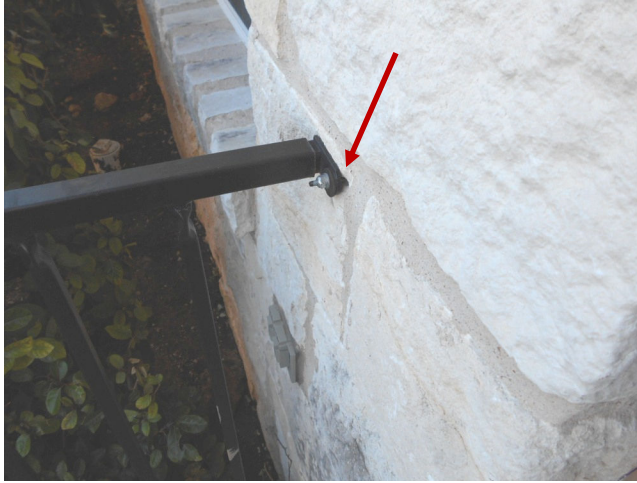
The porch railing at the rear of the house is loose. It is recommended that this be repaired for improved safety.

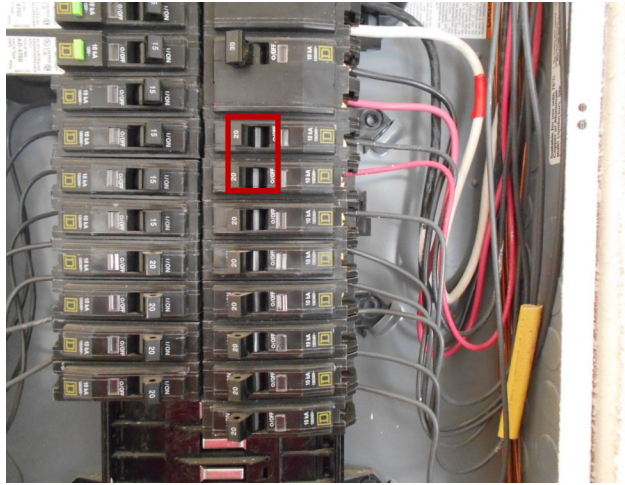
One or more of the breaker trip-ties appear to be missing in the sub panel. The 120V overcurrent devices (breakers) sharing a grounded conductor (Neutral) should be connected together by trip-ties. There is a shock risk even though the breaker may be in the off position. This should be further investigated by a licensed electrician.

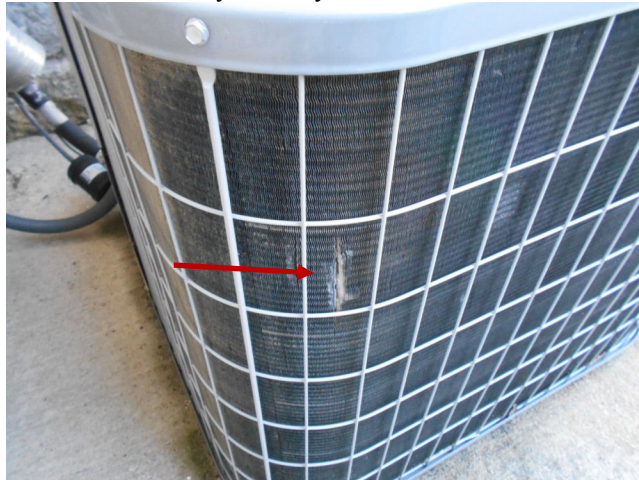
The fins of the outdoor portion of the air conditioning system were observed to be damaged. This condition can reduce the efficiency of the system.

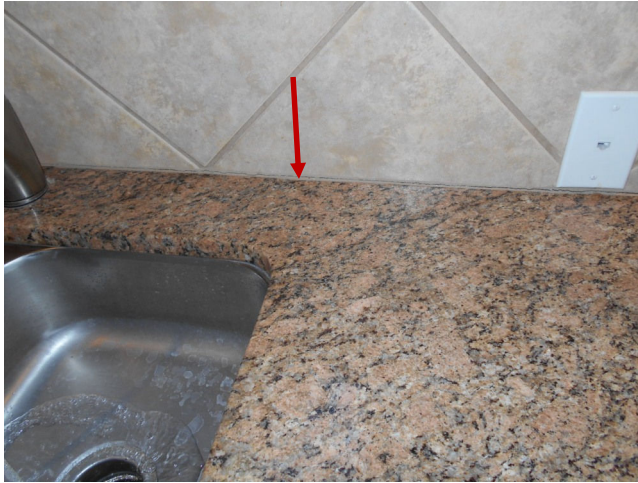
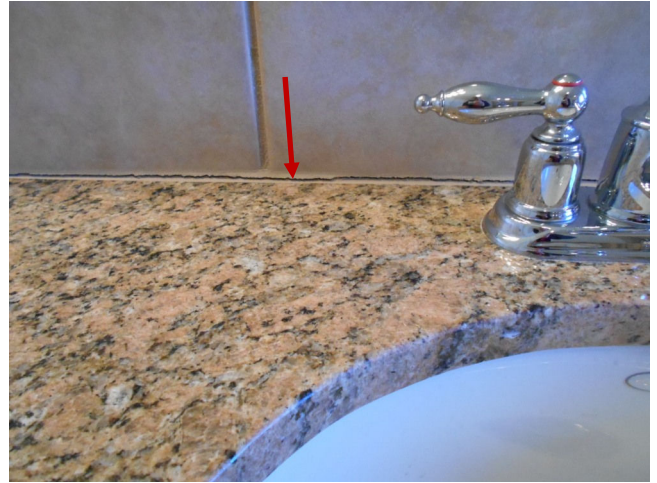
The backsplashes in the kitchen and bathrooms should be sealed to prevent water penetration into the cabinets below.

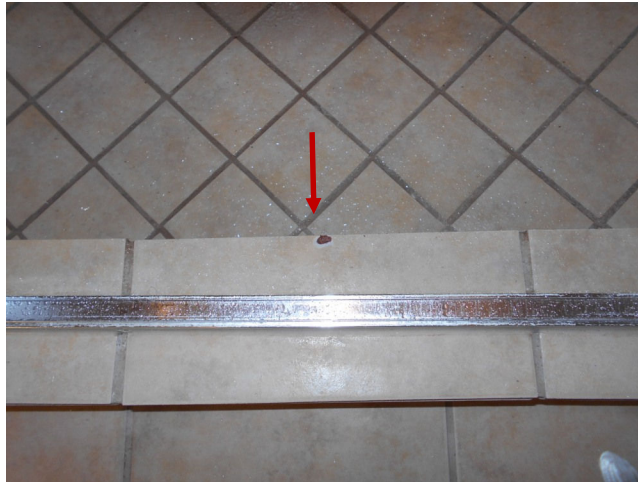
The tile shower stall requires repair in the master bathroom. Damaged tiles should be repaired or replaced as necessary.

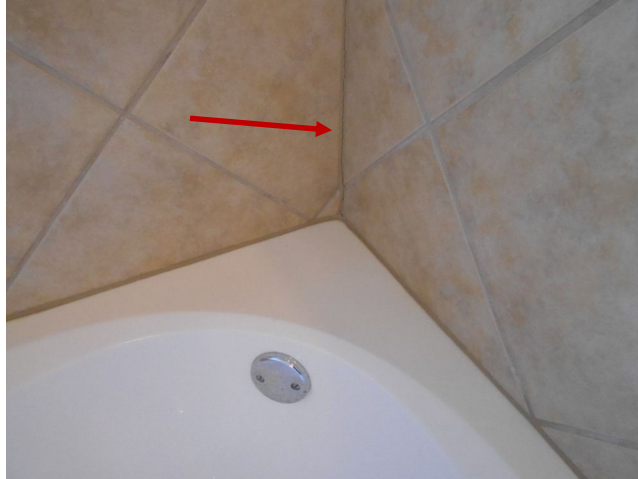
Cracked, deteriorated and/or missing bathtub enclosure grout and caulk should be replaced in the master bathroom.

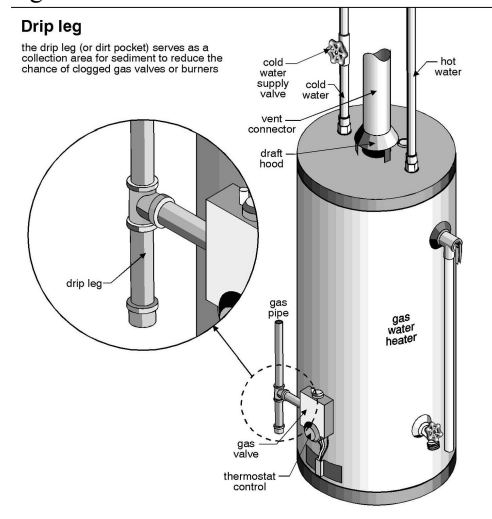
Drip legs were not present at the water heater and furnace connections. Under current building standards, drip legs should be installed downstream from the gas shut-off valve and as close to the equipment inlet as possible.

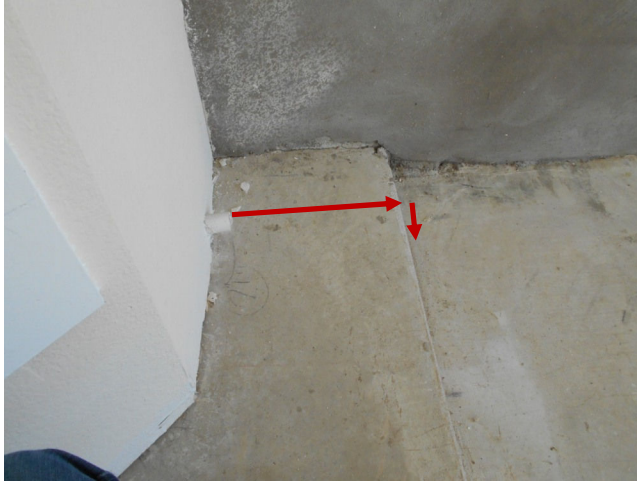
The drain for the water heater safety pan should terminate to the outside of the home or lower portion of the garage floor.

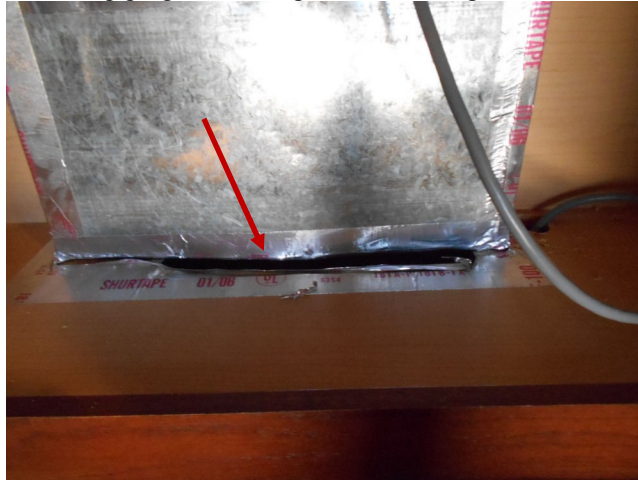
The vent piping for the range hood is damaged and should be repaired.
