Sample Older Home

PROPERTY INSPECTION REPORT

Concerning: Sample Older Home

By: Jeffrey Kent Prokaski TREC #9866

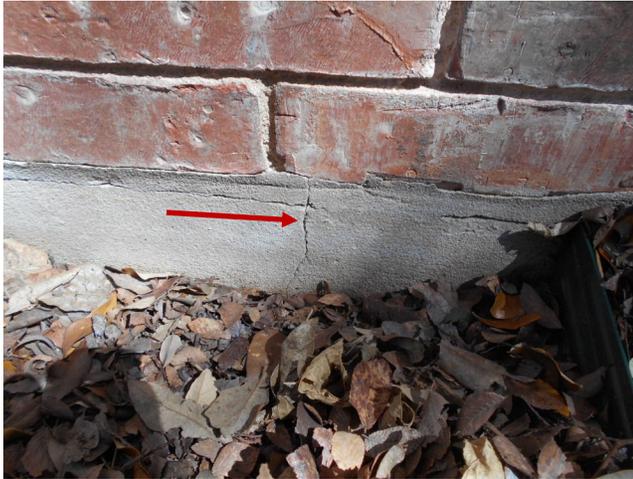
Slightly greater than typical foundation cracking was observed along the west side of the house. The amount of movement does not suggest a serious structural problem. This area should, of course, be monitored. The rate of movement cannot be predicted during a one-time inspection.

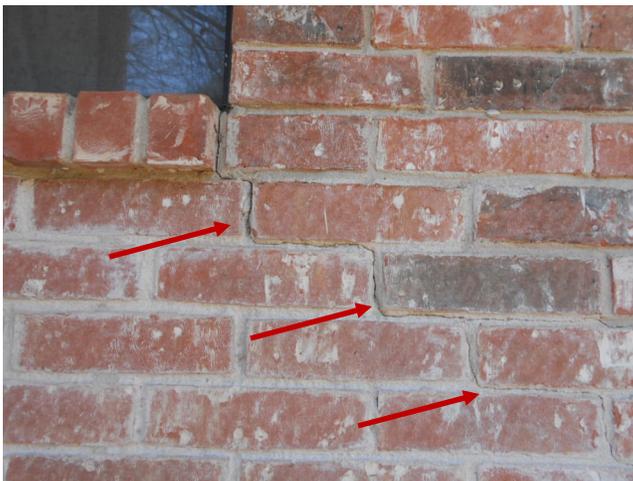
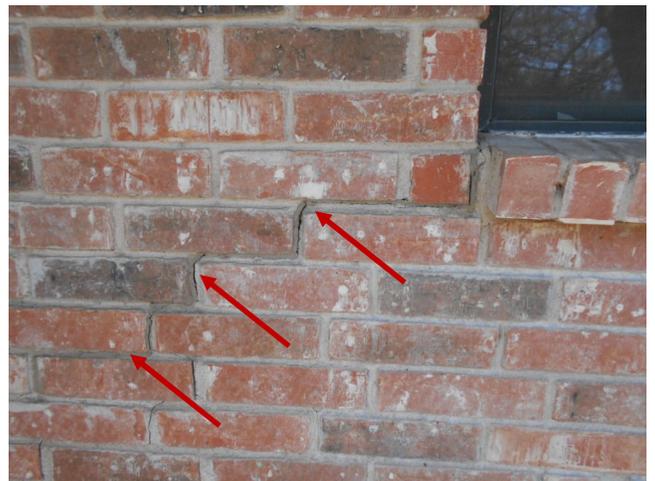
Cracks were observed on the exterior walls along the south side of the house. This implies that some structural movement of the building has occurred.

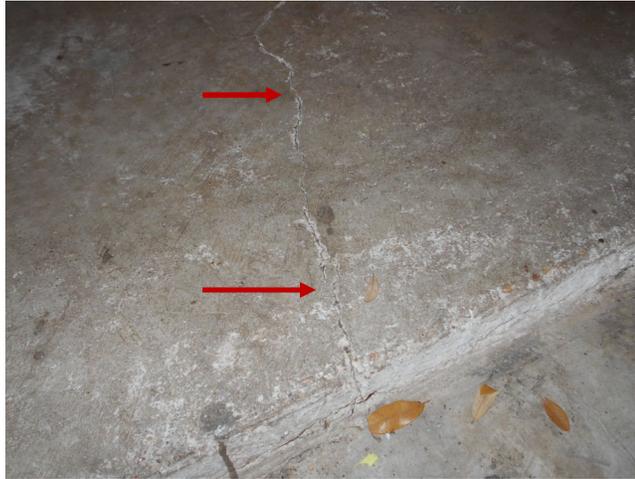
Slightly greater than typical foundation cracking was observed at the garage. The amount of movement does not suggest a serious structural problem. This area should, of course, be monitored. The rate of movement cannot be predicted during a one-time inspection.

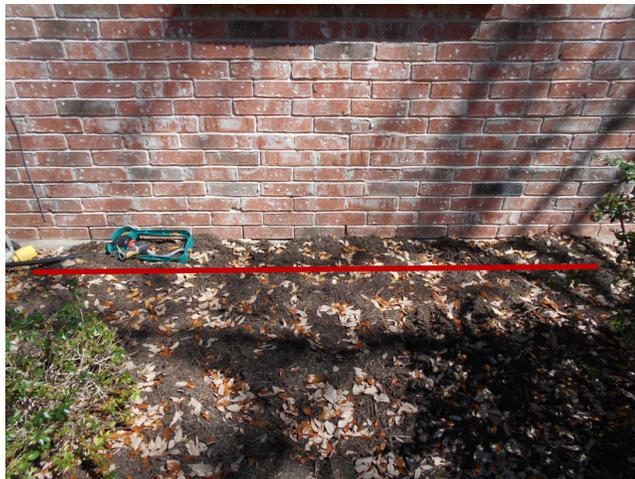
The soil line is too high in various locations. This condition can promote water and insect infiltration. Under today's building standards, there should be at least four (4) inches of foundation visible below masonry veneer and six (6) inches of foundation visible below wood veneer.

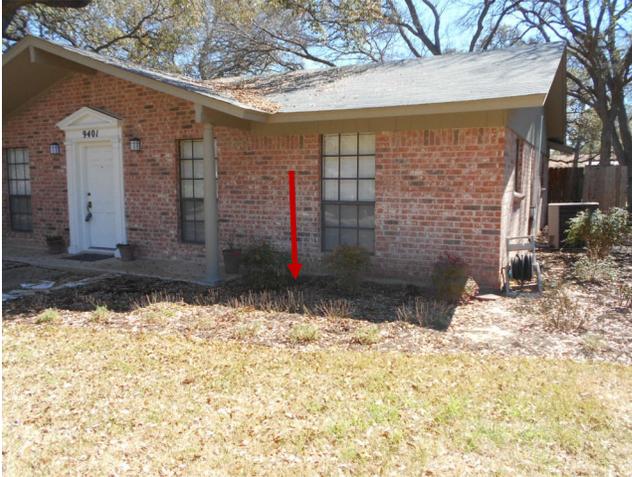
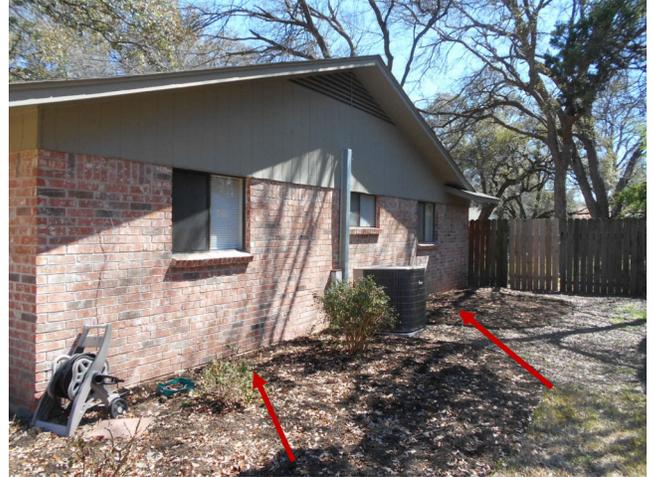
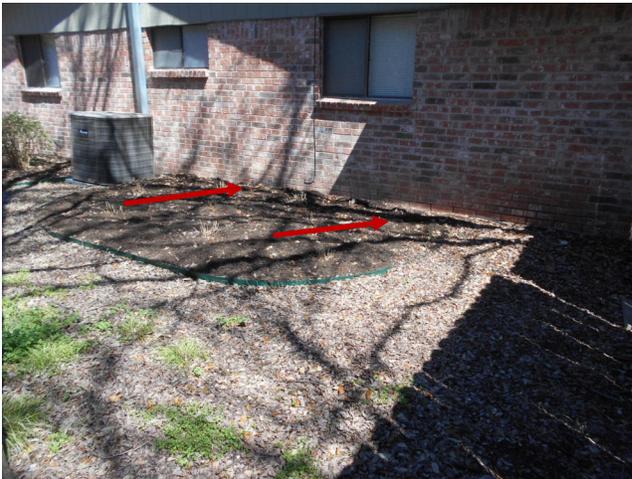
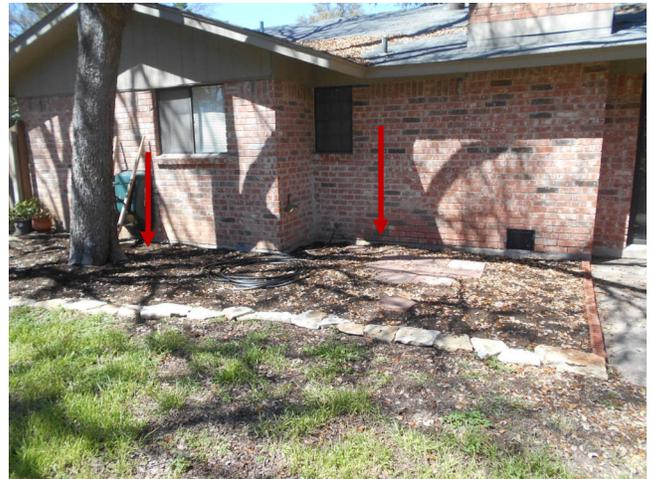
Poor and/or negative site drainage was observed on the entire home. Proper drainage is needed on to help prevent water from standing and/or ponding next to the foundation area. Under today's building standards, the grade away from the foundation walls should fall a minimum of six-inches (6") within the first ten feet (10ft.). If adding soil to the perimeter to create positive drainage, remember to keep the soil level about four (4") inches BELOW the foundation edge. French drains may also be used to divert water accumulation.

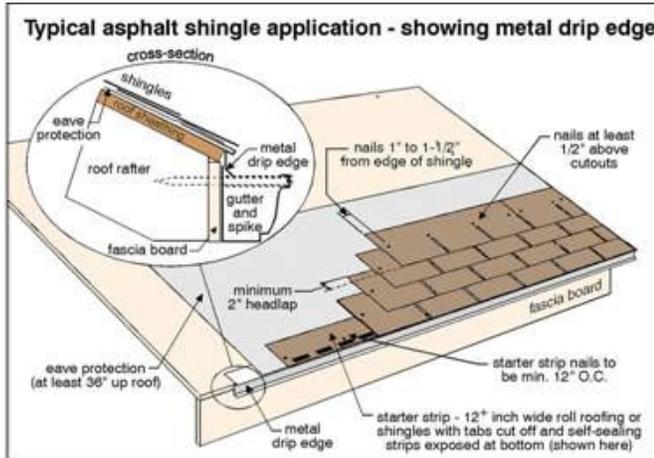
The starter course of the roofing material was not properly installed per the manufacture installation requirements. The starter course shingle should consist of a strip shingle with the tabs cut off with the self-sealing strip at the lower bottom edge. This will help prevent wind damage or lifting of the shingles in high winds.

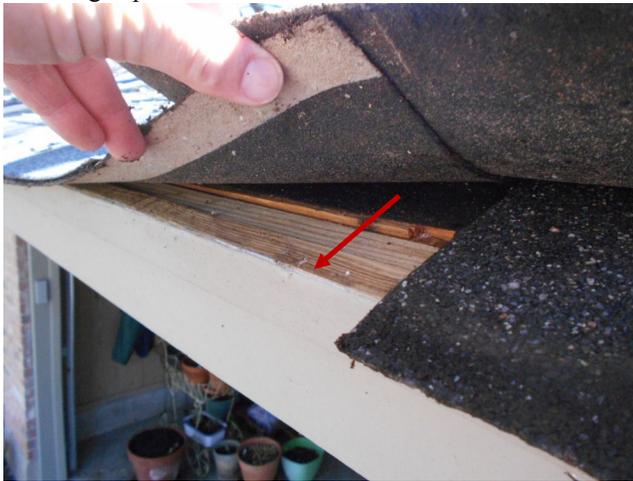
The felt paper was observed to be installed short of the lower drip edge detail. The manufacturer installation suggests the felt paper be installed over the top of the drip edge, in shingle like fashion, to help prevent water intrusion and/or damage to occur behind the fascia board and soffit/eave areas. This is typically repaired when reroofing is performed.

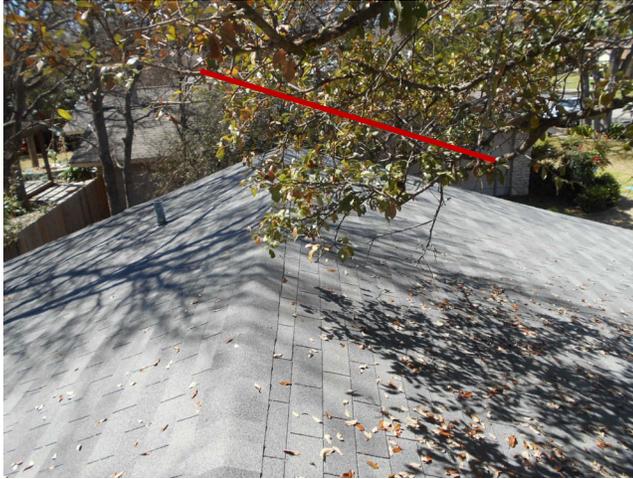
Tree branches should be trimmed away from the roofing material. This condition can lead to damaged roofing material and possible water penetration. Three to four feet of clearance is generally recommended.

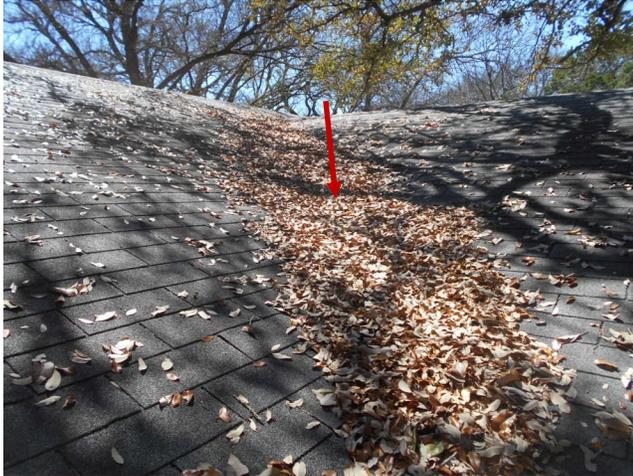
Debris should be removed from the roofing. This condition can trap moisture and shorten the life of the roofing materials.

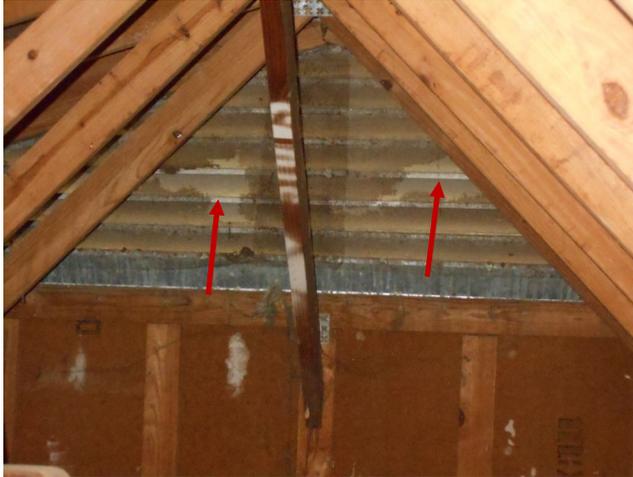
Damaged gable and roof vent screens should be repaired as needed to prevent vermin entry into the attic space.

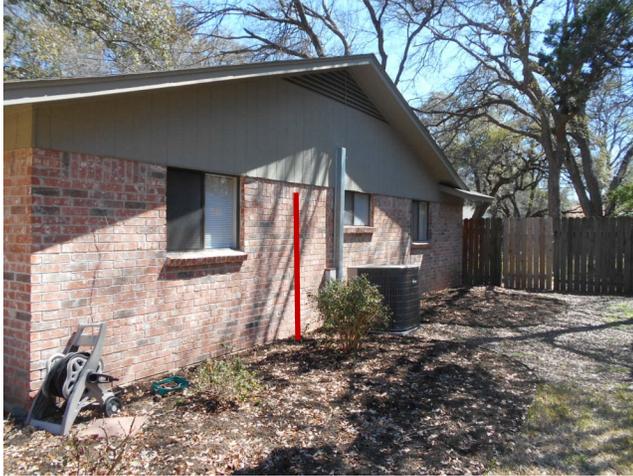
Under current building standards, masonry walls in excess of twenty five feet are required to have an expansion joint which was not present at the time of inspection. An expansion joint allows some structural movement without cracking the mortar joints.

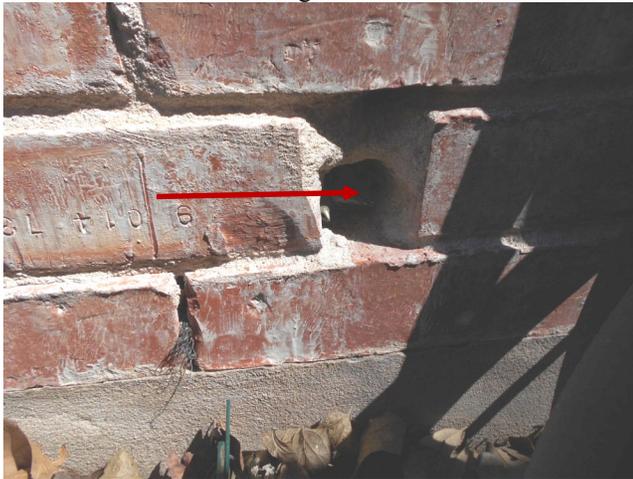
The area where the old refrigerant lines enter the home should be sealed to prevent water penetration.

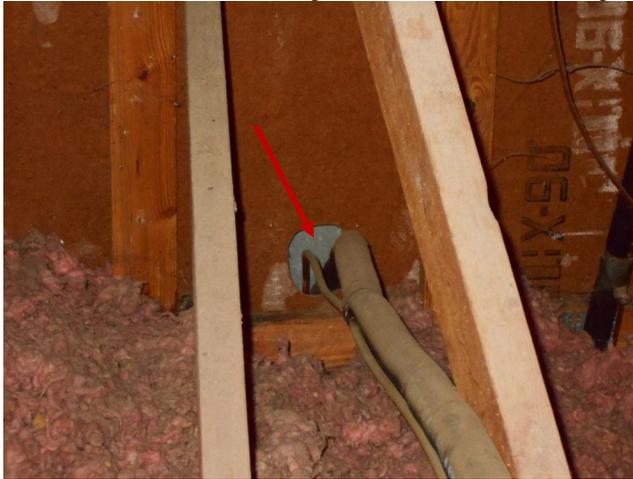
The area where the new refrigerant lines enter the attic space should be sealed to prevent vermin entry.

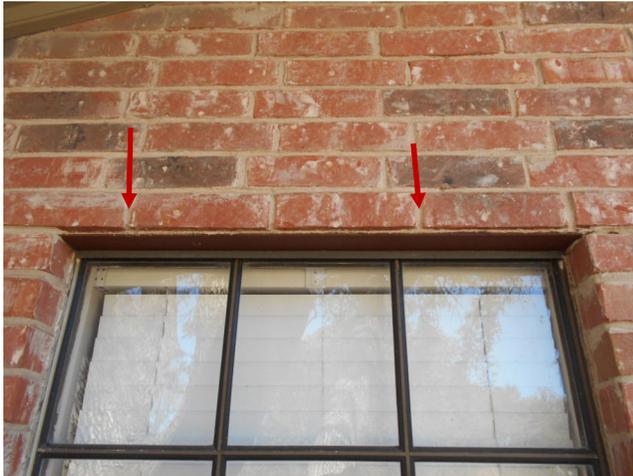
There were no weep holes found above the lintels. Weep holes allow moisture to drain from the wall cavity due to penetration or condensation. Drilling weep holes post construction is routine and simple for someone with some experience. This is a common observation and I did not see any evidence of damage at the time of inspection.

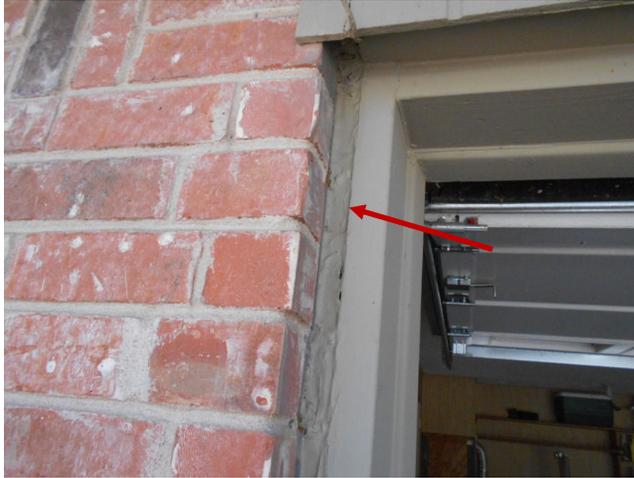
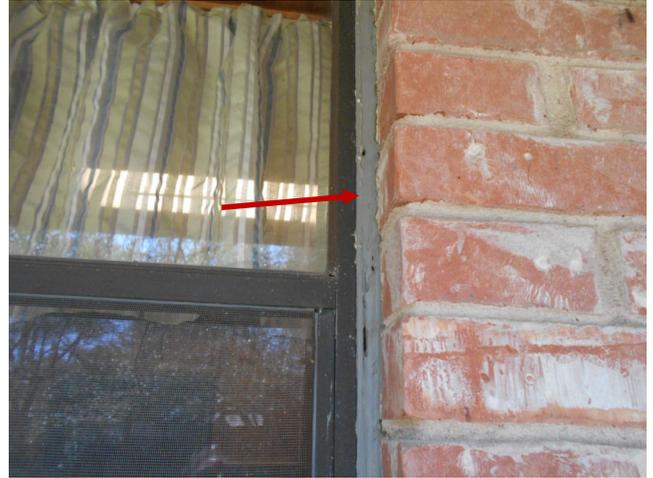
Pronounced exterior wall separation was observed at the front of the garage and kitchen window. This implies that structural movement of the building has occurred. The rate of movement cannot be predicted during a one-time inspection. A foundation company should be consulted to further evaluate this condition and the remedies available for correction.

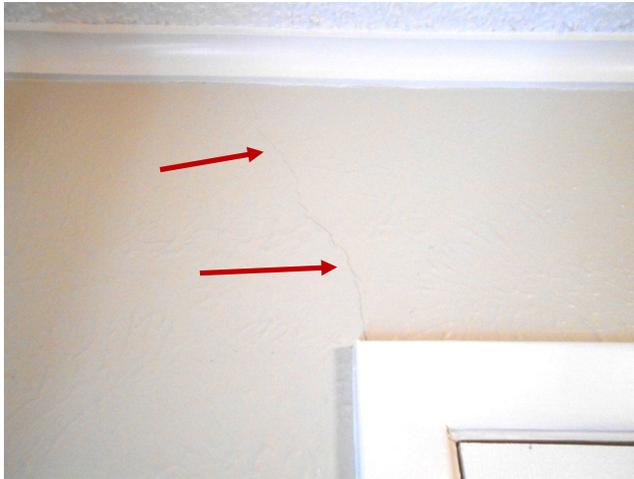
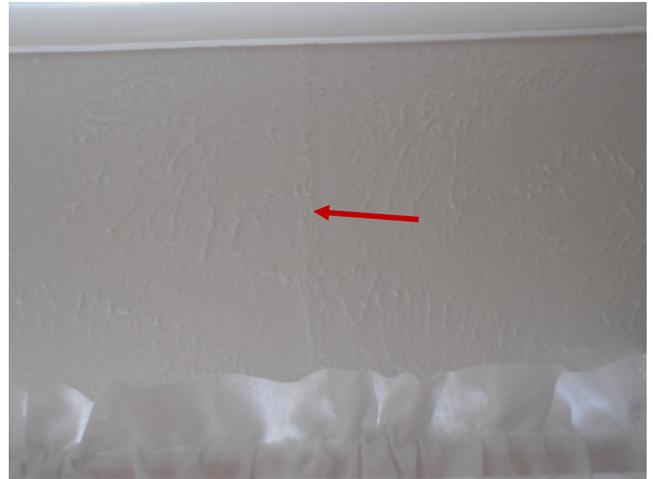
Interior wall cracks were noted in various locations. This condition could indicate greater than normal movement within the structure and potential structural problems. Further investigation may be necessary.

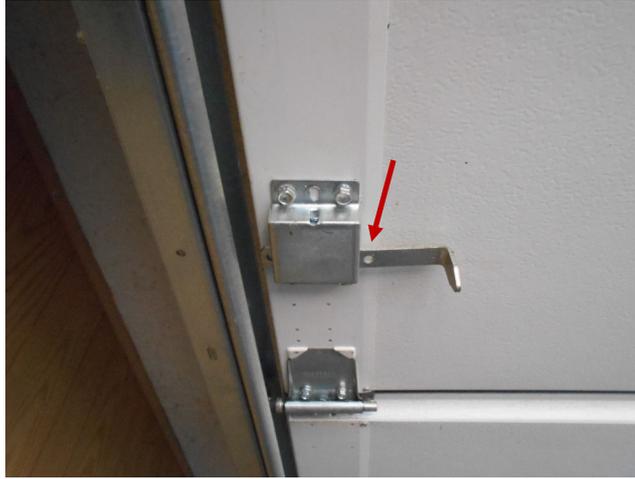
When an automatic garage door opener is installed, the manual locks are required to be disabled. Damage to the garage door can occur if the door is opened in the locked position.

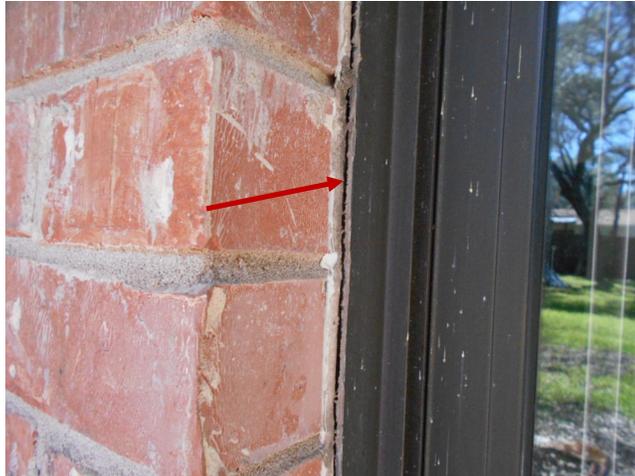
The casing for the door at the rear of the house should be sealed to prevent water and air penetration.

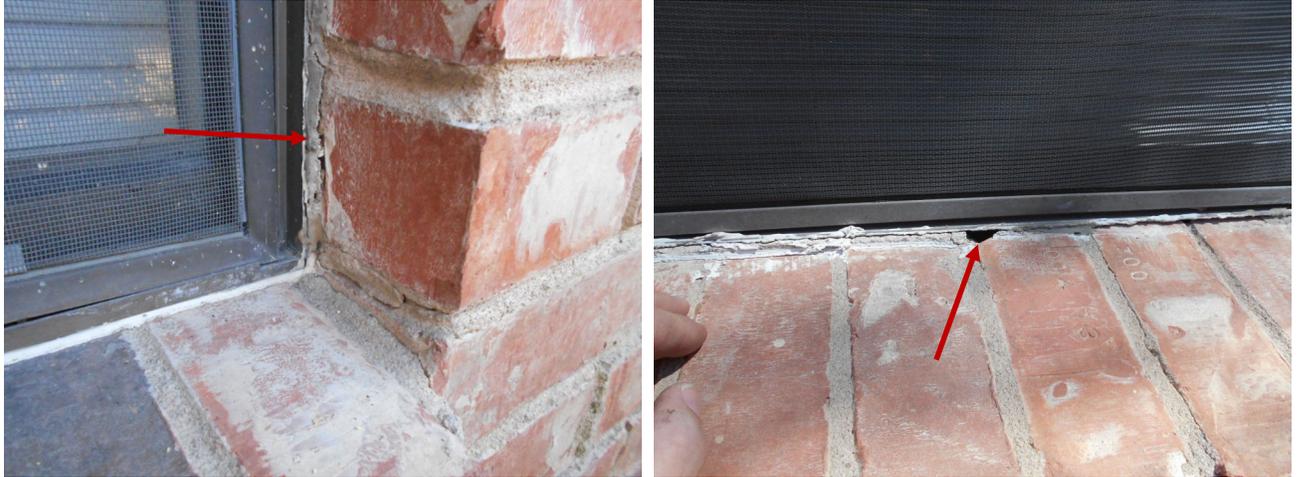
The windows and window sills on the exterior of the house are in need of re-caulking or re-pointing to avoid water penetration.

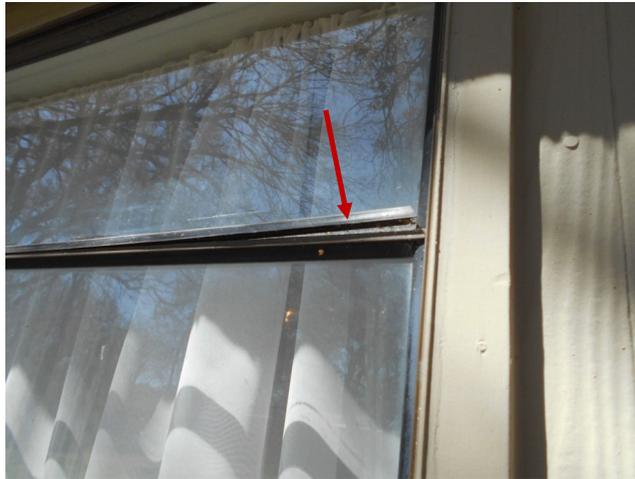
Damaged window glazing was observed in various locations. This is a minor defect and can be easily repaired.

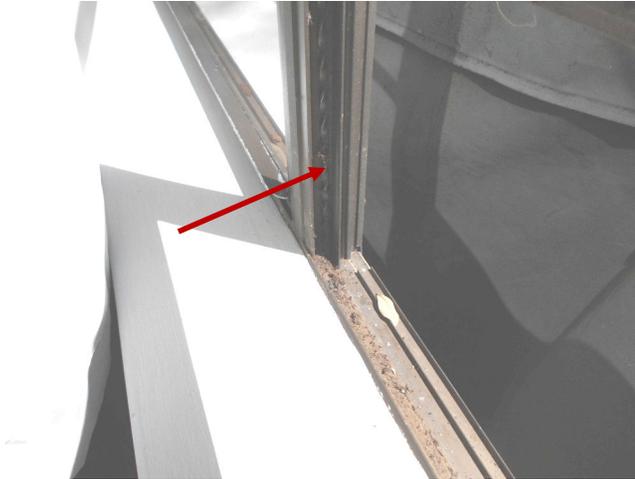
The spiral balancer for a window in the breakfast room is damaged. The spiral balancer keeps the window open.

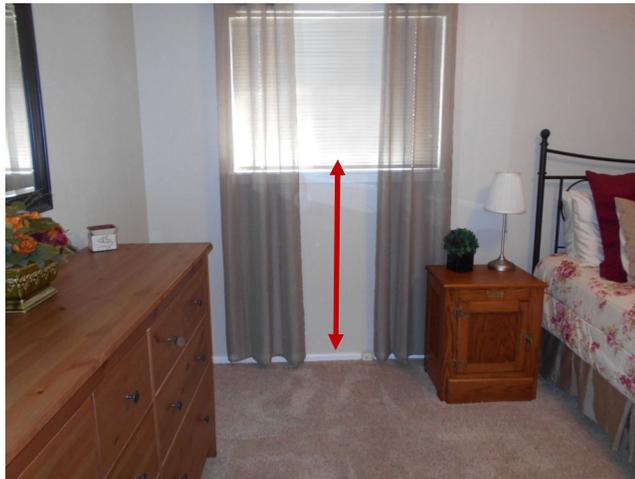
The window sill height in one or more of the bedrooms measured more than 44" from the floor. Under current building standards, these windows are considered too high for a proper emergency egress (escape) exit. The occupants of these bedrooms should be aware of this hazard and be physically able to use this window as an emergency egress exit.

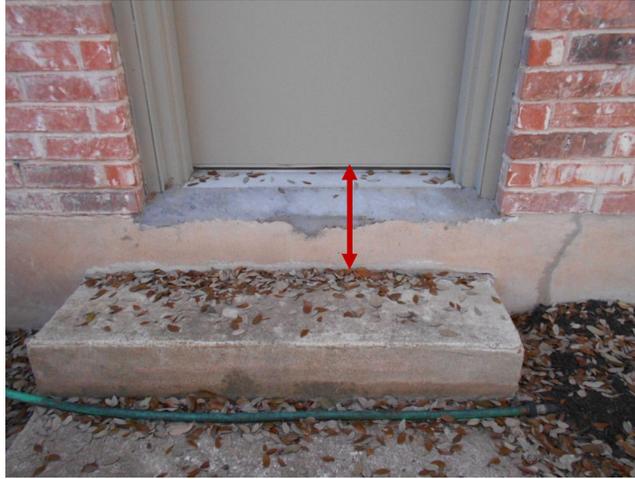
The step from the garage on the east side of the home is too high.

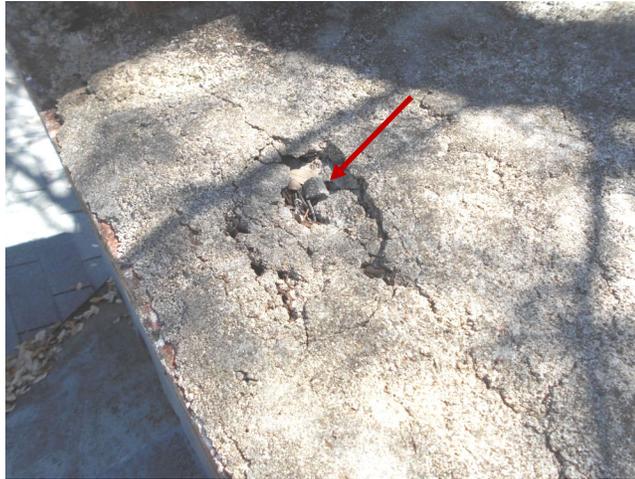
Damage was observed on the top of the chimney cap. The cap of should be repaired or replaced to prevent water penetration.

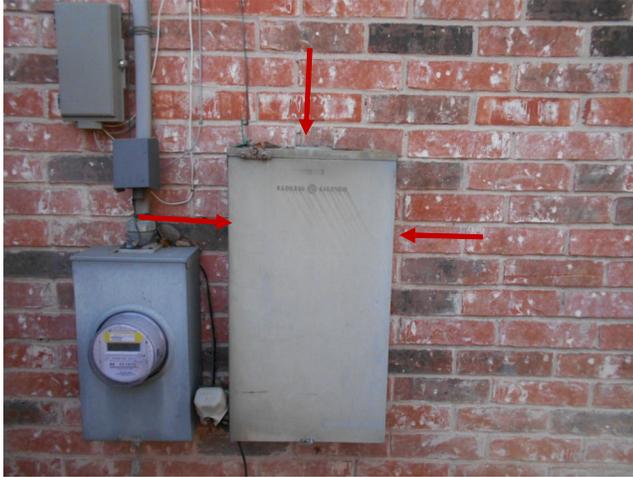
The main panel should be sealed to the structure on the top and sides, leaving the bottom open. This will help prevent water penetration behind the panel.

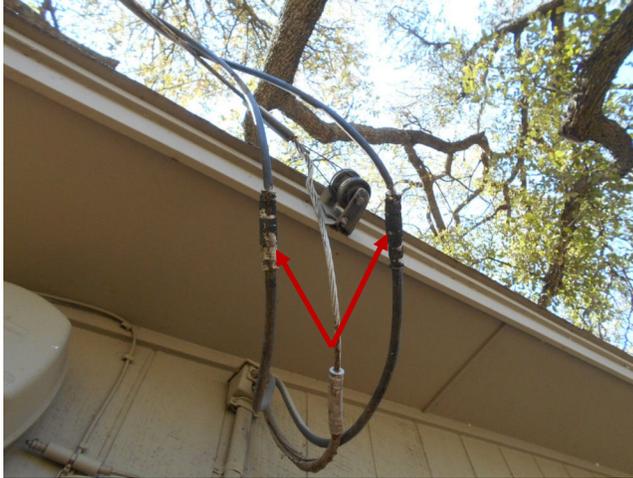
The exposed electrical conductors on the service mast should be protected. Repair by a licensed electrician is recommended.

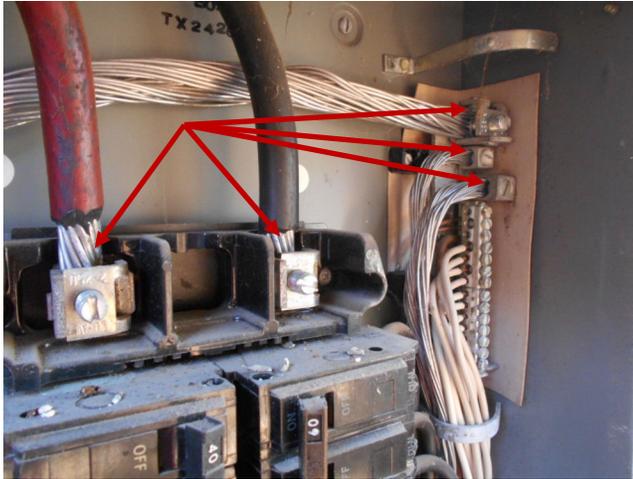
An insufficient amount of antioxidant was observed on the aluminum wiring in the main panel.

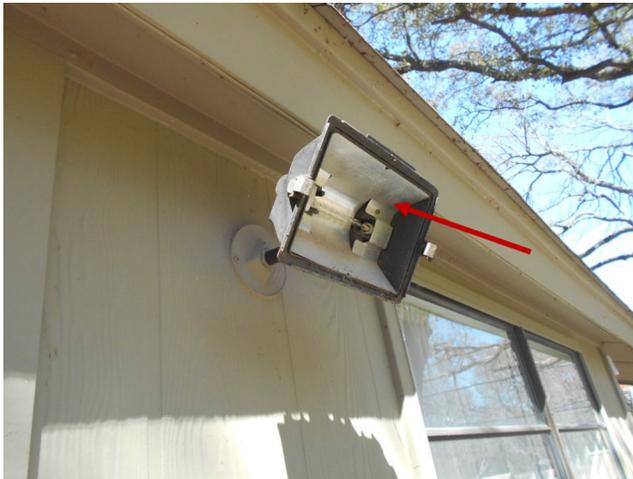
The cover for the light at the rear of the house was missing.

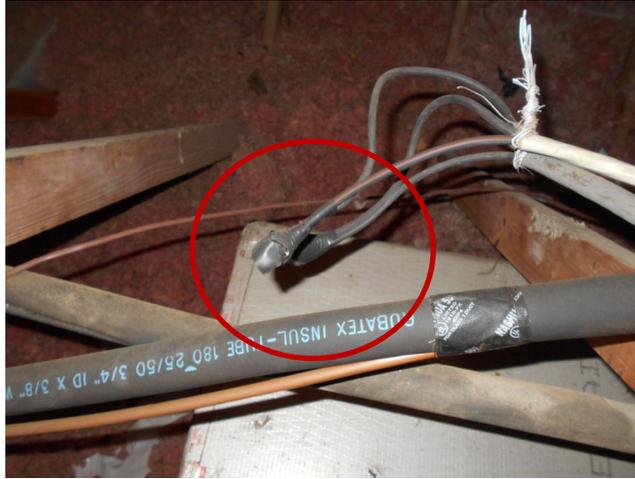
Improper electrical connections in the attic should be improved. All electrical connections should be made inside junction boxes fitted with cover plates.

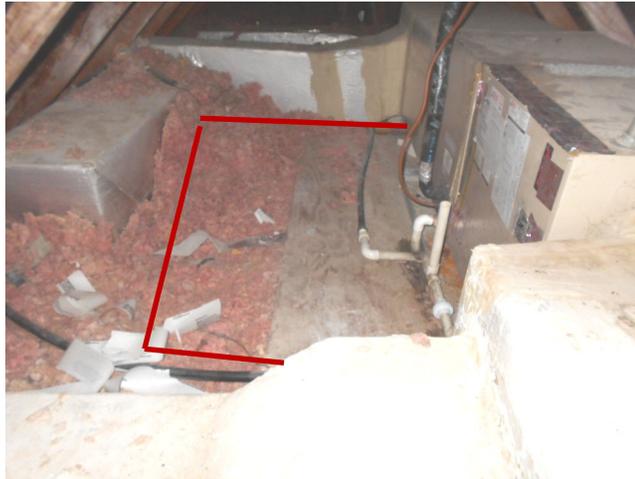
Under current mechanical installation standards, all appliances (i.e. HVAC Equipment and/or Water Heaters) mounted in an attic space should be accessible with a passageway of continuous solid flooring not less than 24-inches wide. A level service space at least 30-inches deep and 30-inches wide should be present along the side of the appliance where access is required.

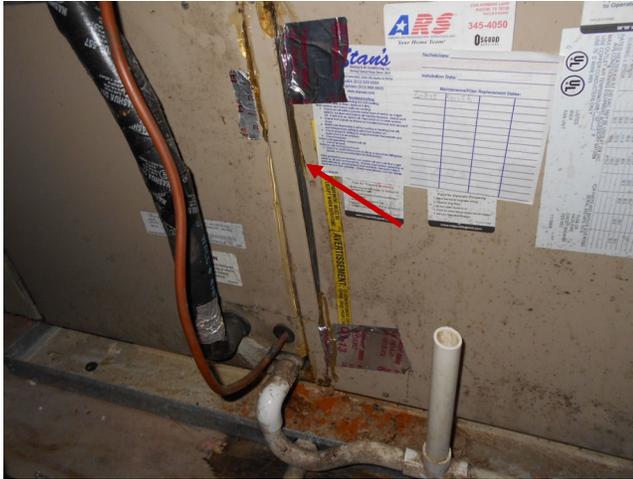
The door of the furnace is damaged and drawing air into the unit. This should be repaired.

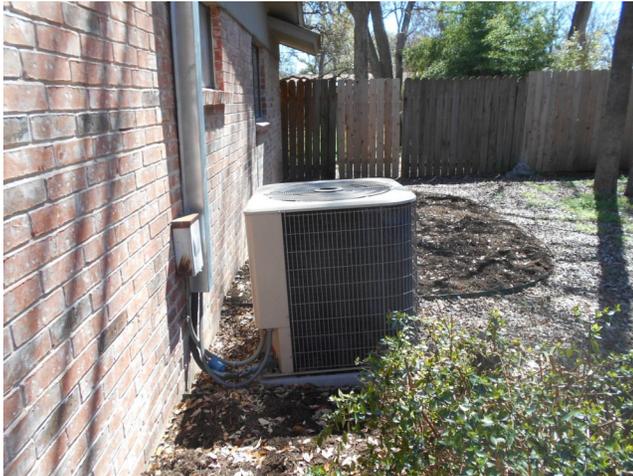
The outdoor unit of the air conditioning system is out of level. This should be improved.

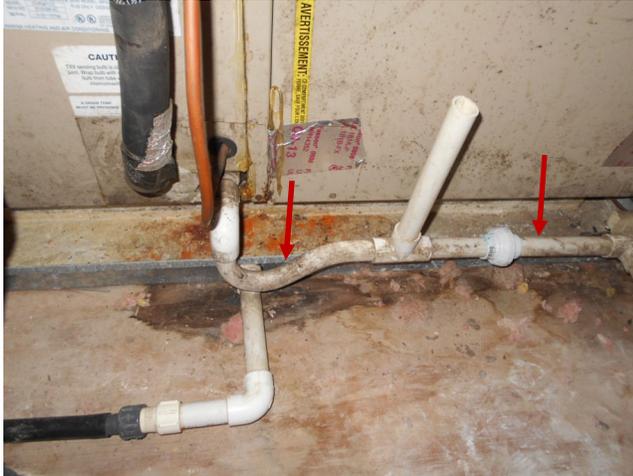
The primary condensate drain line that runs off the coil housing should be insulated. This will help prevent moisture from building on the exterior of the drain line and leaking onto the floors or ceilings.

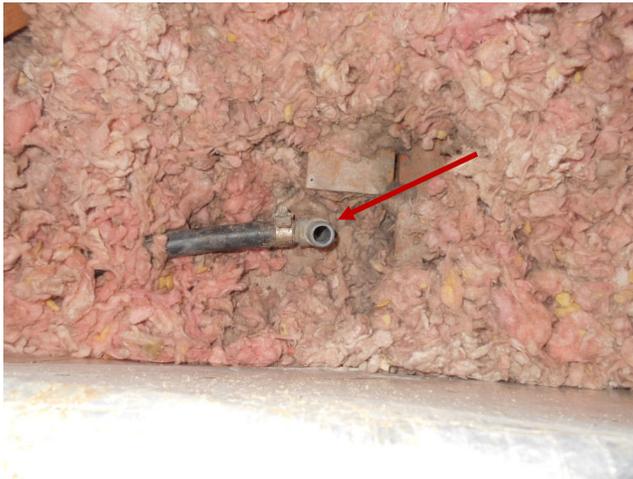
The condensate drain line for the air conditioner was observed to be open in the attic space. This line should be sealed to prevent water from spilling out and causing water damage to the ceiling.

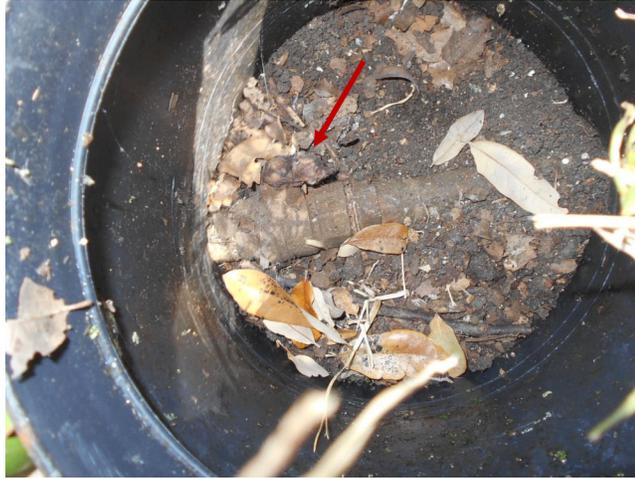
The main supply valve handle is missing/damaged and should be replaced.

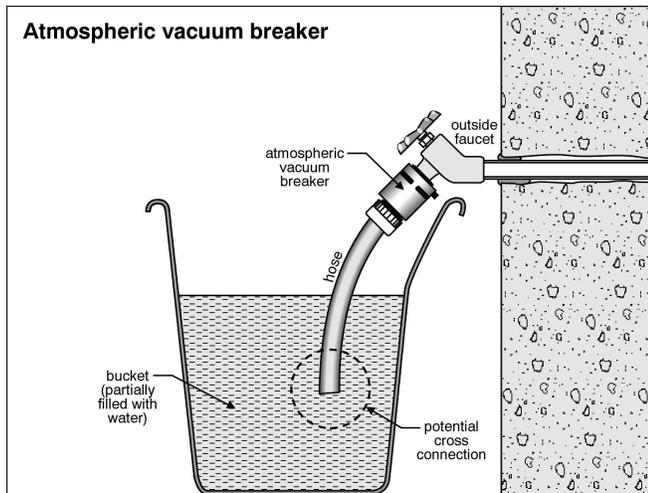
It is recommended that an anti-siphon device be added to all of the hose bib(s) to reduce the potential for potable water to contact a source of contamination. This condition should be repaired as it poses a potential health concern. This is a simple improvement and can be purchased at most hardware stores.

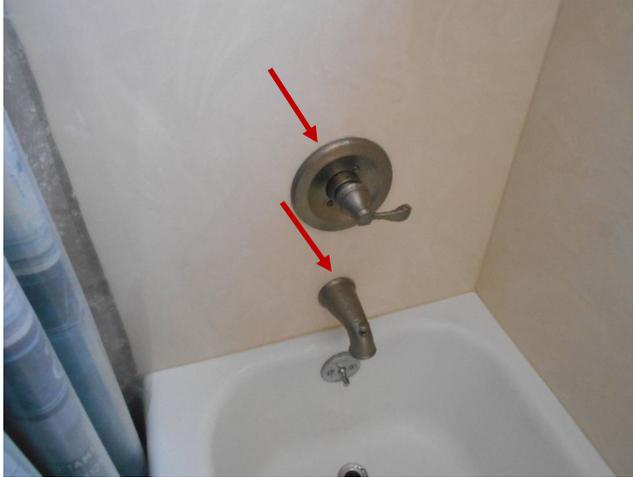
The supply valve covers and faucet for the showers should be sealed to the tile enclosures.

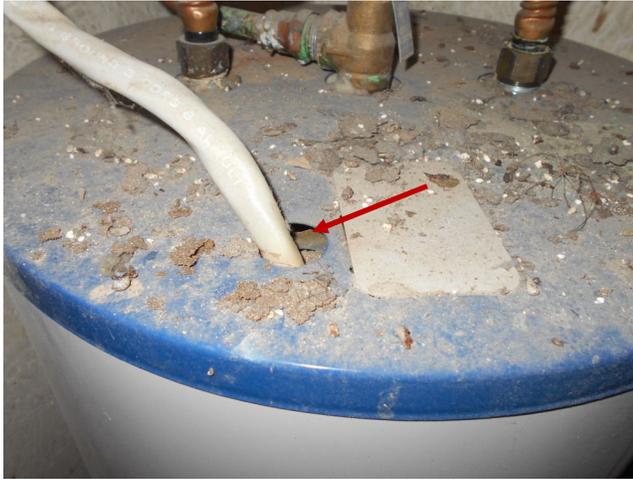
Cable clamps (sometimes referred to as bushings or grommets) should be provided for the wiring on the water heater. Cable clamps serve to protect the wiring from the metal edges of the openings.

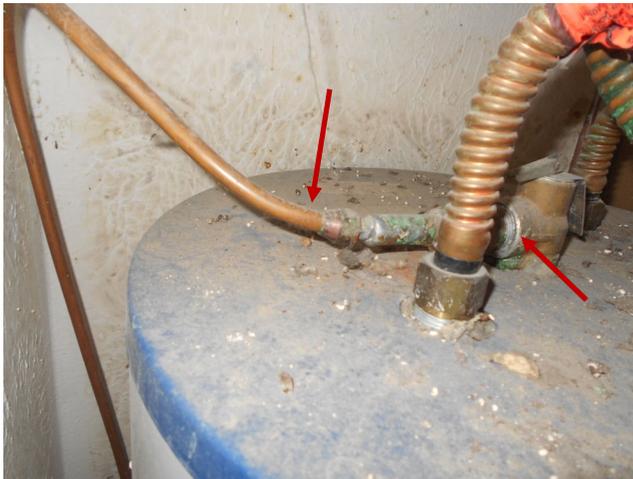
The T&P drain line is required to be the same size as the valve outlet. It is recommended that this be repaired for safety reasons.

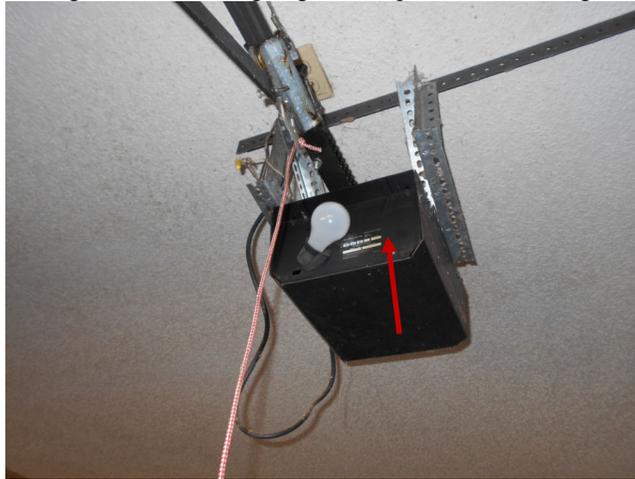
The light cover for the garage door opener was missing.
