## Sample 4-Plex

# PROPERTY INSPECTION REPORT

**Concerning:** Sample 4-Plex

**By:** Jeffrey Kent Prokaski TREC #9866

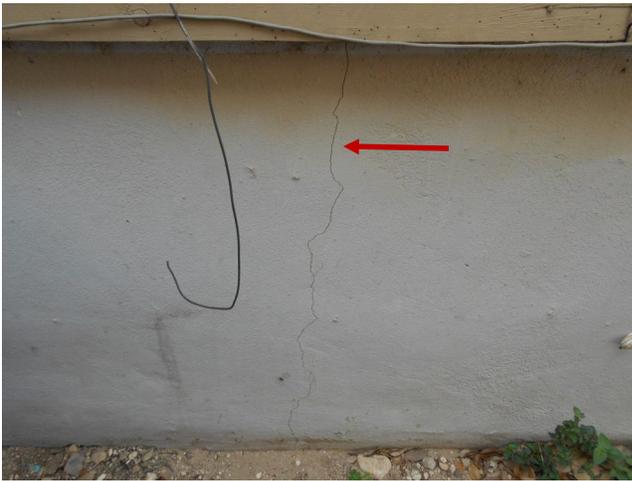
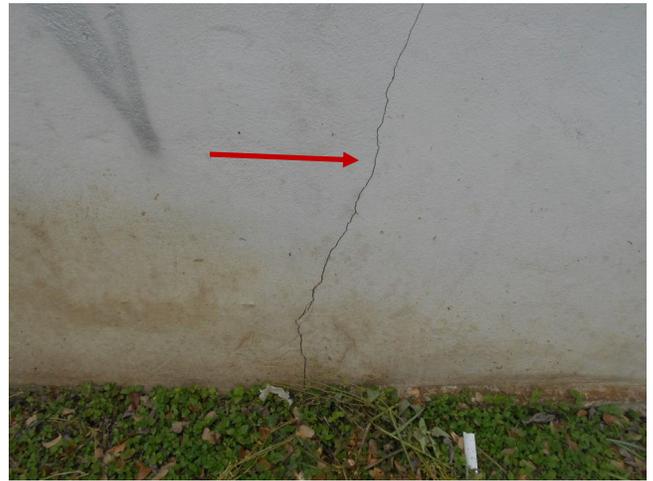
The soil line is too high at the front of the house. This condition can promote water and insect infiltration. Under today's building standards, there should be at least four (4) inches of foundation visible below masonry veneer and six (6) inches of foundation visible below wood veneer.

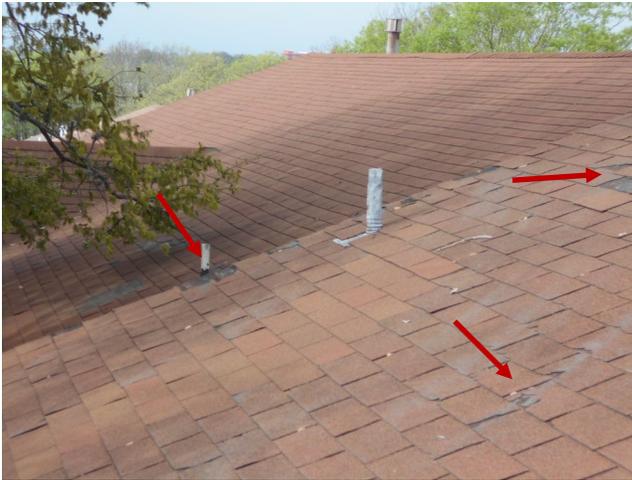
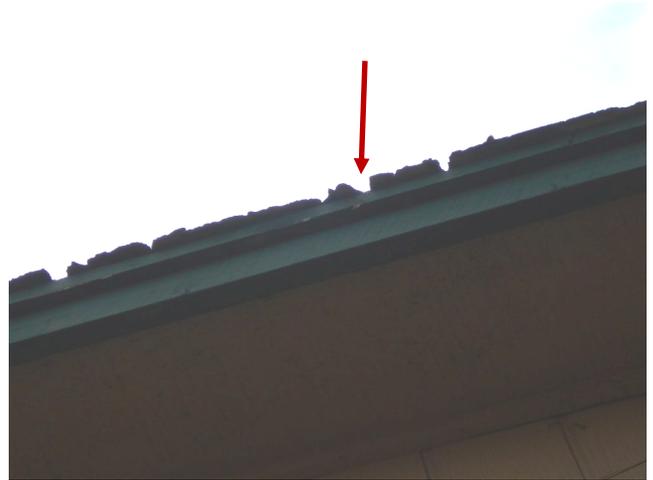
Repairs to the roofing are recommended. Damaged or missing roofing material should be repaired. All roof penetrations should be examined and sealed as necessary.

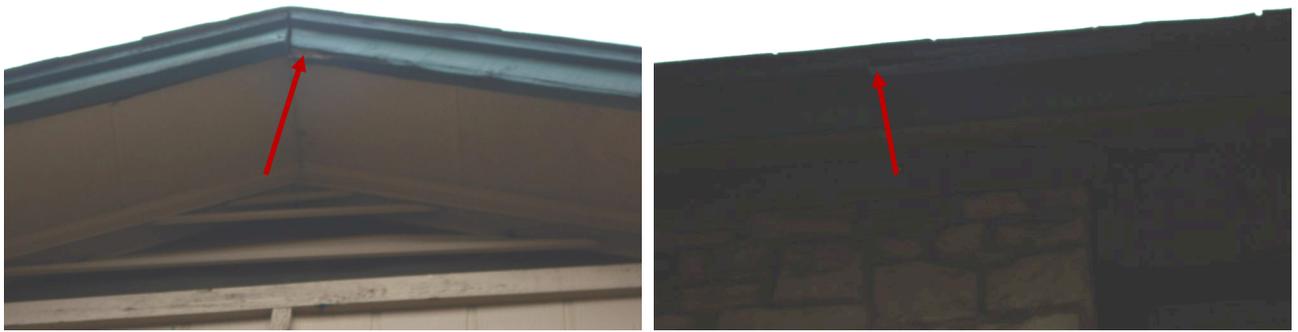
Fascia boards have some deterioration and/or damage on the north and east side of the home.

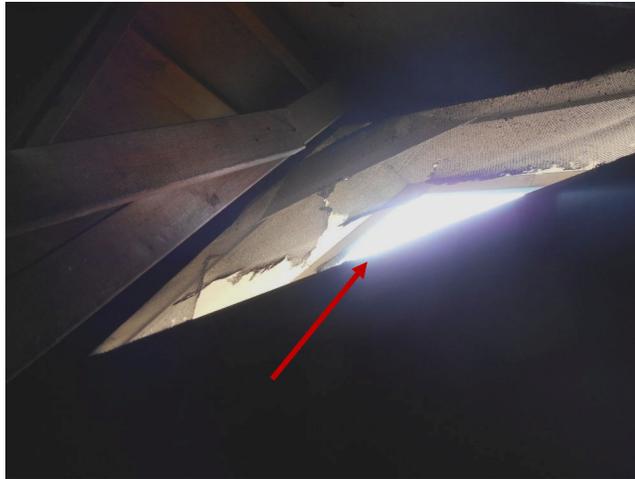
Damaged gable and roof vent screens should be repaired as needed to prevent vermin entry into the attic space.

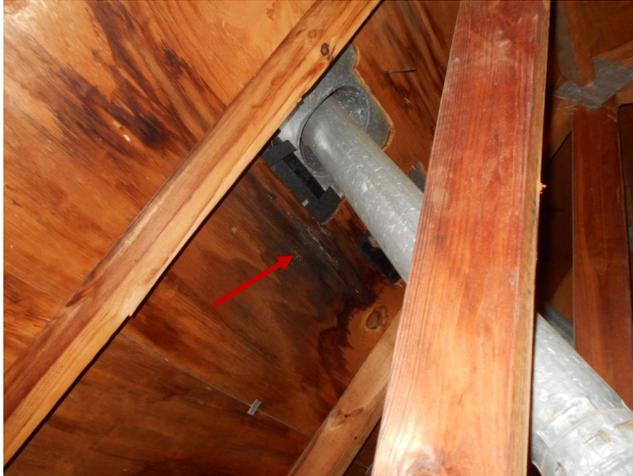
Substantial evidence of roof leakage was observed. This condition should be investigated further and repairs made, as necessary.

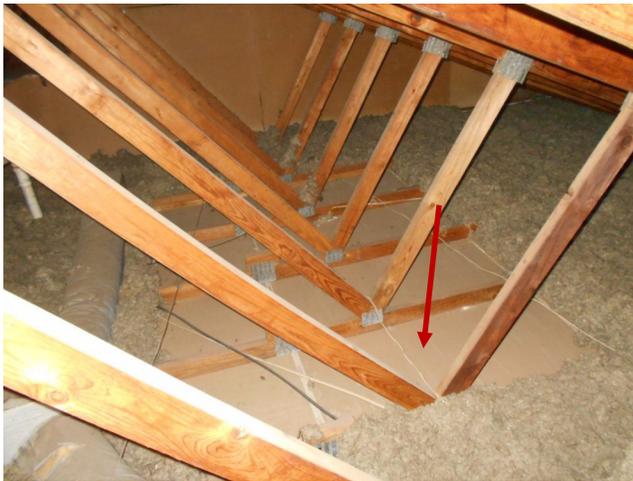
Insulation improvements in the attic space over unit D are recommended.

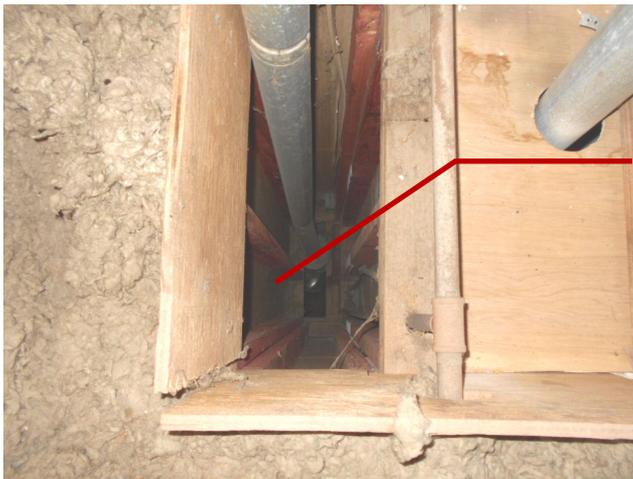
Exposed interior wall

Wall cavities in the attic space should be sealed or the interior walls should be insulated.

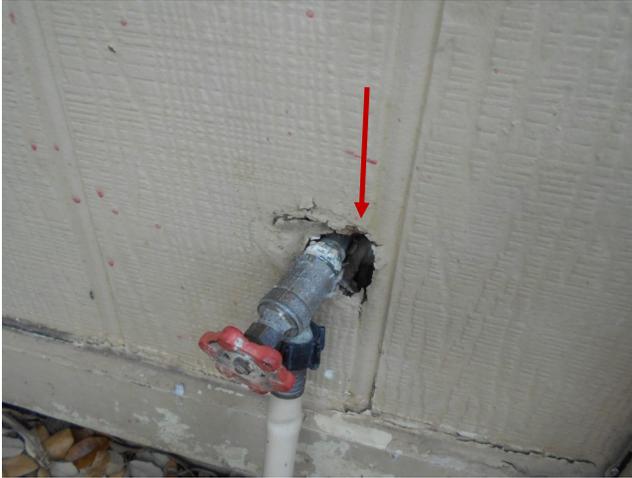
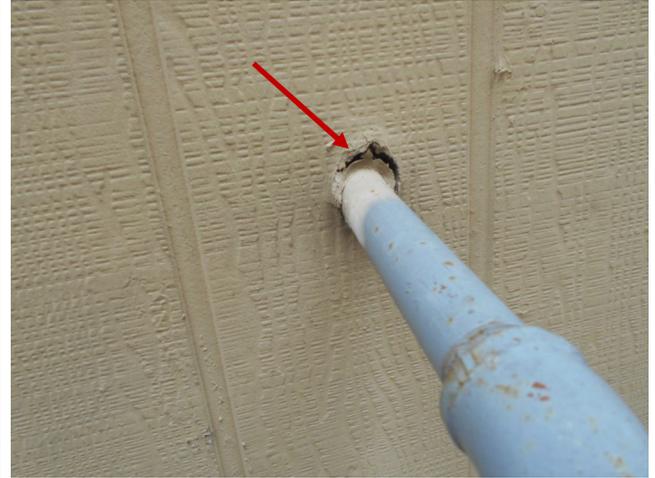
The areas around the exterior hose bibs and gas lines should be sealed to prevent water penetration.

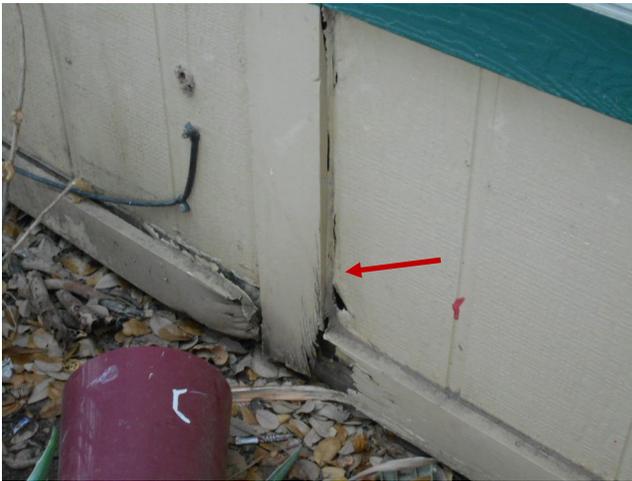
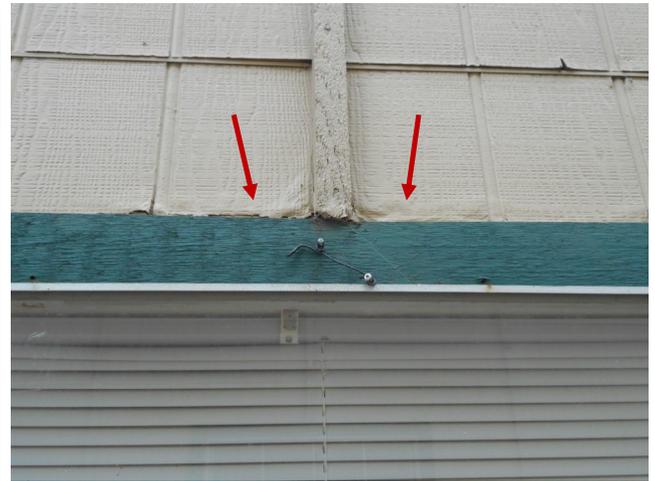
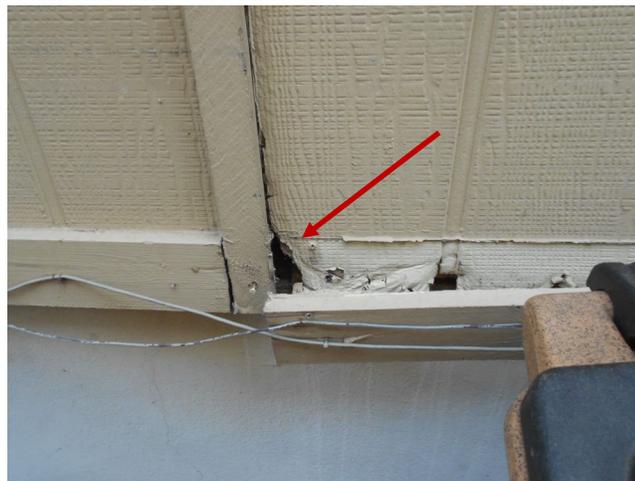
Deteriorated siding was observed in various locations. This item will need repair to prevent damage to the structure.

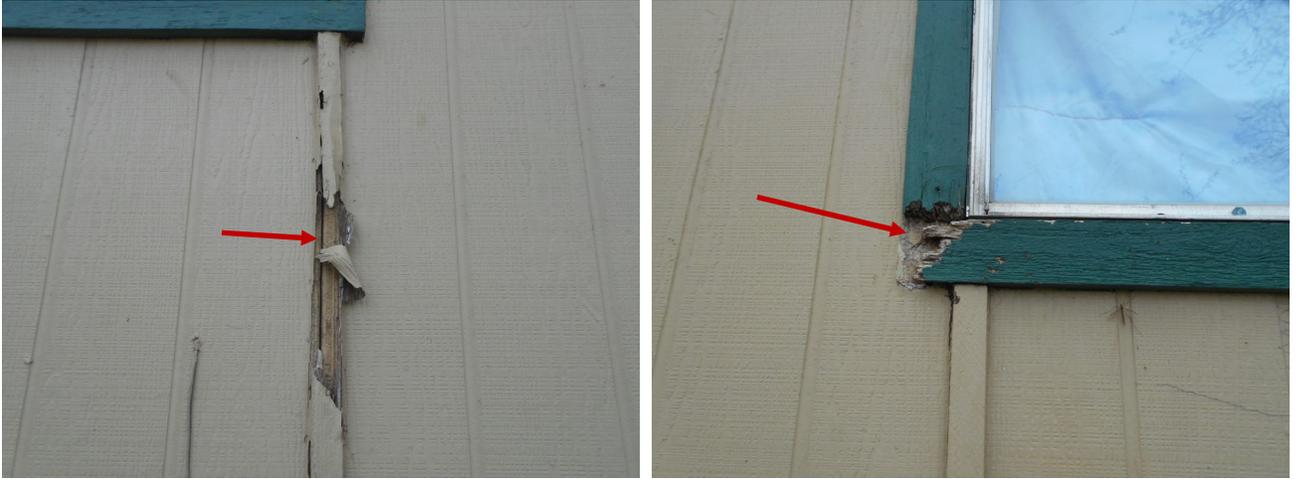
Deteriorated trim boards were observed in many locations. This item will need repair to prevent damage to the structure.

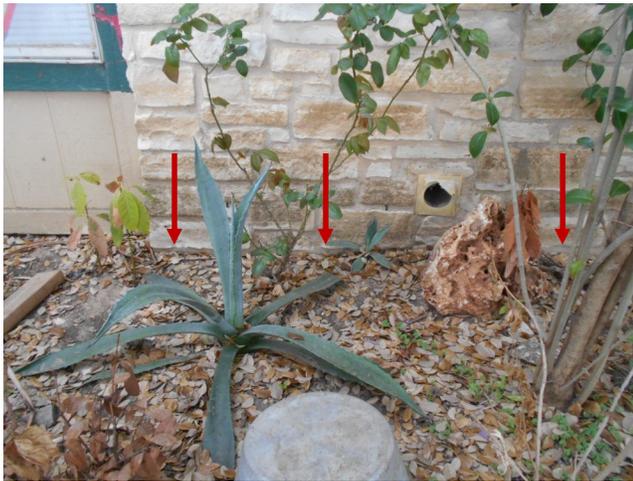
There were no weep holes found at the foundation level at the front of the house. Weep holes allow moisture to drain from the wall cavity due to penetration or condensation. Drilling weep holes post construction is routine and simple for someone with some experience.

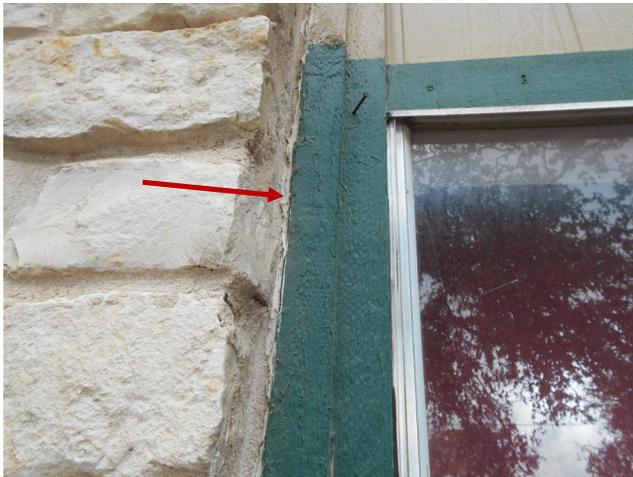
Trim boards on the exterior of the home should be sealed as needed to prevent water penetration and possible wood rot.

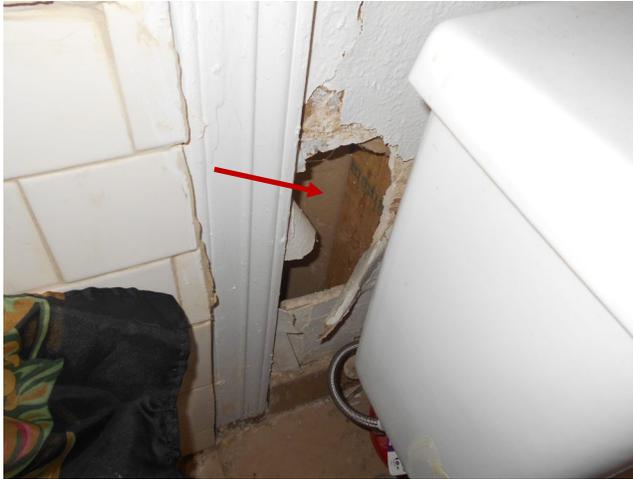
Damage to the interior finish was observed in various locations and should be repaired.

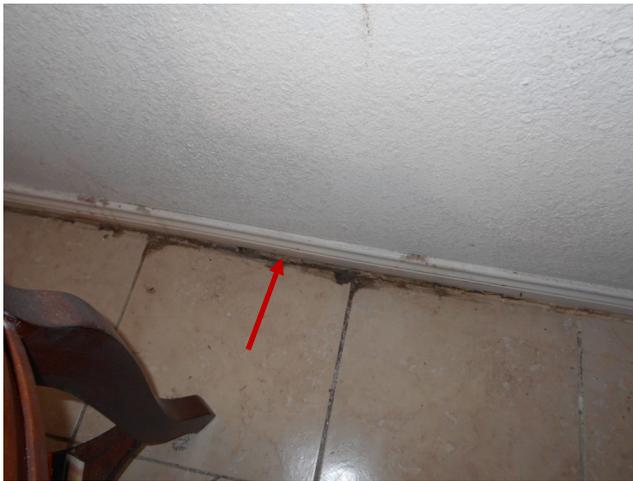
Water damage and moisture was noted in the living room wall of unit B. The cause for the damage should be determined and repairs undertaken, if necessary, to prevent structural damage.

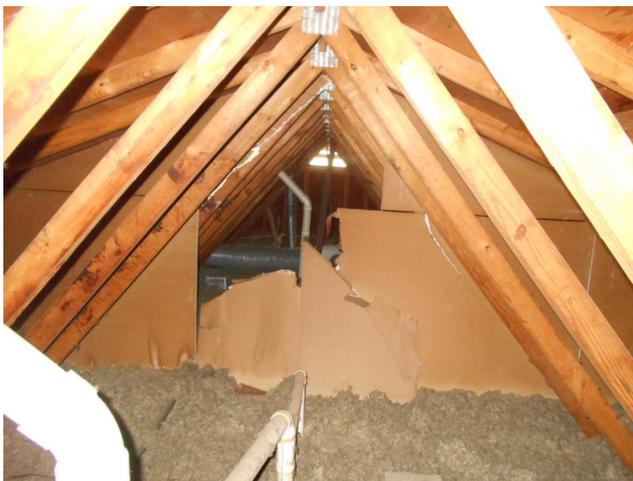
Under current building standards, in a multi-family dwelling, the separating wall (common wall) is required to extend from the foundation to the roof sheathing. This item was damaged at the time of inspection.

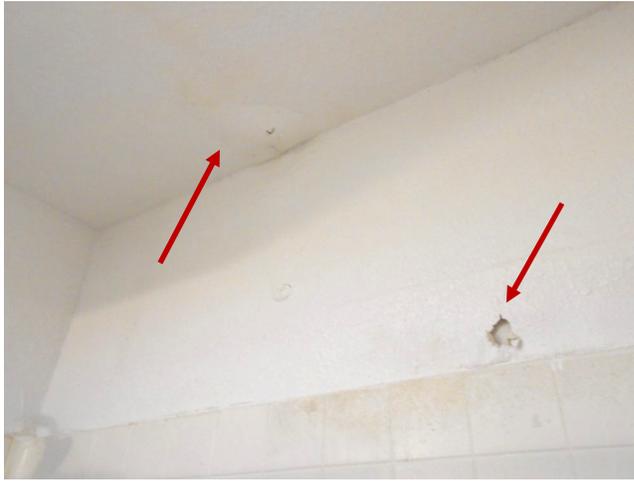
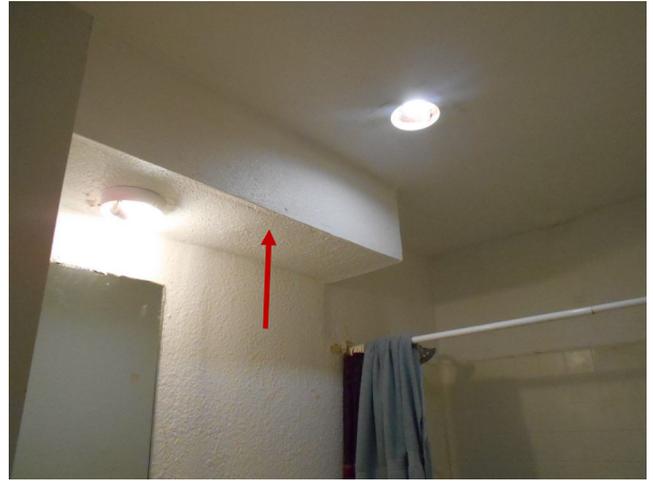
Evidence of ceiling patching and water damage was detected in many locations in units A and B. The patching is primarily under plumbing fixture in the upper units. Further investigation is recommended.

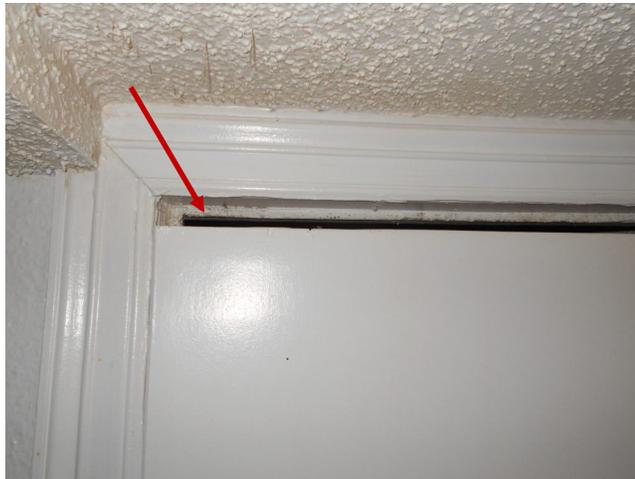
The furnace door in unit A is not properly sized. This condition allows air from inside the home to enter the furnace closet.

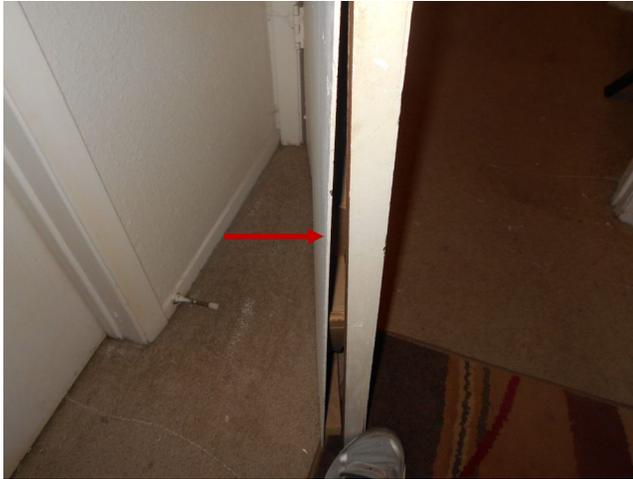
Damaged doors in many locations should be replaced.

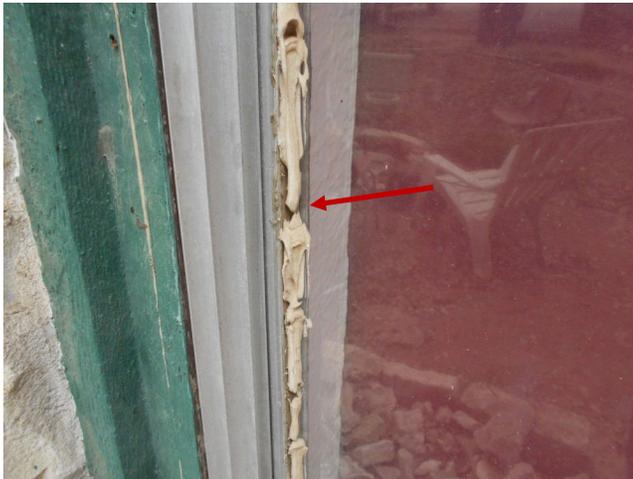
All of the windows in the home have been replaced with Plexi-glass and poorly glazed into the frames. It could not be determined if the windows will leak during wet weather.

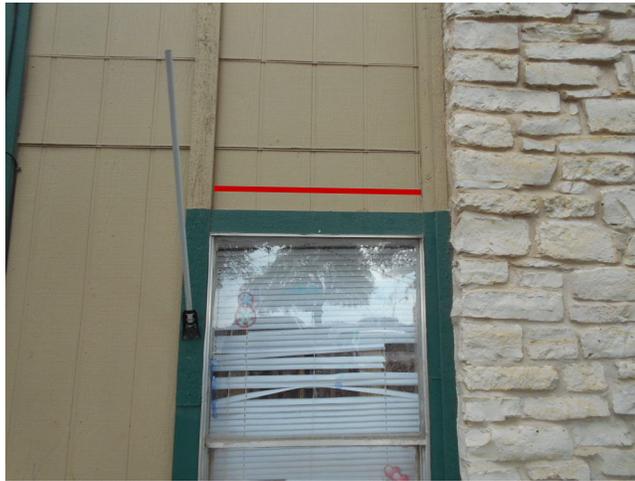
Flashing was missing above door and window trims that project from the wall. Flashing should be installed on top of the trim board and behind the wall covering. At a minimum improvement, a quality bead of caulking should be applied to the top trim boards to prevent water penetration.

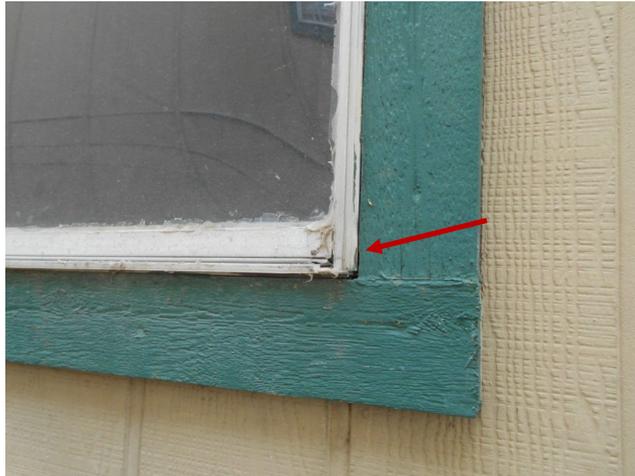
Window trims on the exterior of the house are in need of re-caulking to avoid water penetration.

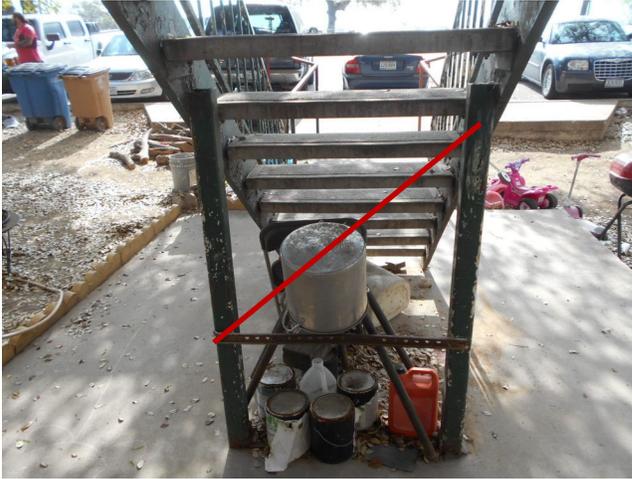
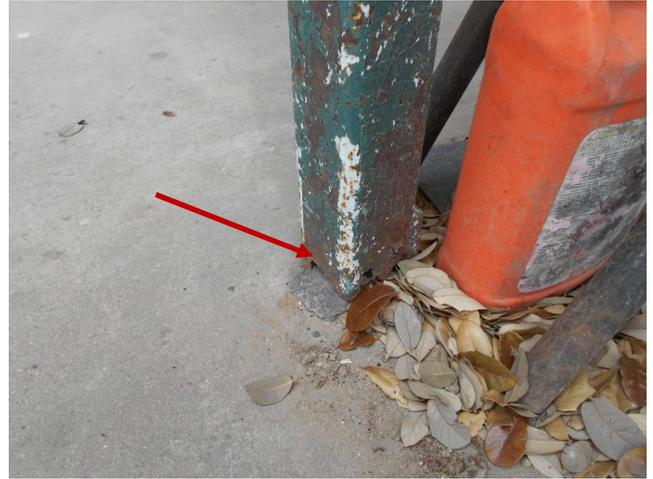
The stairs at the front of the home should be better braced to prevent movement. Rusting steel should be repaired as needed.

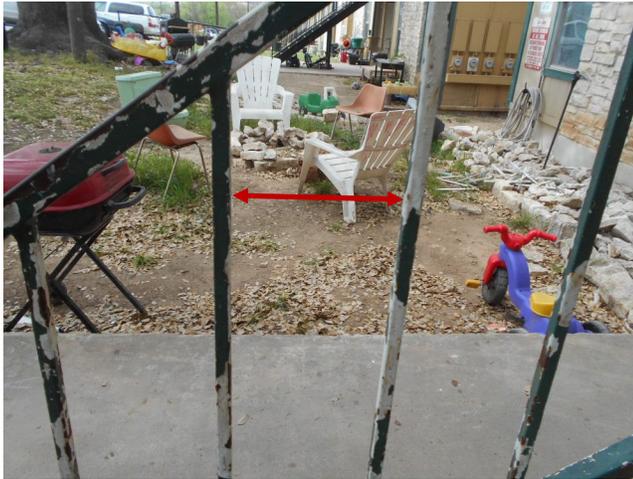
The stairwell balusters and/or spindles are installed to far apart. Under current building standards, guardrails on open sides of stairways, raised floor areas, balconies and porches should have intermediate rails or ornamental closures which do not allow passage of an object more than 4-inches wide. You may consider corrective measures for improved safety.

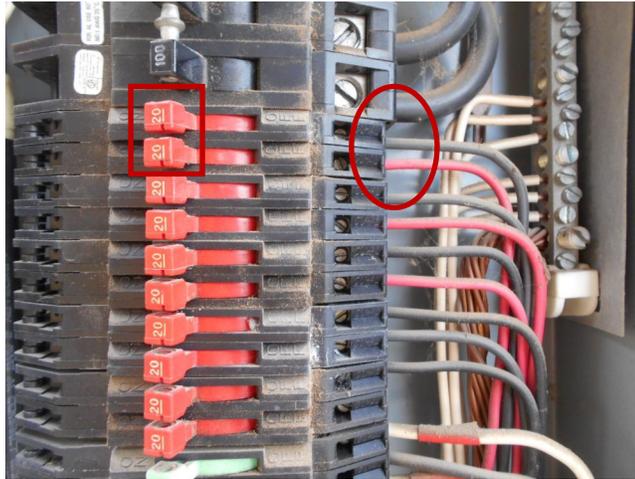
One or more of the breaker trip-ties appear to be missing in the sub panel. The 120V overcurrent devices (breakers) sharing a grounded conductor (Neutral) should be connected together by trip-ties. There is a shock risk even though the breaker may be in the off position. This should be further investigated by a licensed electrician.

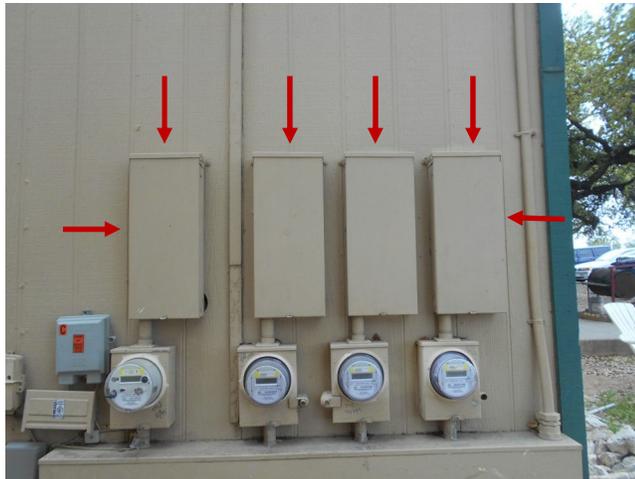
The main panels should be sealed to the structure on the tops and sides, leaving the bottoms open. This will help prevent water penetration behind the panels.

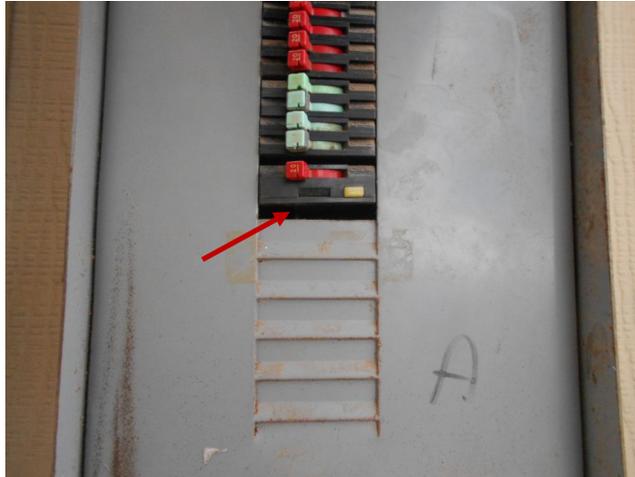
Any openings in the panel covers should be covered.

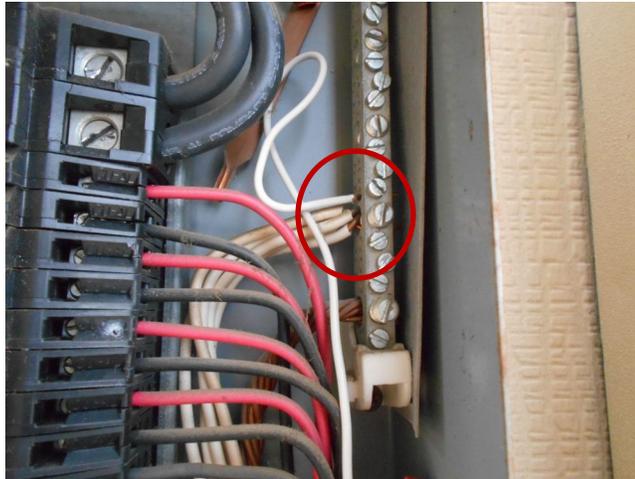
By today's standards, only 1 wire is permitted per lug in a neutral bus bar.

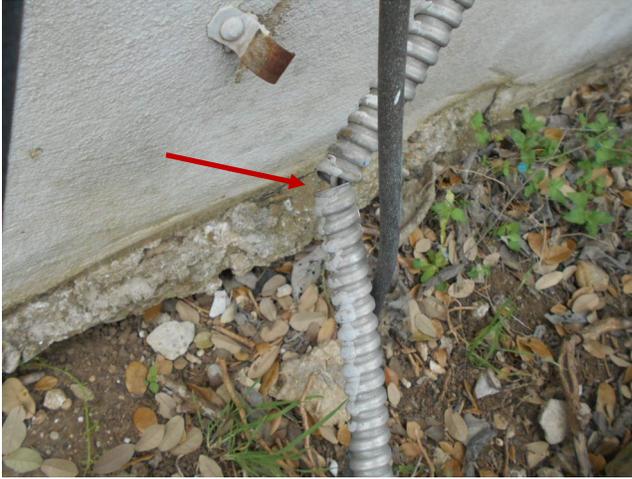
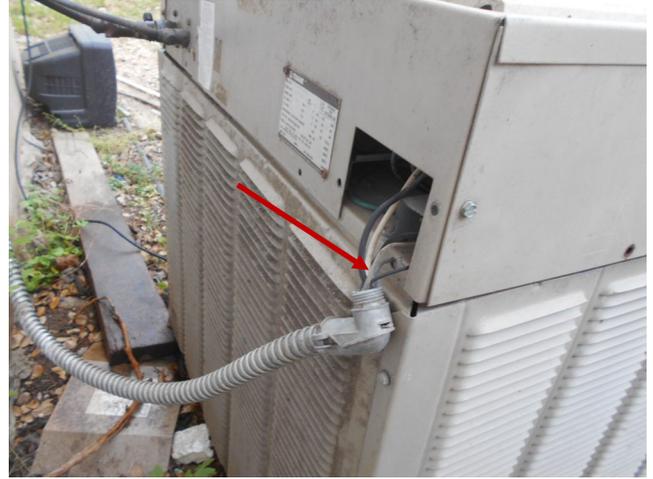
Damaged electrical conduit was observed on units A and C's air conditioning systems.

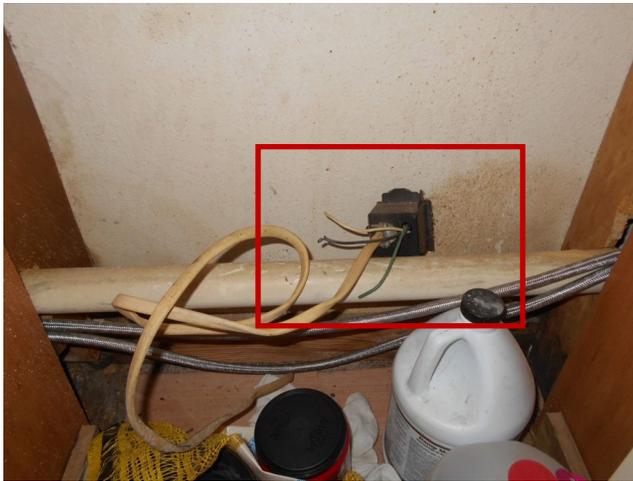
Abandoned wiring in the kitchens from the removed dishwashers should be appropriately terminated.

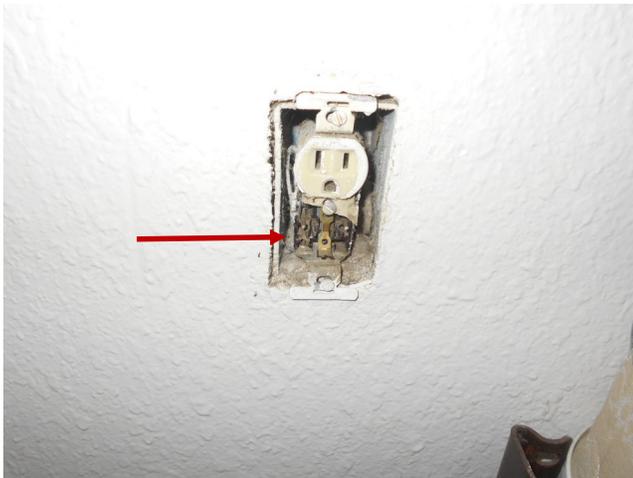
Outlets are damaged in the west bedroom of unit C. They should be replaced.

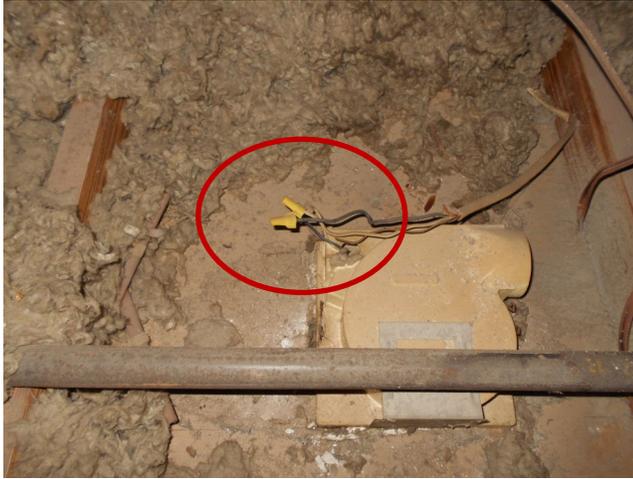
Improper electrical connections in the attic should be improved. All electrical connections should be made inside junction boxes fitted with cover plates.

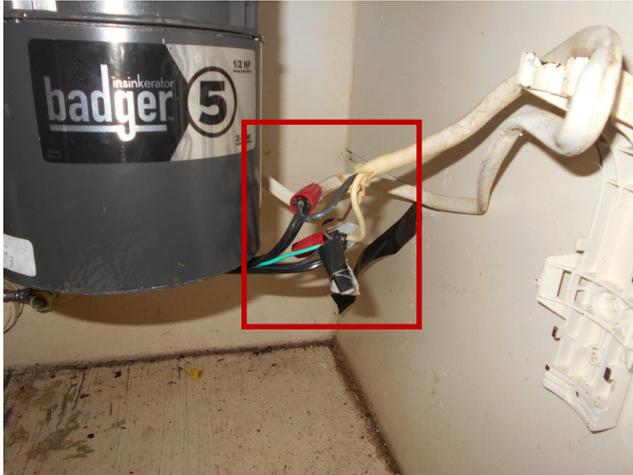
Improper electrical connections for the food waste disposer in unit D should be improved. All electrical connections should be made inside junction boxes fitted with cover plates.

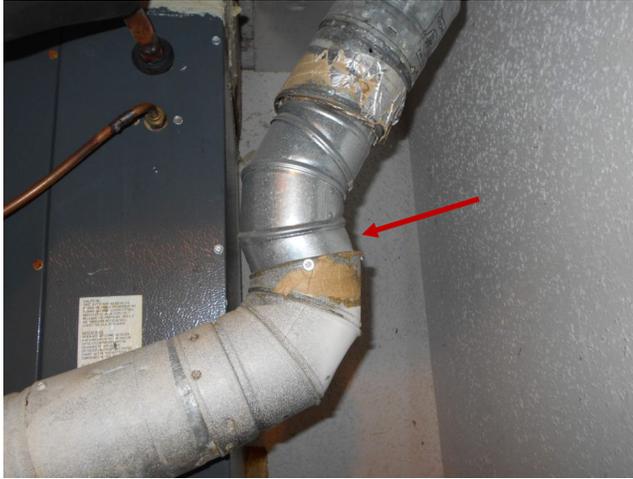
It is recommended that the connections of the water heater venting system in unit D be improved. The connections were improperly assembled and are leaking carbon monoxide into the cabinet.

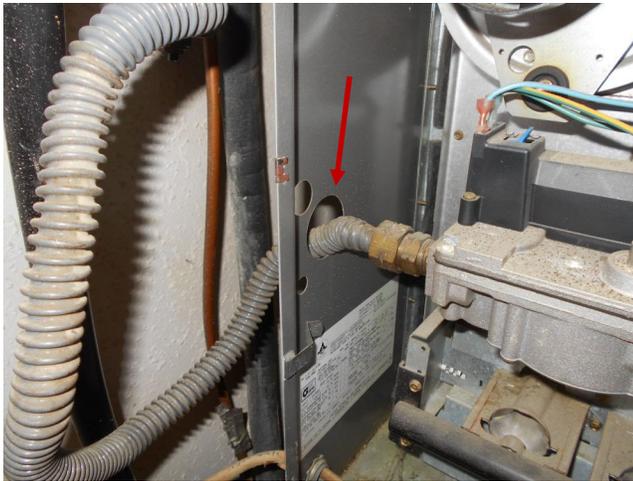
The gas supply flex connectors were observed to be passing through the heating unit cabinets. Ridged piping should be extended to outside the housings and the flex lines connected at that point. The soft metal lines can come in contact with the sharp metal edges of the cabinets causing leaks in the lines.

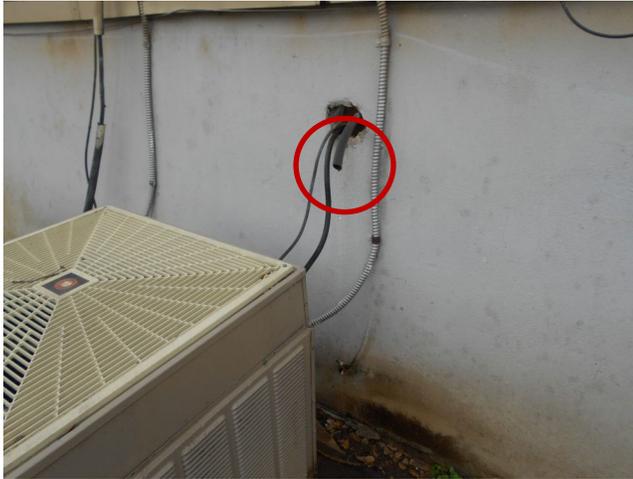
The condensation drain lines, if draining to the exterior, should terminate a minimum of five feet from the foundation.

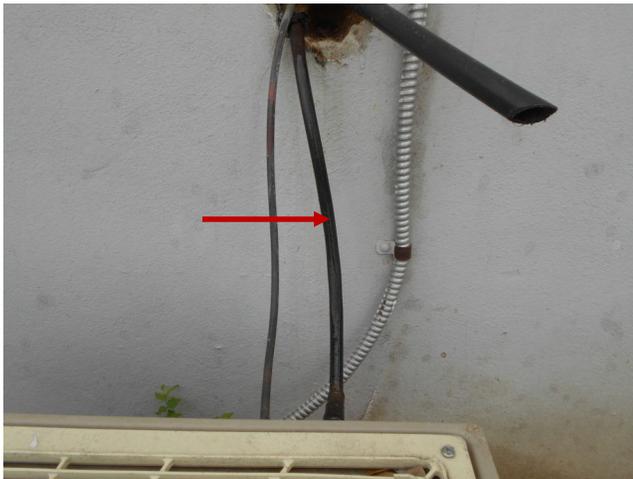
Damaged insulation on refrigerant lines should be repaired. This will help with the efficiency of the systems.

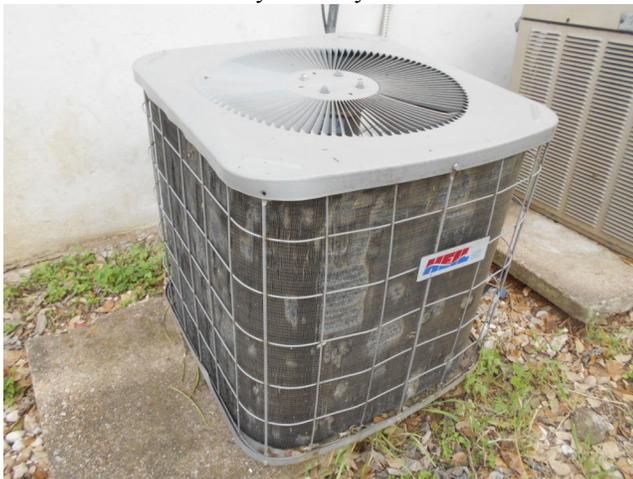
The fins of the outdoor portion of unit C's air conditioning system were observed to be damaged. This condition can reduce the efficiency of the system.

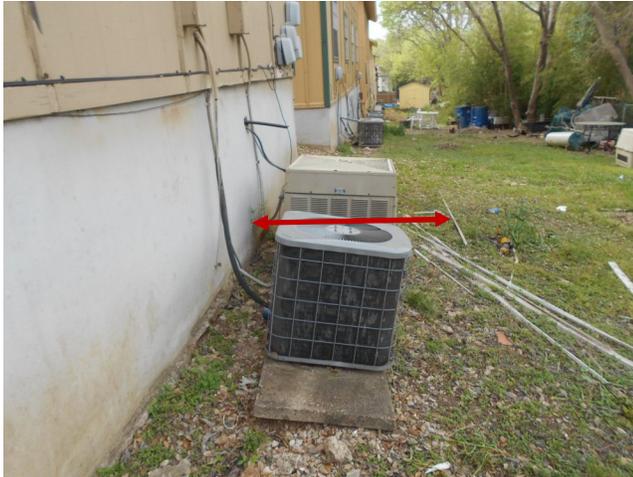
The outdoor units of the air conditioning system for units A and C are out of level. This should be improved.

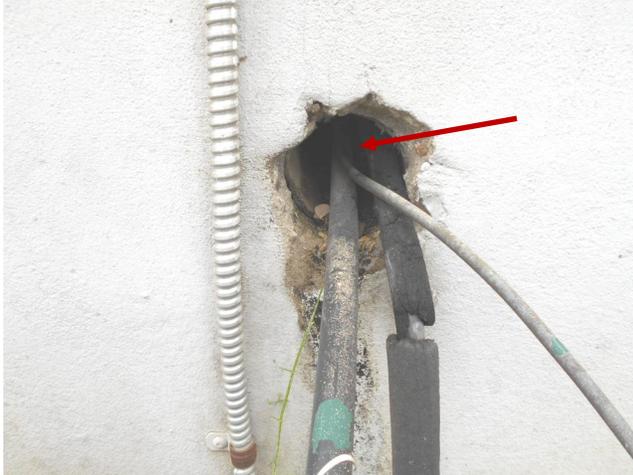
Areas where the refrigerant lines enter the home should be sealed.

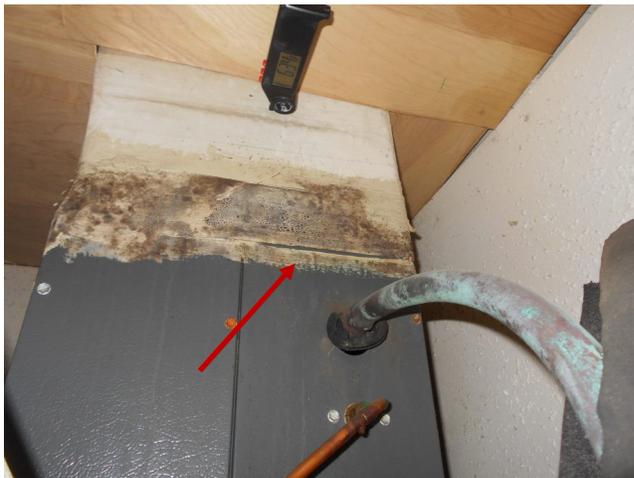
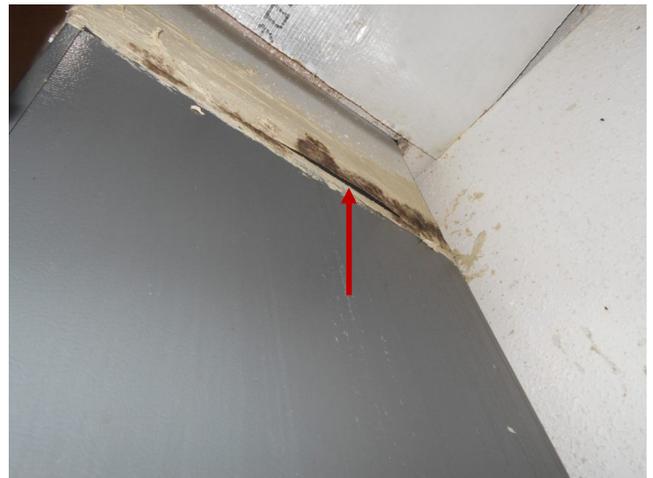
There is air leaking where the supply air plenums attach to the air handlers. This improvement is a minor repair and will reduce energy costs.

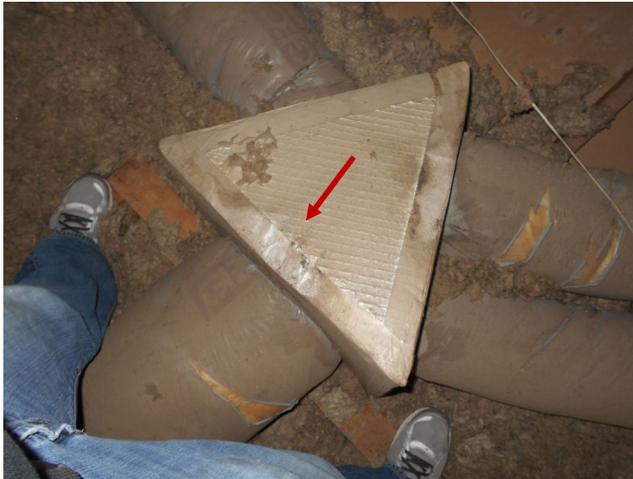
There is air leaking from a supply air plenum in the attic. This improvement is a minor repair and will reduce energy costs.

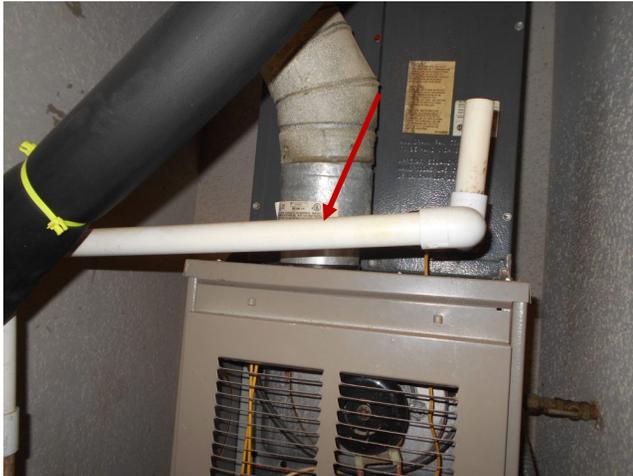
The primary condensate drain lines that run off the coil housings should be insulated. This will help prevent moisture from building on the exterior of the drain line and leaking onto the floors or ceilings.

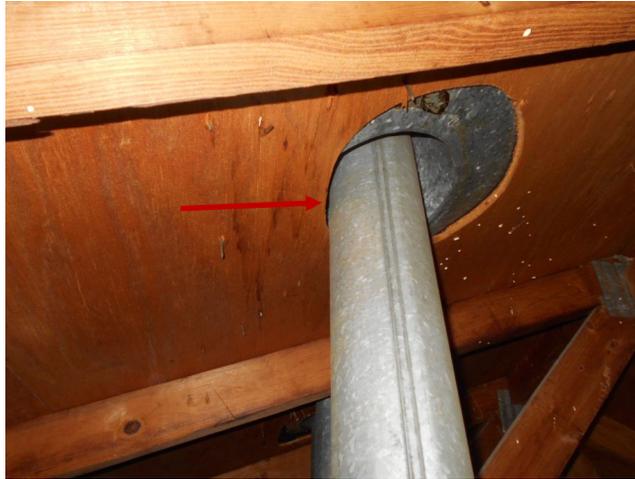
There is insufficient clearance between the furnace and water heater exhaust flues and combustible materials in several locations. *This is a fire hazard.* It is generally recommended that a one (1) inch clearance be maintained. This condition should be evaluated and repaired by a qualified licensed heating technician.

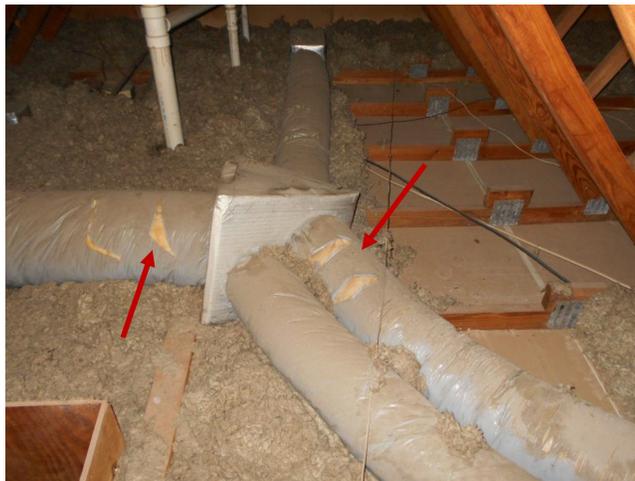
The duct insulation covering in the attic is damaged and pulling loose. Repair or replacement will be needed. An HVAC company should be consulted.

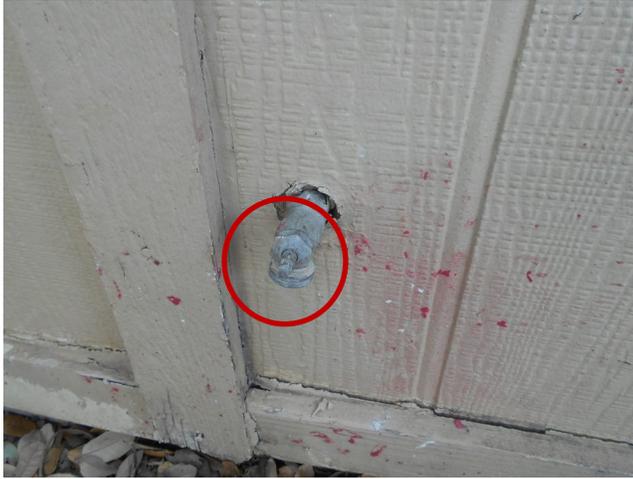
A hose bib handle is missing and should be replaced.

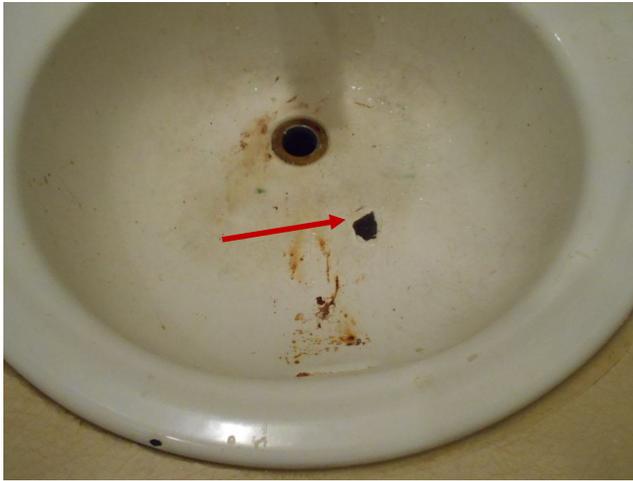
The bathroom sinks in units A and B are damaged and is in need of repair or replacing.

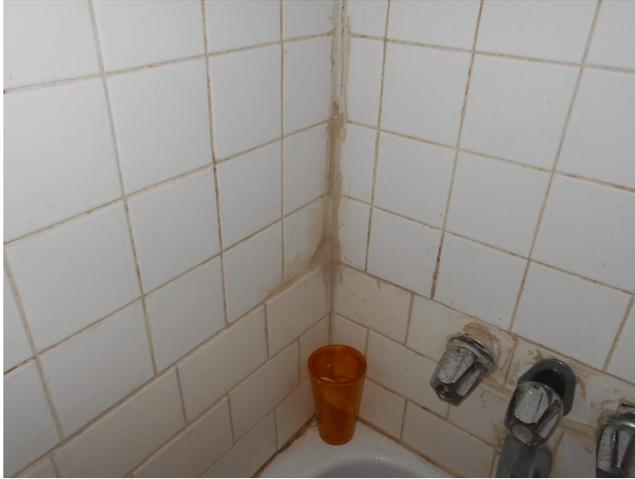
The tile bathtub enclosures have been poorly repaired. Loose or damaged tile, grout and caulk should be repaired or replaced as necessary. Any damage to the wall behind the tile should also be repaired (if necessary).

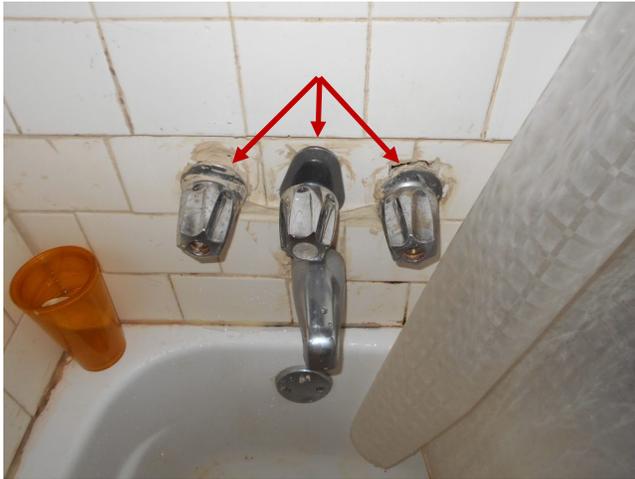
The supply valve covers and faucets for the showers should be sealed to the tile enclosures.

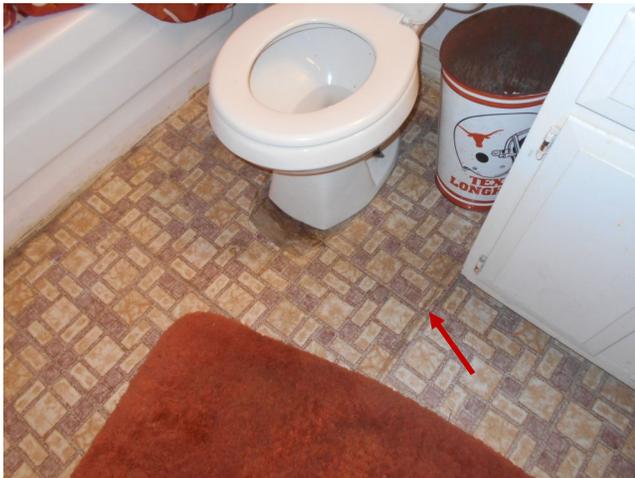
The floor around to the toilets in units C and D show evidence of water damage and weakening. This condition should be repaired before further structural damage occurs.

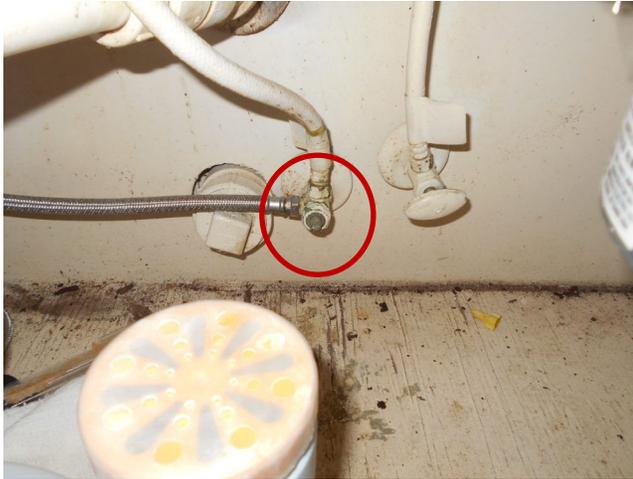
A supply valve handle in the kitchen of unit D is missing and should be replaced.

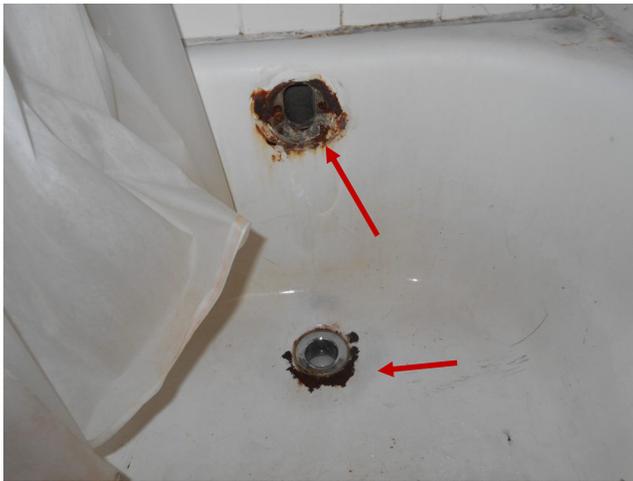
Tub drain and overflow hardware in unit D is damaged. This should be further investigated and repaired by a licensed plumber.

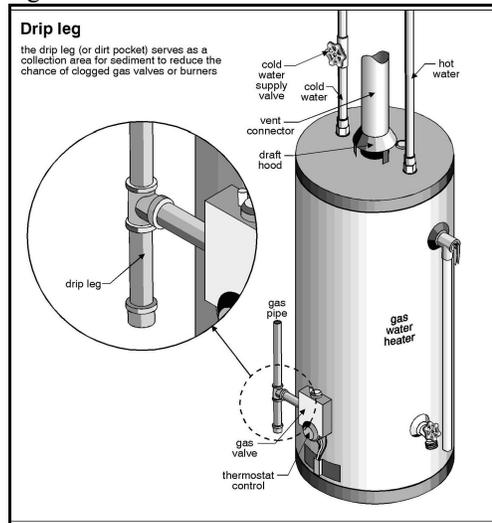
Drip legs were not present at the water heater and furnace connections. Under current building standards, drip legs should be installed downstream from the gas shut-off valve and as close to the equipment inlet as possible.

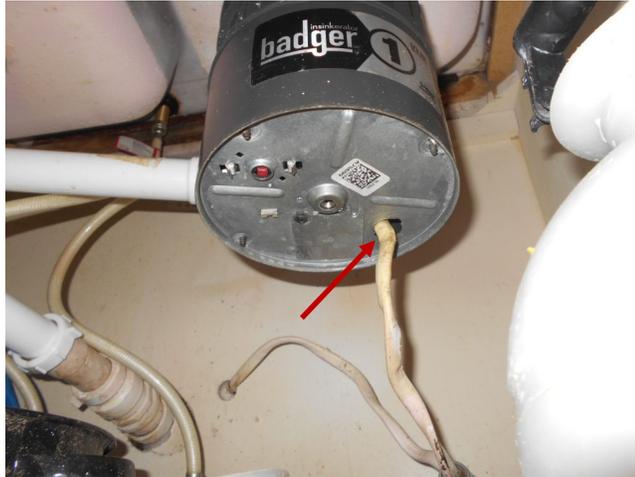
Cable clamps (sometimes referred to as bushings or grommets) should be provided for the wiring on the food waste disposers. Cable clamps serve to protect the wiring from the metal edges of the openings.

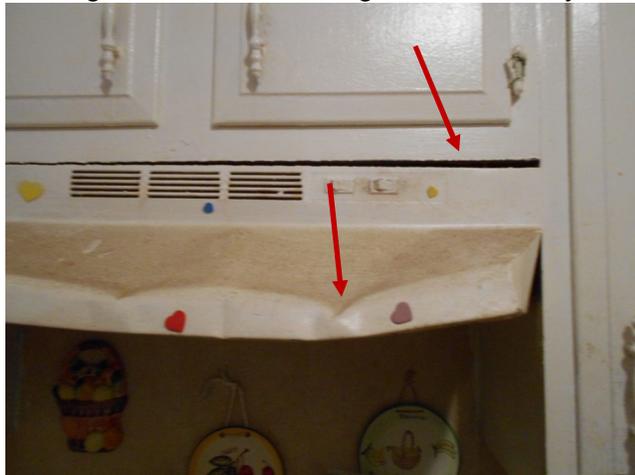
The range hood in unit B is damaged and not securely mounted.

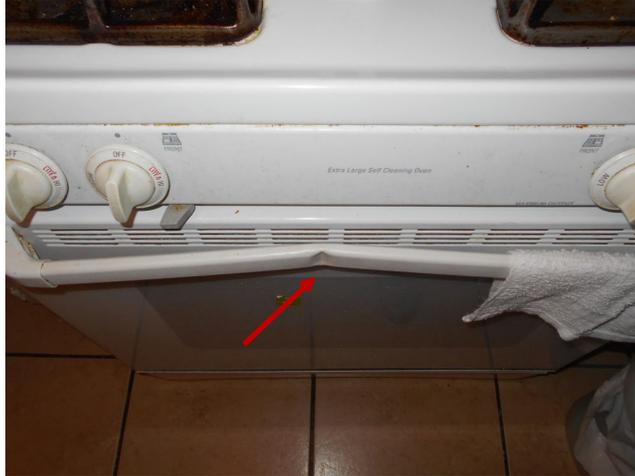
The door handle for the oven in unit A is damaged.

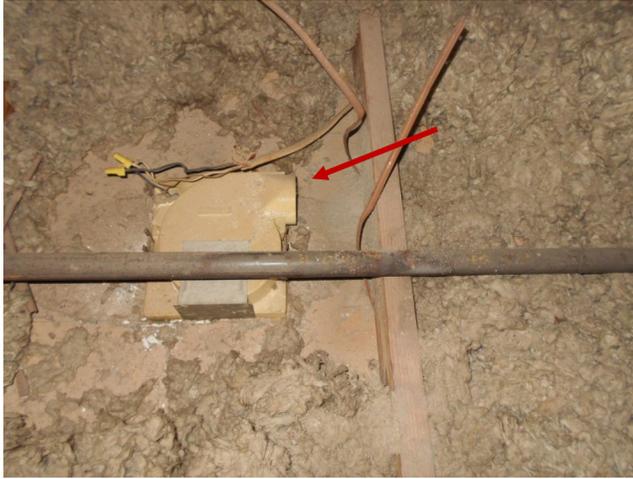
The bathroom exhaust fan in the upper units should be repaired so as to discharge to the building exterior.

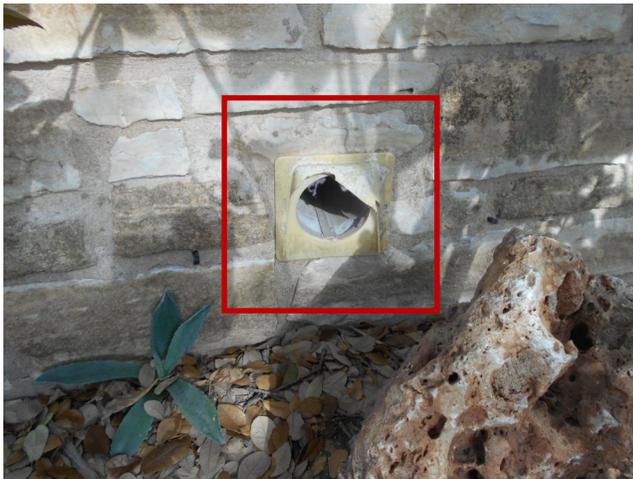
The clothes dryer exhaust vents are damaged or missing and should be replaced.
