# Sample-New Home

Prepared for: Your Name Here  
Inspector: Jeff Prokaski TREC# 9866  
Phone 512-731-0513

# PROPERTY INSPECTION REPORT

**Concerning:** Sample-New Home

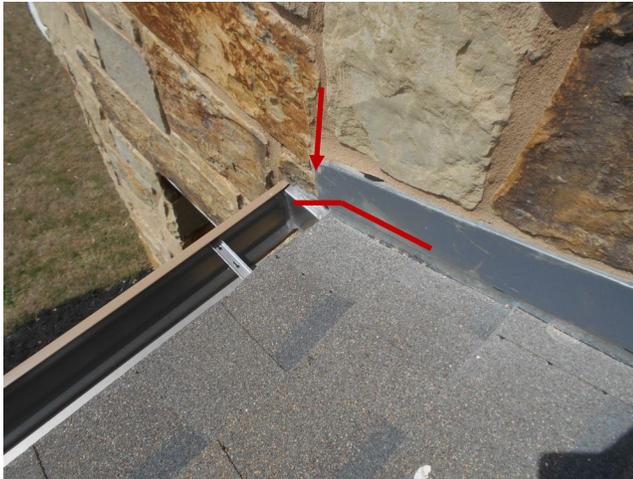
There was no kickout flashing observed. The lack of this kickout flashing can allow water to penetrate at these points.

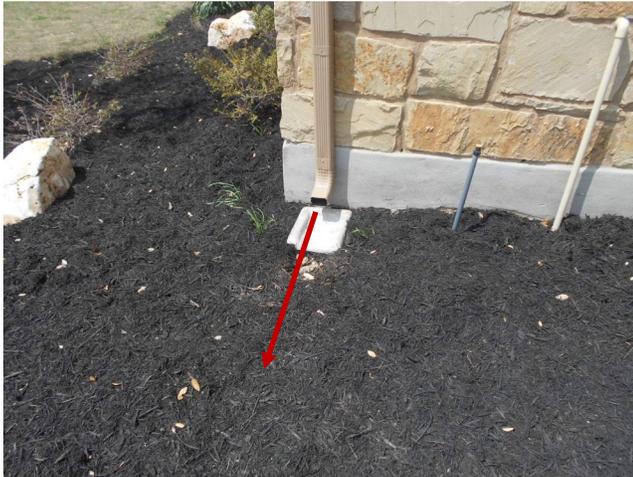
The downspout(s) should discharge water at least five (5) feet from the house. Storm water should be encouraged to flow away from the building at the point of discharge. Extension tubes are recommended.

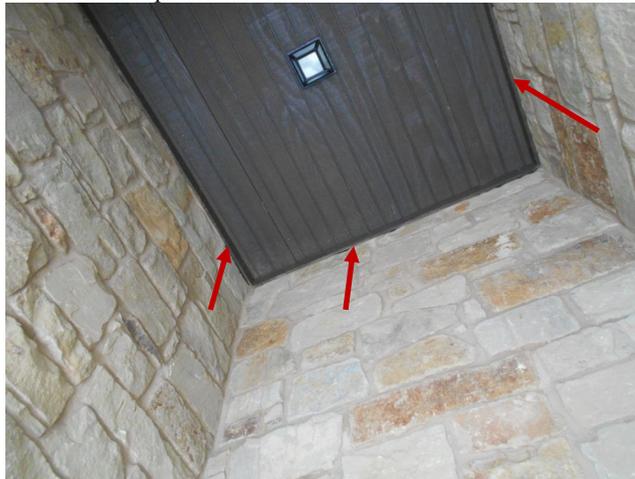
Trim boards at the front entrance of the home should be sealed as needed to prevent vermin and insect activity into the attic space.

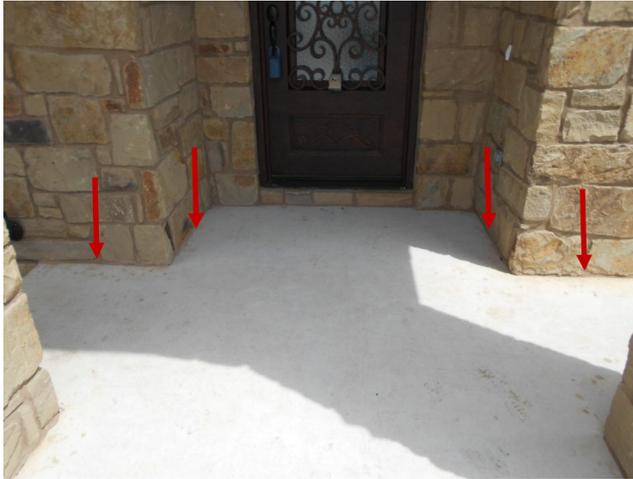
There was an insufficient amount of weep holes found at the foundation level at the front entrance. Weep holes allow moisture to drain from the wall cavity due to penetration or condensation. Drilling weep holes post construction is routine and simple. This is a common observation.

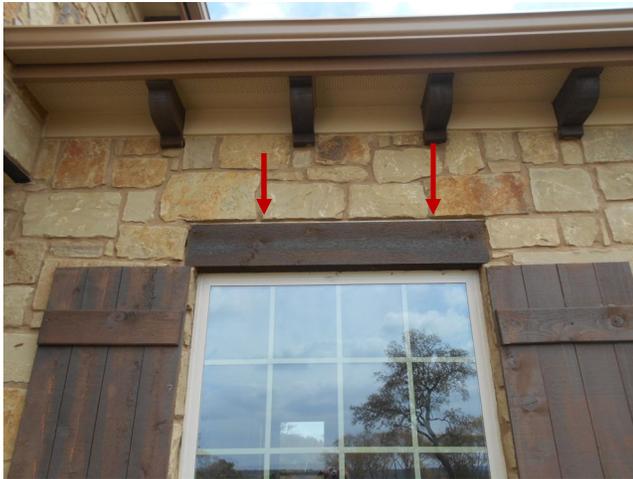
There was an insufficient amount of weep holes found above the lintels at the front of the home. Weep holes allow moisture to drain from the wall cavity due to penetration or condensation. Drilling weep holes post construction is routine and simple. This is a common observation.

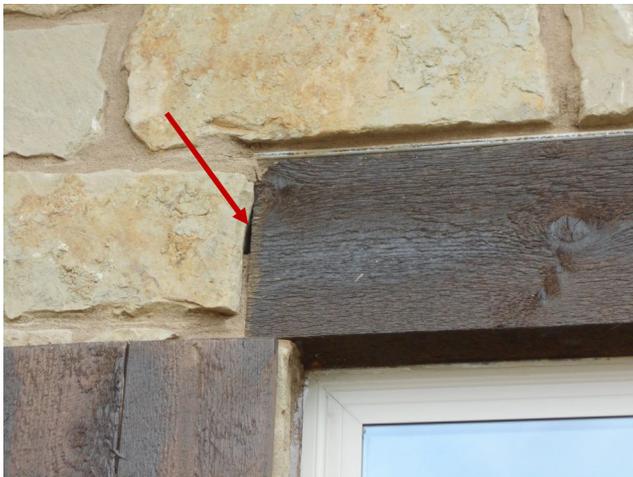
The header over the window at the front of the home should be sealed to prevent water penetration.

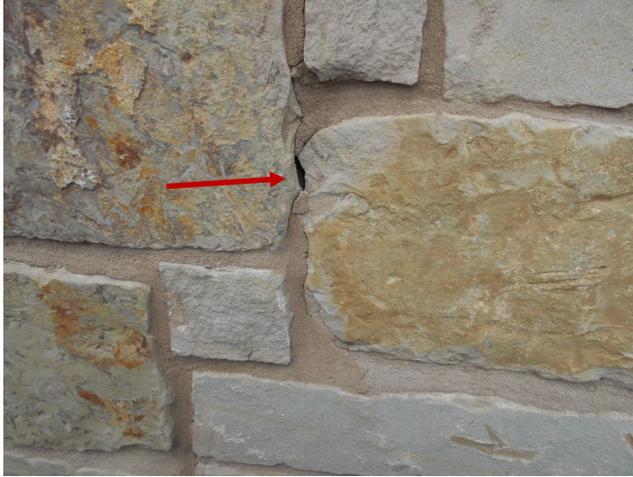
Openings in the mortar joints along the south side of the house should be sealed as necessary to prevent water penetration.

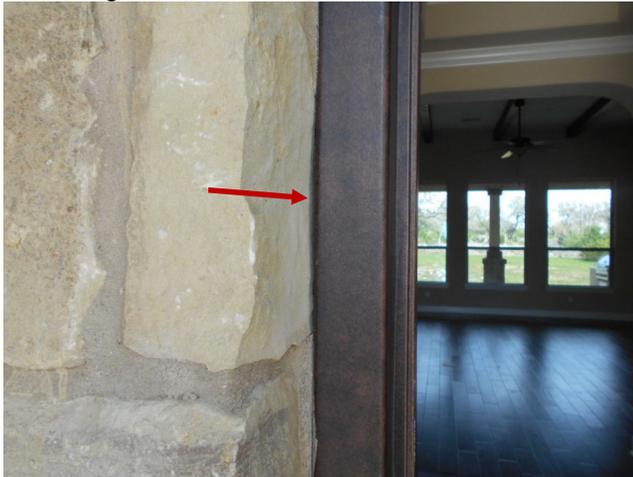
The casing for the door at the front of the house should be sealed to prevent water and air penetration.

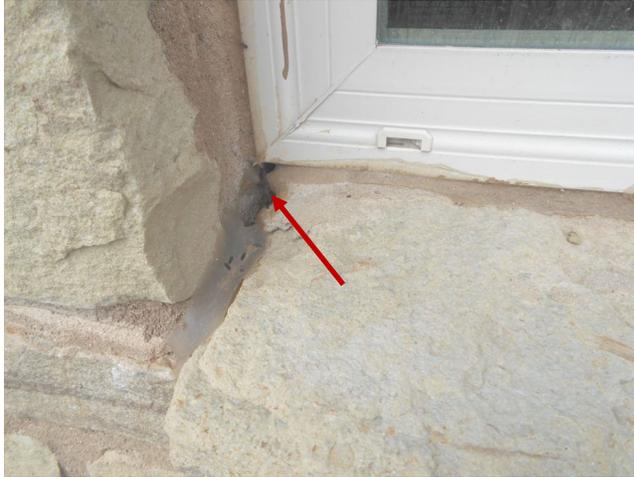
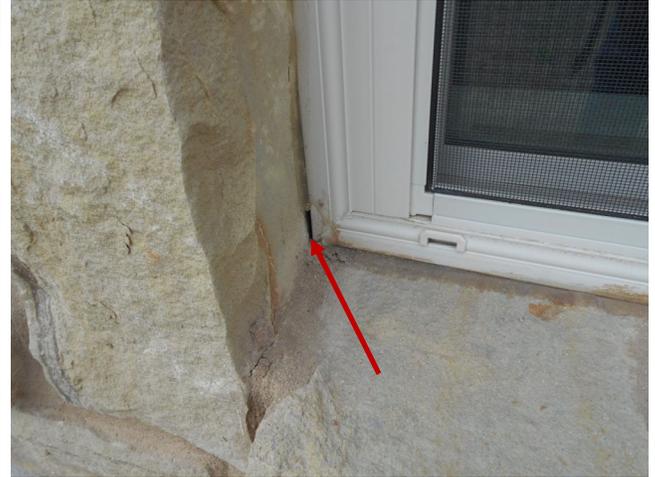
The windows and window sills on the exterior of the house are in need of re-caulking or re-pointing to avoid water penetration.

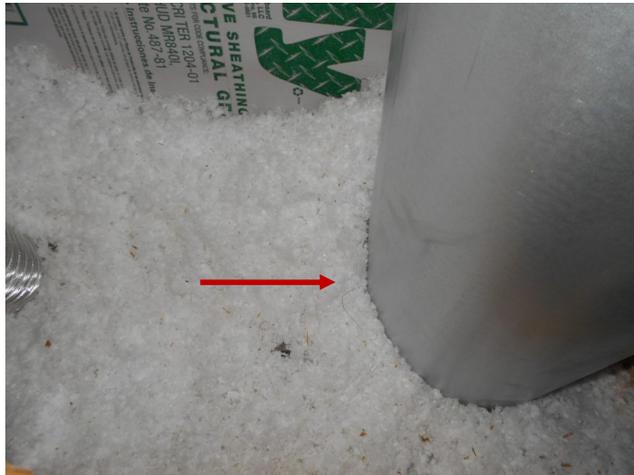
Under today's standards, a minimum clearance of two inches between the metal chimney and insulation is required. Improvement is recommended.

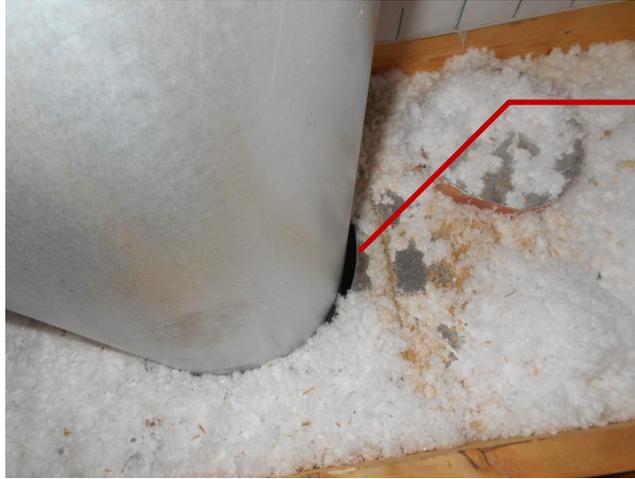
Fire stopping in the attic surrounding the chimney flue is not properly installed. *This should be corrected as this poses a fire hazard.*

Gap excessive

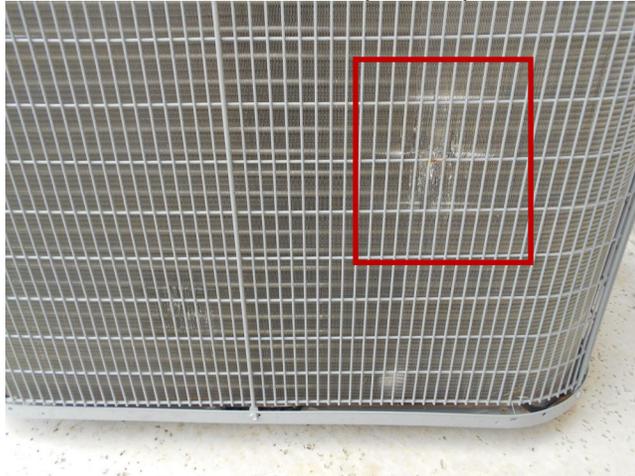
The fins of the outdoor portion of the air conditioning system were observed to be slightly damaged. This condition can reduce the efficiency of the system. Recommend straitening the fins.

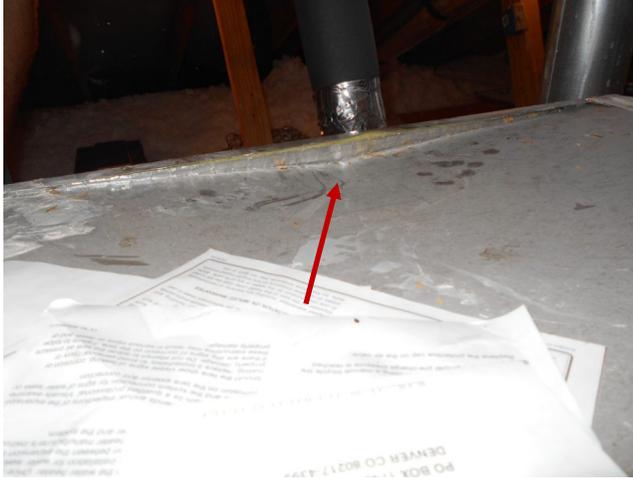
The coil housing was observed to be damaged. Improvement is recommended.

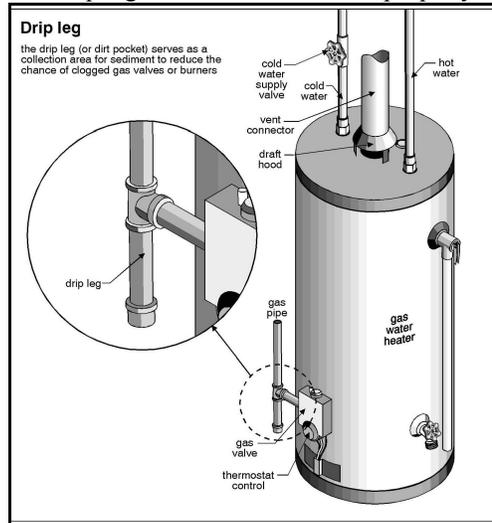
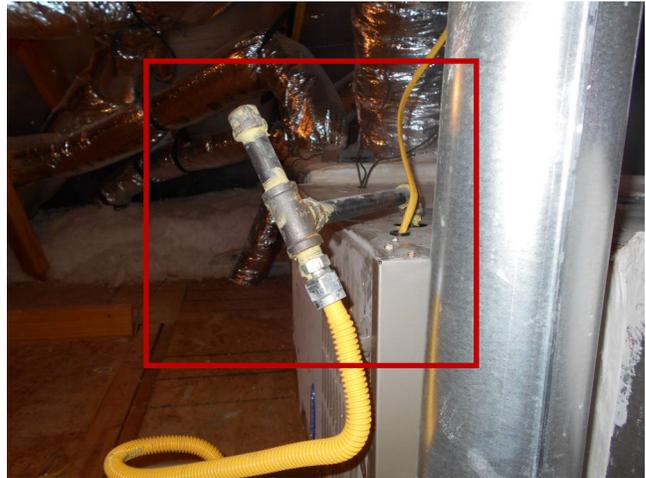
The drip leg at the furnace was not properly installed. Improvement is recommended.
