ROYAL VALLEY SUBDIVISION DRAINAGE REVIEW

Royal Valley Homeowners Association, Inc.

September, 2021

Revised & Final: September, 2023

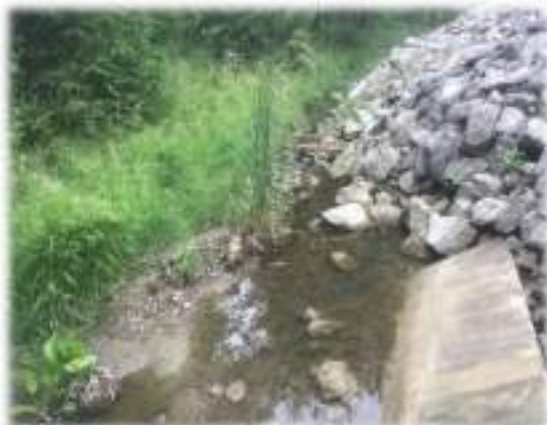
Erosion protection at Persimmon Lane.

This Common Area lies downstream of the Common Areas at PPN 489-17-024 and 489-21-007. To the west of Persimmon Lane, the corridor becomes significantly sloped and narrow, and evidence of erosion protection was found where open channels run near residential structures. This was apparent at the outlet of the northern Ridgeline Drive stormwater outfall.

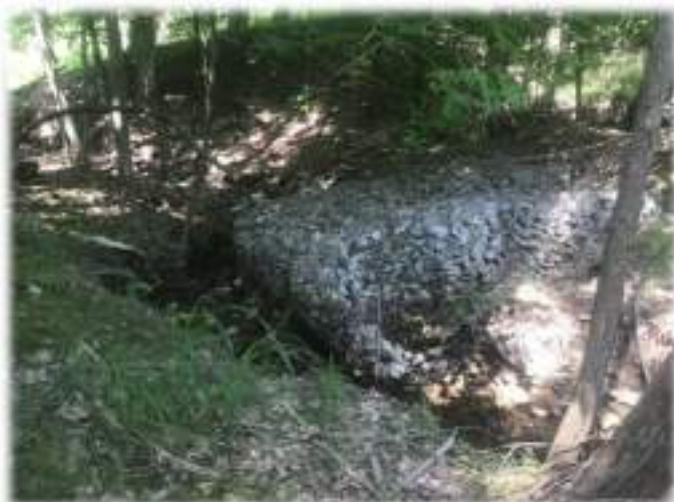
Failed perpendicular gabion feature, 5031 Corkwood Dr.

Near the outfalls (North of Corkwood), perpendicular gabion structures were found in failing or near failing state. The structure appears to have been installed to reduce water flow rate and channelization. This portion of stream channel and surrounding open areas had low quality natural environmental features. Current and past slope failures were present along the riparian corridors.

- 5031 Corkwood Drive: remove failed gabion structure from open channel; install flow dissipation at the outlet; consider natural channel design to expand floodplain downstream of the outfall

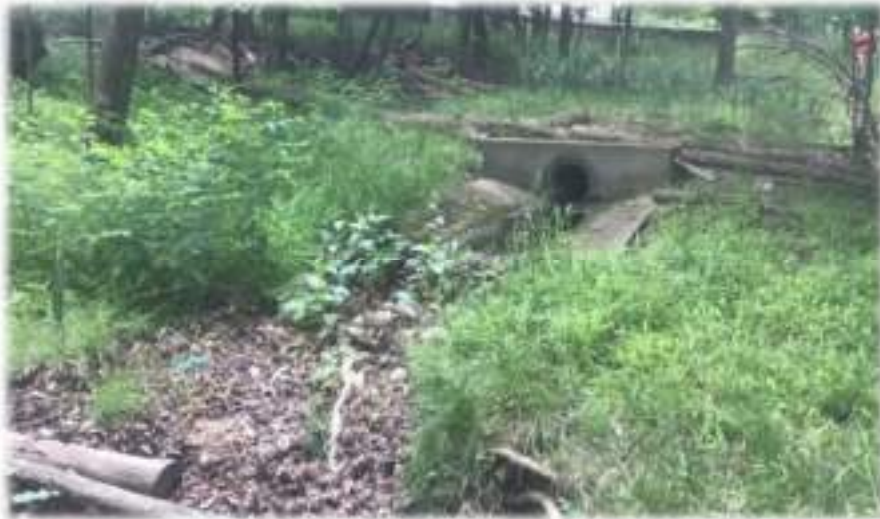
Dublin Dr. outfall near 9890-9880.

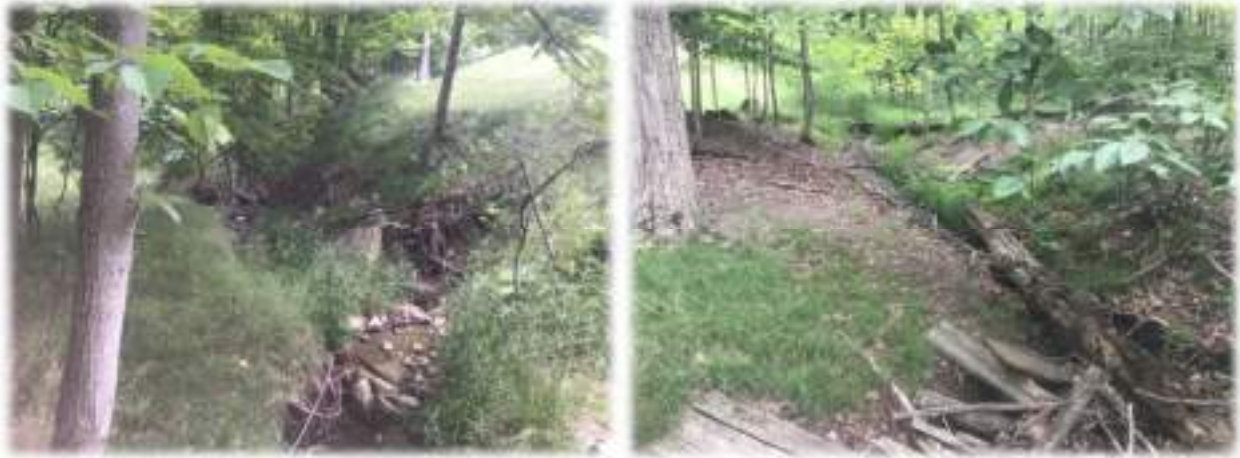
Western degraded stream corridor (left), contrasted with well developed, gently sloping hillside (right)

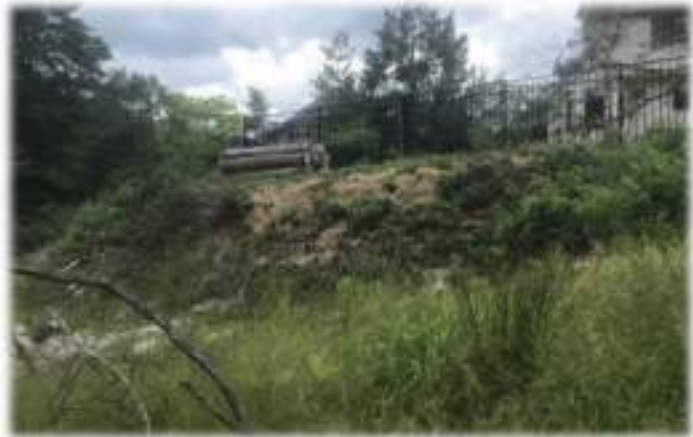
This Common Area is the first of two that drain to Basin #54. The open space within this area is characterized by steep eroding valleys flanked by excessive amount of yard waste. The Common Area contains two stormwater outfalls. The storm sewer system along Sweetleaf Lane and Pinckney Drive discharges behind 5117 Pinckney Drive. This outfall produces deleterious environmental outcomes as the outfall itself is perched above the stream channel, creating scouring at the outfall and undercutting downstream. Failed gabion baskets were noted at the outfall, located perpendicular to the outfall's flow direction.

Yard waste/debris within Common Area PPN 489-21-035

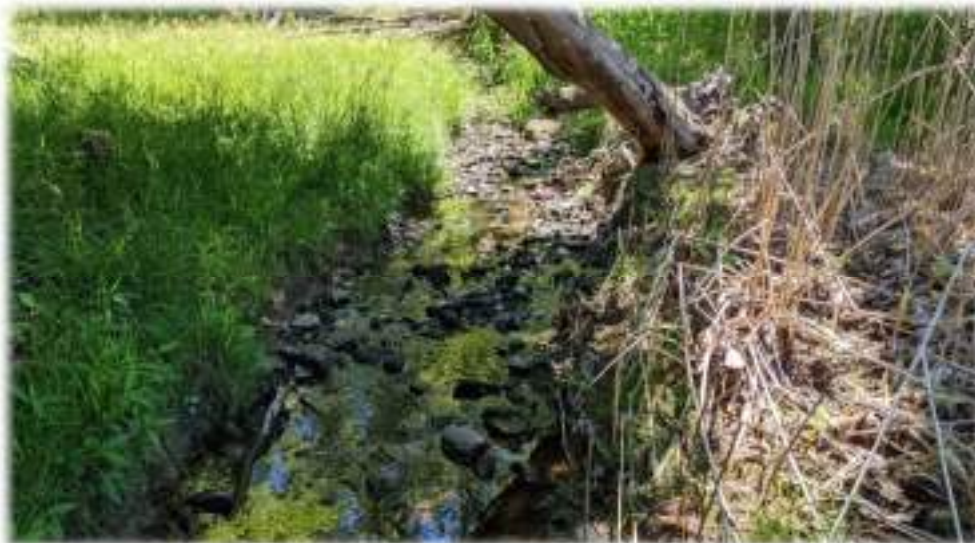
Perennial channel leading to Stormwater Retention Basin #55.

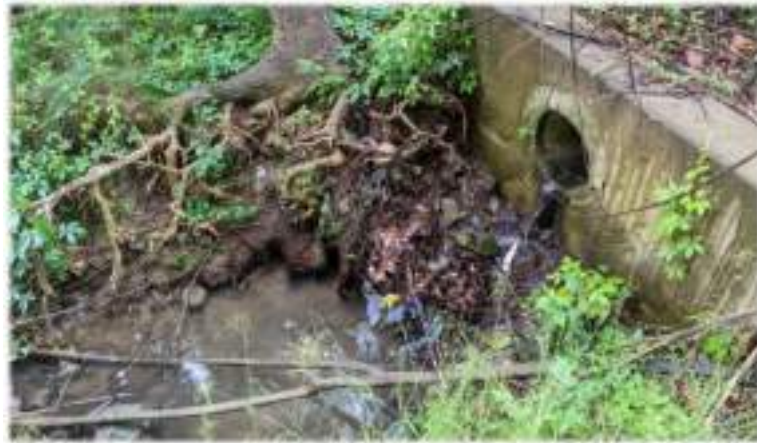
Outfall near 5117 Pinckneya Drive with 2-foot-deep scour pool

- 5117 Pinckneya: remove failed gabion structure from outlet channel; repair scouring and install rock channel protection and flow dissipation measures at outfall

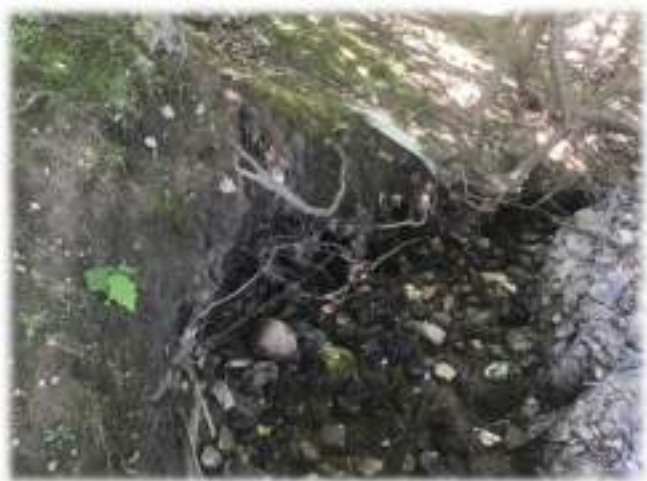
During investigations, several locations of failed gabion baskets were identified. Most were installed perpendicular to the flow of the channel, often near a stormwater outfall. Water has either bypassed these structures or completely removed their functionality. Once these structures have failed, they create a concentrated flow of water through a new channel, increasing erosion and downstream sedimentation. This was apparent at the outfall behind 5031 Corkwood Drive, where water has carved a new channel through what was previously upland. Additional failed gabion structures are present at 9780 Royal Valley Drive and 5117 Pinckneya.

5031 Corkwood Drive- failed gabion baskets

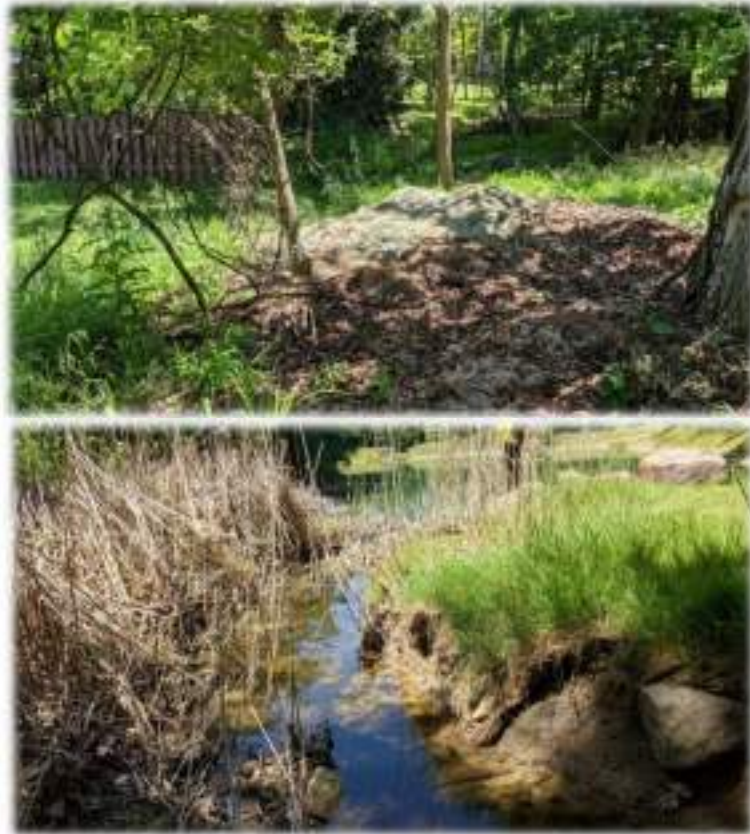
Lastly, and most frequently, evidence of eutrophication was observed throughout the Royal Valley Subdivision. Eutrophication is the process where nutrients such as nitrogen or phosphorus are added to water resources at elevated levels. In urban areas, these nutrients typically come from the composting of yard waste (grass clippings, branches, vegetation), excessive fertilization, and pet waste. These nutrients create an environment which is deleterious to native aquatic species, depleting oxygen and preventing growth of most native flora and fauna. Evidence of this can be observed in downstream portions of all open channels, where algae dominate the surface and a layer of organic detritus is found covering substrate. The algae growth observed in the stormwater basins, as summarized in the following section, is another indicator of eutrophication within the watershed.

Comparison of upstream yard waste decomposing and downstream evidence of eutrophication.

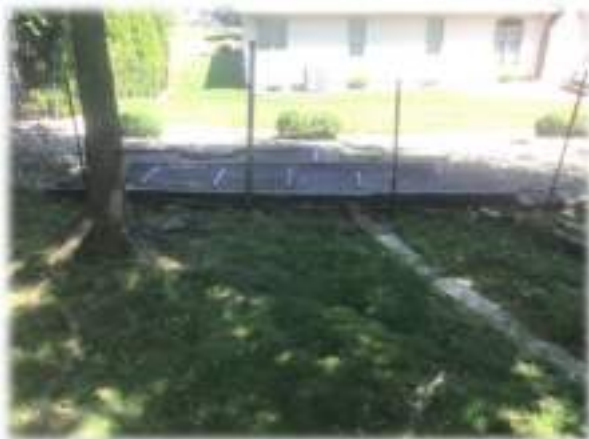
The drainage channel at 5060 includes a rock-lined channel to a rear yard catch basin that is covered with screening in order to capture debris (see Figures 5 and 6, below). This catch basin catches approximately 2.0 acres of drainage, which is mostly wooded land and can be defined as good condition, based on the presence of adequate litter and brush covering the soil. The drainage area is naturalized and no specific cause for the excessive debris to this catch basin was noted. Flooding specific to this residence was not evident in field investigation. However, the installed debris screening indicates there is excessive debris within the runoff carried to this inlet. The current homeowner is maintaining the system and it appears in good condition; however there is concern that such a high burden of maintenance rests with a homeowner on a private property.

Figure 5. Screening over inlet basin at 5060 Corkwood Drive

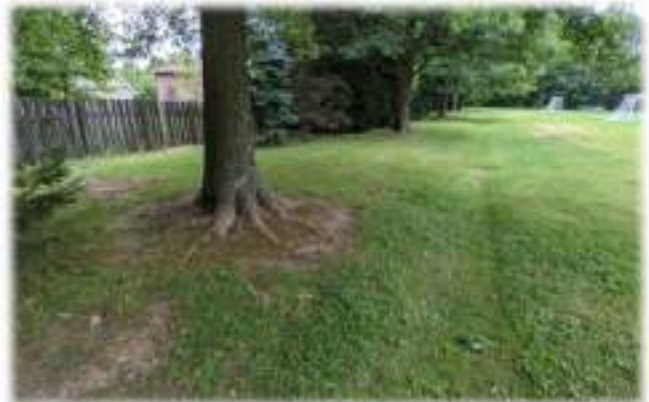
Existing drainage swale to the north of Heasley Soccer Fields

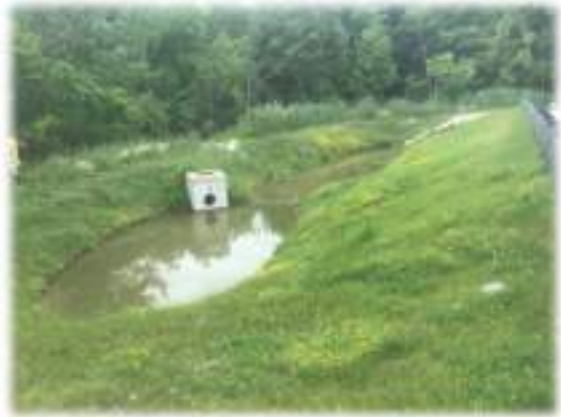
Stormwater basin west of church parking expansion.

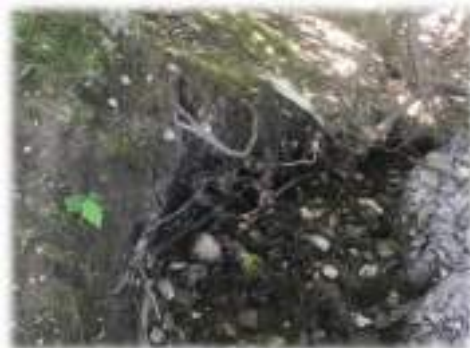
Failed gabion and bank erosion downstream of 5031 Corkwood Drive

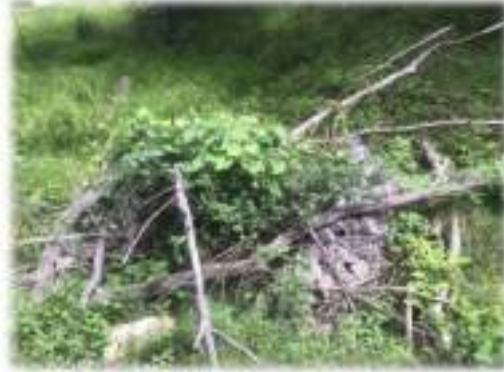
Failed gabion downstream of 5117 Pinckneya

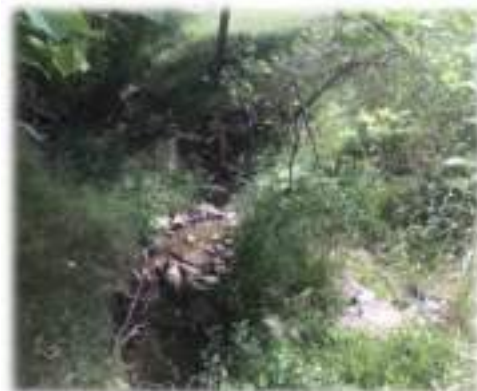
Downstream bank erosion at 9769 Royal Valley

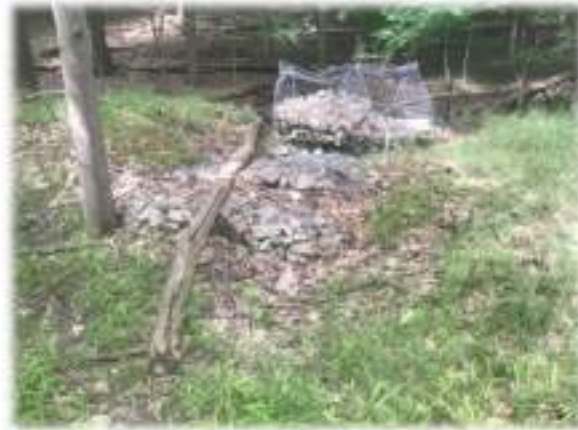
*Failed Gabion structure within channel between
Dublin Drive and Buttonbush Lane*

- 9780 Royal Valley: install flow dissipation at outlet, remove failed gabion structure, combined with natural channel design to address downstream erosion

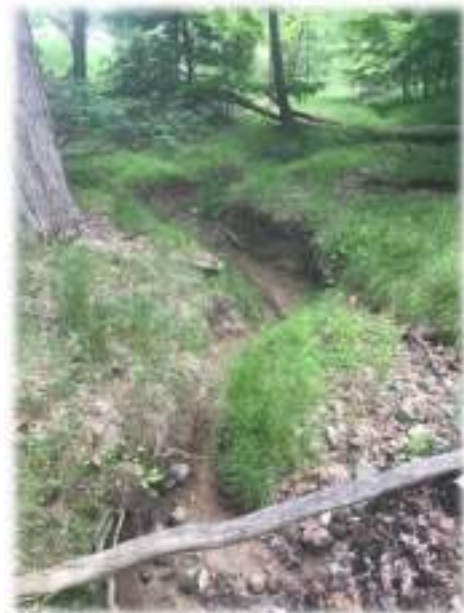
Incised channel between Dublin Drive and Buttonbush Lane

One potential area that would be an appropriate location for stream channel restoration utilizing facets of natural channel design is in portions of Stream 55 (see Appendix C, Figure 5 for location). The specific project location is both north and south of Royal Valley Drive, west of Dublin Drive. This area of stream exhibits incised banks subject to erosion. There are also failed gabion structures in the area that could be removed, and a natural stream channel with floodplain could be installed. The priority would be to perform the project for the portion North of Royal Valley Drive first, and then proceed with the portion south of Royal Drive once the downstream improvements are installed.

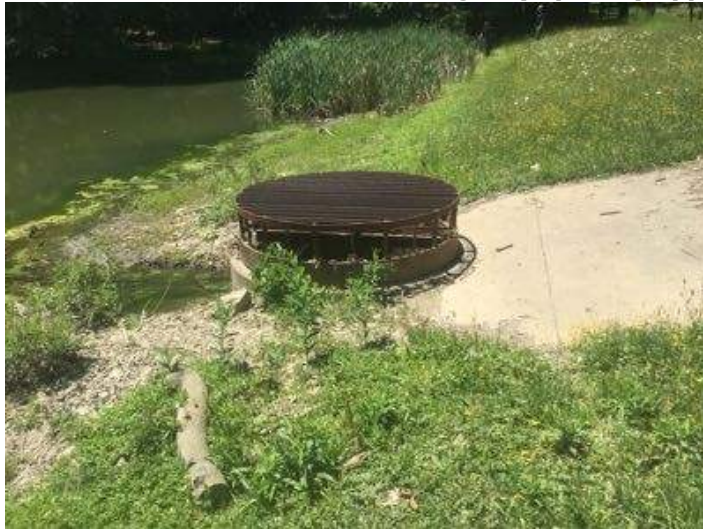
Photo 1 - 07/23/2021

Outlet structure and emergency spillway appear to be in good condition and functioning properly.

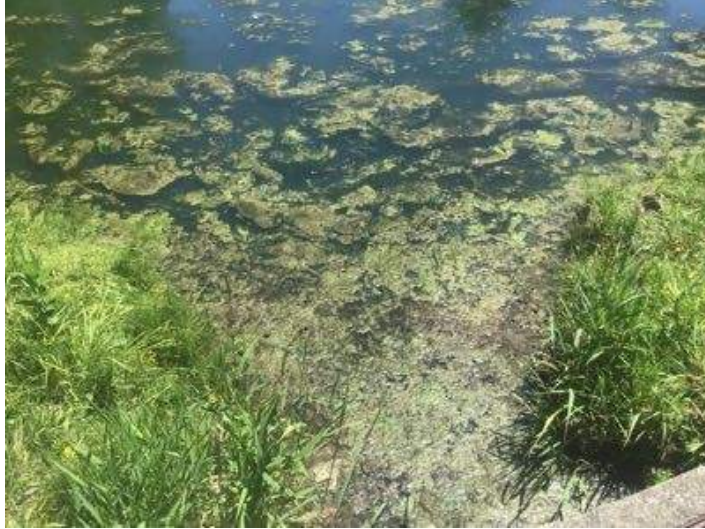
Photo 2 - 07/23/2021

Outlet structure appears to be in good condition and functioning properly.

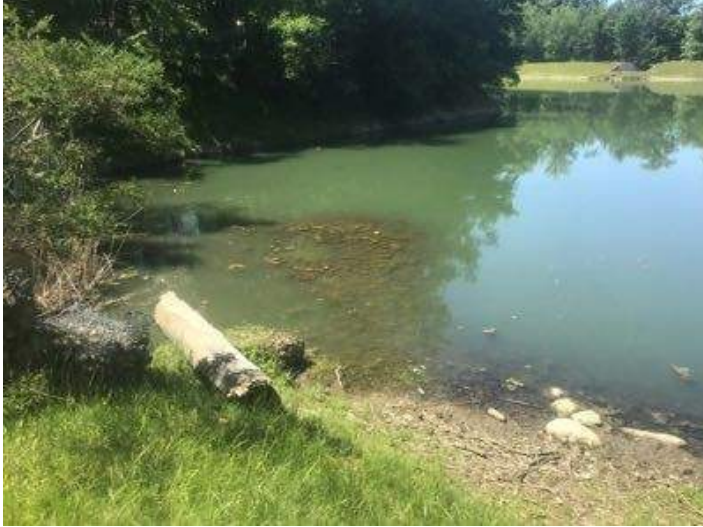
Photo 2 - 07/23/2021

Outlet structure and emergency spill way appear to be in good condition and functioning properly.
