Field Report

REPORT NO: 037

DATE: 06/05/13

Project: North Country Environmental Services Landfill – Phase II-B
Bethlehem, NH
CMA Project No: 865 (file: Field Reports: 865 C.1)

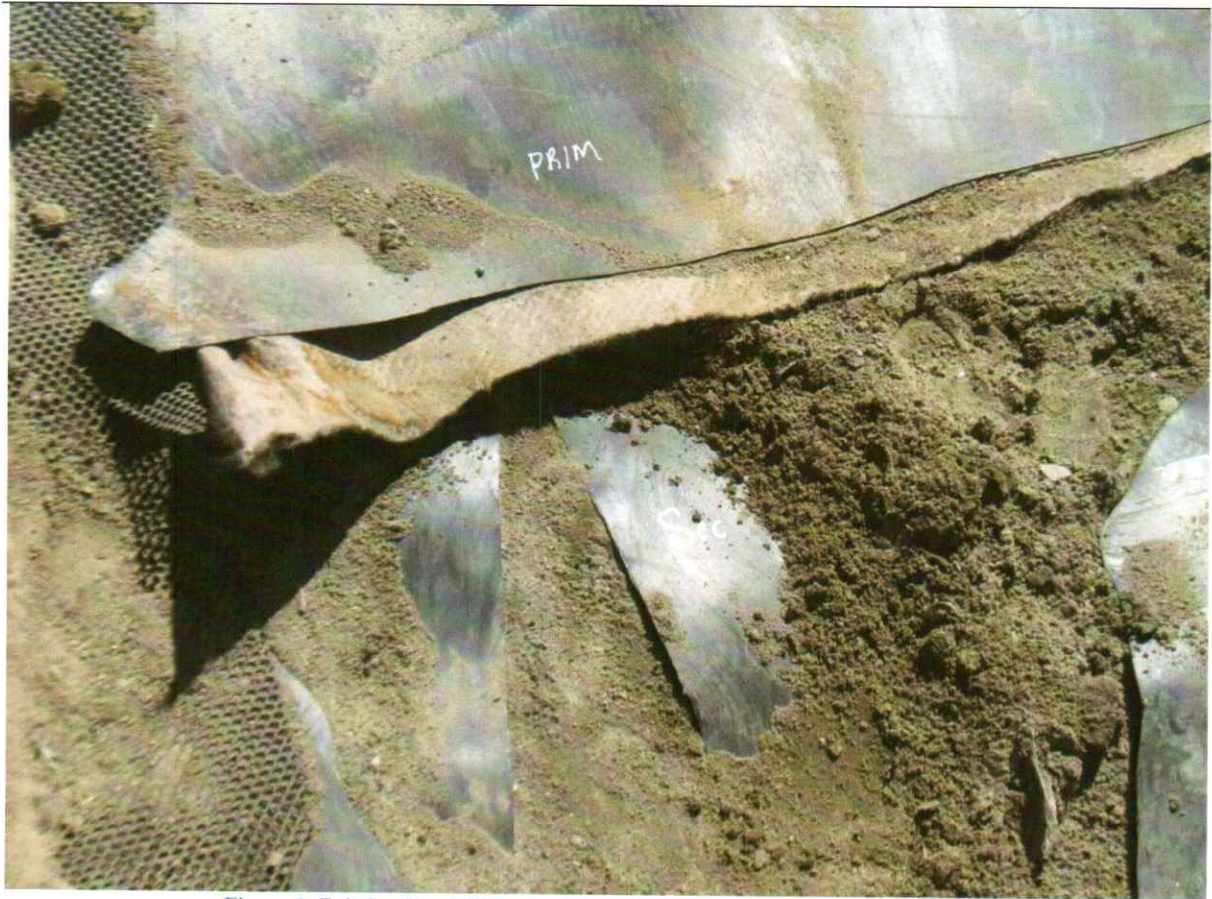
RTD crew opened existing primary liner (Appears to be National Seal product; smooth, shiney, flat-die extruded sheet) at proposed tie-in. Pike crew uncovered several areas, near the former 12" HDPE stormwater drain, of equipment damaged primary and secondary existing geomembrane. This damage appears to be old damaged sheet dating back to original construction (SANCO?).

Figure 1 Existing Landfill Equipment Damage below Proposed Tie-in Seam.

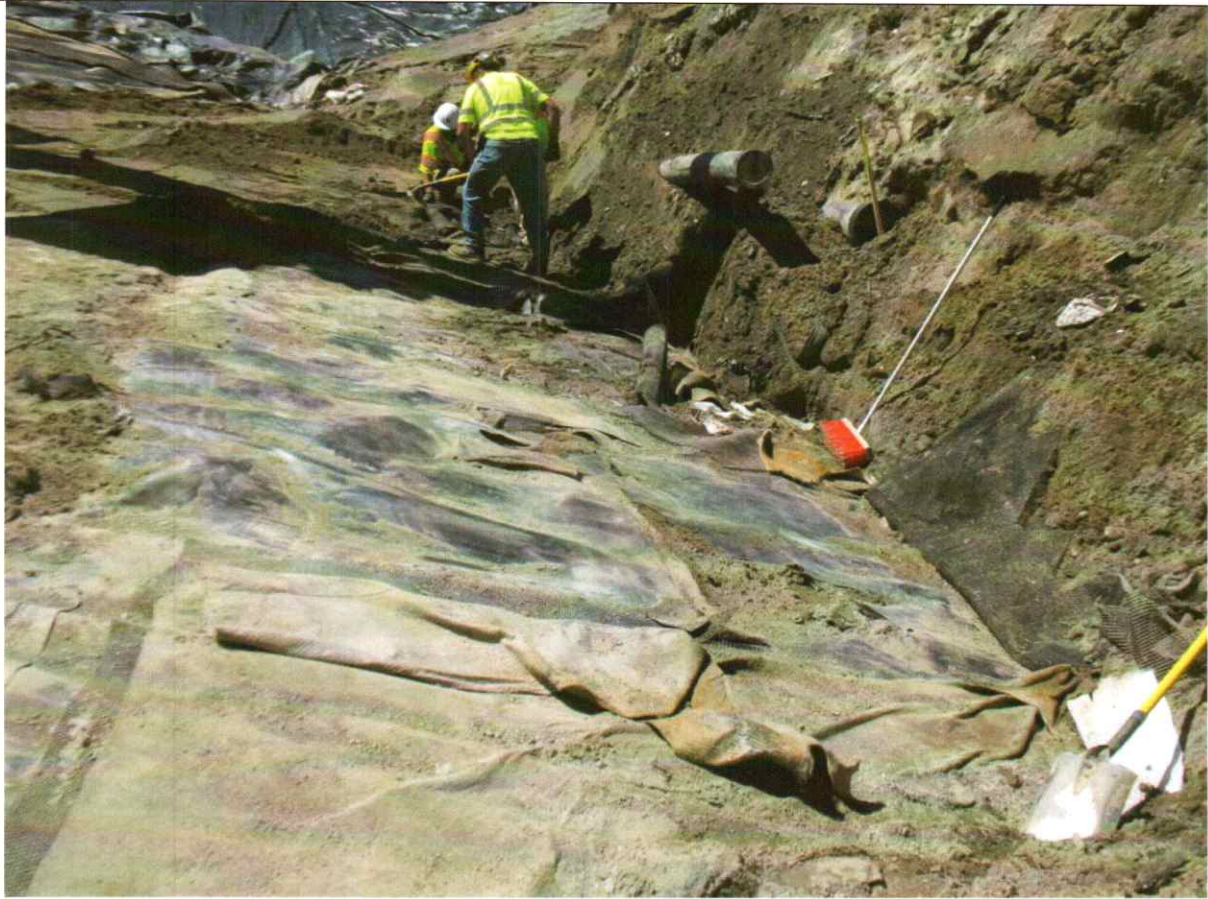
Figure 2 Existing Landfill Construction Damage
