November 30, 2022

**RE: NCES Lined Landfill Stage IV, V, VI
Lined Landfill Facility – Bethlehem, New Hampshire
Response to NH DES Facility Inspection and Deficiency Report – 11/2/2022**

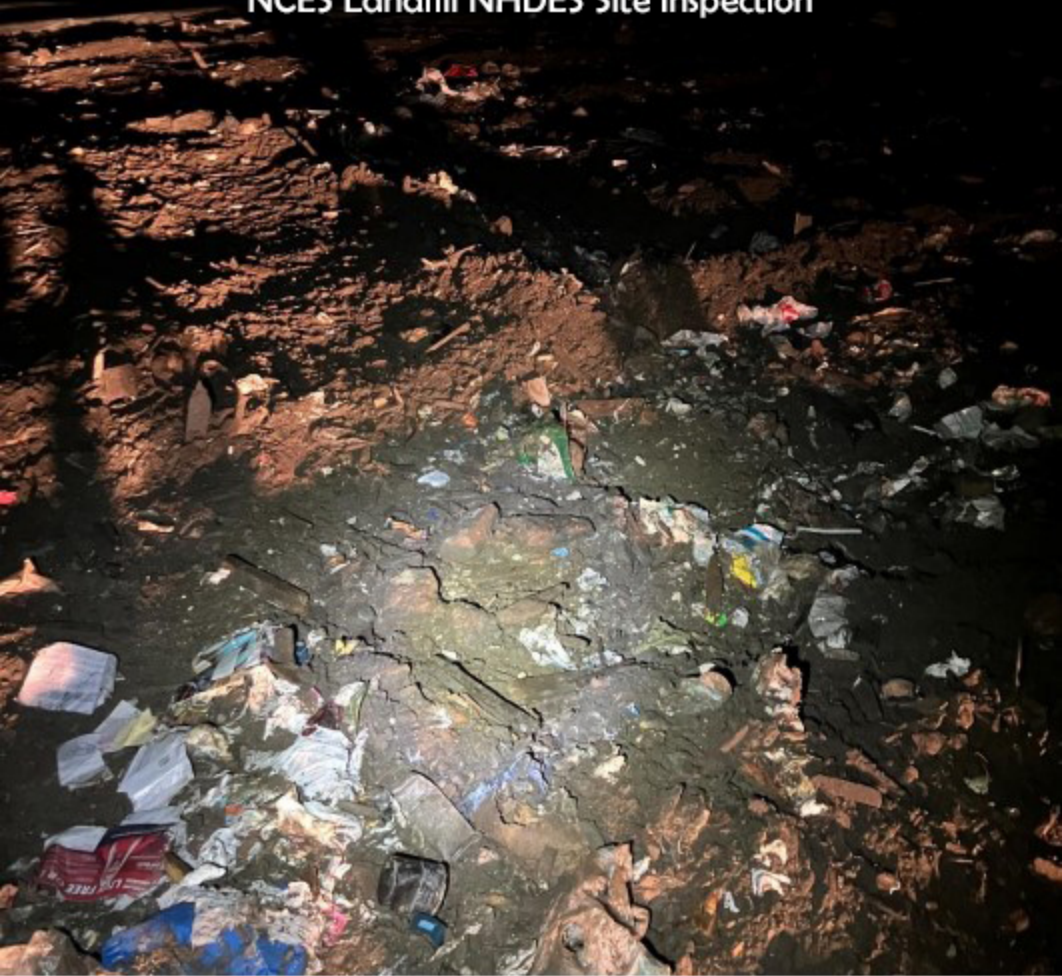
Area #3: The tipping area from the day before was discovered to contain some small areas of waste not exhibiting application of cover material.

Tipping area uncovered waste Nov 2 2022
NCES Landfill NHDES Site Inspection

NCES collected photographs of daily and intermediate cover applied at the end of each day from November 2, 2022 through November 11, 2022. The photographs were emailed to you as verification

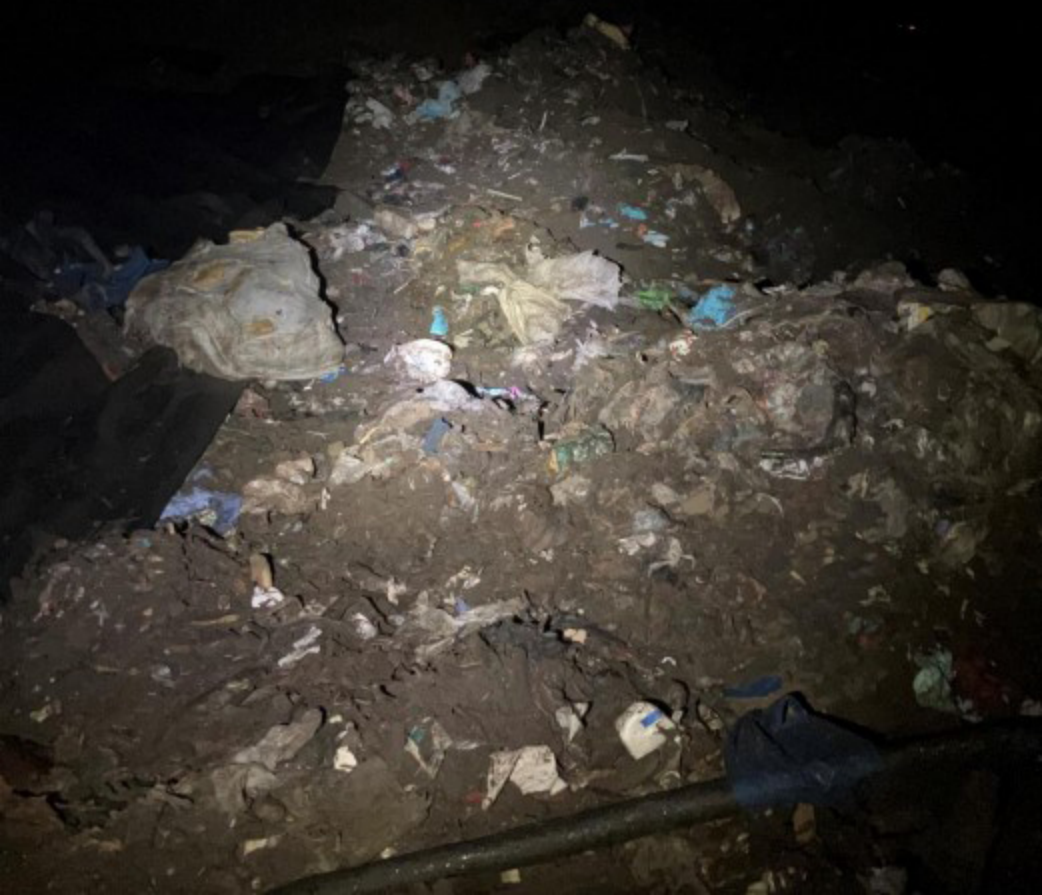
Area #1: Downslope from the termination of geosynthetic tarp coverage, there were small berms of primarily intermediate cover material containing intermixed wastes observed. These berms were beyond the reach of the geosynthetic tarping used as daily cover and did not appear to be covered otherwise. The wastes appeared to have been uncovered and mixed with intermediate cover during prior cover stripping operation in order to conduct subsequent lifts. The berms were intermittent in nature and did not span the whole width of the active area.

Base of geosynthetic tarping system with intermediate cover
mixed with waste
NCE5 Landfill NHDES Site Inspection Nov 2 2022

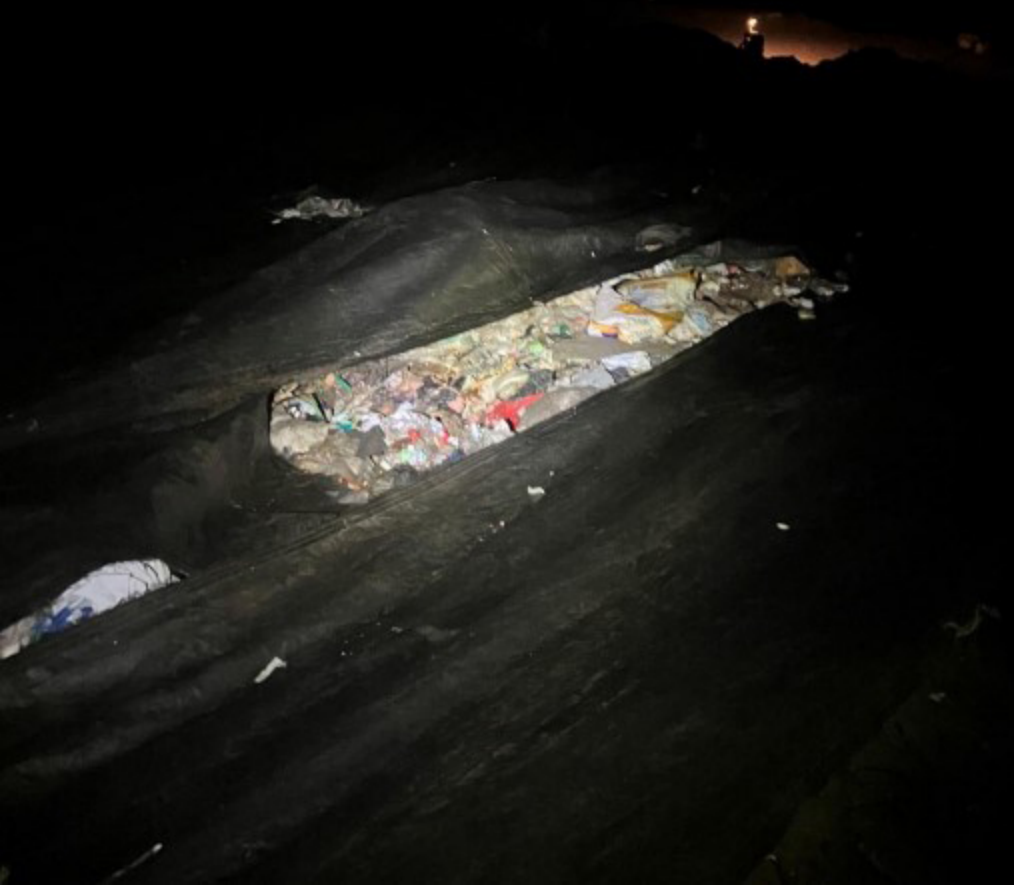
Area #2: There was a single gap in the geosynthetic tarping system measuring approximately 3 feet by 10 feet. No cover material was observed to be applied to this waste.

Gap in geosynthetic tarping system
NCES Landfill NHDES Site Inspection Nov 2 2022
