STATE OF NEW HAMPSHIRE  
INTER-DEPARTMENT COMMUNICATION

DATE: September 16, 2009  
AT(OFFICE): P&DRS

**SUBJECT:** Stage 1 Phase 1 Anchor Trench Repairs/NCES/Bethlehem/  
DES-SW-SP-03-002

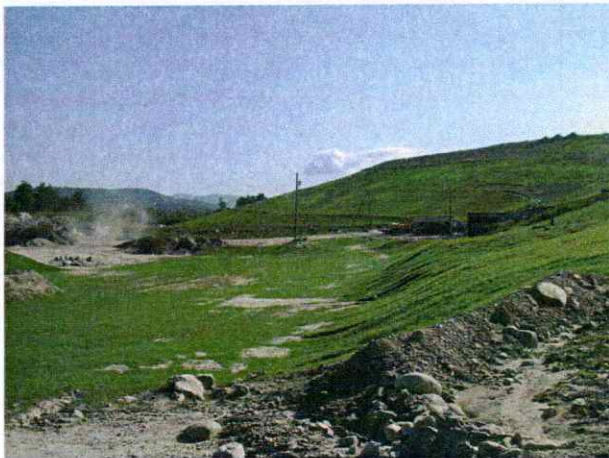
On Tuesday, September 9, 2009, Paul Gildersleeve and I visited the NCES landfill in Bethlehem to attend a Leachate Management Improvements construction meeting. Prior to the meeting, we were given a tour of the facility by Kevin Roy. Picture 1 shows the amount of soil that has been removed from the area between the old leachate loadout area and MW 402U & L.

**Picture 1.** This picture shows the area to the north of Stage 1 where the leachate loading tanks and area were formerly located.

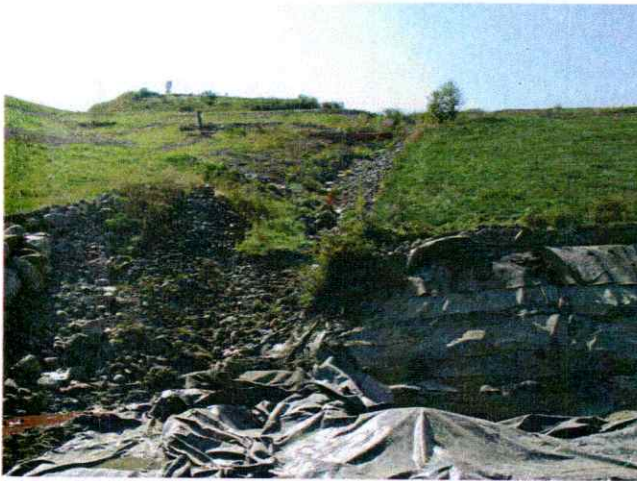
Kevin then proceeded to show us the area near the Stage 1 Phase 1 downchute. While removing the 36-inch culvert, Kevin saw landfill gas coming from the direction of the Stage 1 Phase 1 anchor trench. Upon removing soil from approximately 200 feet of anchor trench and exposing the geomembrane cap, Kevin noted that the cap was badly deteriorated. It had holes in it and the cap was not welded to the liner in this area.

**Picture 2.** This picture is looking up (south) the Stage 1 Phase 1 downchute. The excavated anchor trench is to the right.

He explained that his intent was to have CMA prepare a plan to replace the existing cap and to weld it to the liner.

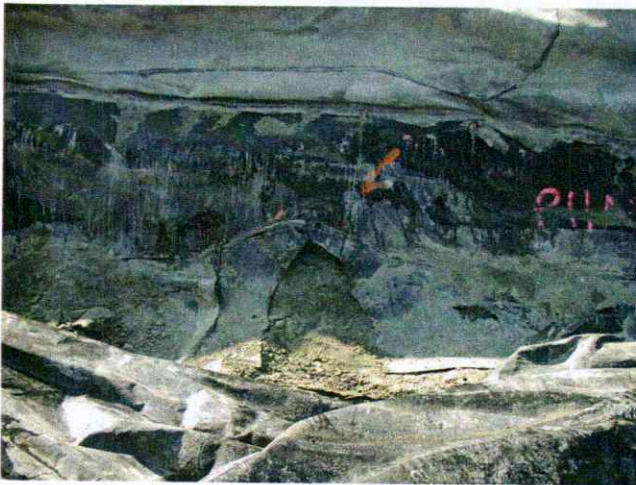
**Picture 3.** This picture is looking north at the Stage 1 Phase 1 anchor trench. Note arrow pointing out hole in geomembrane cap.

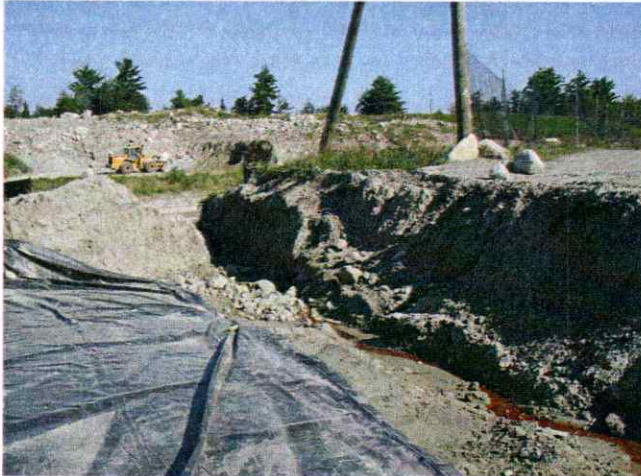
**Picture 4.** This picture is looking north towards MW 913M. The open trench is where the 36" culvert connecting the Stage 1 Phase 1 down chute to detention pond 3 was located.
