Site Visit Report	New Hampshire Department of Environmental Services Waste Management Division P.O. Box 95, 29 Hazen Drive Concord, NH 03302-0095 Phone: 603-271-2925 Fax: 603-271-2456
---	--------------------------	--

Facility/ Site Information	
Facility Name/ Permit No.	North Country Environmental Services Inc / DES-SW-SP-03-002
Permittee	North Country Environmental Services Inc.
Physical Address	581 Trudeau Road, Bethlehem, NH
Mailing Address	1855 VT Route 100, Hyde Park, VT 05665
Facility Type / Waste Types Accepted	Other Permit No. / Date Issued
Lined Landfill / Mixed MSW, C&D, Contaminated Soil, Ash, Other Waste Types	Groundwater Permit: GWP-198704033

Visit Information			
Date of Visit	6/12/2024	NHDES Staff Conducting Site Visit	Mary Daun, Jaime Colby
Time Arrival / Departure	10:18AM / 12:45PM	Weather	Cloudy, 71 - 76°F
Purpose of Site Visit	Construction Meeting for CAP 4 and Site Visit		
Photos Taken: <input checked="" type="checkbox"/> Yes <input type="checkbox"/> No (see end of report)

PROJECT: *North Country Environmental Services – Cap 4*
CMA #1262

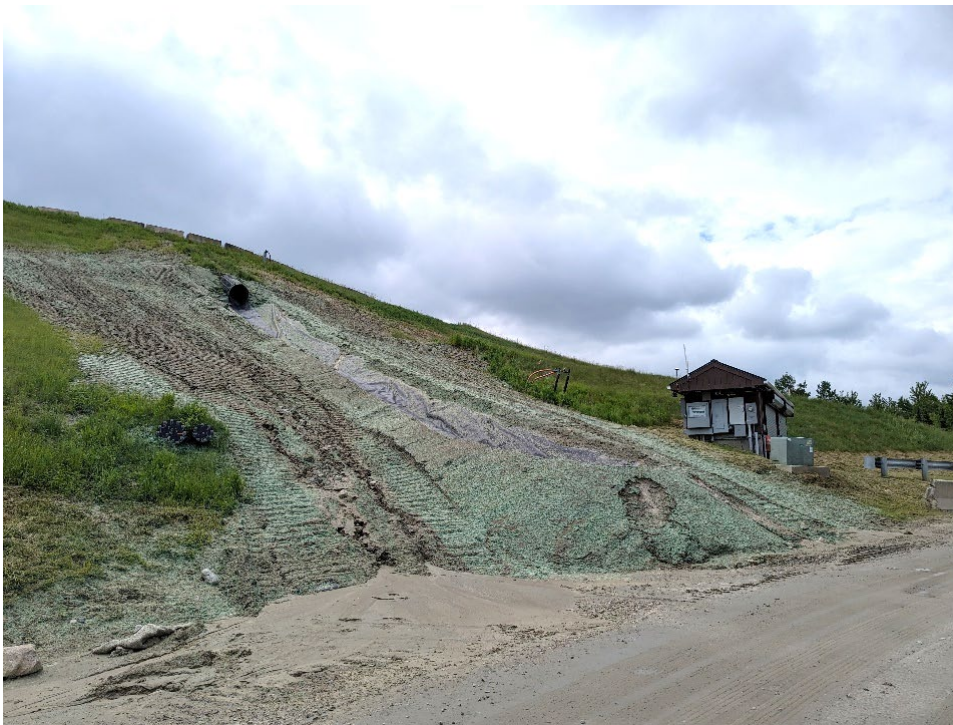
NHDES staff, Joe Gay, Kevin Roy, Hunter Whitcomb, and Brett Deyling proceeded on a site walk clockwise around the landfill, primarily to view the work on Cap 4. A stormwater down chute located in Stage V, near Pump Station #1, was reworked within the past week, and other areas on the Stage V slope were repaired or needed repair. In areas of erosion, waste was not observed. See photographs. Intermediate cover was observed over the Cap 4 area. The swale at the toe of the Cap 4 area slope was also cleared of sediment within the past week due to erosion from recent rainstorms. The slope of Cap 4 is about 2.7H:1V. A gas header pipe with a pitch issue was excavated and reset on the northeast side of the landfill, in the Cap 4 area. NHDES staff observed waste on top of the intermediate cover in this area. NCES stated that they would cover it in the afternoon of the same day.

PXL_20240612_150344151: Stormwater downchute in Stage V, near Pump Station No. 1

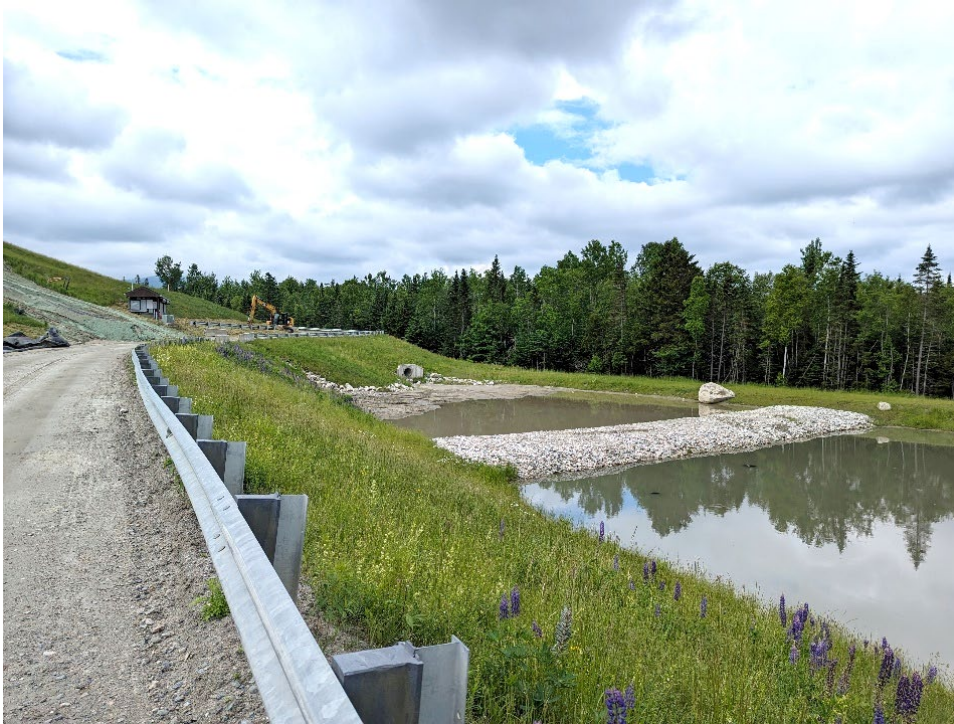
PXL_20240612_150436038: Stormwater Pond near Stage V, sediment observed in forebay

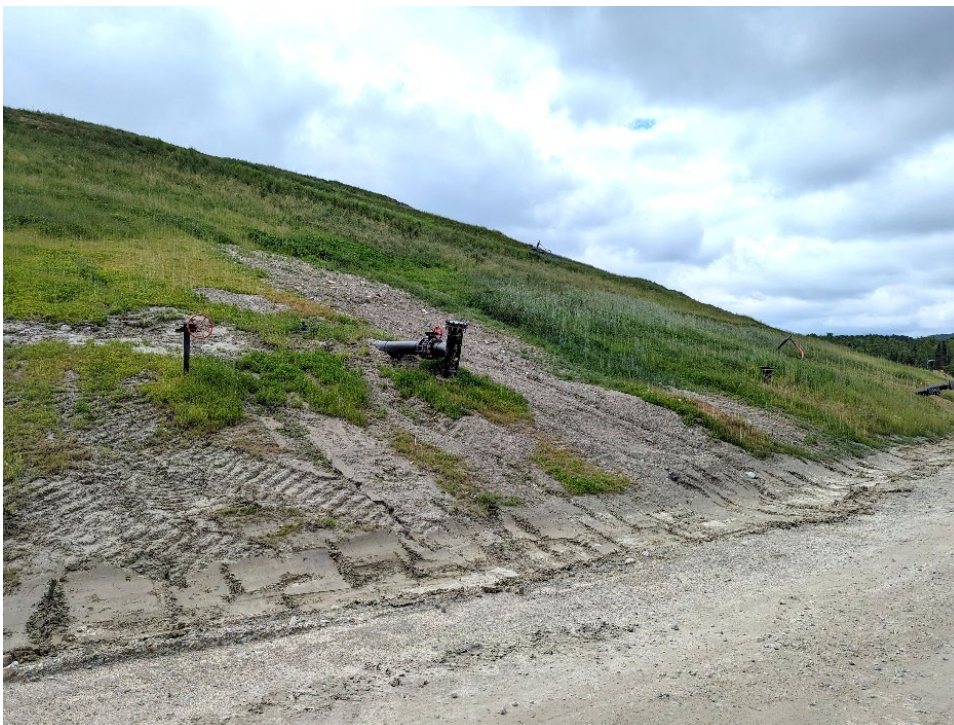
PXL_20240612_150657128: Stage V Slope erosion/repair

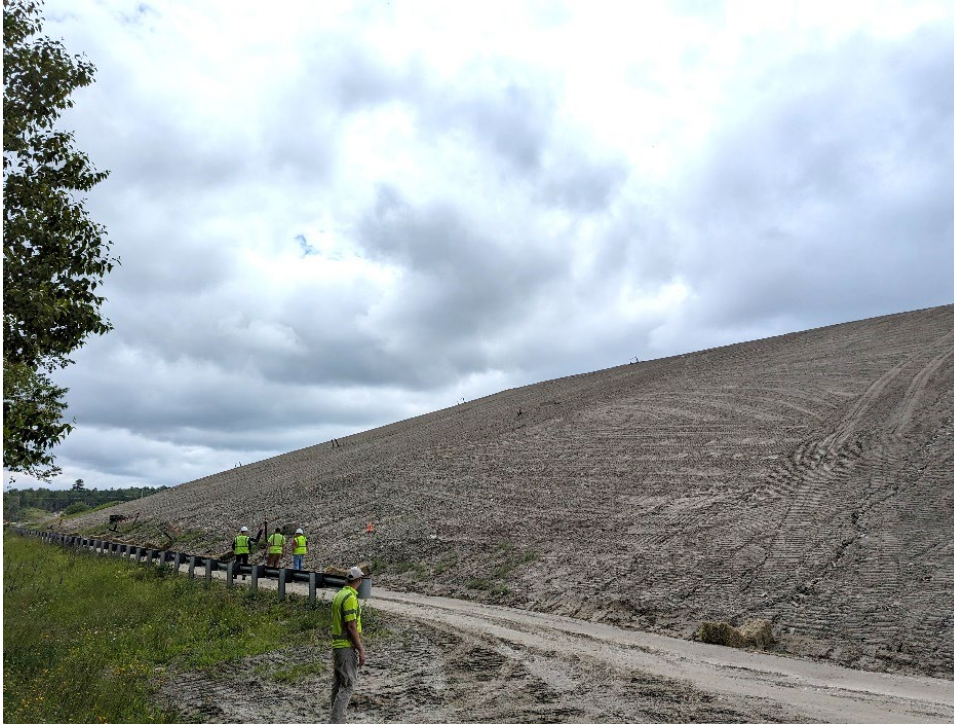
PXL_20240612_150815453: Cap 4 area with intermediate cover

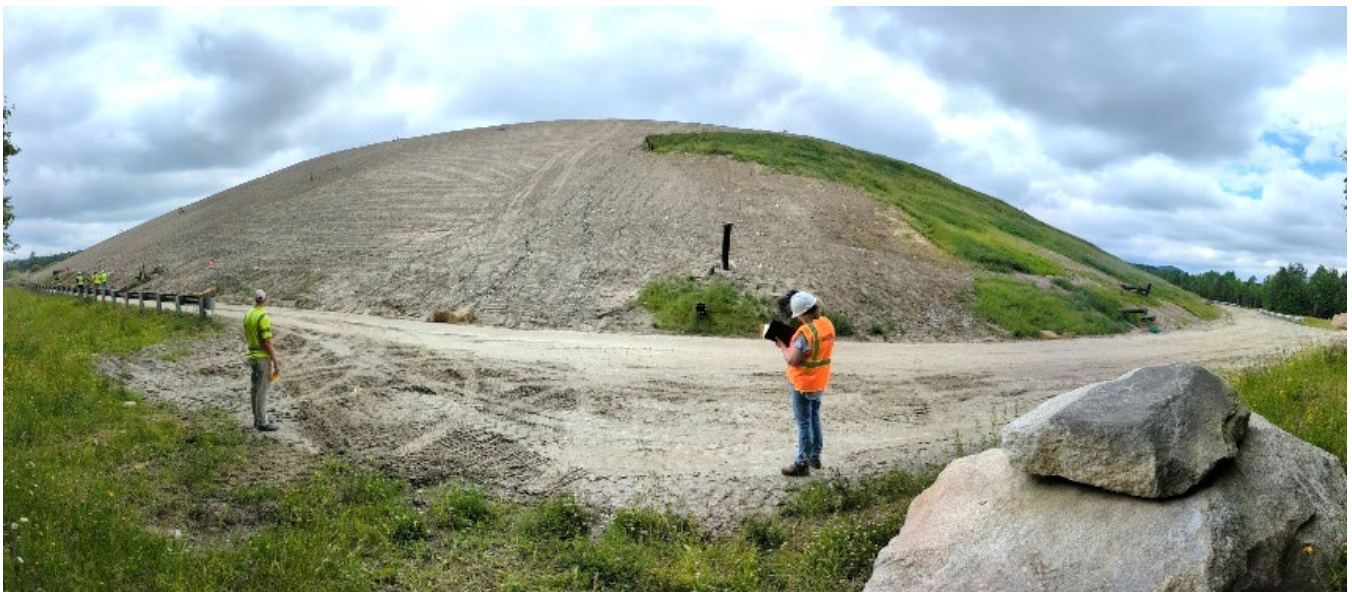
PXL_20240612_150844222PANO: Cap 4 area with intermediate cover

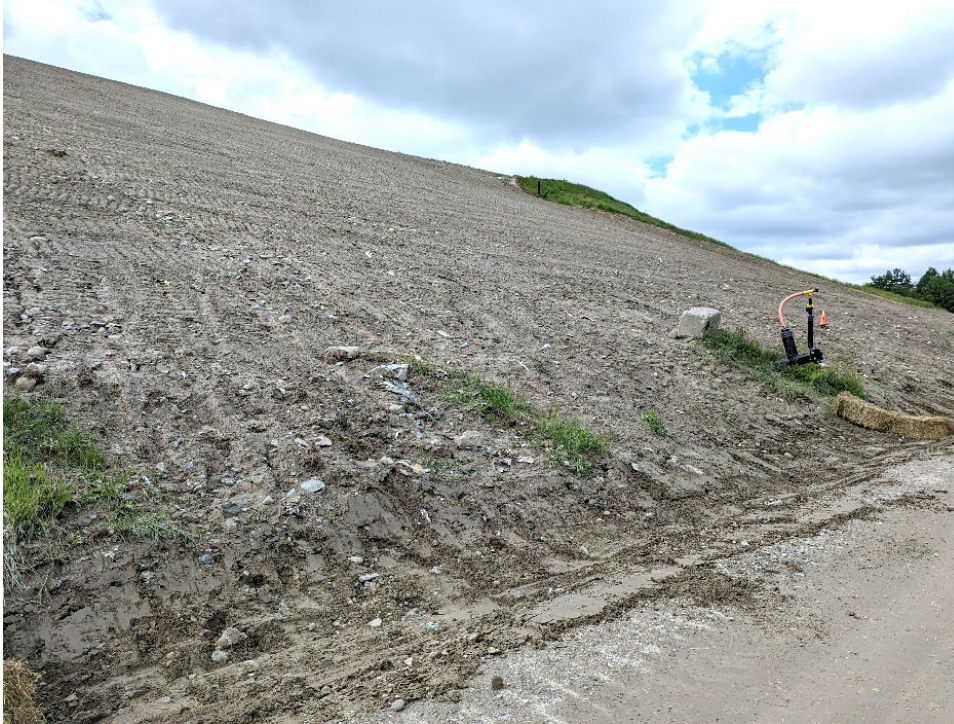
PXL_20240612_151001465: Cap 4 area with intermediate cover

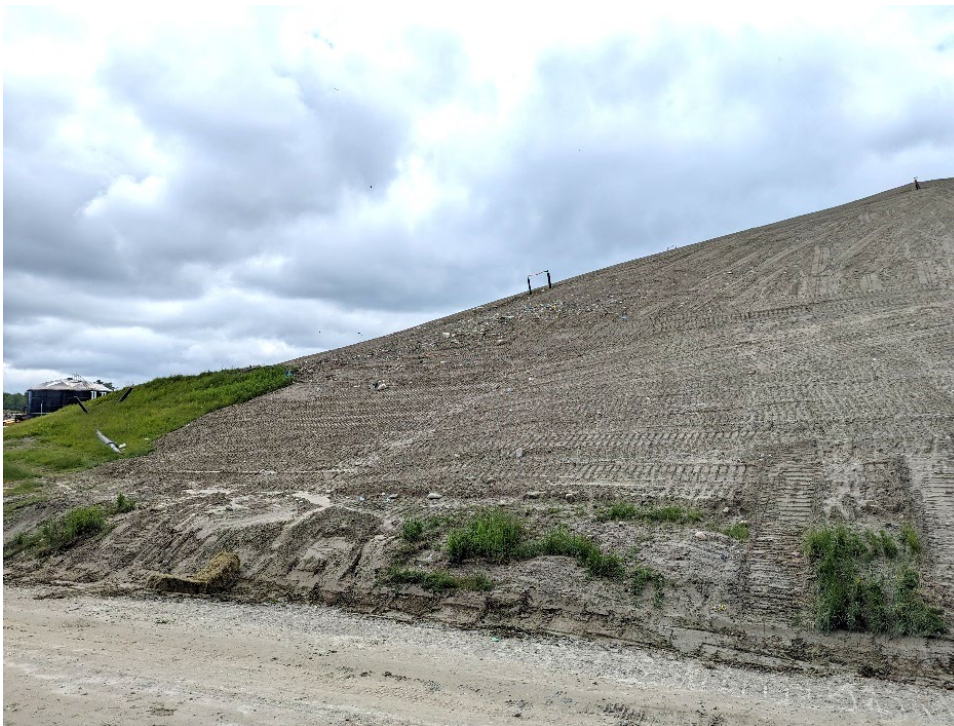
PXL_20240612_151157977: Cap 4 area with waste visible where gas header pipe was excavated and re-pitched

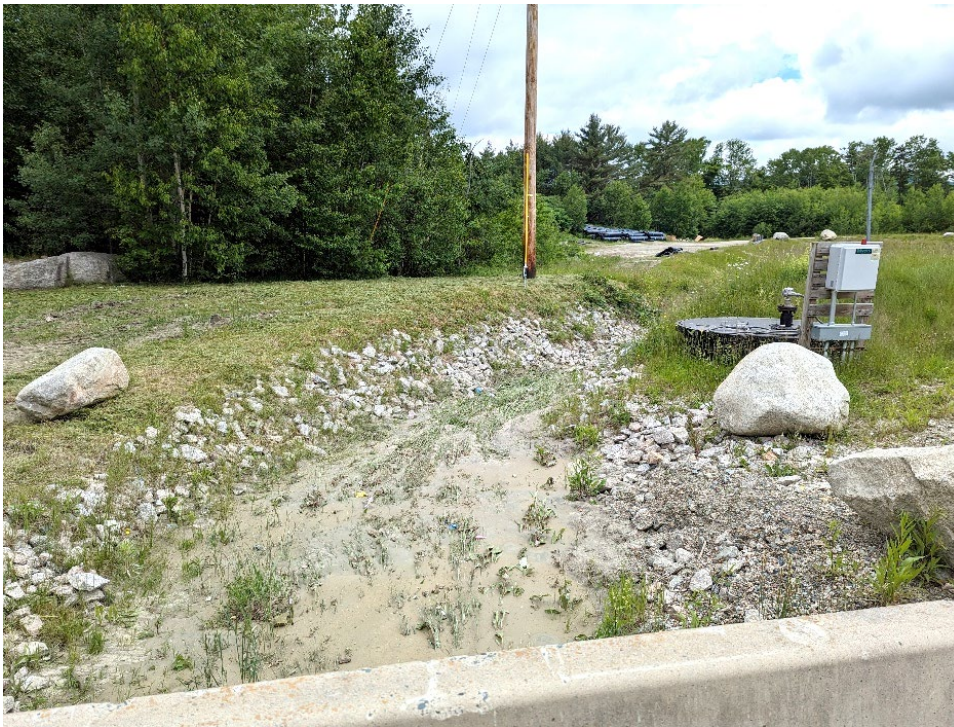
PXL_20240612_151932547: Stormwater swale near Cap 4 area

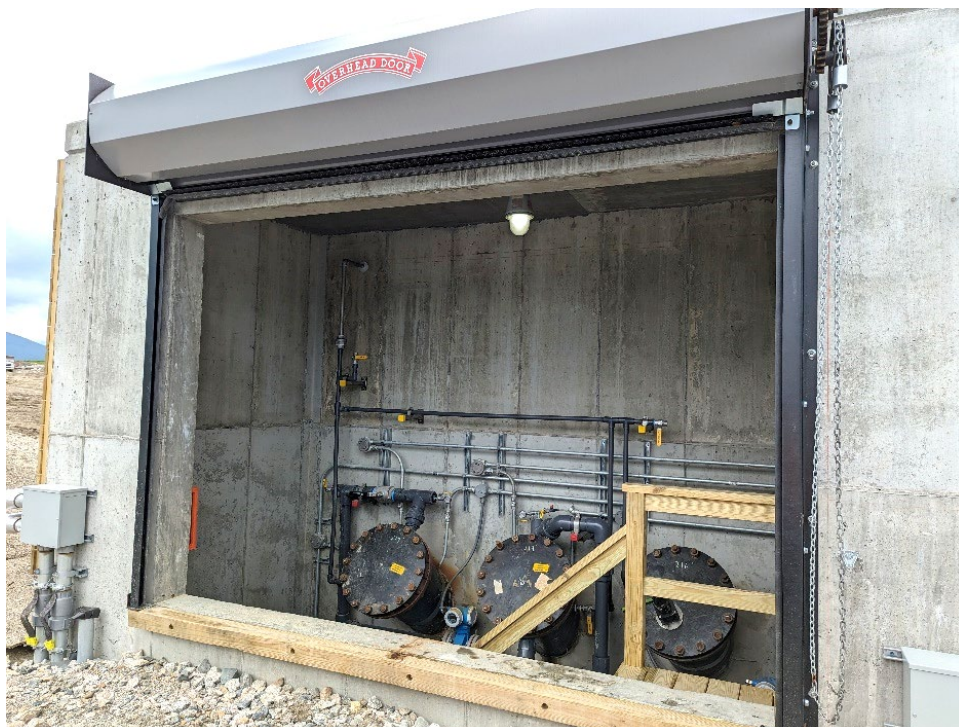
PXL_20240612_153108195: Pump Station No. 3

NHDES staff, Joe Gay, Kevin Roy, and Brett Deyling then proceeded to Pump Station No. 3, where Bruce Grover joined the group. NHDES asked several questions about the primary sump transducer that was recently replaced at this location. NHDES asked about the testing/calibration of the transducer before installation. NCES stated that the transducer was installed by the electrician, and they did not know what type of testing was performed before installation. NHDES also asked how NCES knew that the original transducer was malfunctioning. NCES stated that they observed that the pump would turn on, but there was no flow in the pipes (as noted by a liquid flowing noise). NCES staff also stated that the transducer was located about six inches above the sump floor, and they changed the automated switch for the pump to start when the transducer reads 20 inches. At the time of the site visit, NHDES staff noted the panel readout for the transducer to initially be at about 13 inches and the pump turned on when the transducer reading reached about 20 inches. The secondary sump transducer was reading 24.7 inches. See pictures below.

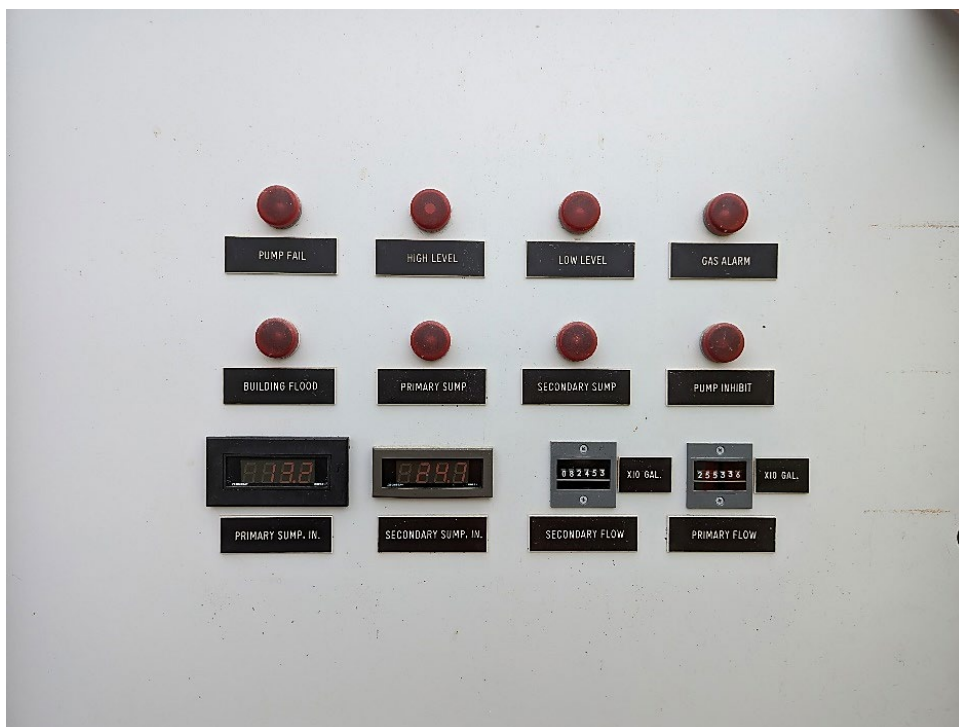
PXL_20240612_153857327: Pump Station No. 3 Panel Display
