STATE OF NEW HAMPSHIRE
INTER-DEPARTMENT COMMUNICATION

DATE: September 16, 2009
AT(OFFICE): P&DRS

SUBJECT: Stage 1 Phase 1 Anchor Trench Repairs/NCES/Bethlehem/
DES-SW-SP-03-002

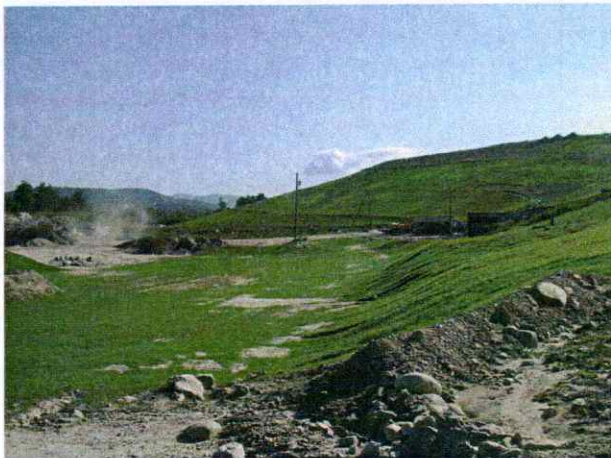
On Tuesday, September 9, 2009, Paul Gildersleeve and I visited the NCES landfill in Bethlehem to attend a Leachate Management Improvements construction meeting. Prior to the meeting, we were given a tour of the facility by Kevin Roy. Picture 1 shows the amount of soil that has been removed from the area between the old leachate loadout area and MW 402U & L.

Picture 1. This picture shows the area to the north of Stage 1 where the leachate loading tanks and area were formerly located.

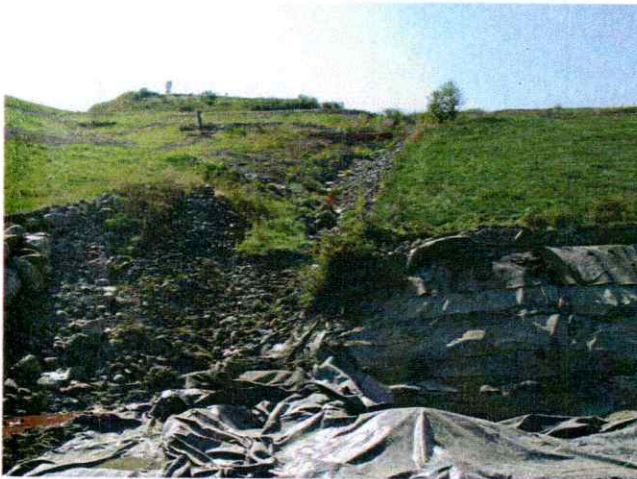
Kevin then proceeded to show us the area near the Stage 1 Phase 1 downchute. While removing the 36-inch culvert, Kevin saw landfill gas coming from the direction of the Stage 1 Phase 1 anchor trench. Upon removing soil from approximately 200 feet of anchor trench and exposing the geomembrane cap, Kevin noted that the cap was badly deteriorated. It had holes in it and the cap was not welded to the liner in this area.

Picture 2. This picture is looking up (south) the Stage 1 Phase 1 downchute. The excavated anchor trench is to the right.

He explained that his intent was to have CMA prepare a plan to replace the existing cap and to weld it to the liner.

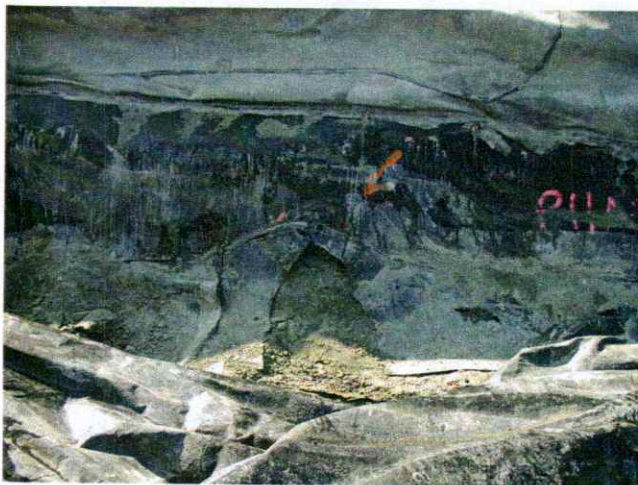
Picture 3. This picture is looking north at the Stage 1 Phase 1 anchor trench. Note arrow pointing out hole in geomembrane cap.

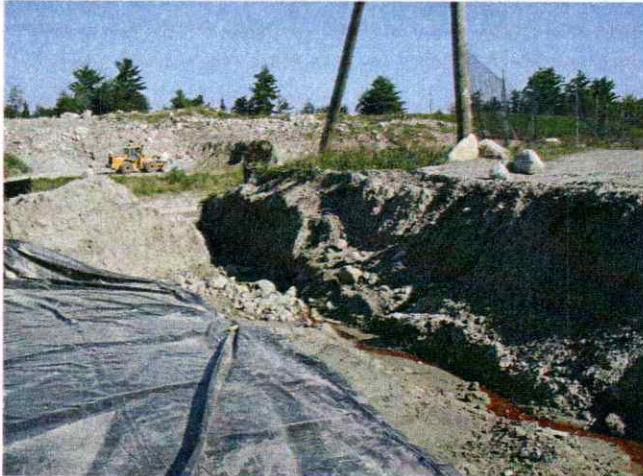
Picture 4. This picture is looking north towards MW 913M. The open trench is where the 36" culvert connecting the Stage 1 Phase 1 down chute to detention pond 3 was located.
