# Field Report

REPORT NO: 036 DATE: 06/04/13

North Country Environmental Services Landfill - Phase II-B

Bethlehem, NH

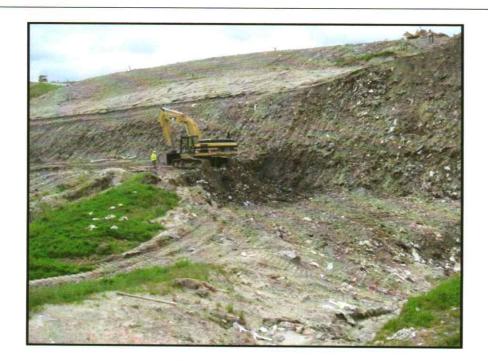
Waste Excavation - Looking South

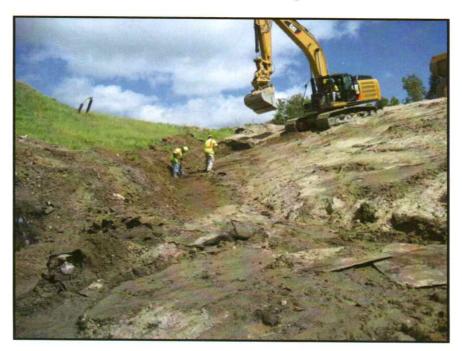
Uncovering Anchor Trench - Looking Southeast
