**LETTER OF DEFICIENCY**  
**No. WMD LOD 19-132**

**SUBJECT: North Country Environmental Services, Inc. Landfill**  
**581 Trudeau Road, Bethlehem, NH**  
**Solid Waste Permit No. DES-SW-SP-03-002**

**Inadequate Daily Cover**

<b>SOLID WASTE FACILITY INSPECTION REPORT</b>	<b>New Hampshire Department of Environmental Services Waste Management Division P.O. Box 95, 29 Hazen Drive Concord, NH 03302-0095 Phone: 603-271-2925 Fax: 603-271-2456</b>
---	---	--

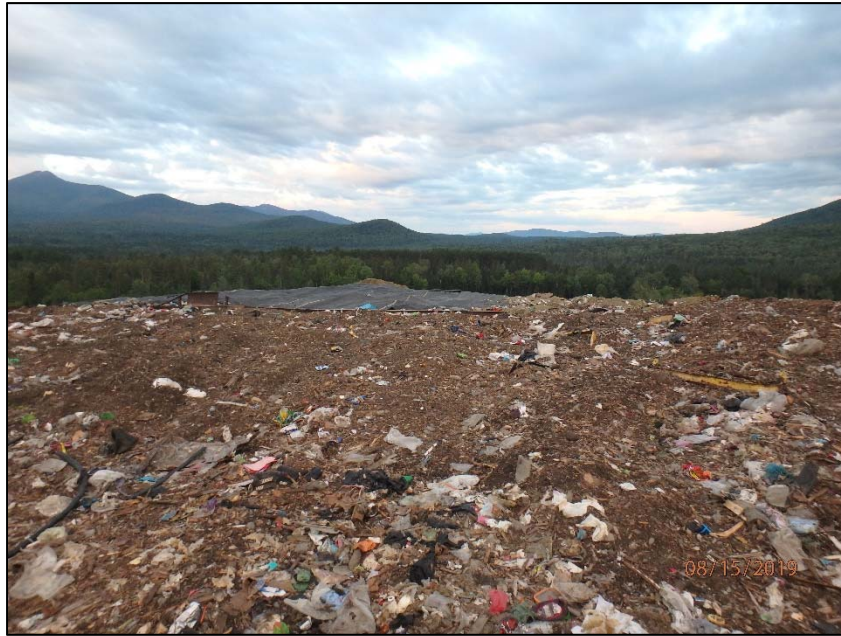
P8150001: Overview of the southern portion of Stage IV/Phase II, prior to the working face being uncovered. Looking west. The tarps present in the center of the photograph are the approximate location of a working face.

**Assessment:** NHDES personnel observed exposed waste during inspection of the working face located in the southern portion of Stage IV/Phase II (see Photographs P8150001 through P8150008), as well as the working face located in the southern portion of Stage V/Phase II (see Photographs P8150021 through P8150025).

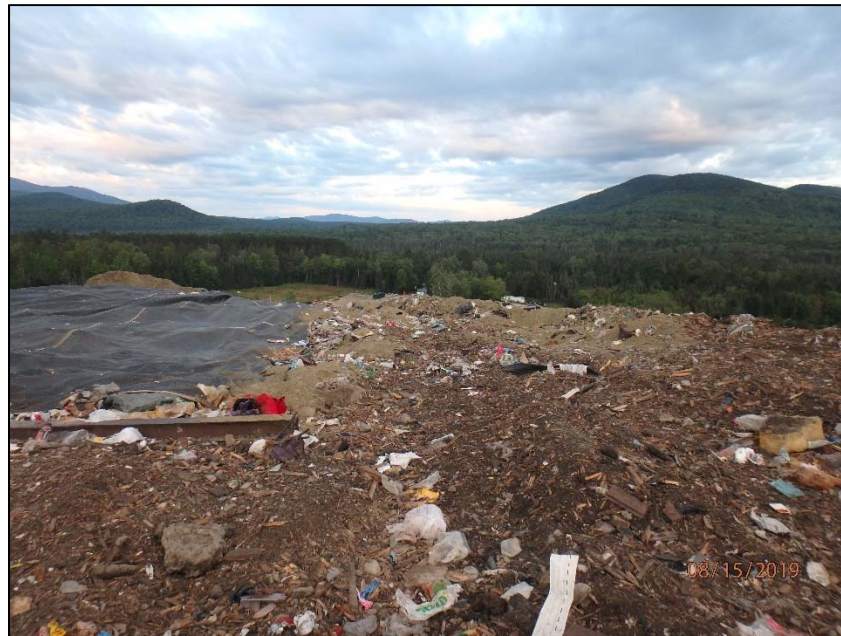
P8150002: Working face in the southern portion of Stage IV/Phase II, prior to the working face being uncovered. Looking west. Exposed waste is visible along the northern edge of the daily cover tarp.

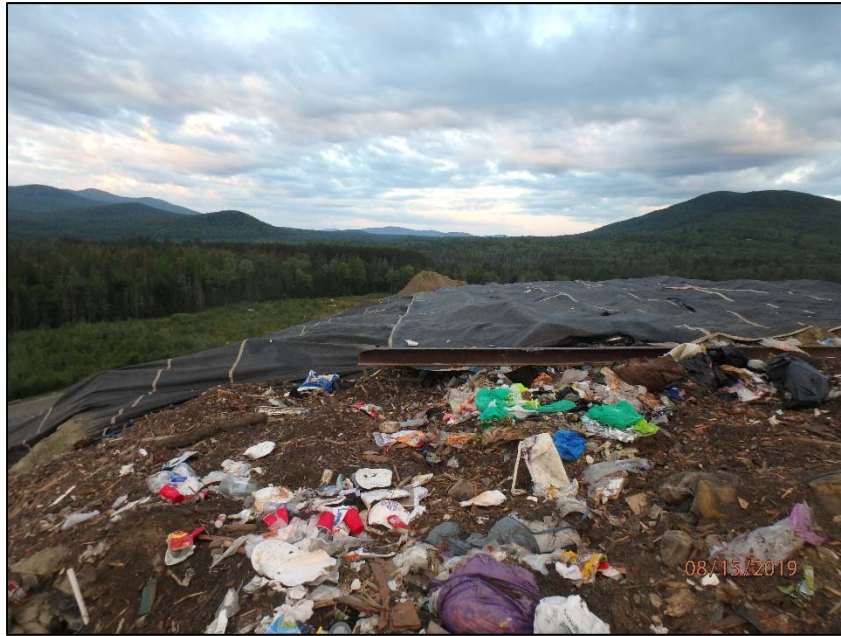
P8150003: Working face in the southern portion of Stage IV/Phase II, prior to the working face being uncovered. Looking west.

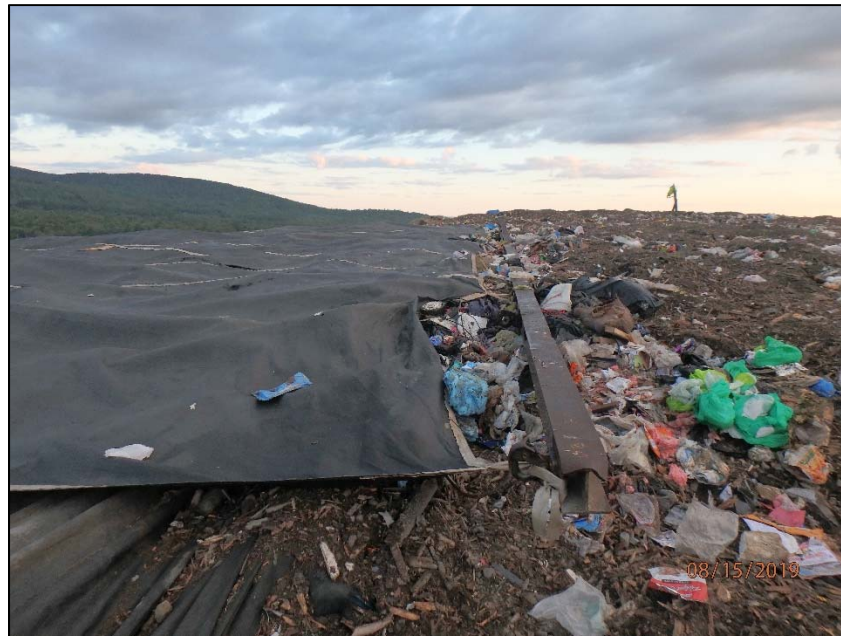
P8150004: Working face in the southern portion of Stage IV/Phase II, prior to the working face being uncovered. Looking north.

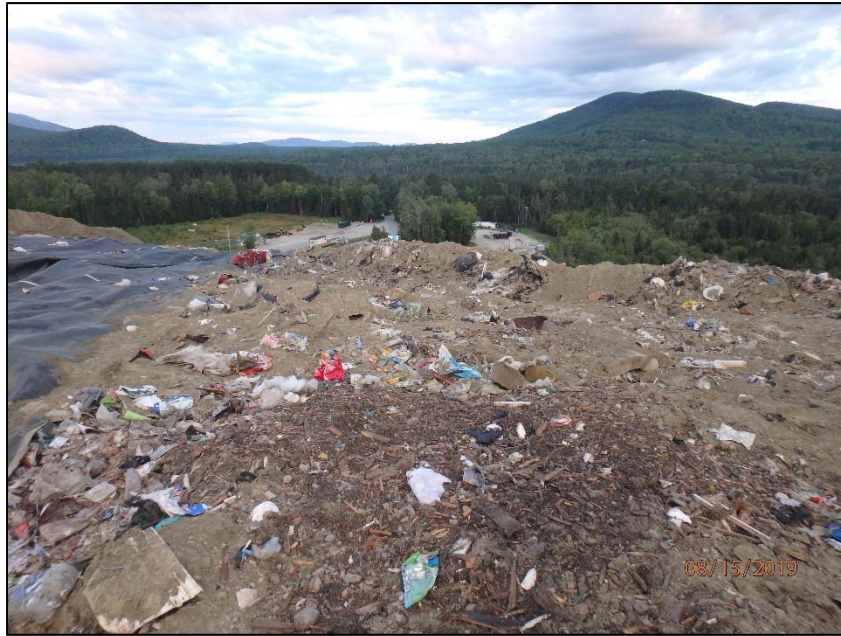
P8150005: Southern portion of Stage IV/Phase II, prior to the working face being uncovered. Looking west. Exposed waste is visible beyond the northern edge of the tarp.

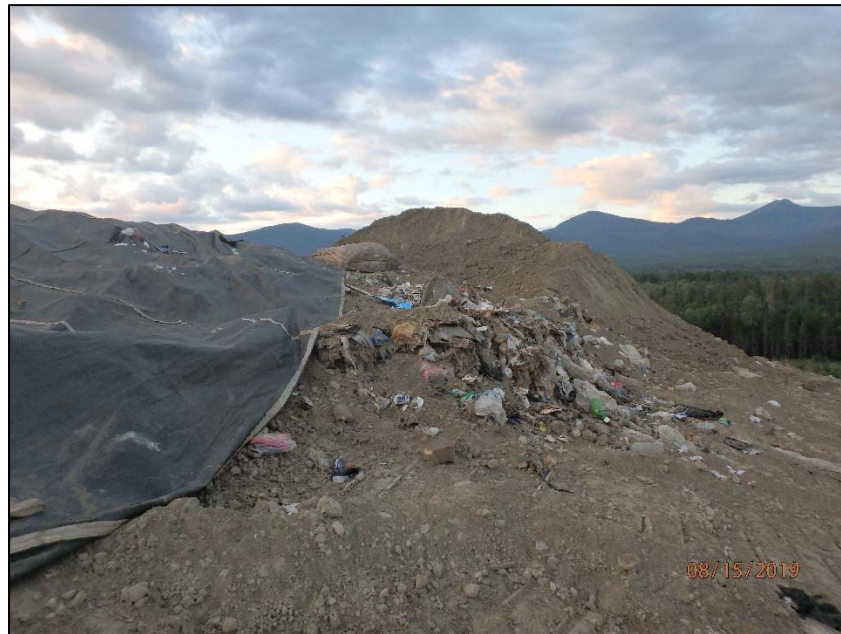
P8150006: Southern portion of Stage IV/Phase II, prior to the working face being uncovered. Looking south. Pile of soil cover mixed with debris present in the center of the photograph; pile of soil cover present in the background of the photograph.

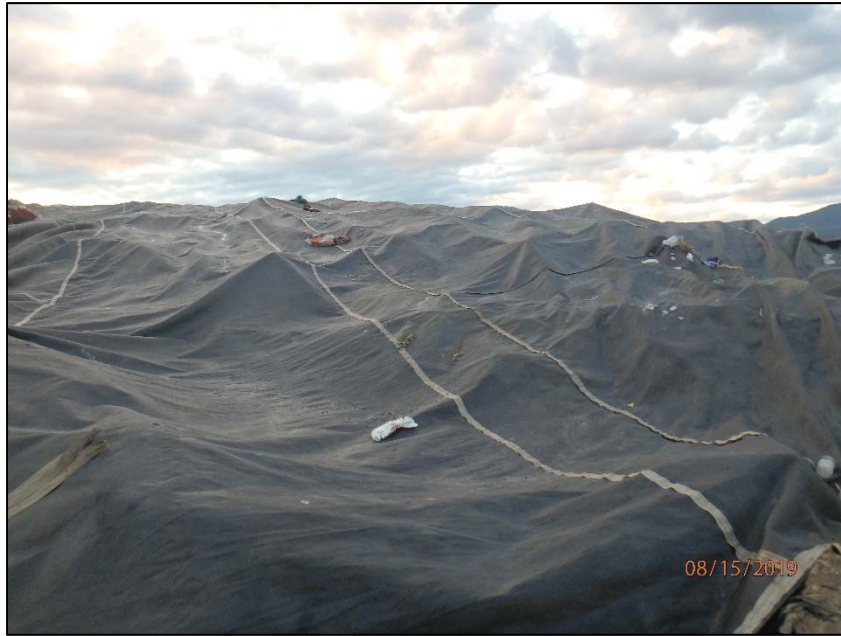
P8150007: Representative photograph of the tarp used as daily cover in the southern portion of Stage IV/Phase II, as viewed from the west and looking upslope in an easterly direction.

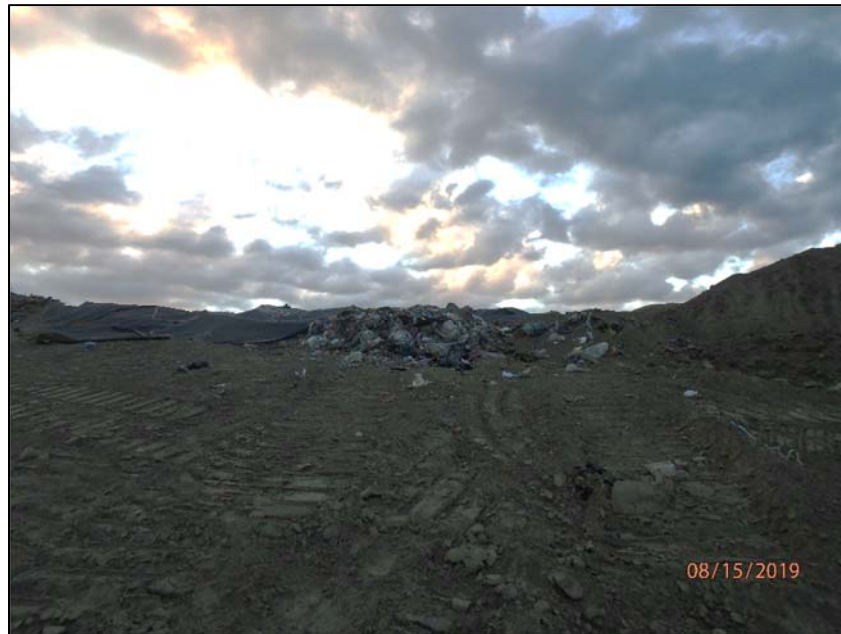
P8150008: Working face in the southern portion of Stage IV/Phase II, prior to the working face being uncovered, as viewed from the west and looking upslope in an easterly direction. Pile of soil cover mixed with debris present in the center of the photograph; pile of soil cover present on the right of the photograph.

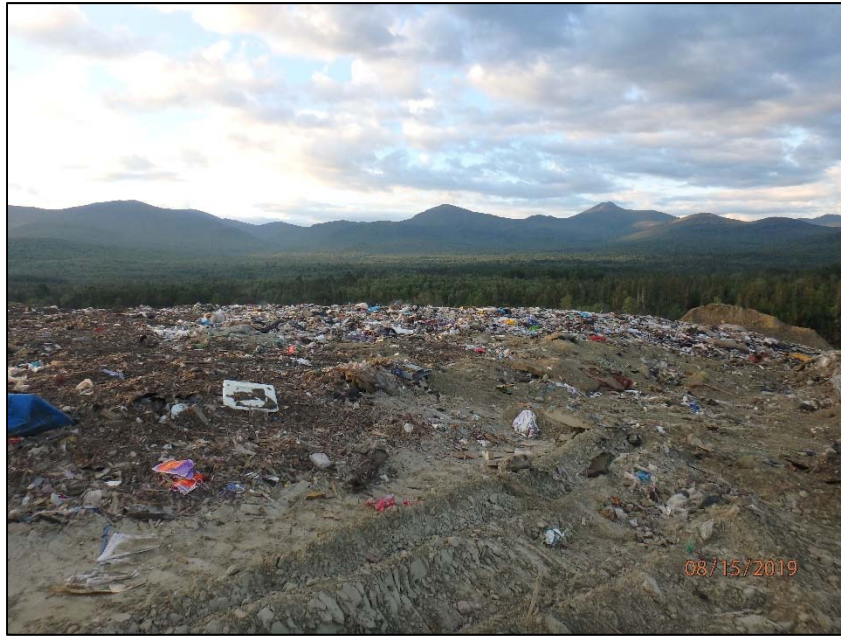
At approximately 6:30 a.m., NCES personnel removed the daily cover tarps from the working face in the southern portion of Stage IV/Phase II. Photographs P8150017 through P8150019 depict the condition of the working face following removal of the daily cover tarps. NHDES noted an overt odor upon removal of the daily cover tarps.

P8150017: Overview of the working face in the southern portion of Stage IV/Phase II following the removal of the daily cover tarps, as viewed from the north and looking in a southerly direction.

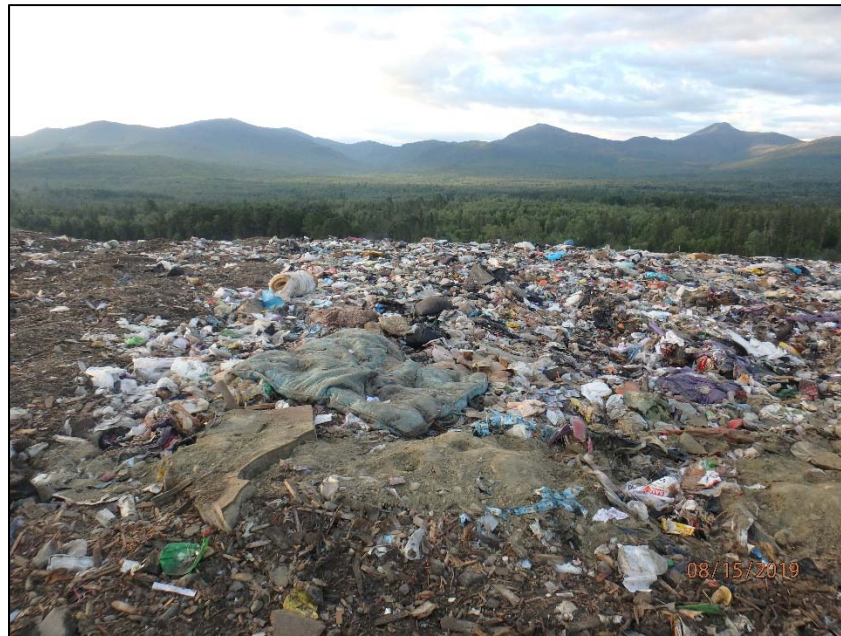
P8150018: Working face in the southern portion of Stage IV/Phase II following the removal of the daily cover tarps, as viewed from the north and looking in a southerly direction.

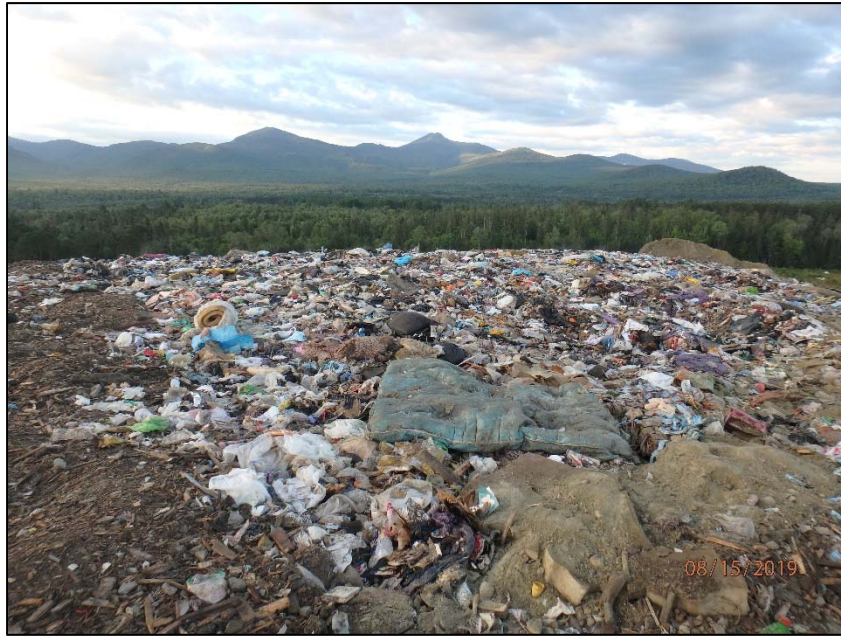
P8150019: Working face in the southern portion of Stage IV/Phase II following the removal of the daily cover tarps, as viewed from the north and looking in a southwesterly direction.

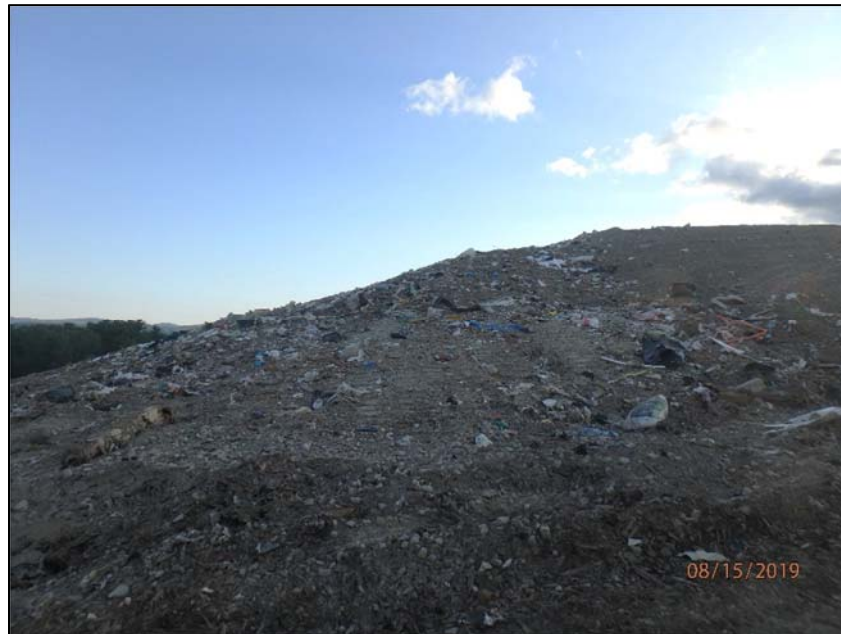
P8150021: Working face located in the western portion of Stage V/Phase II, as viewed from the south and looking in a northerly direction.

NHDES personnel also inspected the working face located in the southern portion of Stage V/Phase II. NCES staff stated that the last filling at this working face occurred approximately one week prior to the inspection, but that it had been approximately one month since filling in this area had occurred on a regular basis. As such, NCES personnel stated that a combination of daily and intermediate cover was being used in this area. During the inspection, NHDES personnel observed that soil, an approved cover material, was being used as daily/intermediate cover in this area. Additionally, NHDES personnel observed exposed waste throughout the area, as shown in Photographs P8150021 through P8150025.

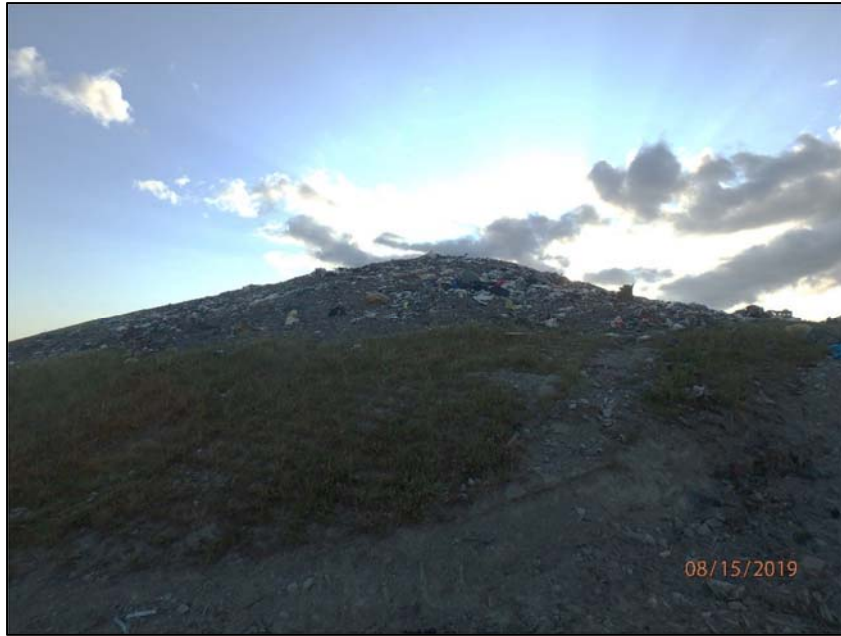
P8150022: Overview of the working face in the western portion of Stage V/Phase II, as viewed from the west and looking in an easterly direction.

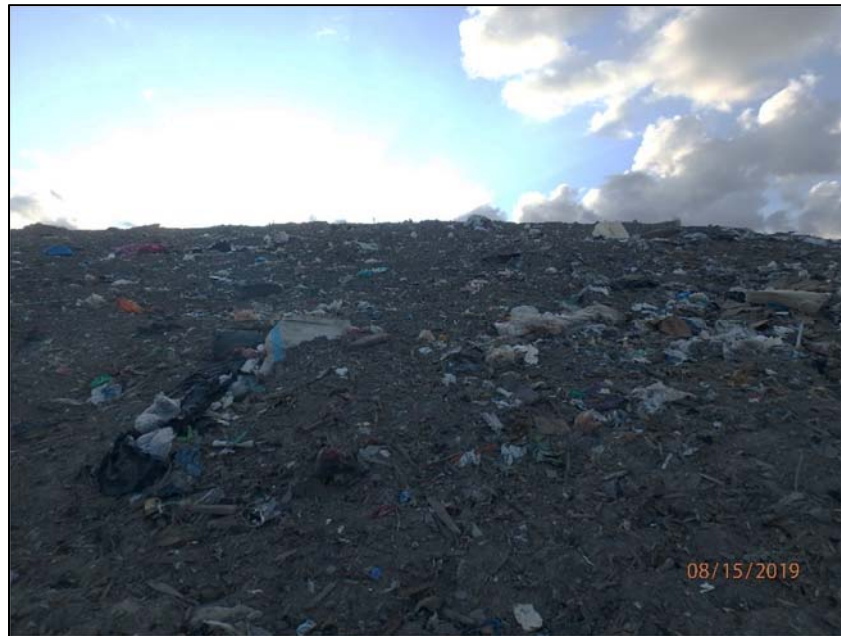
P8150023: Working face located in the western portion of Stage V/Phase II, as viewed from the west and looking upslope in an easterly direction.

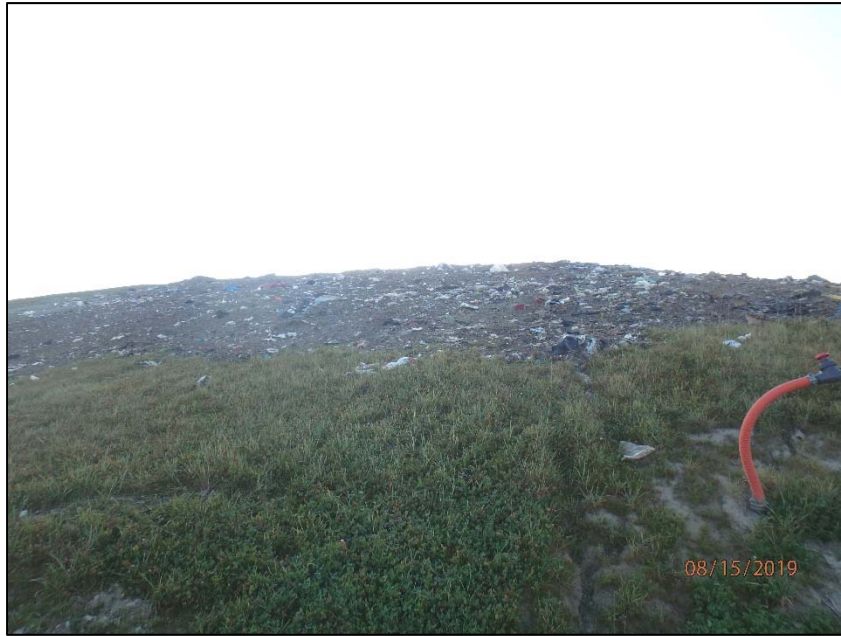
P8150024: Working face in the western portion of Stage V/Phase II, as viewed from the west and looking upslope in an easterly direction.

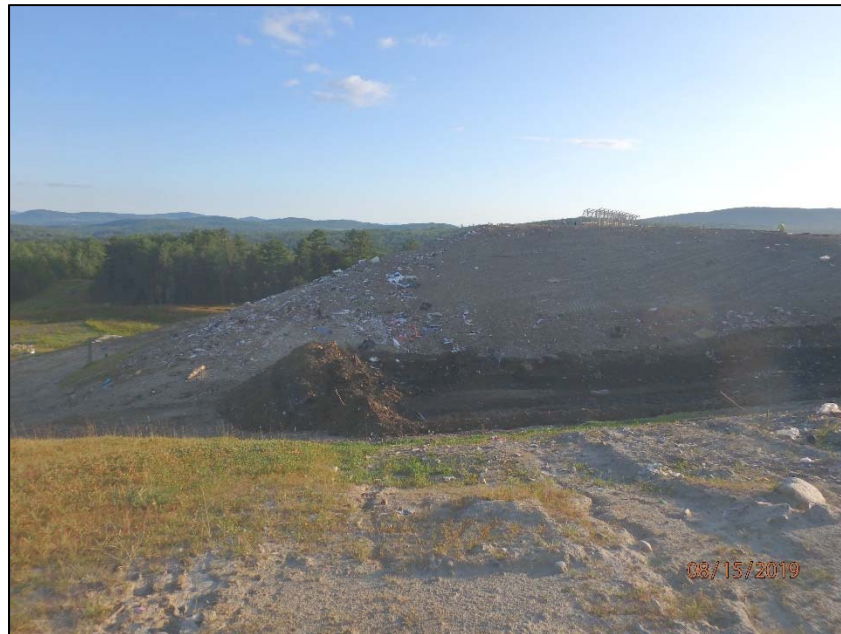
At approximately 6:50 a.m., NCES personnel removed a layer of cover material on the southern edge of the Stage V/Phase II working face to create room in which to deposit a load of sludge, as seen in Photograph P8150025. An overt odor was noted at this time, and was attributed by NHDES personnel to the disturbance of cover material and waste. Following the inspection of both working faces, NHDES personnel traveled the perimeter road of the landfill, and returned to the facility office at approximately 7:15 a.m.

P8150025: Working face in the western portion of Stage V/Phase II, as viewed from the south. Prior to this photograph, NCES personnel removed a limited layer of cover material on the southern edge of the Stage V/Phase II working face to create room in which to deposit a load of sludge.
