Subject: NH DES Landfill Facility Inspection - 11/2/2022

Solid Waste Facility Limited Inspection Report

A. GEN	ERAL INFORMATION			
Facility Name: NCES Li	ned Landfill Stage 4, 5, 6	Date of Inspection: 11/2/2022			
Permittee Name: North Country Environmental Services Inc. Nature of Inspection: 🗵 I			ıtine 🗆 Re-inspect	ion □ Requested □ Complaint	
Permit #: DES-SW-SP-0	03-002	•	•	·	
	rudeau Rd., Bethlehem, NH

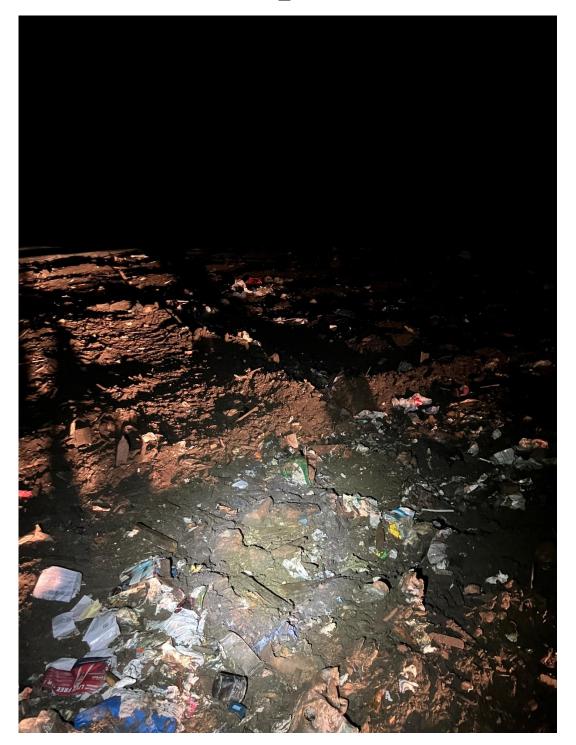
Photograph Information						
Date of Photographs	11/2/2022		Photographer	Austin Mills		
Camera Used	iPhone SE					
Photograph Number		Description				
IMG_1294		Tipping area uncovered waste				
IMG_1303		Tipping area uncovered waste				
IMG_1298		Base of geosynthetic tarping system with intermediate cover mixed with waste				
IMG_1299		Base of geosynthetic tarping system with intermediate cover mixed with waste				
IMG_1302		Gap in geosynthetic tarping system

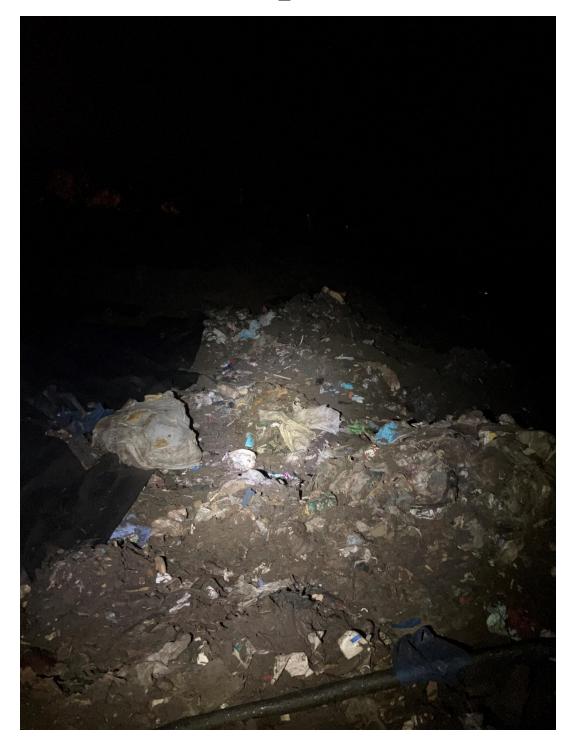
Area #1: Downslope from the termination of geosynthetic tarp coverage, there were small berms of primarily intermediate cover material containing intermixed wastes observed. These berms were beyond the reach of the geosynthetic tarping used as daily cover and did not appear to be covered otherwise. The wastes appeared to have been uncovered and mixed with intermediate cover during prior cover stripping operation in order to cond subsequent lifts. The berms were intermittent in nature and did not span the whole width of the active area.					
	Area #2: There was a single gap in the geosynthetic tarping syst applied to this waste.	em measuring approximately 3 feet by 10 feet. N	No cover material was observed to be			
	Area #3: The tipping area from the day before was discovered to contain some small areas of waste not exhibiting application of cover material.					
Corrections: Beginning daily on 11/7/2022 and continuing through 11/11/2022, please submit to the email below evidence of complete daily cover application to all wastes landfilled during the previous working day.		Deficiency Correction Due By:
