July 8, 2013

**RE: North Country Environmental Services, Inc., Trudeau Road, Bethlehem, NH
Stage IV Phase II-B Landfill Expansion
Leak Detection Flows/Repair Summary
Permit #: DES-SW-SP-03-002
CMA #865-B.2**

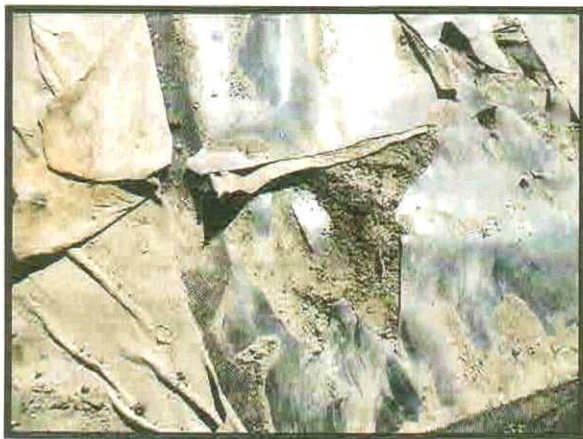
Location 1

<u>Location</u>	<u>N</u>	<u>E</u>	<u>Elev.</u>	<u>Description</u>
1	641149.94	994013.24	1347.39	2' x 4' Stage I Phase III – Thru primary & secondary
2	641144.27	994006.81	1347.56	2' x 4' Stage I Phase III – Thru primary & secondary

The observed damage at locations 1 and 2 was immediately inboard of the Stage I Phase III anchor trench on the uppermost portion of the landfill side slope where the expansion ties into Stage I Phase III. It appeared the damage occurred prior to Stage IV Phase II construction, likely during construction, operation or closure of Stage I. Waste was not located over these locations as the limits of Stage I waste had been offset from the anchor trench to provide freeboard and to accommodate cap construction. As such, these damage locations had not been exposed to leachate, or essentially even any clean water, due to their location at the top of the cell side slope. These damaged areas had subsequently been sealed by the final Stage I cap. Prior to Stage IV Phase II construction, therefore, the previous damage in Stage I did not result in measurable flows in the leak detection system or leakage from the landfill.

Second, 2011 construction removed the Stage I cap from the area over Stage I Phase IV. Damage areas 1 and 2 are located within the ponded water area and within or immediately adjacent to the area where the cap was removed. Damaged areas 1 and 2 therefore became exposed to a steady supply of free water from clean runoff due to this temporary interim construction condition. The removal of the cap over Stage I Phase III in May 2013 further exposed the damaged area to ponded stormwater and saturated conditions.

Damage locations 1 and 2 were repaired by replacing the primary and secondary liners with new Stage IV Phase II-B liners. The new liners were extended down slope over the damaged areas and tied into competent Stage I liner. As shown on the Primary and Secondary Liner Plans in the Stage IV Phase II-B Record Drawings, primary liner panel P-2 and secondary liner panel S-26 were extended to the north to cover and replace these damaged areas.

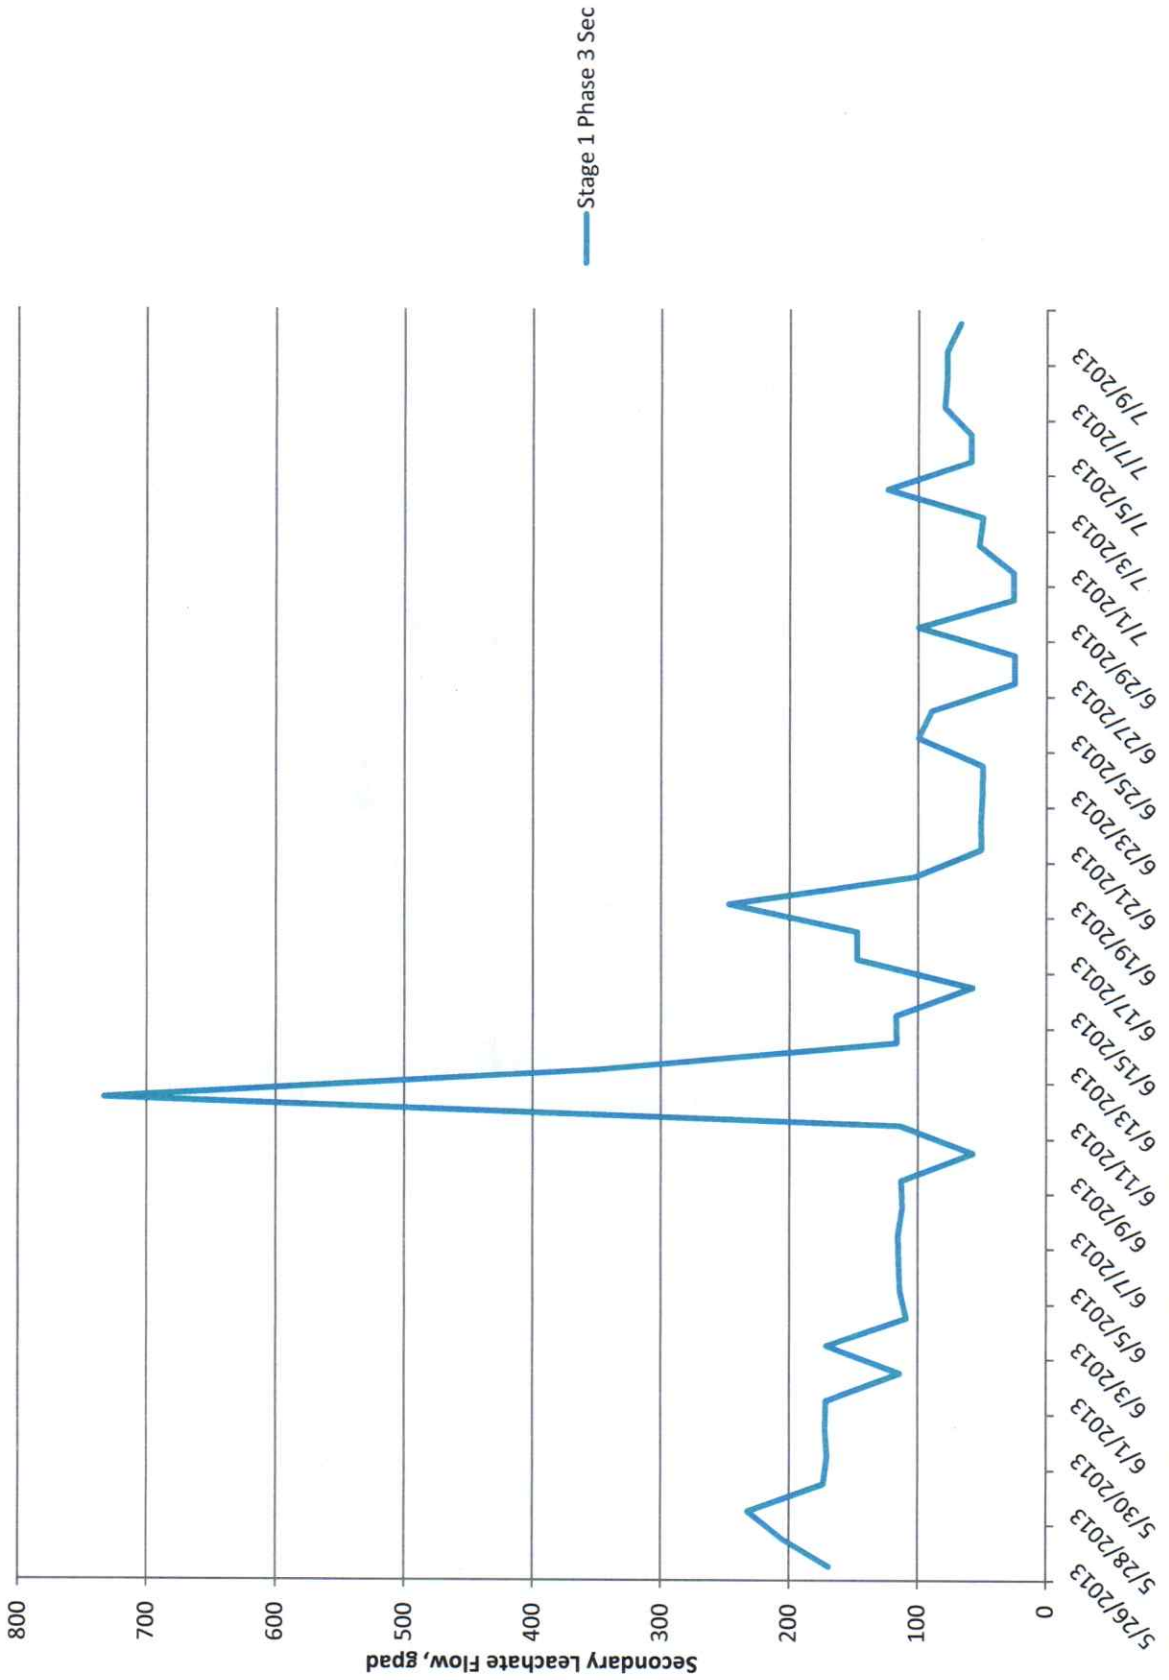
Stage 1 Phase 3 Secondary Flow, GPAD

A summary of recent Stage I Phase III leak detection flows is attached. As indicated in the attachment, elevated leak detection flows have been recorded during construction as the lining system was uncovered and the area was exposed to heavy rainfall. In particular, from June 5 through June 19, the Stage I Phase III leak detection system was open to precipitation to facilitate Stage IV

Phase II-B liner construction and tie-in. All stormwater within the southern construction area drained into the leak detection system during this time interval. This also was a period of heavy precipitation as evidenced by Stage I Phase III leak detection flows generally exceeding 100 gpad and peaking at 733 gpad. The leak detection system was re-sealed on June 19 with the completion of the primary liner tie-in.

Stage I Phase III leak detection flows have subsequently lessened and are trending downward. As the leak detection system was likely flooded during the previous weeks by construction-phase stormwater, it may take some time for the various components of the system, such as the drainage sand, to drain. NCES will continue to monitor leak detection flows until the Stage I Phase III sump is decommissioned. This is scheduled to occur later this month.
