Energy Savings through Pump Refurbishment and Coatings

by Karen Verosky, Henkel Corporation (Loctite) and Paul Maier, Randy White, Steve Connell, Kurt Knoll,

Pumps & Systems, November 2008

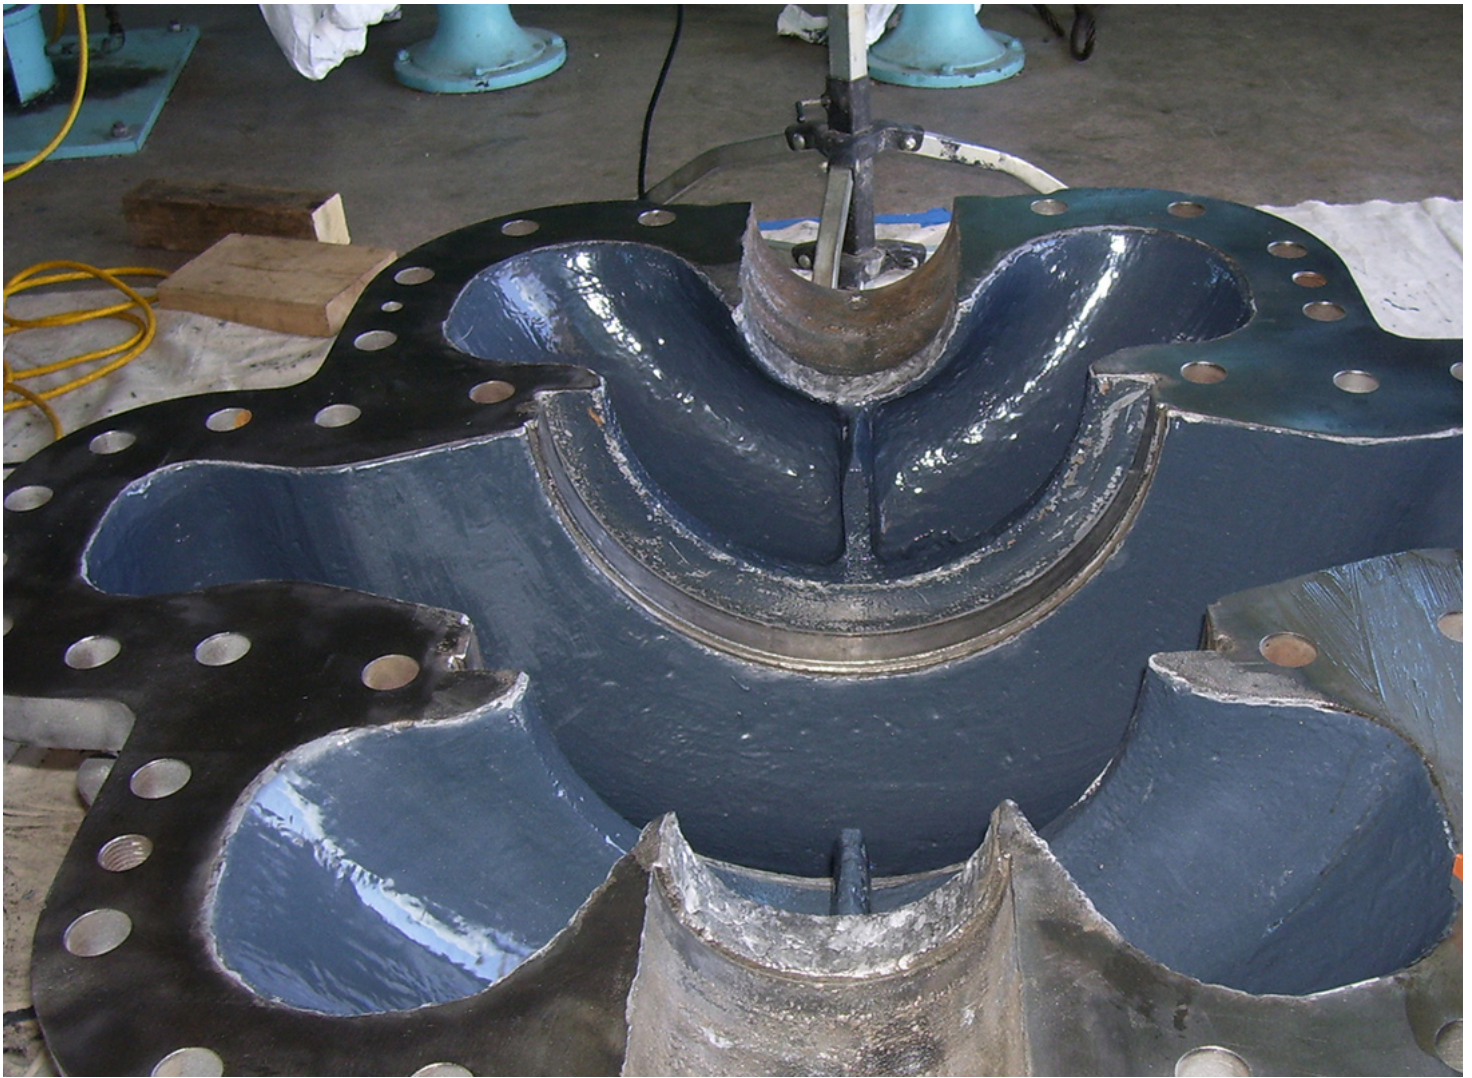
Figure 2. Pump interior after coating with brushable ceramic epoxy

The MCWA team started by filling in any deep pitted areas or gouges with a metal-filled epoxy and allowed that to cure before applying two 15-mil thick coats of brushable ceramic. Although inexperienced with these epoxy products, the team found them generally easy to apply, although it was initially difficult to be neat on the larger pumps. In addition to using short nap brushes and rollers designed for epoxy application, they also found inexpensive items such as household scrub brushes attached to broom handles ideal tools to reach into and apply the coating to the interior of the larger pumps, especially large double volute pumps.

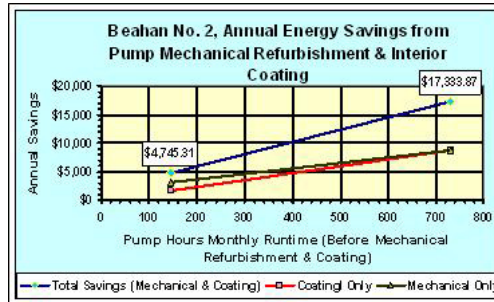
Figure 3

Energy analyses also revealed that mechanical refurbishment alone could only achieve about half of the total potential energy savings of a pump compared to what could be achieved if the pump was sandblasted and coated in addition to being mechanically refurbished. This is illustrated by the results for MCWA's Beahan No. 2 unit (see Figure 3)

Beahan No. 2 pump is a 300-hp pump located at a key pump station in the MCWA's distribution system. Installed in 2000, this pump had a manufacturer's stated efficiency of 88 percent at the pump's best efficiency point (BEP), pumping 6000-gpm at 150-ft of head. By 2006, pump efficiency at the BEP had dropped to 77.8 percent. The pump was first sandblasted and coated, which increased pump efficiency at the BEP to 85.2 percent (an increase of 7.4 percent). Mechanical refurbishment increased efficiency at the BEP an additional 2.8 percent, which brought the pump back to original manufacturer's specifications.

As with all pumps, total energy savings resulting from mechanical refurbishment and coating efforts are dependent on the total hours a pump operates. If the Beahan pump operated more or less continuously before any work was performed on it, the combined effect from mechanical refurbishment and interior coating on reduced energy use through increased performance and efficiency would result in more than \$17,000 in annual energy savings (assuming energy costs of \$0.085/kWh and \$10.00/kW demand charge). Kilowatt hours (kWh) consumption would be reduced by approximately 82,000-kWh annually (the equivalent of the total annual greenhouse gas emissions of 11.8 passenger vehicles).

As shown in Figure 3, it was also calculated that half (\$8,500) of the savings could be attributed specifically to sandblasting and coating-savings that would not have been achieved if the pump had only received the traditional mechanical refurbishment. The MCWA team estimates that if all of its 100+ pumps were mechanically refurbished, sandblasted and coated, the MCWA could realize energy cost savings in excess of several hundred thousand dollars from its \$4 million annual energy budget.
