Case Study 1

Location: SEZ, Dahej, Gujarat

Customer Category: Specialty Chemical Manufacturer & Exporter

Problem Statement

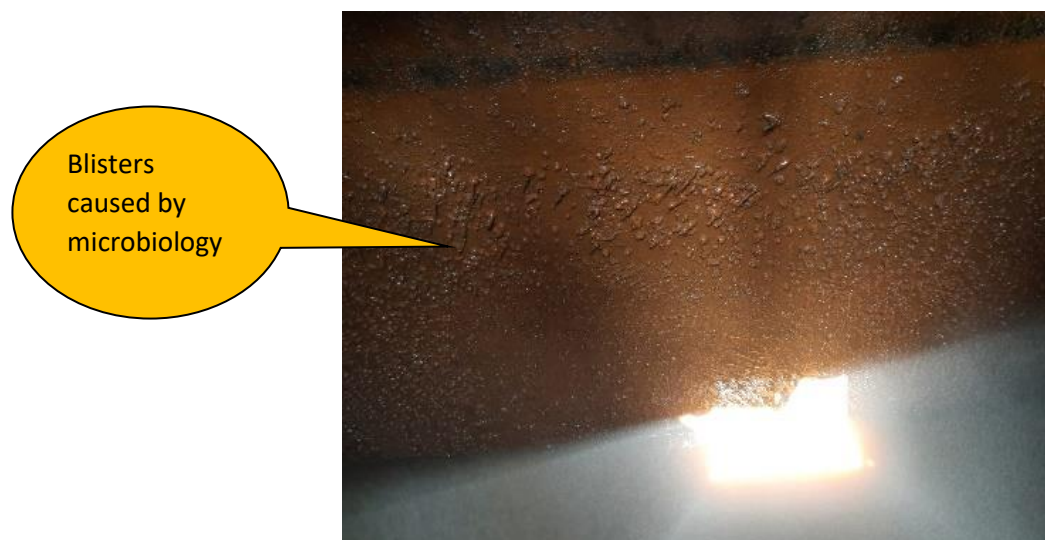
- Based on the details provided & observed, COP calculated was to be 2.94
- Strainer was full of iron chips.
- Chilled water tank was corroded due to MIC. Blisters were observed.

- Corrosion was also due to caustic attack also as caustic was being used to elevate pH in circulating water.
- Water parameters were as follow:

It was summarized that strainer was being choke because of iron chip and there was severe corrosion because of poor water treatment quality and ineffective water treatment program.

Precleaning and passivation was carried out which was followed by regular water treatment program.

- Regular chiller and cooling water treatment shall be carried out which take care of all water born issues of corrosion, scale, deposit, and microbiology. In absence of effective regular treatment, corrosion is likely to reoccur.
- Filter shall be installed to minimize the fouling in the system caused by inlet water from plant.
- Treatment program shall be regularly monitored and adhered to.
- Imparting the training is also highly recommended.

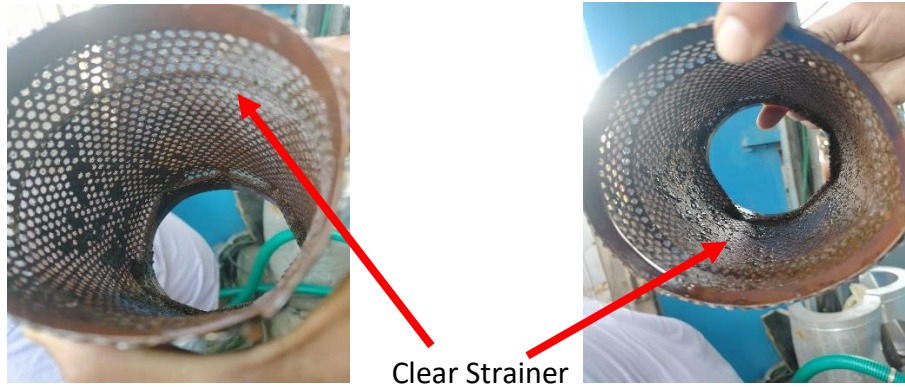
- Pump strainers were clean; minor particles were observed. Prior to P & P activity, strainers had to be cleaned every day at least once. Refer to the picture.

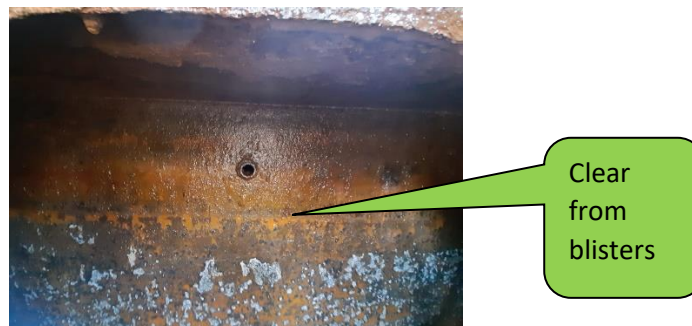
- Tank walls were clean from blisters caused by microbiology. Refer to the picture.

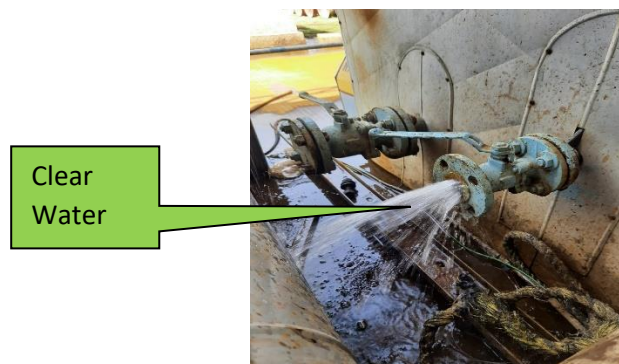
- Water was clear with turbidity less than 20 NTU. Refer to the picture.
