**Residential Home Inspection Report for
Your Name**

Inspection Address: 100 Your Lane, My Township, NC 27540-8441

Inspection Date: May 18, 2017

Supplemental Aerial Roof Inspection Observations

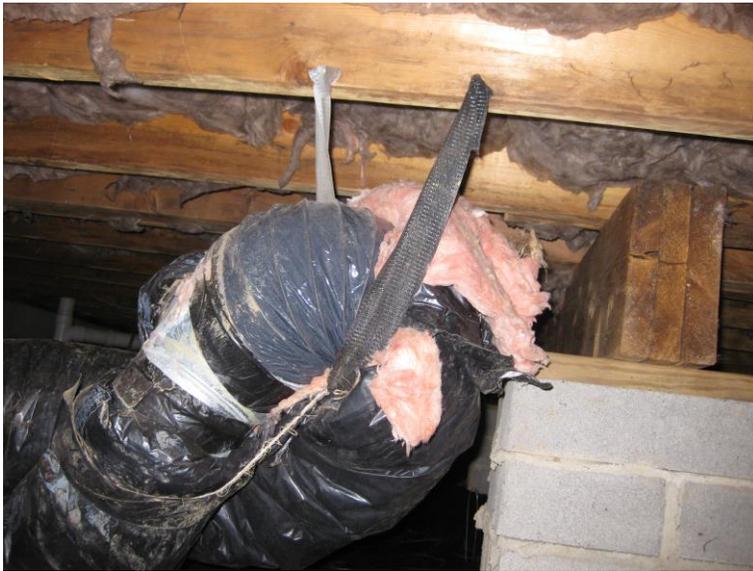
Flexible insulated ducts in crawl space are damaged, sagging or loose from hanger straps and/or separated from the metal distribution boxes. This condition results in inefficient use of the HVAC system preventing proper conditioning of living spaces of the property and increase consumption of energy

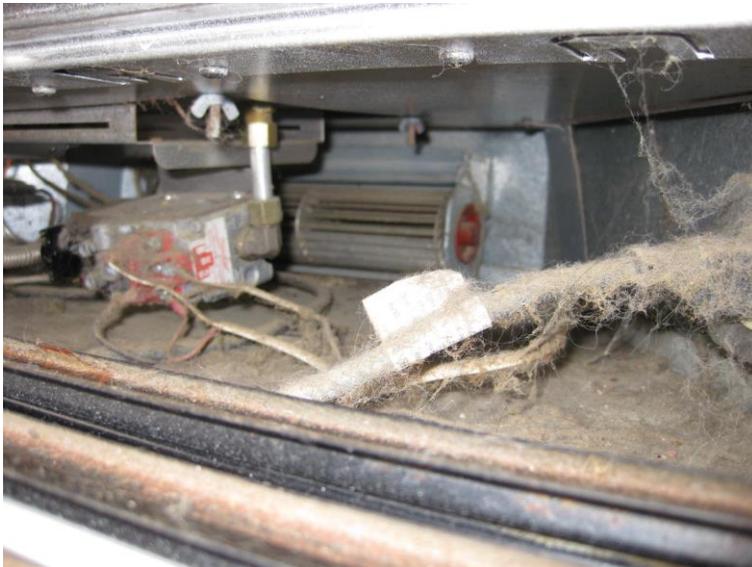
NG fireplace mechanical chamber is dirty and in need of cleaning. Existing condition may result in spontaneous ignition of dust and dirt. It is recommended for the mechanical chamber to be cleaned by a professional in the business before the use of the fireplace

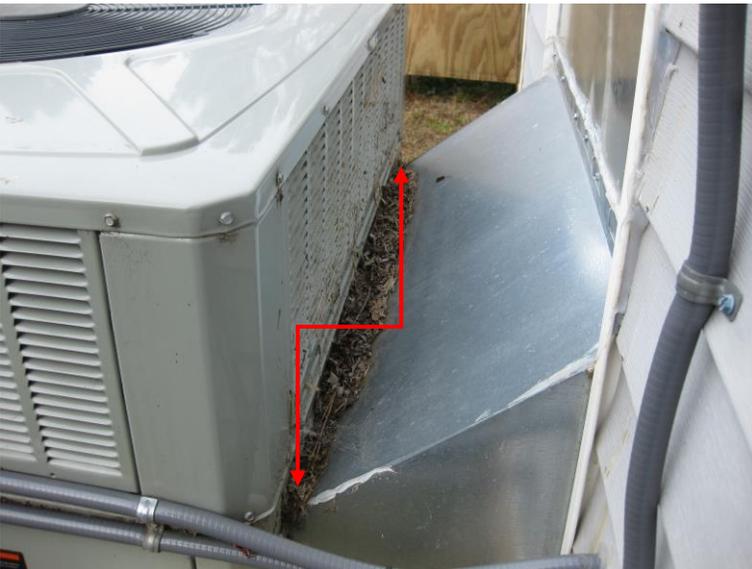
The exterior HVAC system as well as the NG premanufactured fireplace exhaust flue shall be checked and cleaned of dry vegetative debris prior-and-during heating season to prevent spontaneous ignition of dry vegetative debris accumulated above device

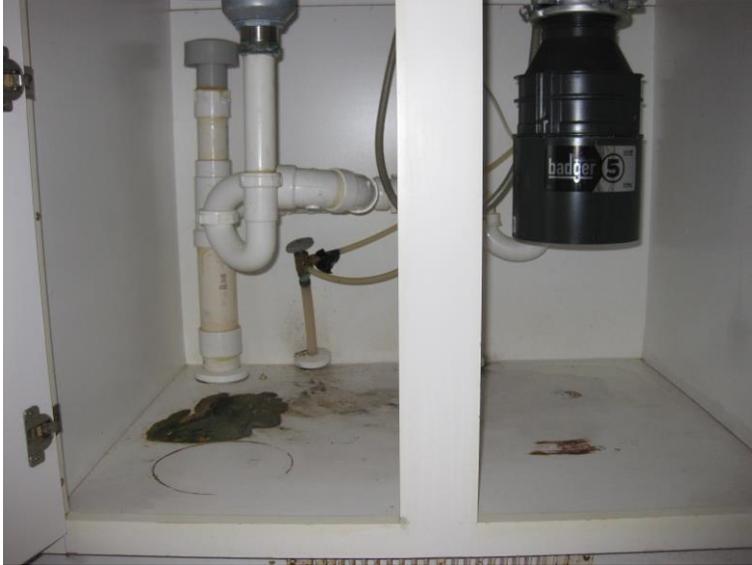
Cabinet below kitchen sink has water stains and bacterial growth. This is possible indication of a prolonged water leak from the drain or water supply. Condition could not be inspected due to lack of water supply to the residence during inspection. Recommend a professional in the business inspects and repair condition

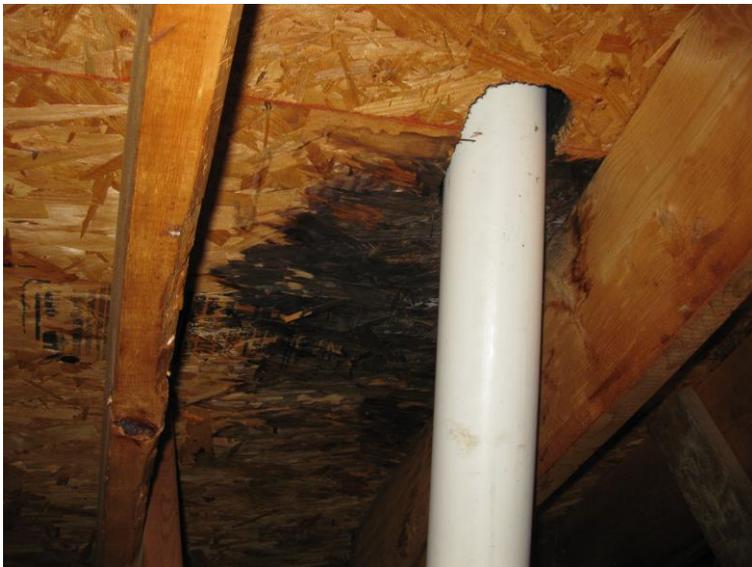
There is bacterial growth noted below the PVC vent in rear of the attic. Condition is indicative of water infiltration from the roof system. It is recommended to have a professional in the business inspect conditions and repair/replace accordingly

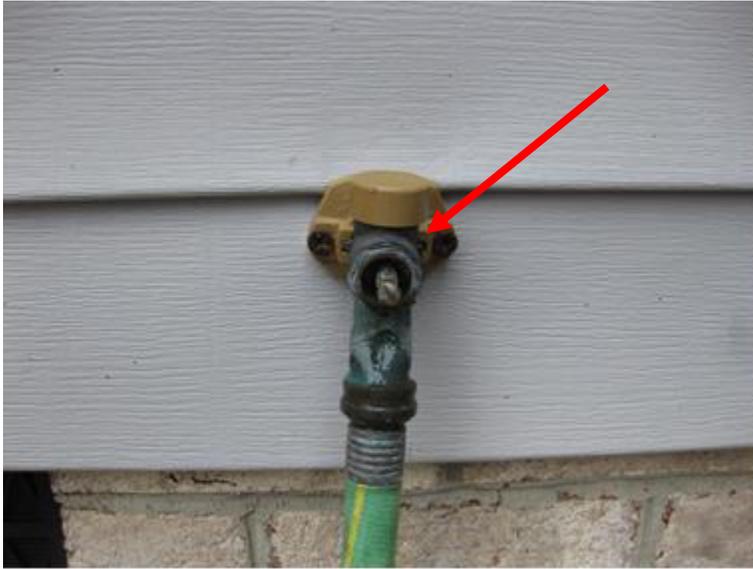
Exterior front water faucet is missing knob making opening and closing the faucet difficult. Recommend a professional in the business inspect and repair as necessary

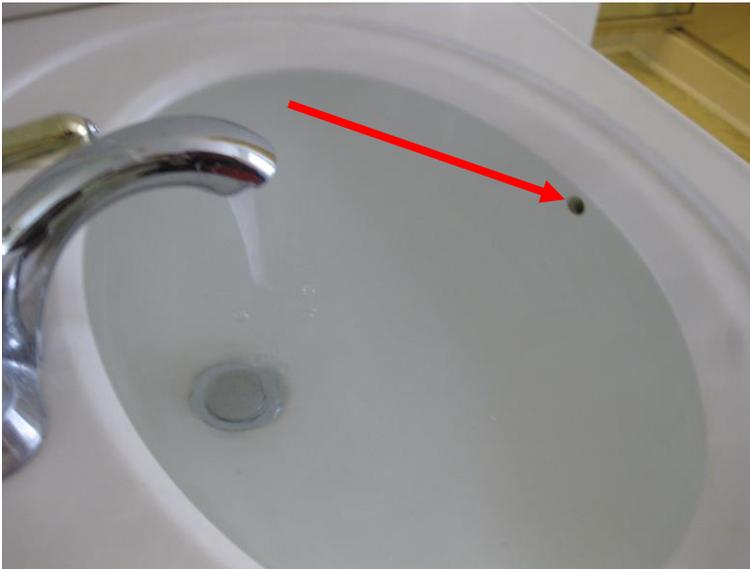
Bathroom sinks' secondary drains do not function as intended and need to be unclogged to prevent accidental overflow

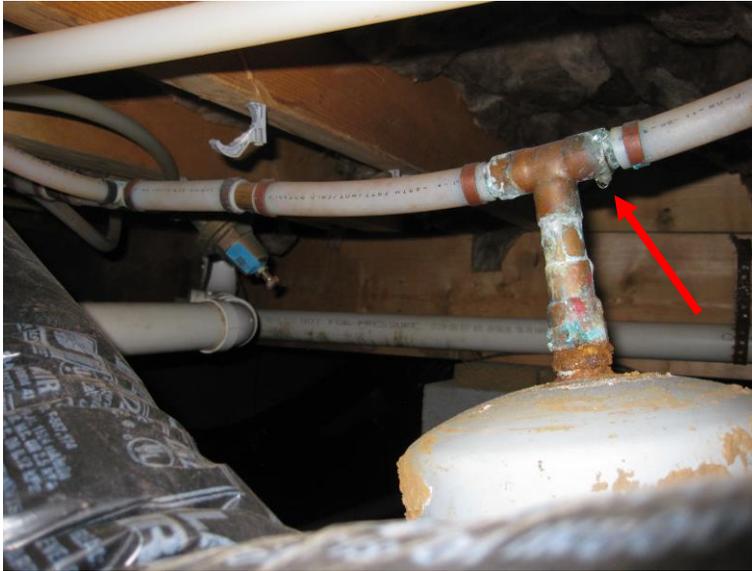
This home has a plumbing supply system that uses polybutylene plastic distribution lines and compression band fittings. Even though plumbing system was installed in many homes from 1978 until mid-1990, it is no longer an approved plumbing system due to a history of material failures. The failures were related to improper installation, improper handling, improper storage, and plastic deterioration due to chemical reactions with the water supply. Due to the nature of this latent defect, it was not possible to

adequately assess the condition of the plumbing system during the home inspection. At the time of the inspection the following concerns were noted:

1. Current leaks
2. Plastic fittings (deteriorated)
3. Improper support of plumbing lines
4. Poor installation of fitting bands
5. Evidence of past repairs
6. Evidence of past leaks

A licensed plumbing contractor should be consulted for a complete evaluation of the plumbing system to determine the significance of this concern and to make necessary repairs.

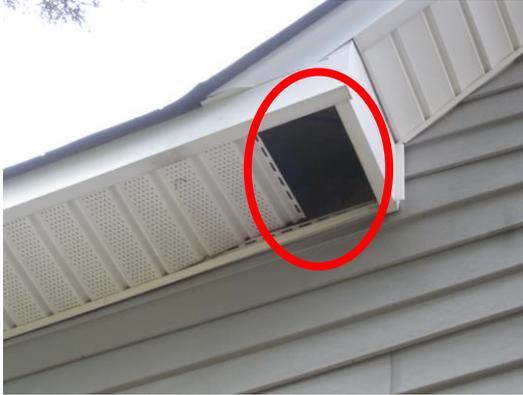
There is a section of the soffit vent screen missing on the right rear side of the property. This condition may allow rodents and pests to enter and nest in the structure cavity and/or attic. Recommend section be installed by a professional in the business

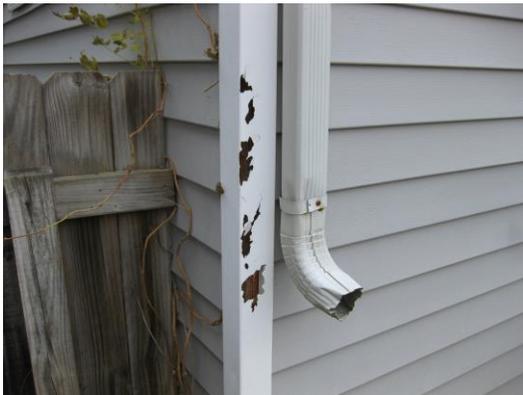
There are sections of the vinyl trim damaged on the rear right side of the property. The picture also illustrates how a downspout discharges about three (3) feet above ground resulting in water being in close proximity to the foundation. Picture also illustrates a shrub growing between vinyl trim and cladding. Unattended, these conditions may result in deterioration of structural components and settlement of foundation

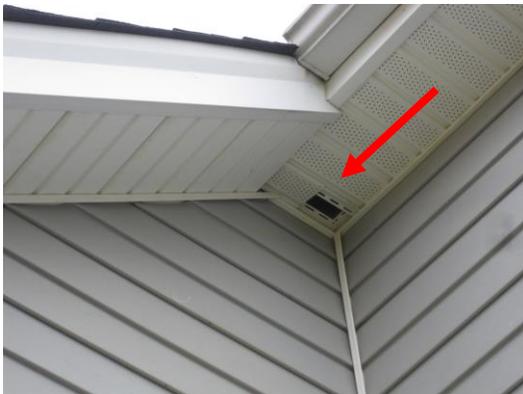
There is a section of the soffit vent missing on the rear left side of structure. This condition may allow rodents and pests to enter and nest in the structure cavity and/or attic. Recommend section be installed by a professional in the business

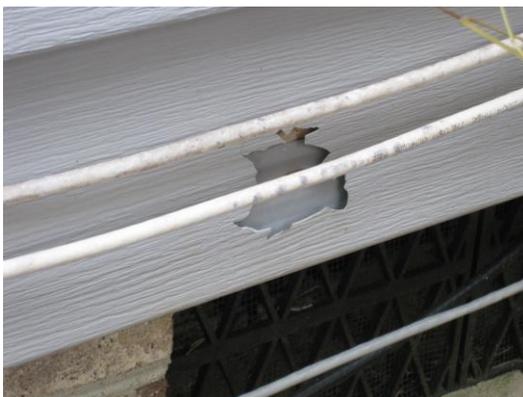
There is damage to the vinyl cladding on the rear of the property

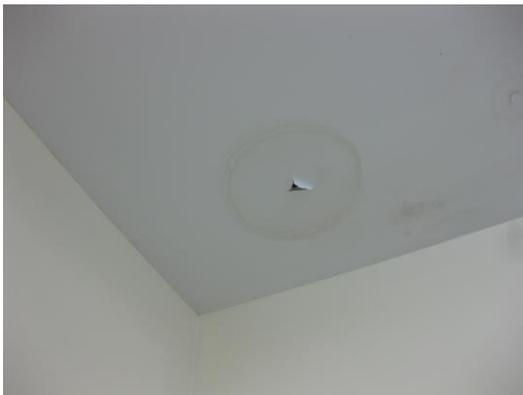
There is a water stain in the rear right corner of the master bedroom walk-in closet. This may be an indication of some water infiltration from the attic. Recommend condition be inspected and repaired by a professional in the business

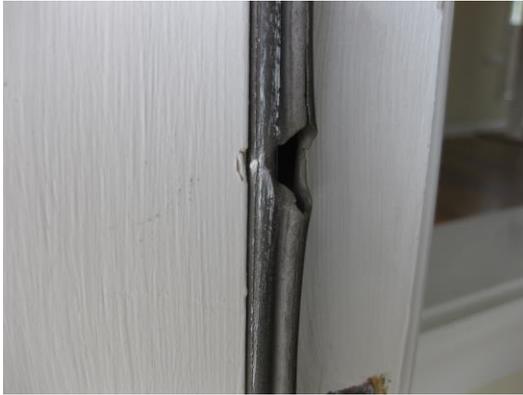
The main door trim is damaged, cracked or frail. Damaged weather seal prevents proper insulation and separation of living space from exterior resulting in added energy usage and possible entry points for rodents and pests. It is recommended for the weather seal of the main entrance door be replaced by a professional in the business

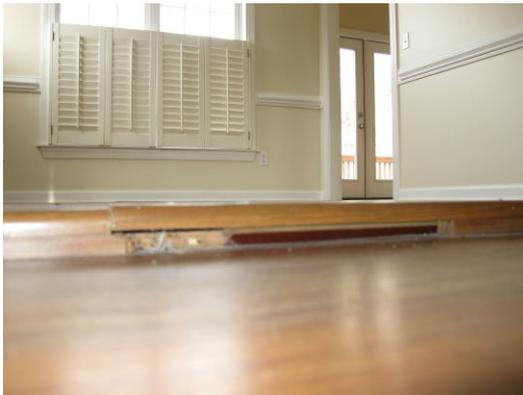
The laminate floor edge between the living and dining room as well as between the kitchen and foyer is damaged. This may result in a tripping hazard and shall be inspected and repaired by a professional in the business

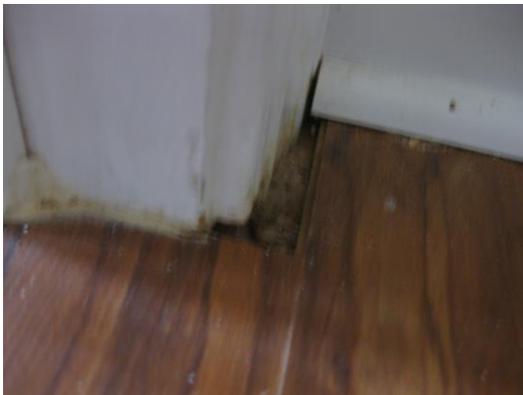
The wood laminate floor in the pantry closet is improperly terminated. This condition may result in water moisture entering the subfloor and damaging the structural component of the dwelling. It is advised to have a professional in the business review and repair conditions

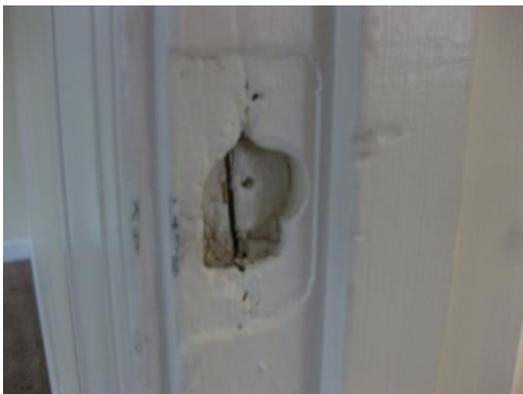
The strike plate of the master bedroom door is missing from the door frame. This condition prevents proper latching of door and results in additional damaging of the door frame. Recommend a strike plate be installed by a professional in the business

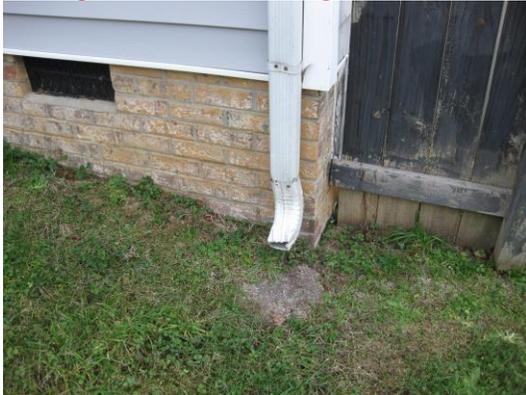
Downspouts are missing splashguards to channel water away from foundation. Water in close proximity to the foundation may result in differential settlement and structural damage. Recommend installing splash guards on all downspouts

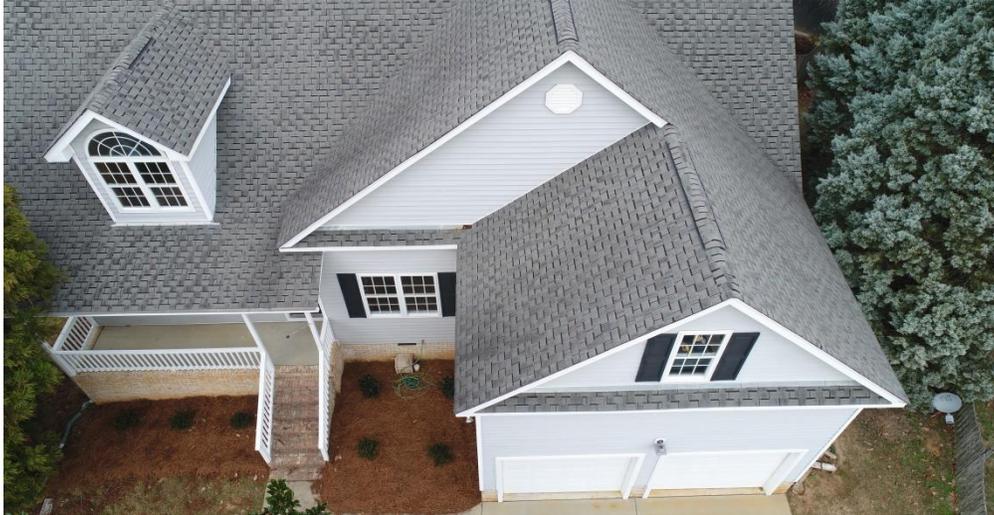
Figure 1: Front Aerial View of 100 Highland Springs Lane

Close observations of the asphalt shingles in roof valleys, and ridge, did not alert the Inspector of any asphalt shingle conditions of concern illustrated in R048 above at

the time of the aerial inspection. In summary, there was no indication of roof shingles curling, cracked, split or broken at the time of the inspection. In addition, the aerial photography did not reveal any clawing, cupping, and curling of shingles.

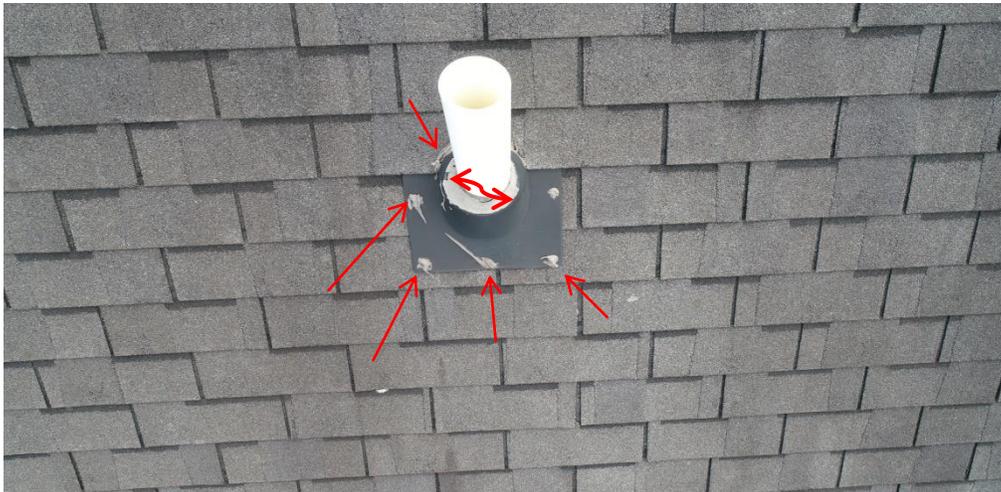
Figure 2: Aerial View of PVC Vent Pipe with Visible Sealant/Caulking Application

Upon close review of the PVC vent pipe on the rear right side of the roof, the Inspector noted calking applied to the flashing screws and pipe penetration thru-rubber boot. All other vent penetrations were noted without any sealant/caulking applications.

A professional in the business is recommended to review conditions and repair or replace vent boots and flashings as necessary. Due to the age of the property, it is advised to replace all thru-roof rubber boots as others may fail soon.

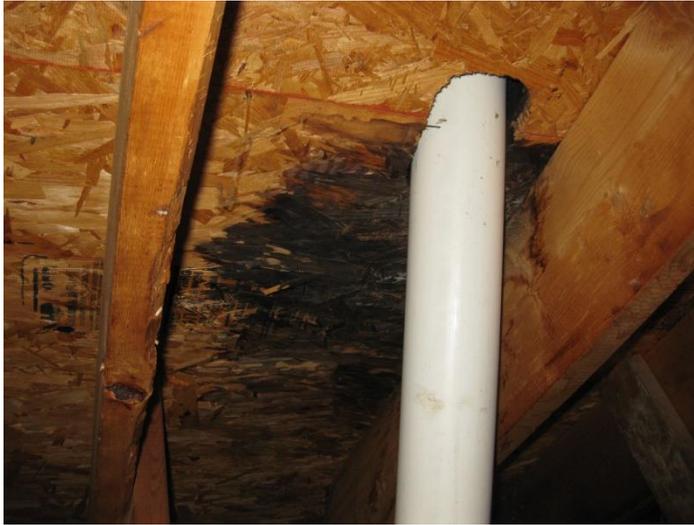
Figure 3: OSB Stains in Attic below Vent Pipe

The aerial survey of the vent and attic inspection may indicate that the source of

water stains and bacterial growth on the OSB sheathing in the attic below the vent pipe may be the result of damaged or worn boot or flashing. The dark color of the bacterial growth in the attic is an indication that previous attempt(s) to stop this water seepage using sealants and/or caulking has failed.

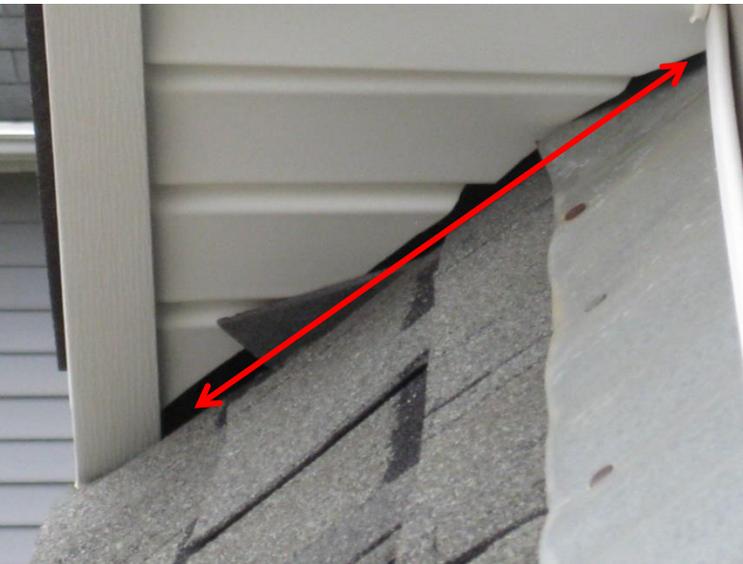
Figure 4: Missing Flashing on Front 'Water-Table'

ROOF – There are voids between both ends of the on water table on the front of the house and cladding indicating missing flashing (see photograph on **Supplemental Aerial Roof Inspection Observation Report**). There is bacterial growth below the rear right PVC vent in attic indicating water seepage from roof. The rear right downspout does not reach the ground. All downspouts are missing splash guards to divert water away from foundation. **This system of the property needs to be inspected and repaired by a licensed professional in the business.**

There is a void between the cladding and the roof system on both ends of the front 'water-table'. This is an indication of missing flashing. Further review of attic conditions below the corners of the 'water-table' show water stains. This is indicative that when the right directional rain is experienced, water enters the attic.
