FOOTHILL RANCH MAINTENANCE CORPORATION

NORTHWEST FOUNTAIN PROJECT

ACCOUNTABILITY, CLARIFICATION &

DOCUMENTATION

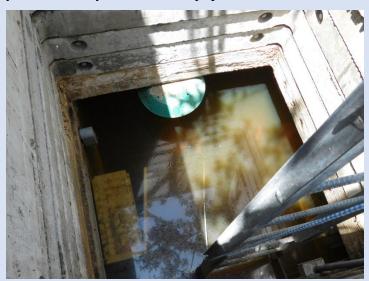
The Fountains are designed with an equipment vault at the lower end of the Fountains. The vault is made of concrete forms connected together; the NE fountain vault is about 25 feet below the finished grade. The image below is what we discovered once we opened the vaults entry hatch, you can clearly see that the equipment vault is underwater.

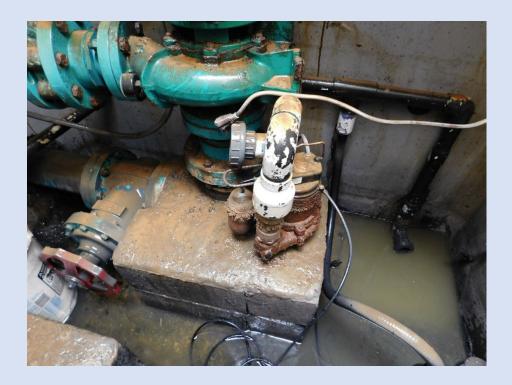
This is an image of one motor and pump damage.

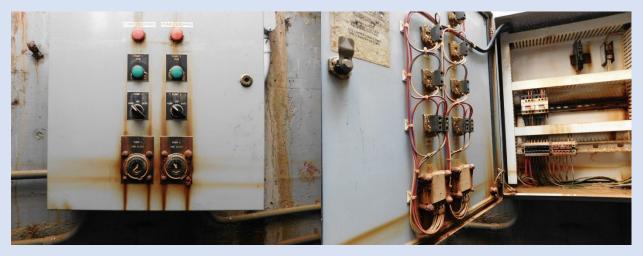
The Images above show the Fountain equipment electrical panel, which is completely useless, the damage was too extensive to attempt any repairs.

As noted on page 5, the existing Electrical Panel, the original panel was not rated for the specific environment, NEMA has specific rating depending on the environment this being a wet and damp environment NEMA 4X type was used, see below.

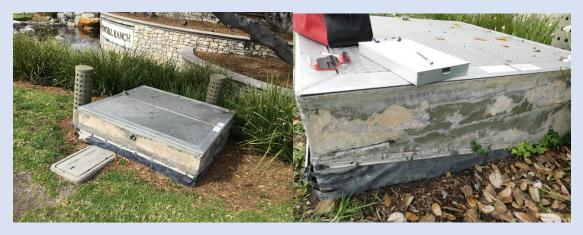
The Image above is the existing fountain equipment vault entry hatch, the concrete on the exterior was in a state of dilapidation, water causing the concrete to break off which allowed more water to enter breaking down the inter-locking concrete form seals, also note the rubber exterior skirt again breaking down reveling opening for more water.

After months of work (please remember this was COVID-19 and Dec the end of the year) we were ready, the exterior of the fountain equipment vault was resurfaced a new rubber insulating boot securing the upper section between the soil and the vault (added protection) a new vault entry hatch with provisions to direct any water / rain that may find its way past the lid, it was time to install the new equipment, one point I should note, the equipment vaults being below 15 feet below the surface, water is the enemy typically sump pumps are installed to keep any waters from building up, two pump are typical however I wanted to provide as much redundancy as possible, we designed the system to have 3 sump pumps a primary and a secondary as backup both running on 120 volt, the 3rd sump pump we design to be battery powered 12 DC being completely separate form the AC source, if the AC powers fails for any reason the DC sump pump will active as needed, this allows for vault protection until the vendor either clear a fault or ac power is restored.

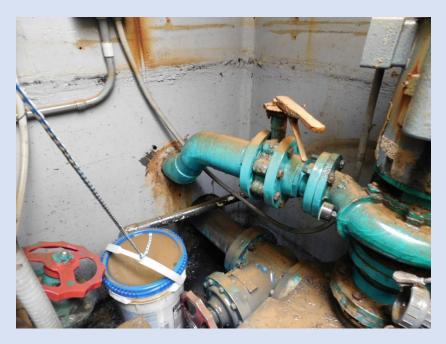
Piping vault wall penetration.

But this was not the only issue as to the water problem, in the image below you can see the piping from the pump penetrating the wall, the rust around the pipe entry is a result of leaking the packing gland (seal) was damaged allowing water to enter.

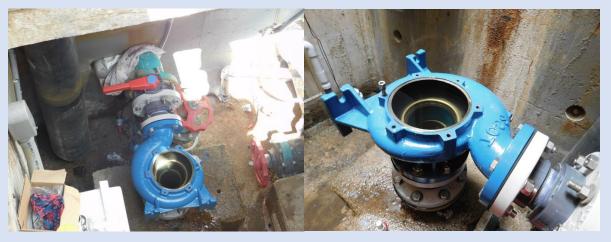
The images show the new Pump mounted ready for the Motor assembly.

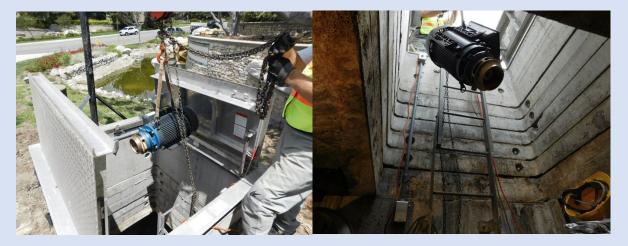
Images of the new Motor being lowered into the vault I was standing on the floor of the vault at the time.

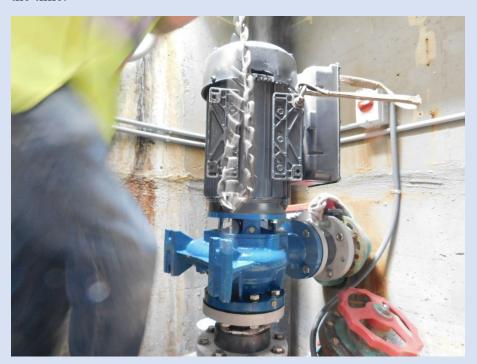
Image one of the new Motors being installed

As you can see in the images just to lower the equipment into the vault the vendor erected a support system with pullies, and winches.

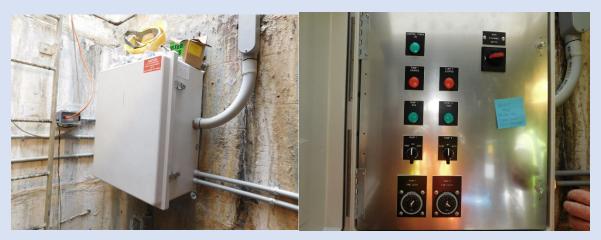
NEMA 4X panel for a superior level of protection from corrosion and extreme environments.

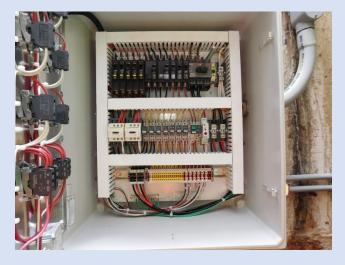
Image of the interior of the electrical panel.
