File: FHR-LL-001

**FOOTHILL RANCH
MAINTENANCE CORPORATION
RESIDENTIAL DEVELOPMENT**

**ALTON STATUE
LANDSCAPING LIGHTING**

**ACCOUNTABILITY, CLARIFICATION
&
DOCUMENTATION**

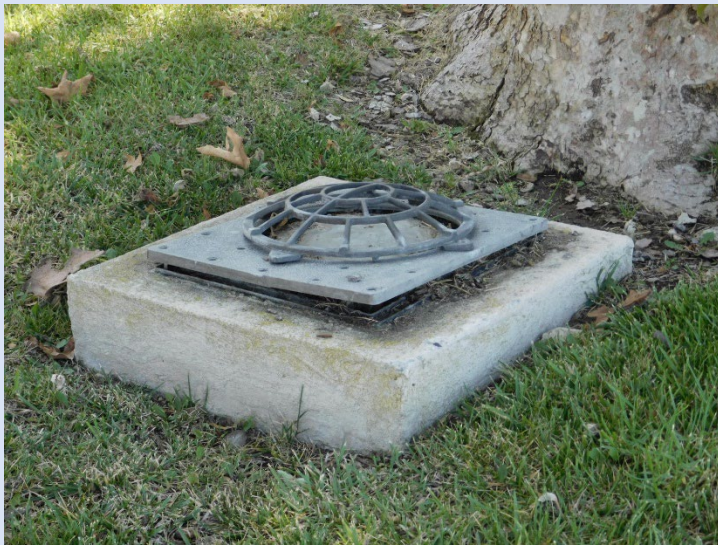
The image above shows the concrete base and the dome fixture, the actual dome fixture which is made from what appeared to be steel, as shown the dome fixture has separated from the concrete base exposing the inner electrical components including the wiring, the insulation that covers the wiring was most gone a result of the elements and rodents chewing off the Insulation leaving exposed copper wiring in some places, the Len which should be clear was found to be covered in calcium from rain and Irrigation water turning into white powder when touched, this specific fixture was not functional.

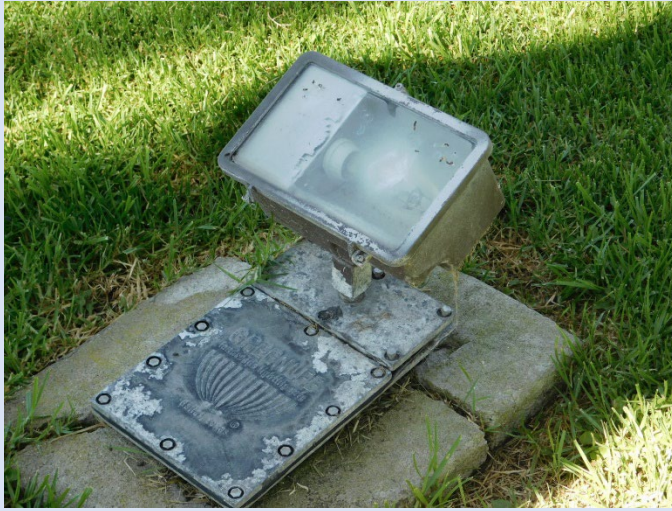
This is an Image of an adjustable spotlight again the damage to the concrete base can be seen, this fixture was also full of water, the Len can also be seen with the same calcium deposits
