**VANGUARD**  
PROPERTY SURVEYORS

# LEVEL 3 Home Survey Report

Property Address:  
**Green Gardens, Wharlingham, CR8 9PQ**

Date of Inspection:  
**Wednesday 1<sup>st</sup> October 2025**

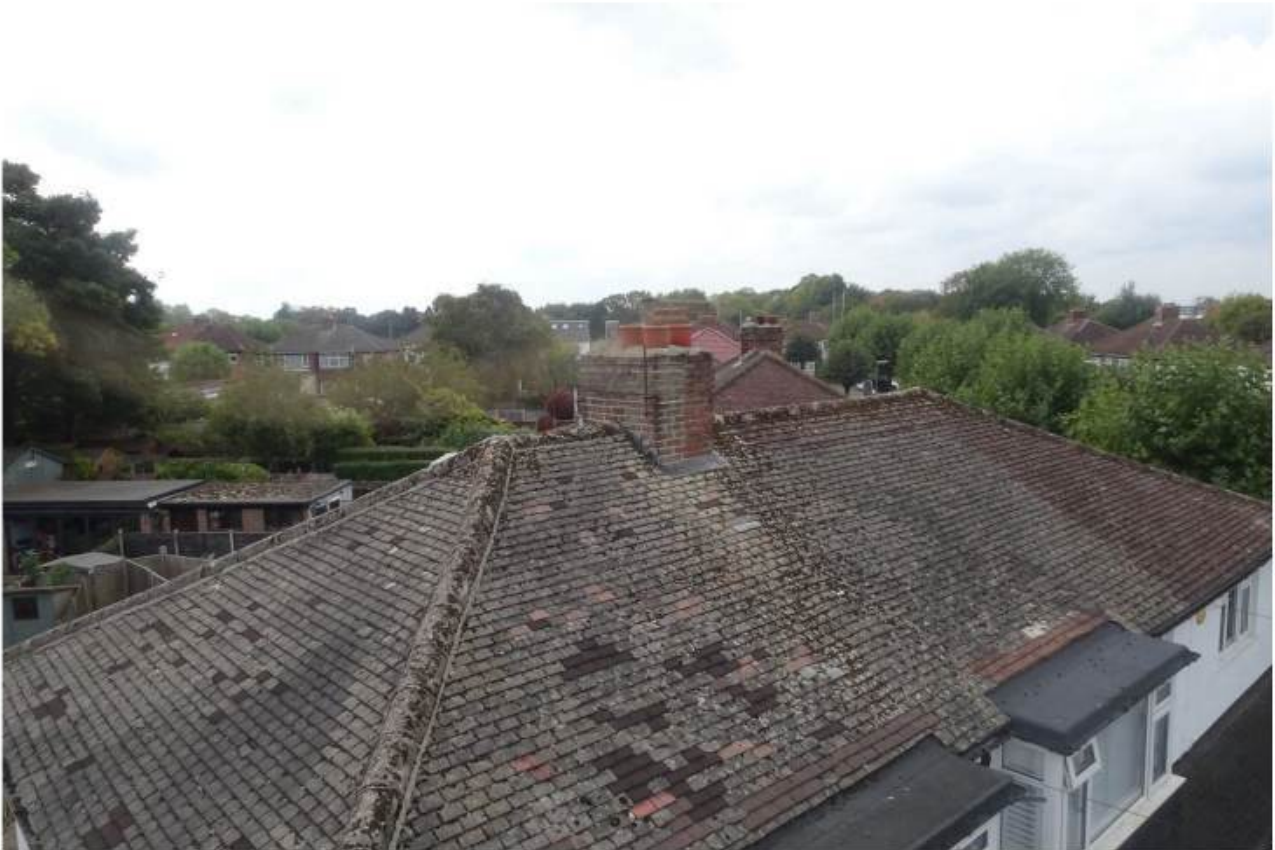
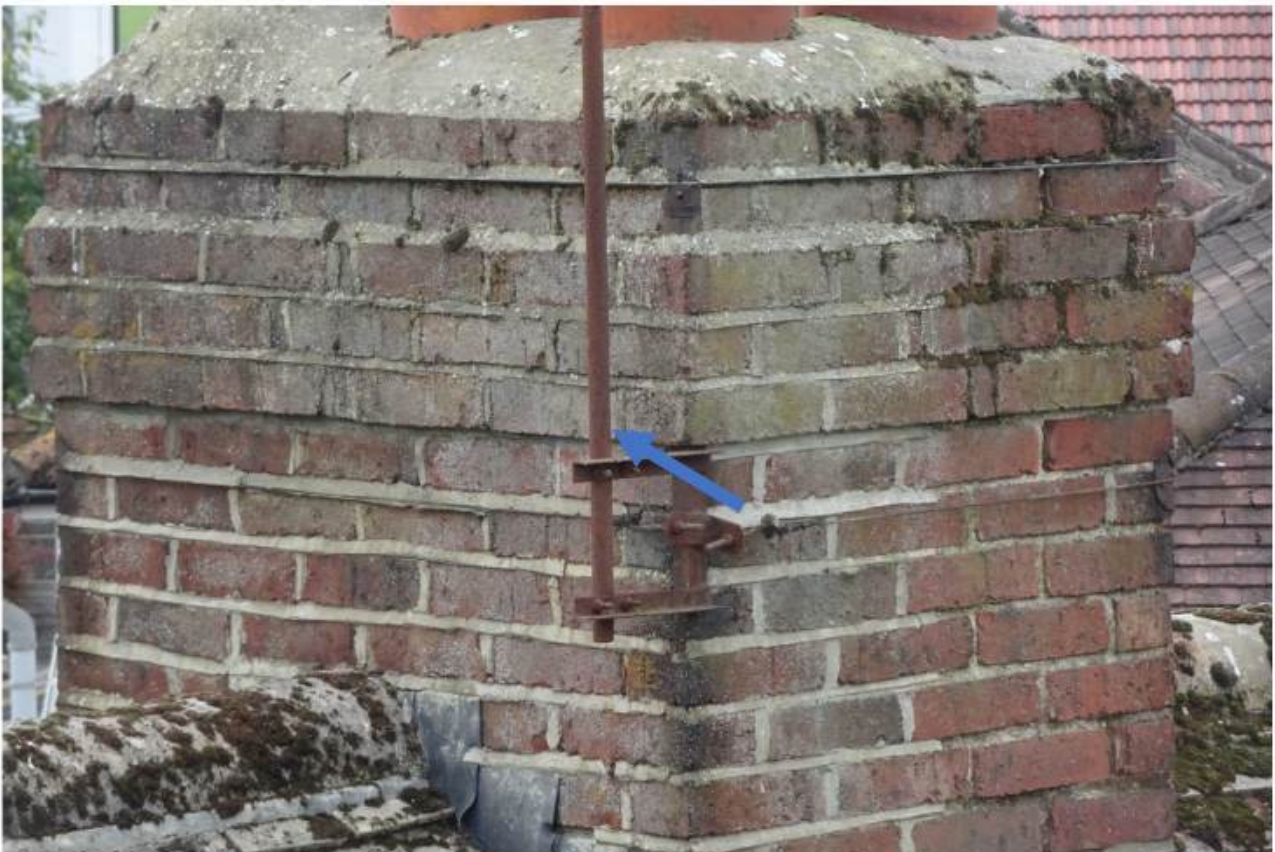
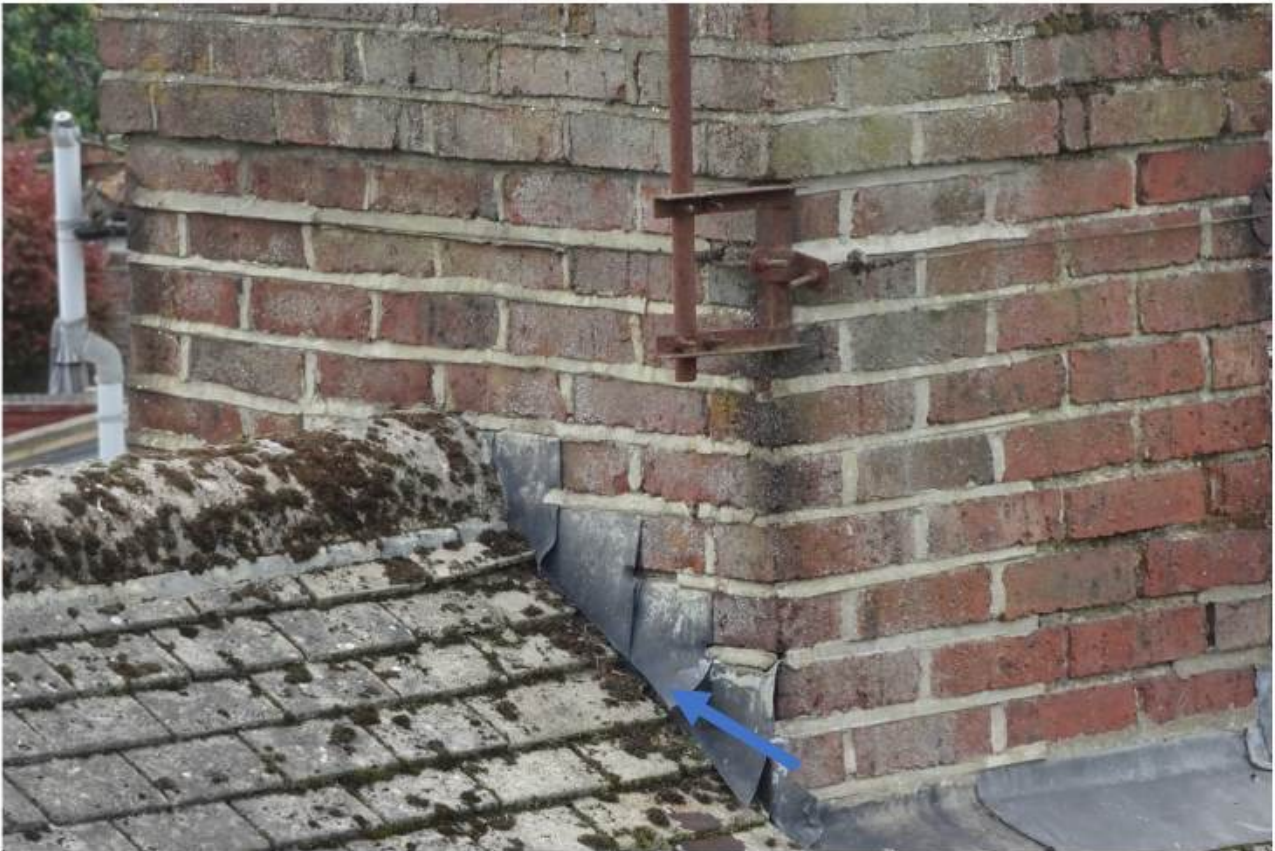
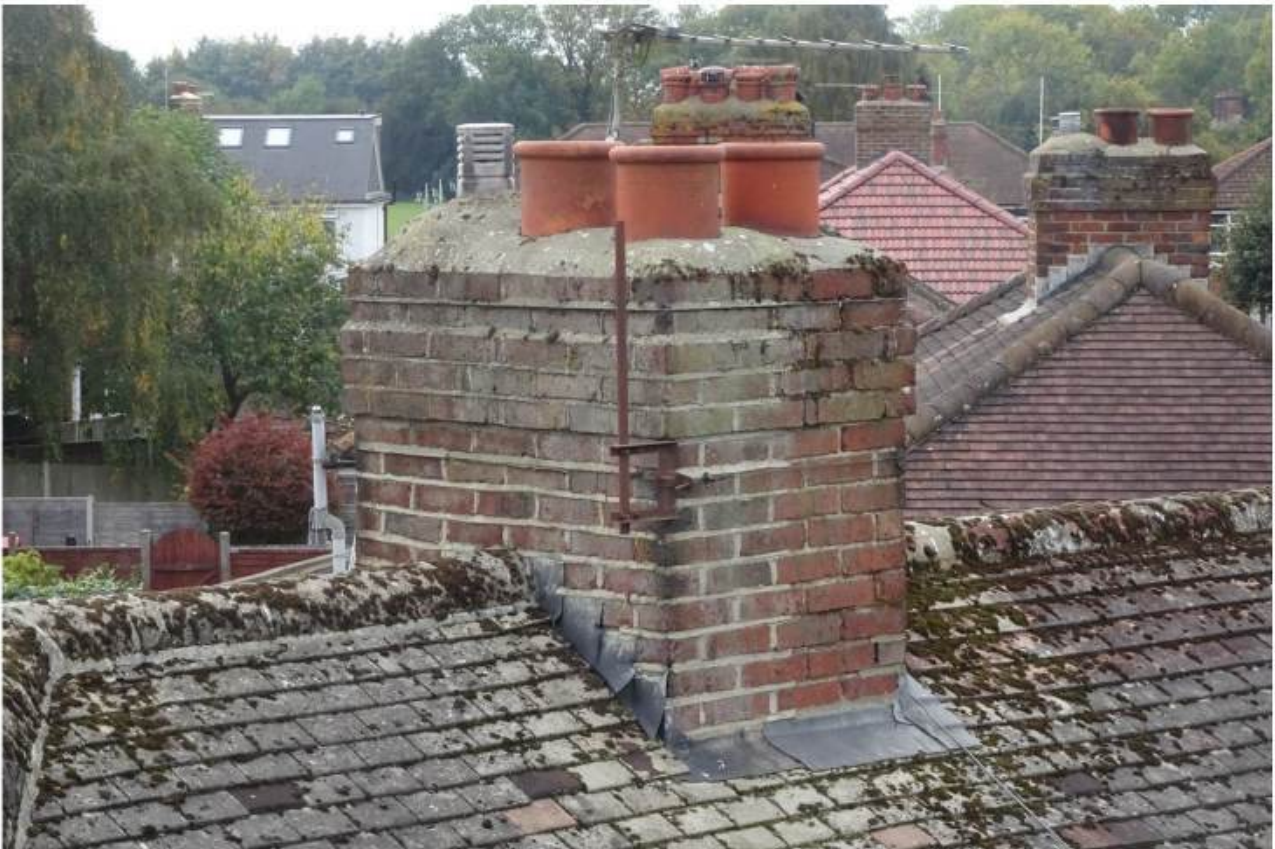
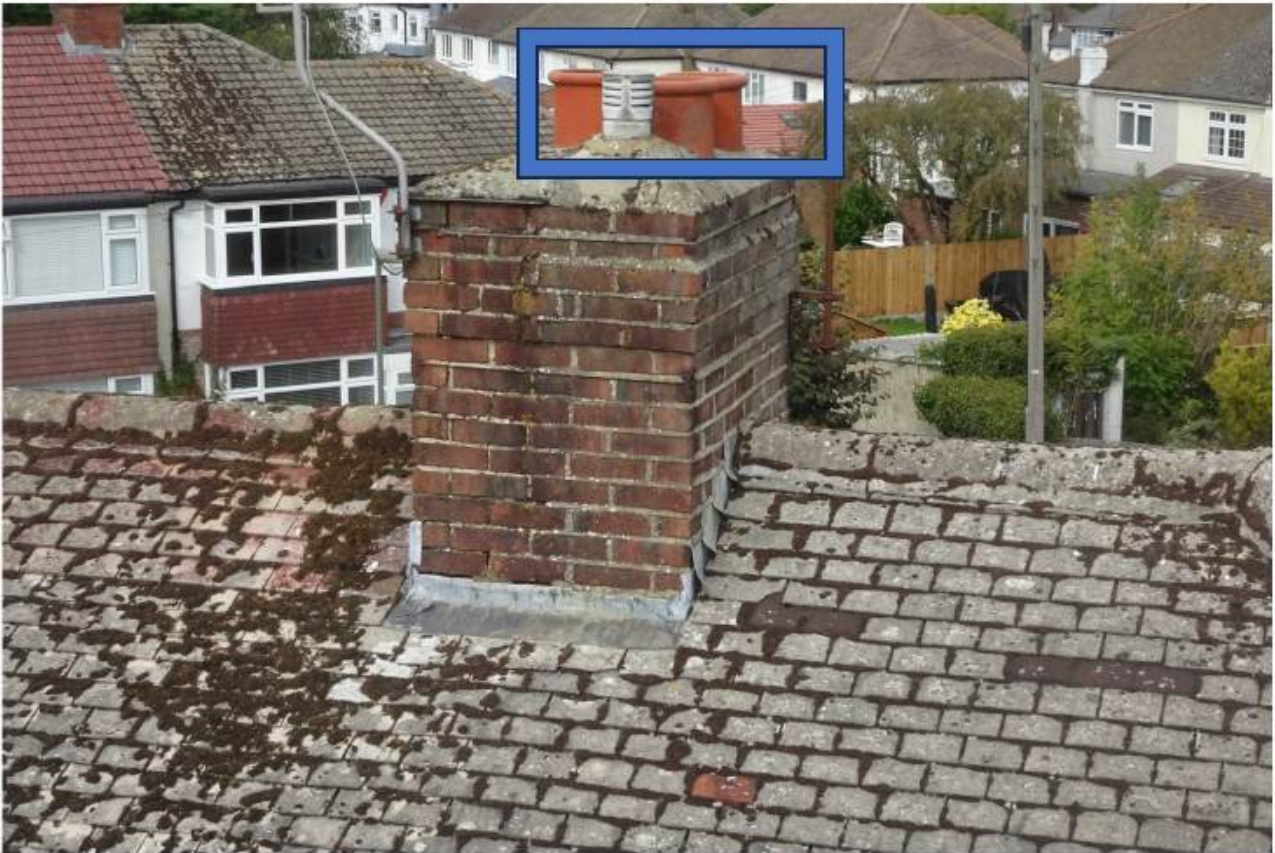
The main chimney was seen to be in a poor condition.

Television aerals are fitted to the stack. The front aerial appears redundant and exhibits corrosion and fatigue. The rear aerial appeared to remain in use and was in satisfactory condition.

- The mortar joints require repointing, and the flaunching to the crown is cracked, weathered and locally fractured.
- Not all chimney pots are fitted with suitable cowls. Appropriate cowls should be installed to reduce direct rainwater entry and deter nesting animals.
- The lead flashing is in poor condition and requires renewal to reinstate a weather-tight junction.
- The redundant front television aerial is corroded and should be removed.

*We estimate £4,000 to repoint the chimney stack, renew the defective flaunching and lead flashing, install suitable cowls and remove the redundant aerial.*

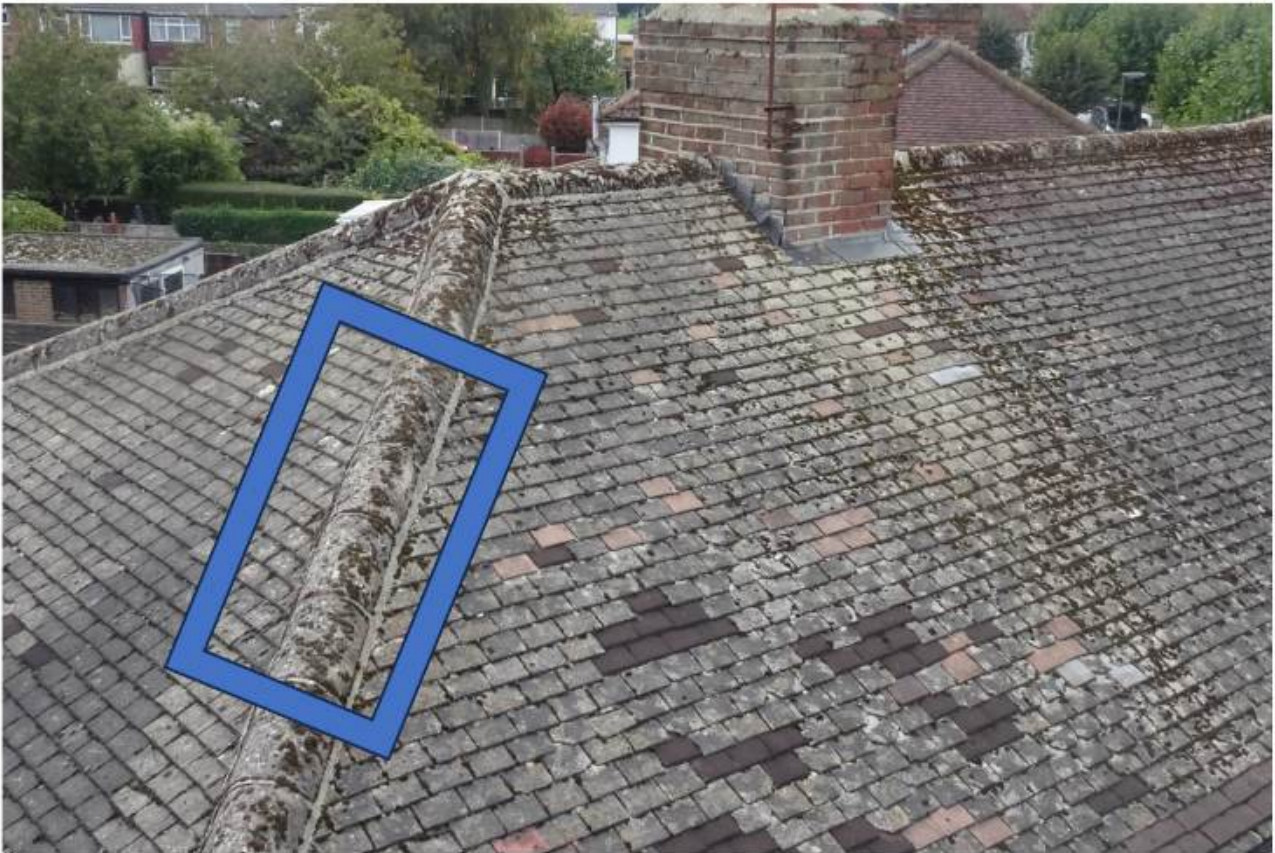
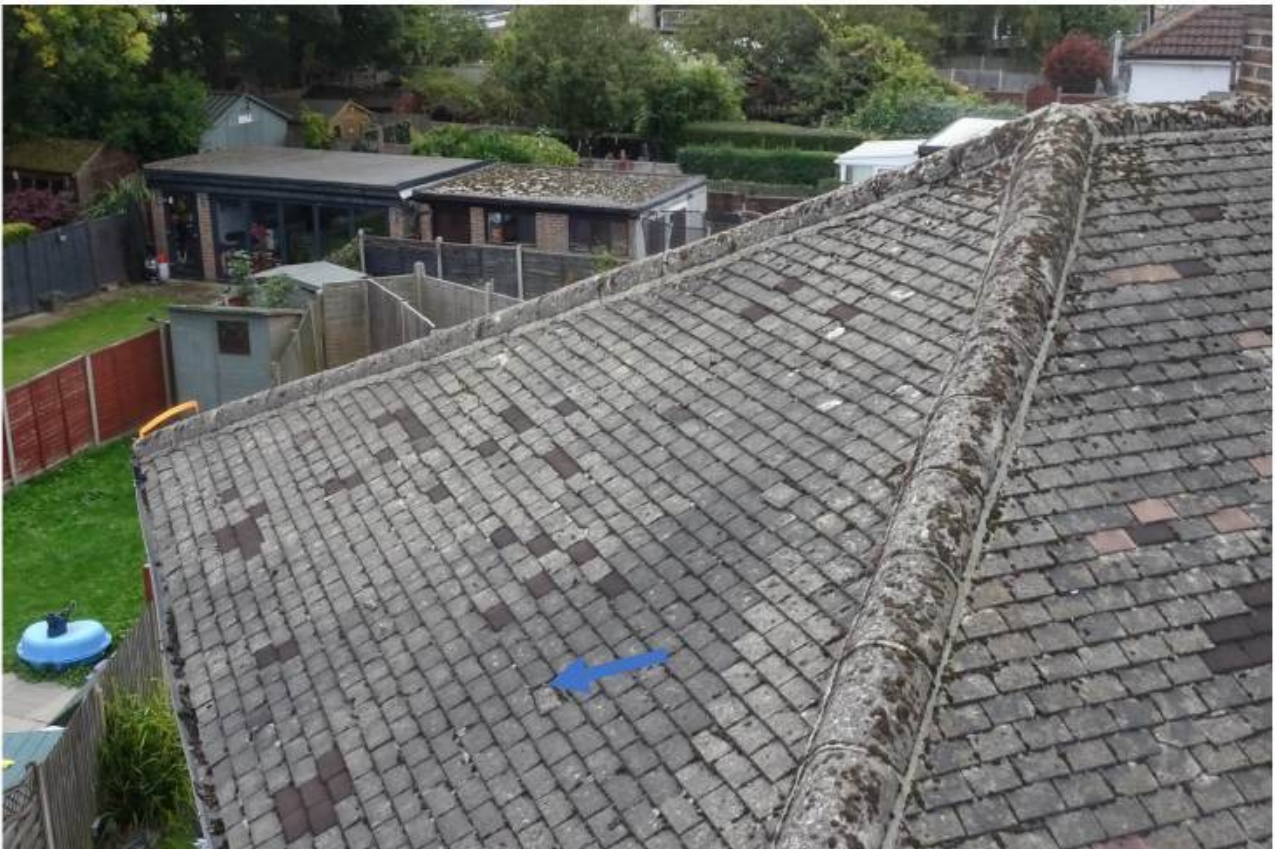
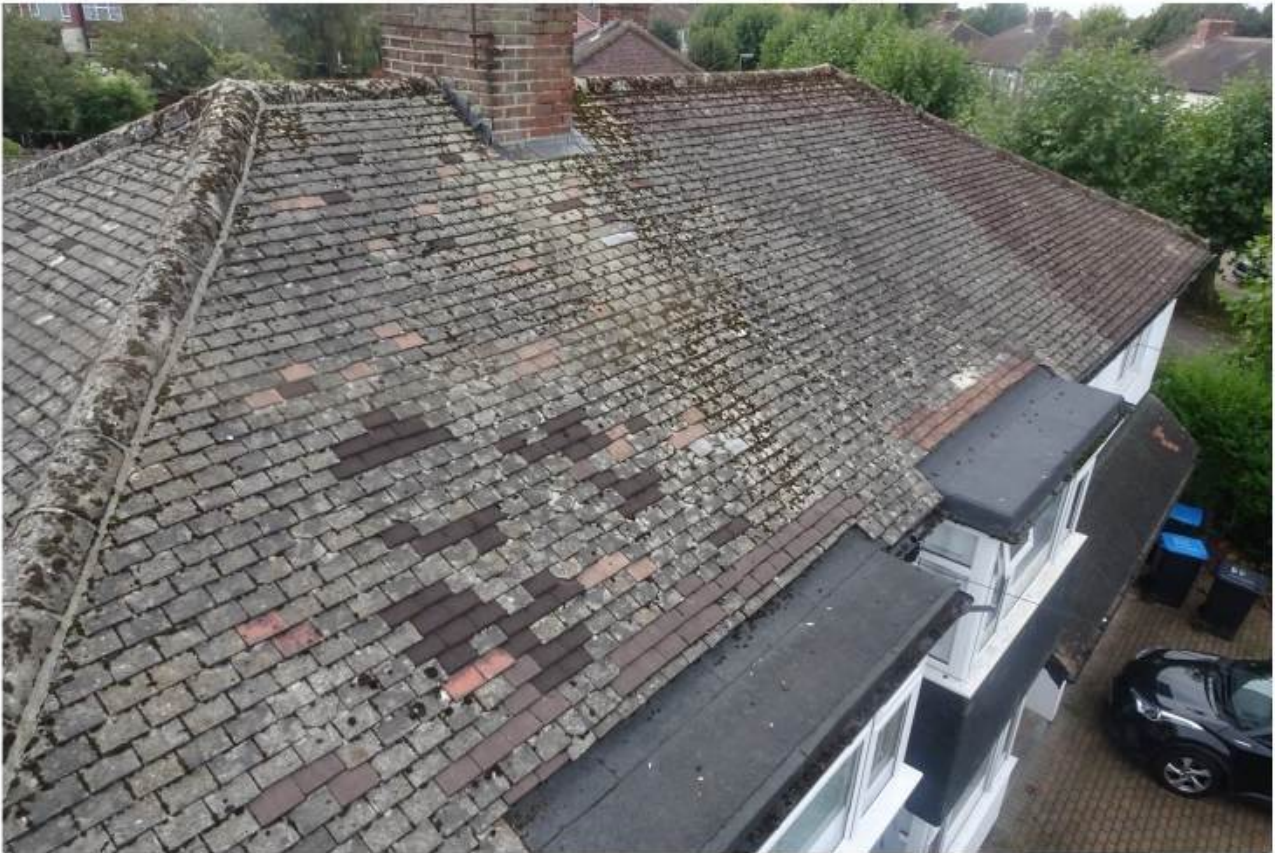
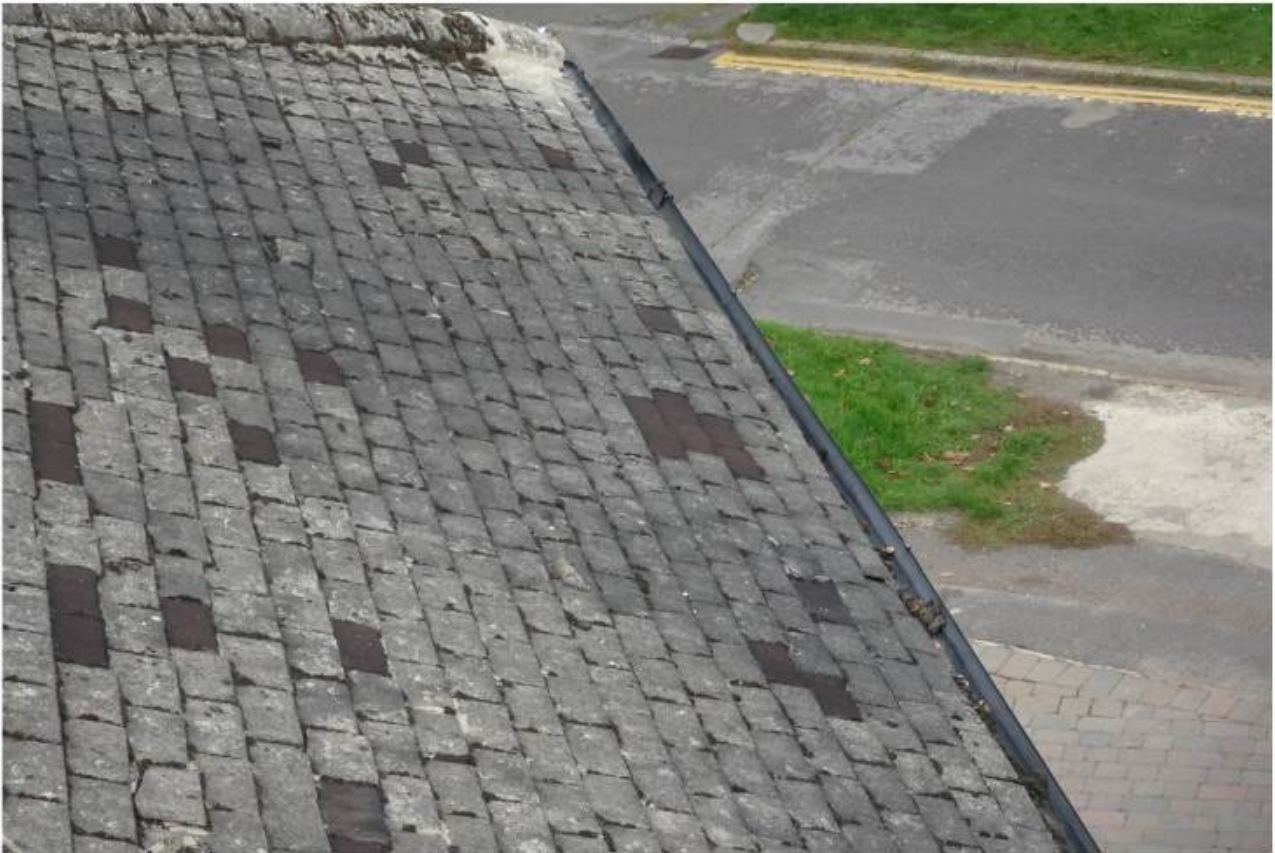
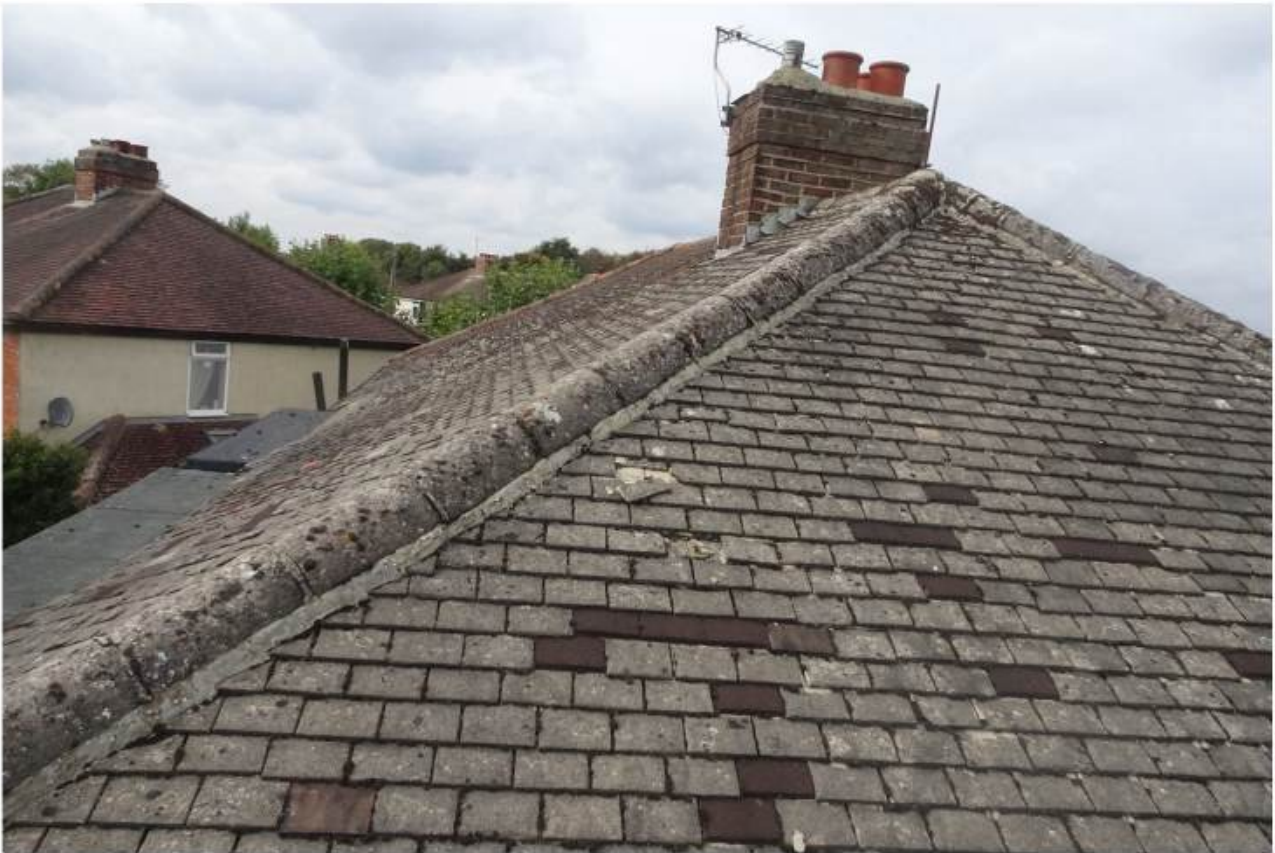
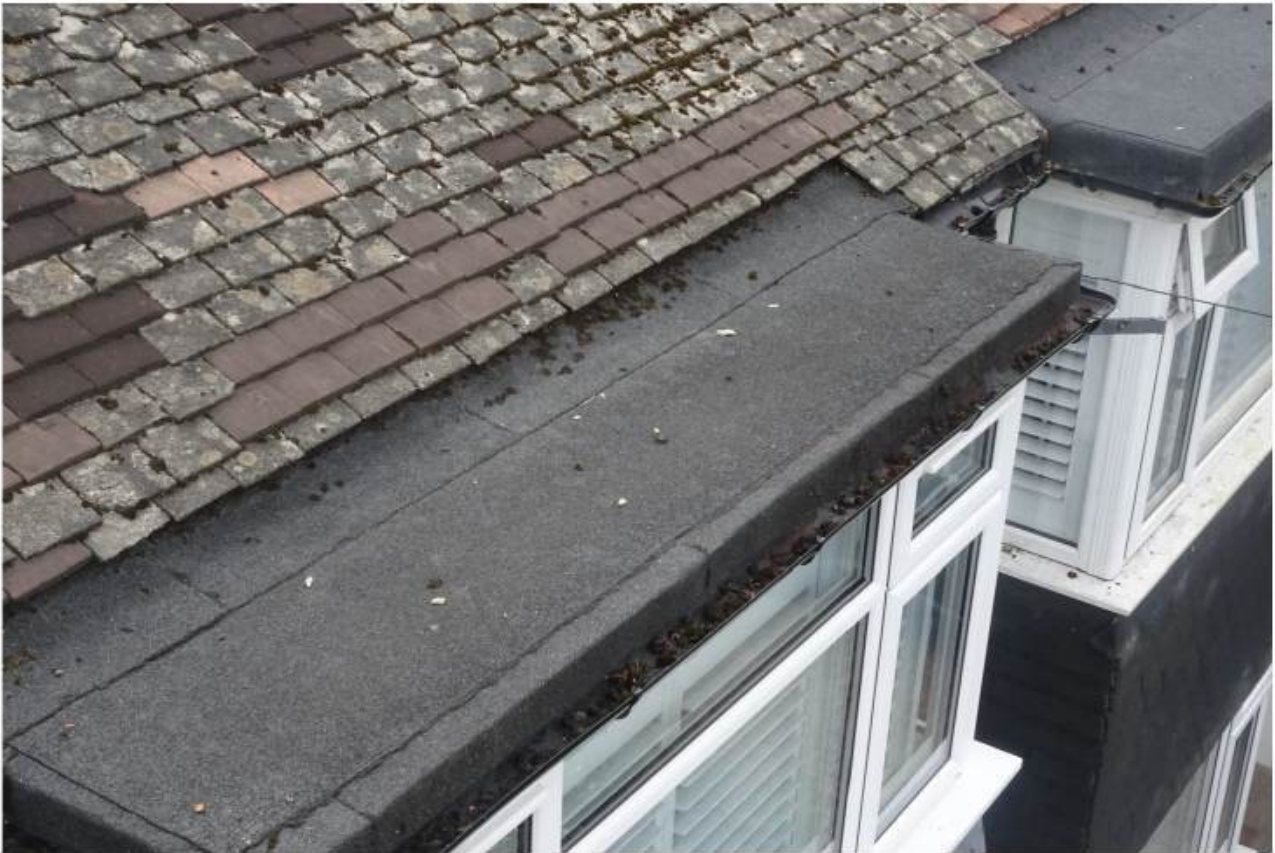
The front and rear box-bay roofs are formed with timber decking and weathered with a traditional three-layer bituminous felt system. The front covering was in satisfactory condition. The rear covering exhibits localised loss of the mineral finish and is likely to require renewal within the next three to five years.

- The main concrete-tile covering is at the end of its serviceable life. The tiles are weathered and thinned, with numerous historic patch repairs and several broken units.
- Deterioration is most pronounced along the apex and hips, where the mortar bedding and alignment are poor.
- No underfelt is present beneath the tiles. Defective or displaced tiles can therefore allow direct rainwater entry into the roof space.
- Heavy moss and lichen growth is present across the slopes and contributes debris to the rainwater goods.
- The rear box-bay felt covering is deteriorating and should be renewed within the short to medium term.

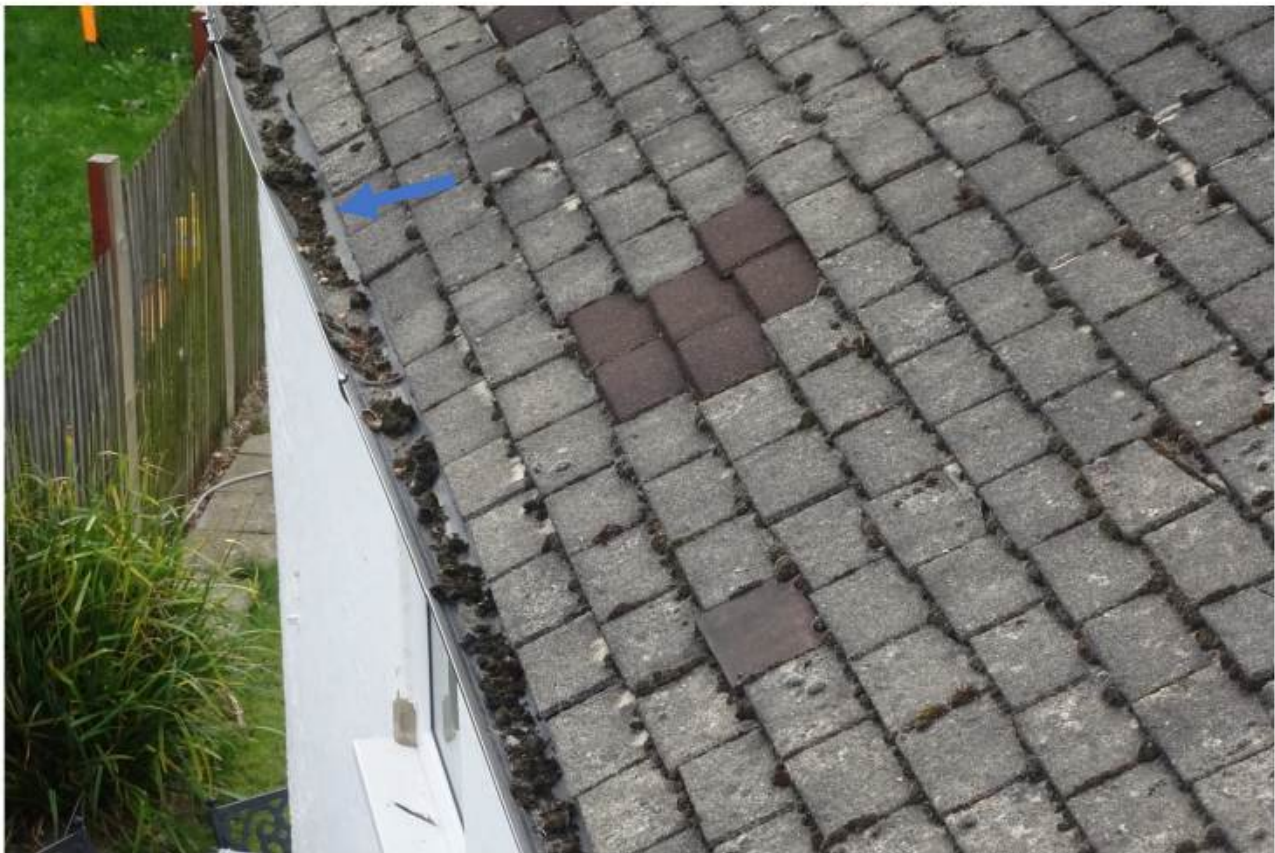
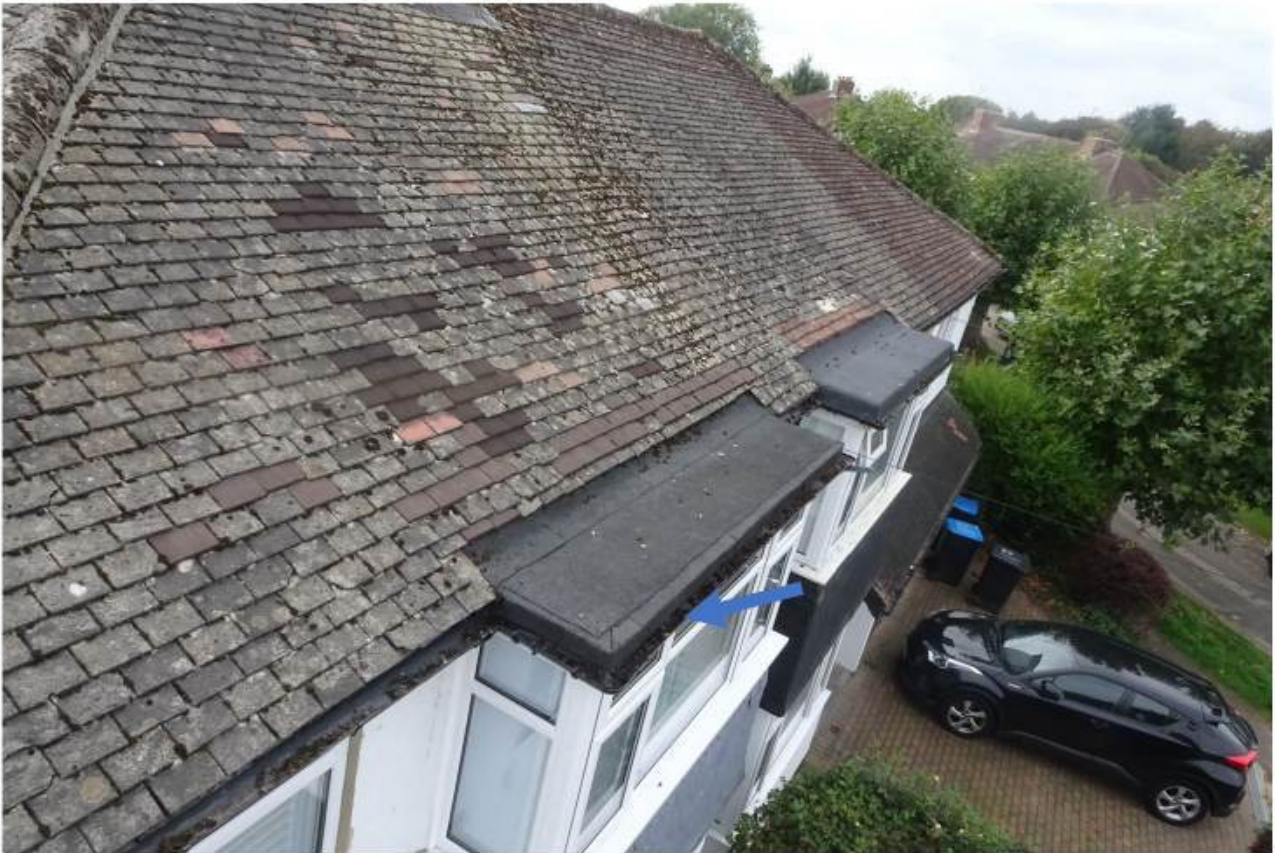
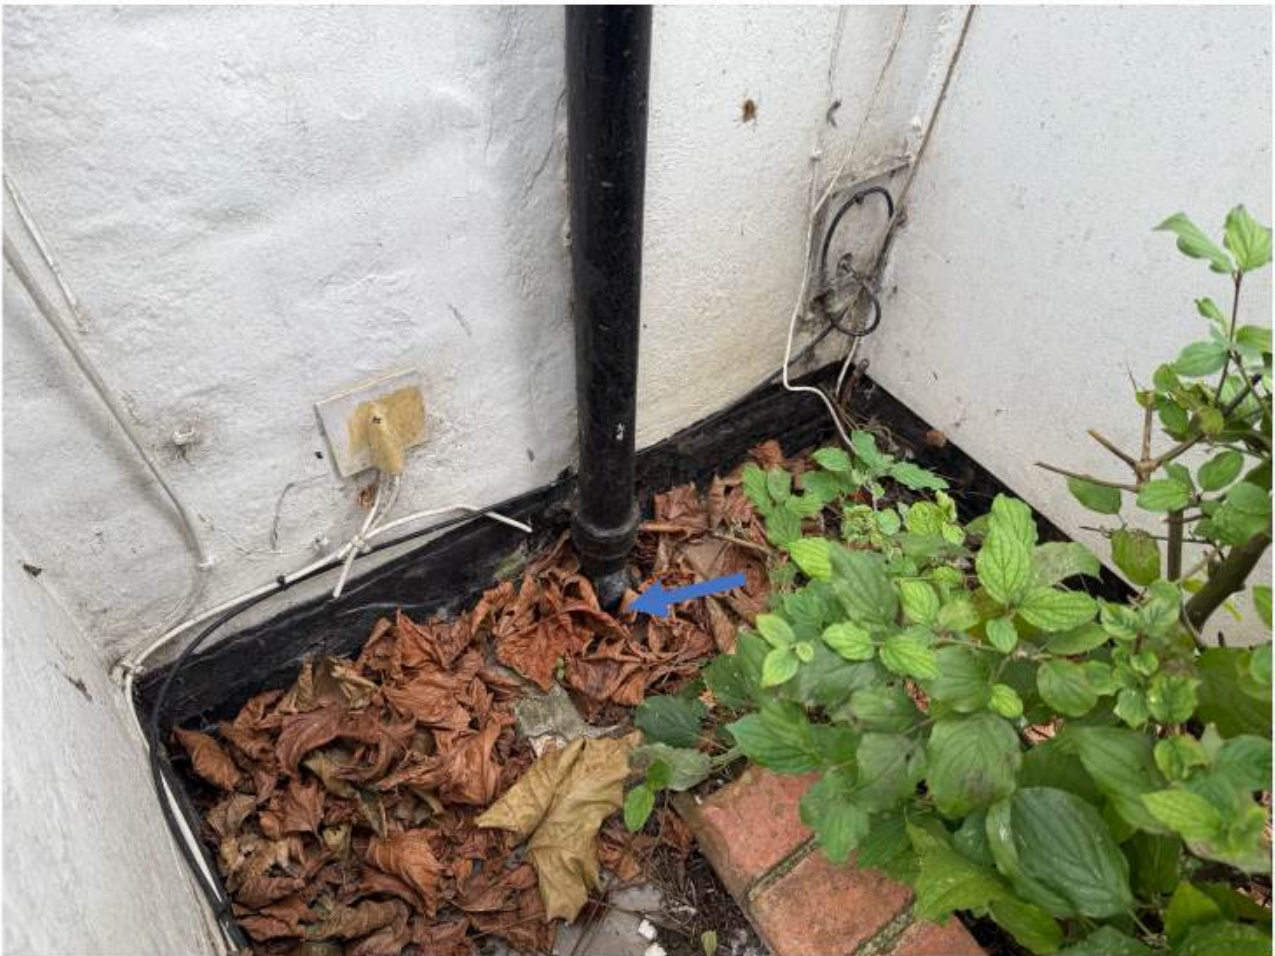
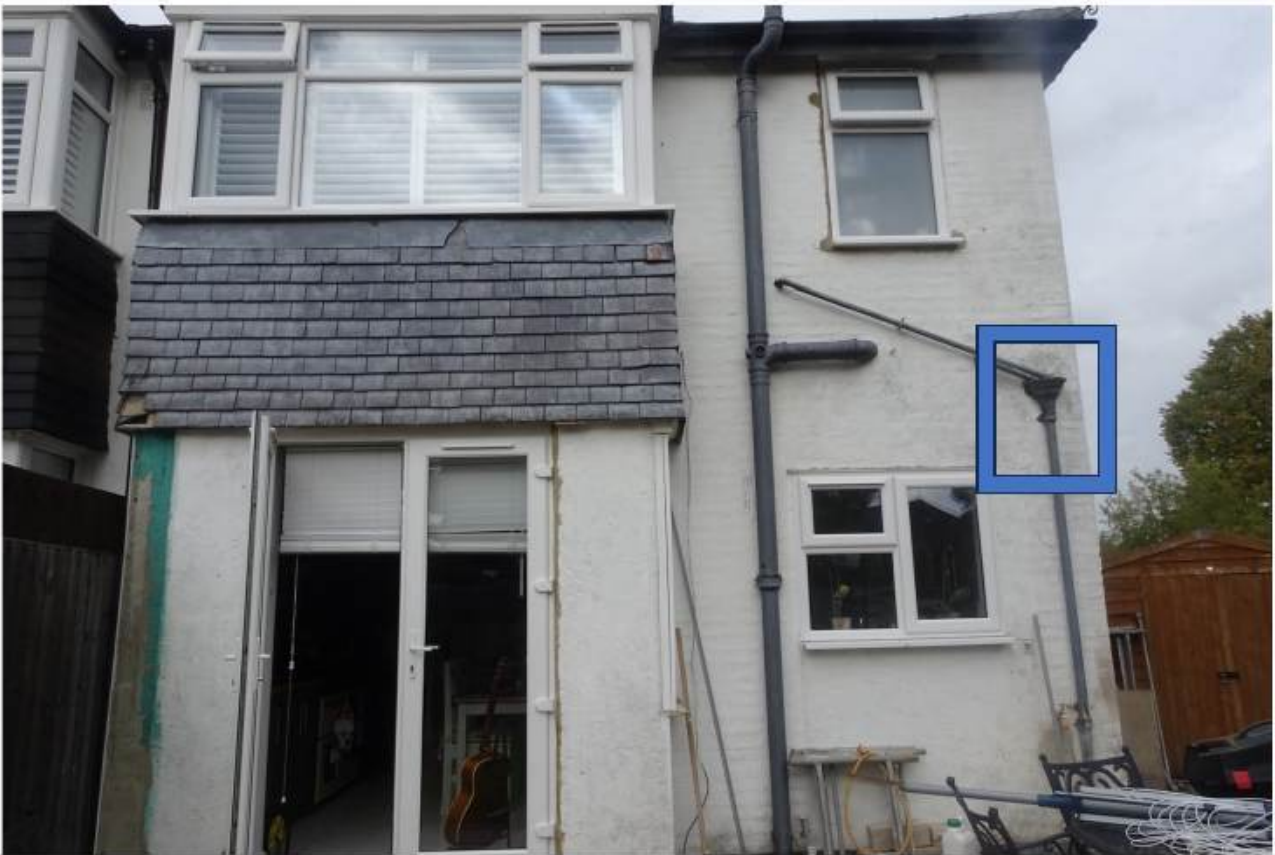
- Debris has accumulated within the uPVC gutters and lower gullies, restricting the free discharge of rainwater.
- The metal hopper receiving grey water from the bathroom is heavily corroded and requires replacement.
- The soil-and-vent pipe is securely fixed but lacks a suitable vent terminal.

*We estimate £800 to clear the gutters and gullies, replace the corroded hopper with a suitable uPVC fitting and install a vent terminal to the soil-and-vent pipe.*
