**VANGUARD**  
PROPERTY SURVEYORS

# LEVEL 3 Home Survey Report

Property Address:  
**Green Gardens, Wharlingham, CR8 9PQ**

Date of Inspection:  
**Wednesday 1<sup>st</sup> October 2025**

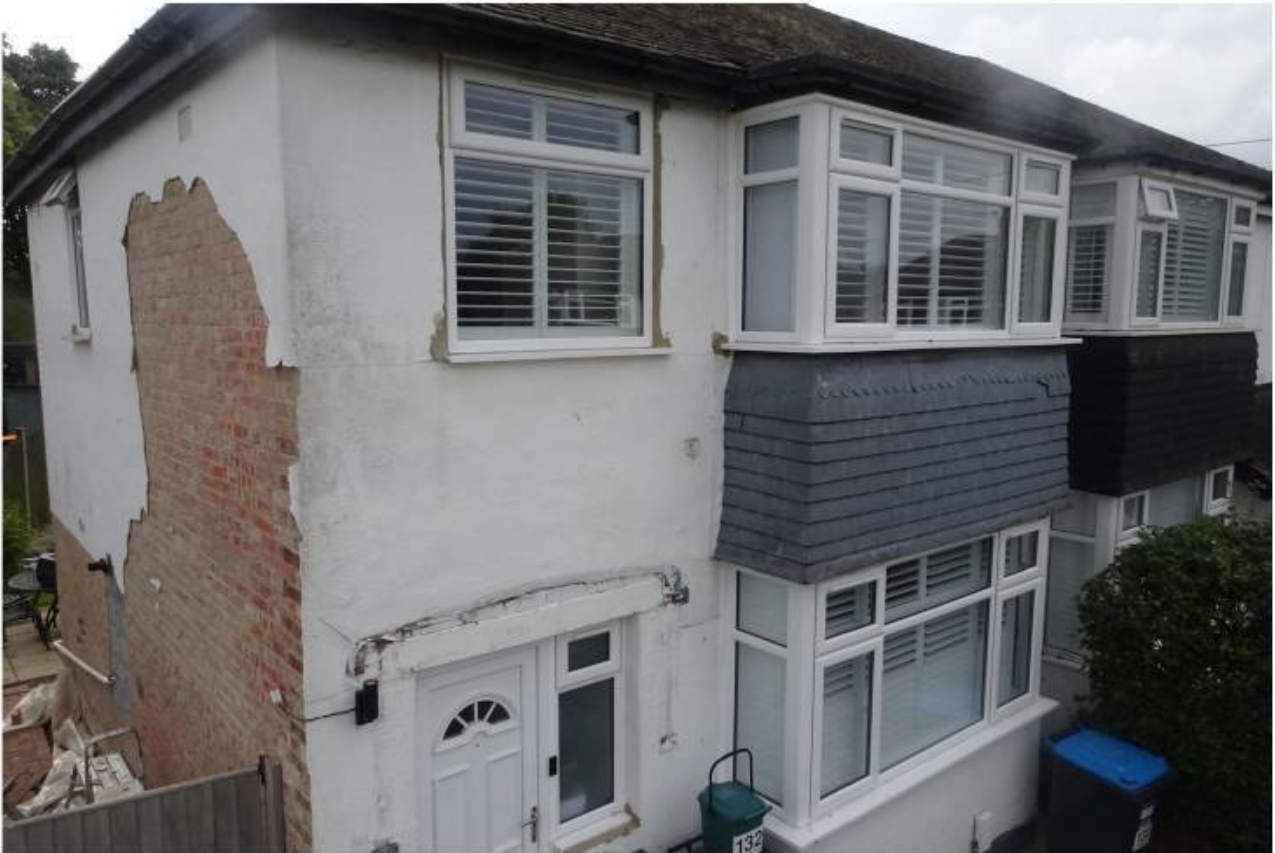
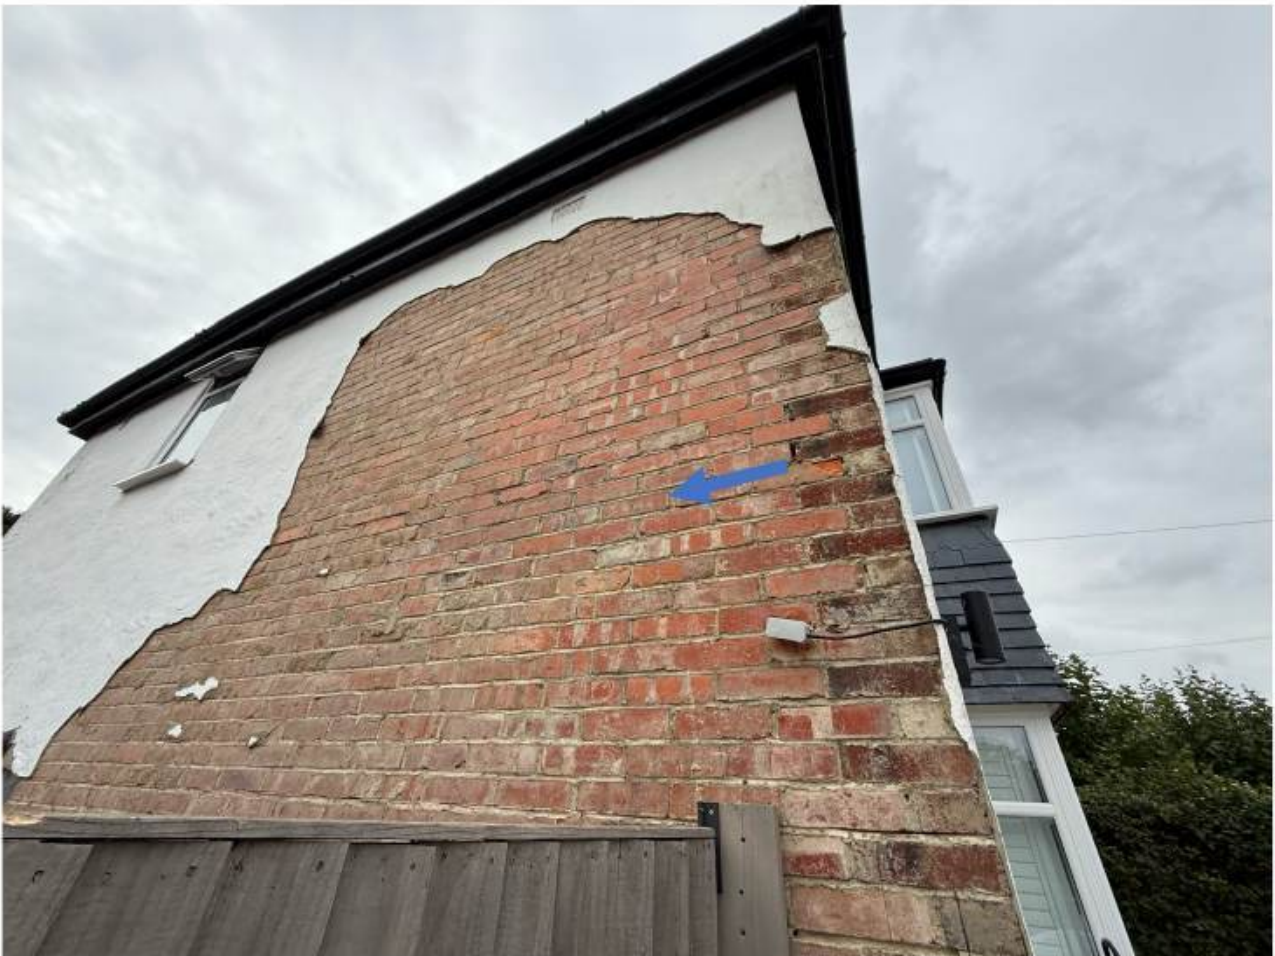
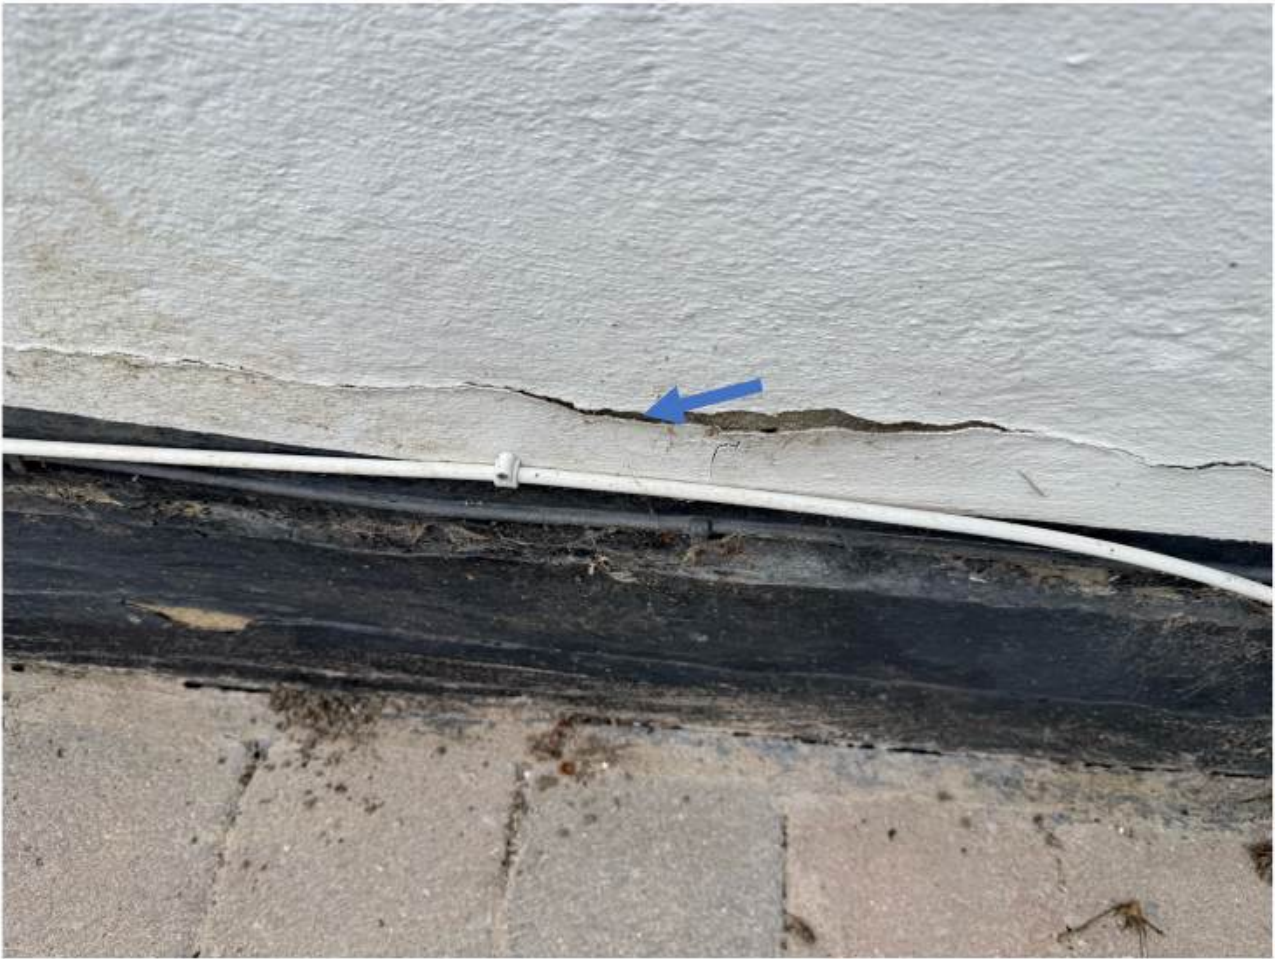
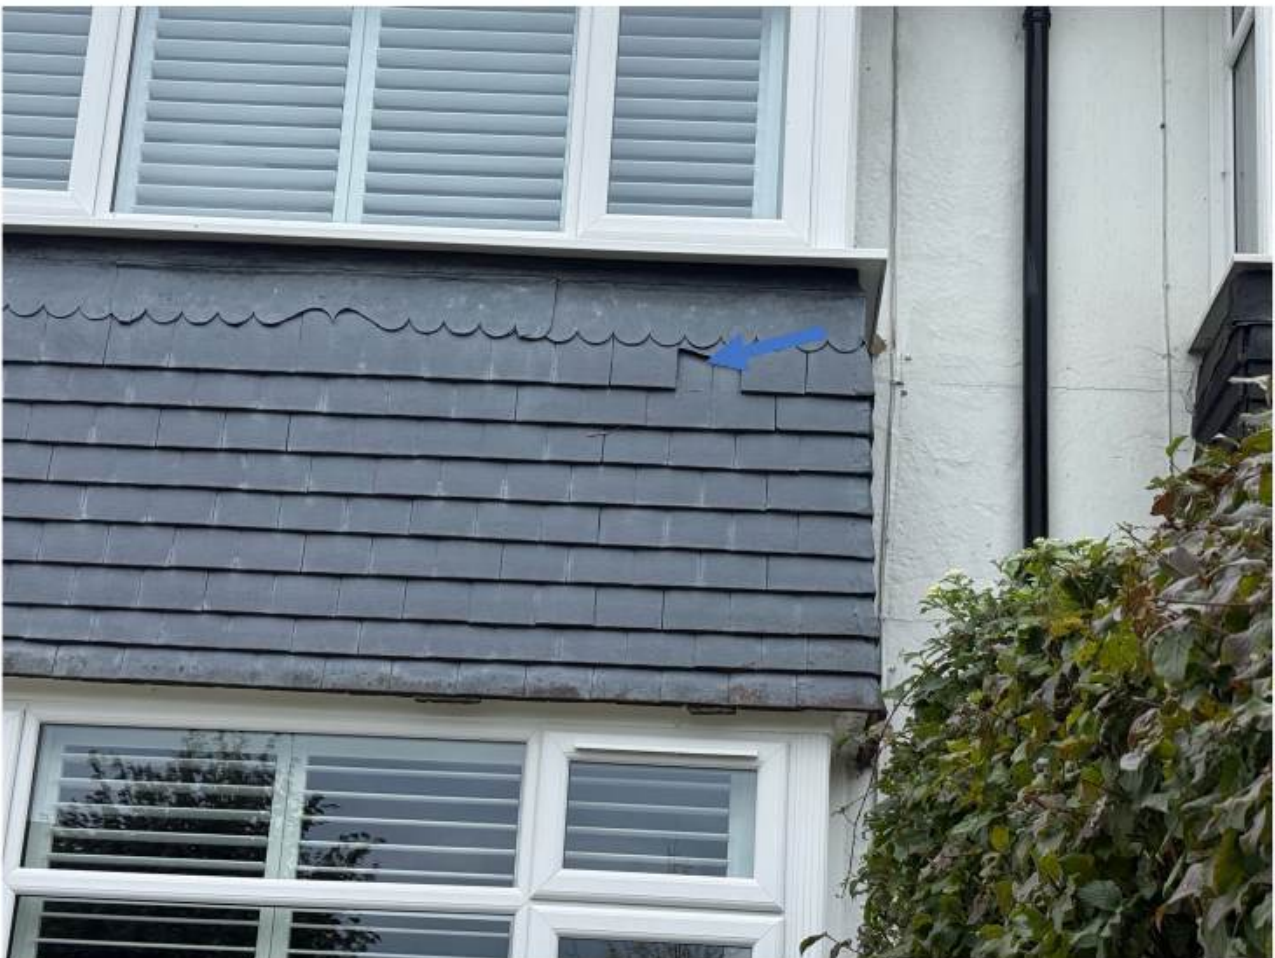
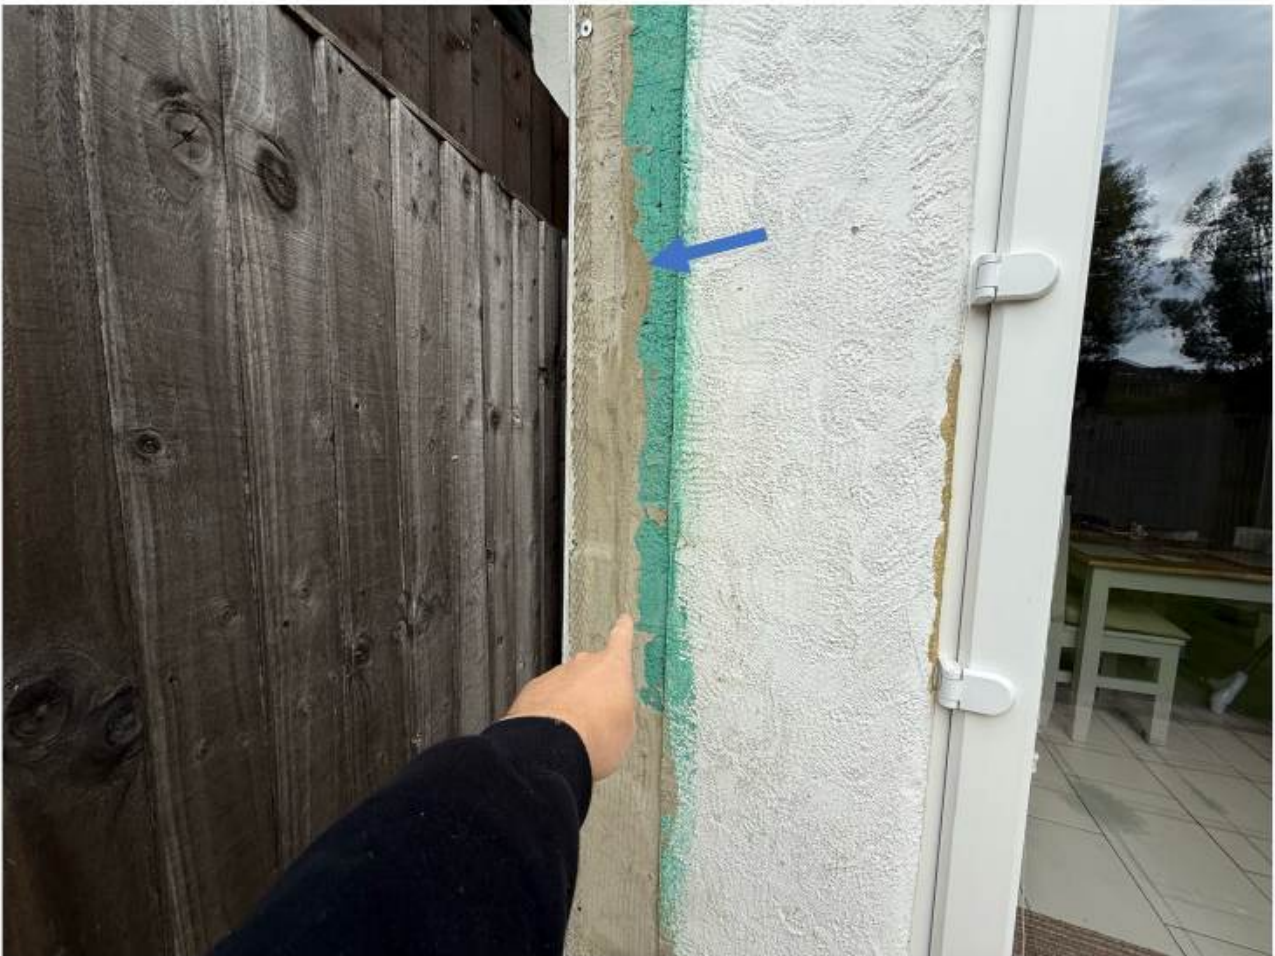
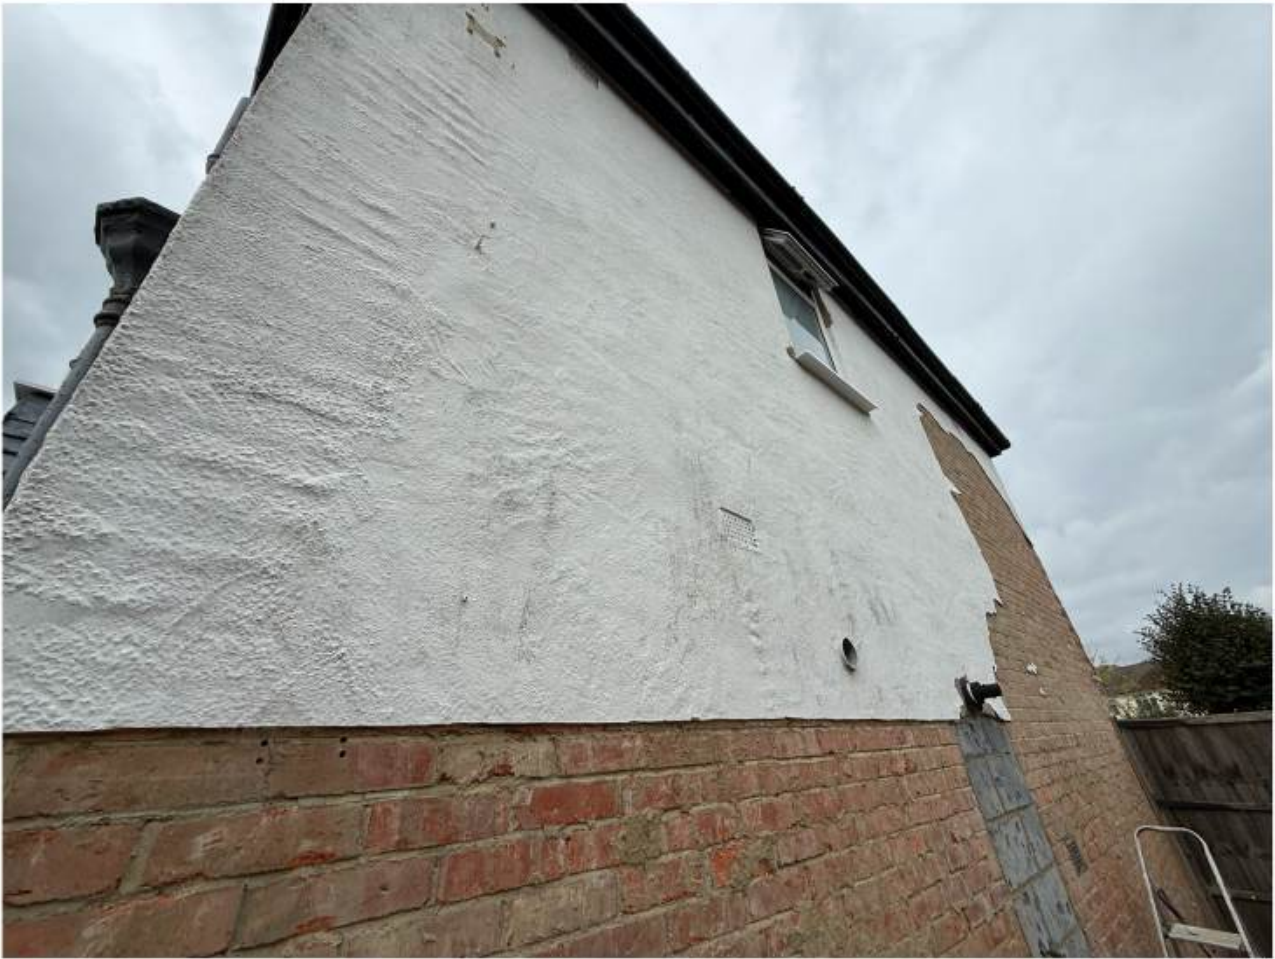
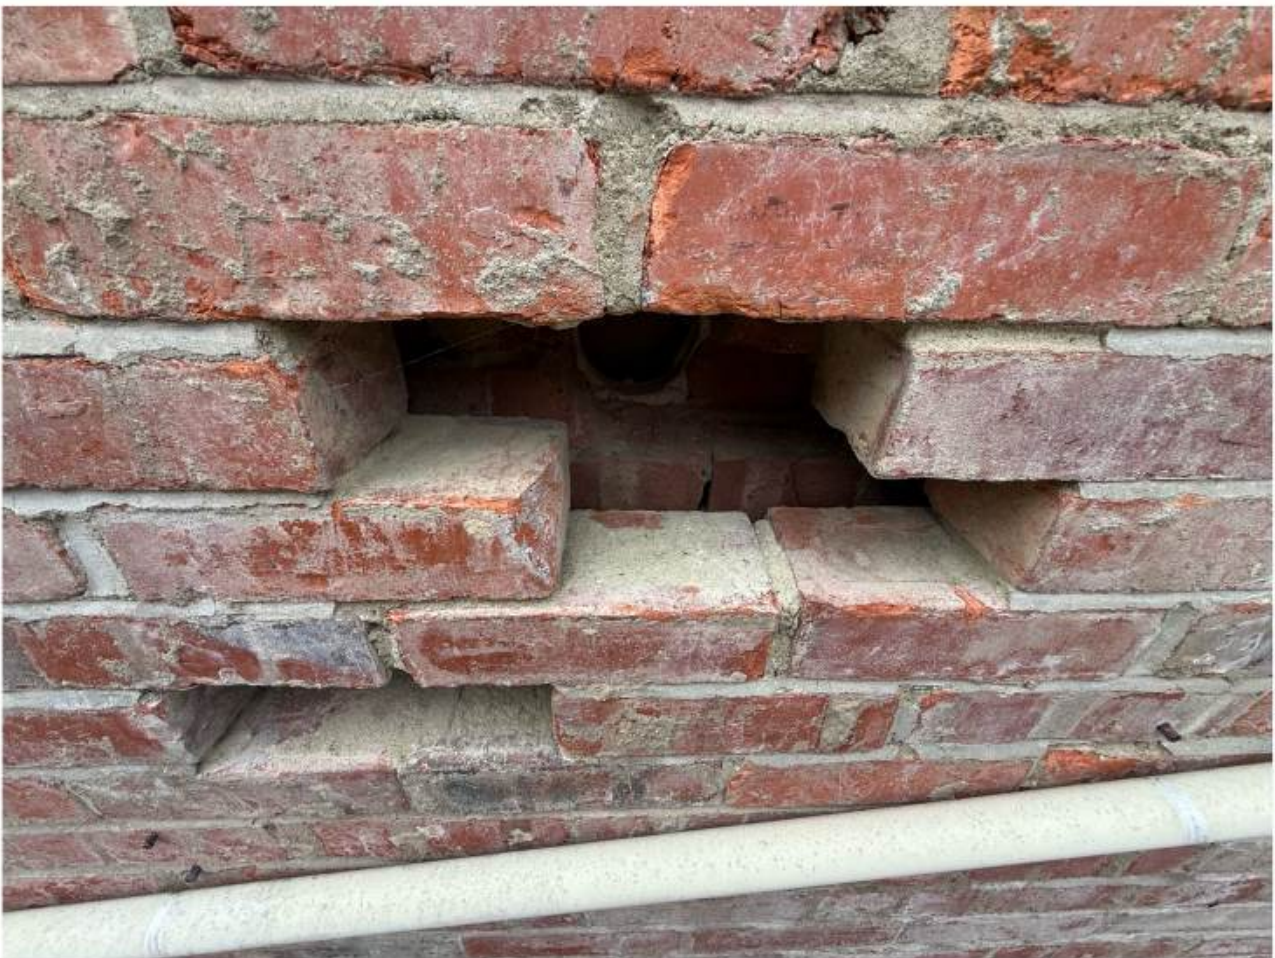
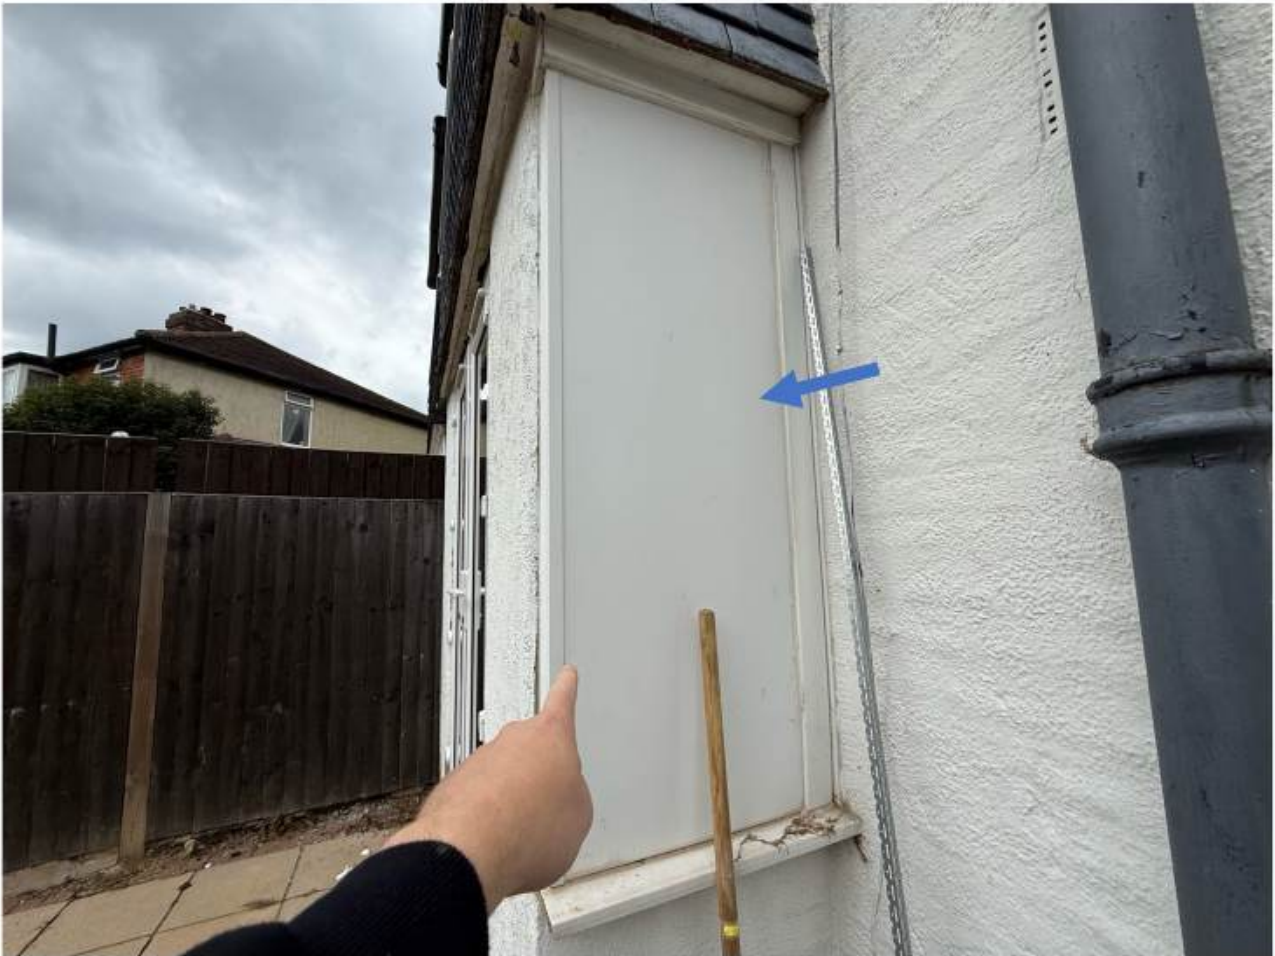
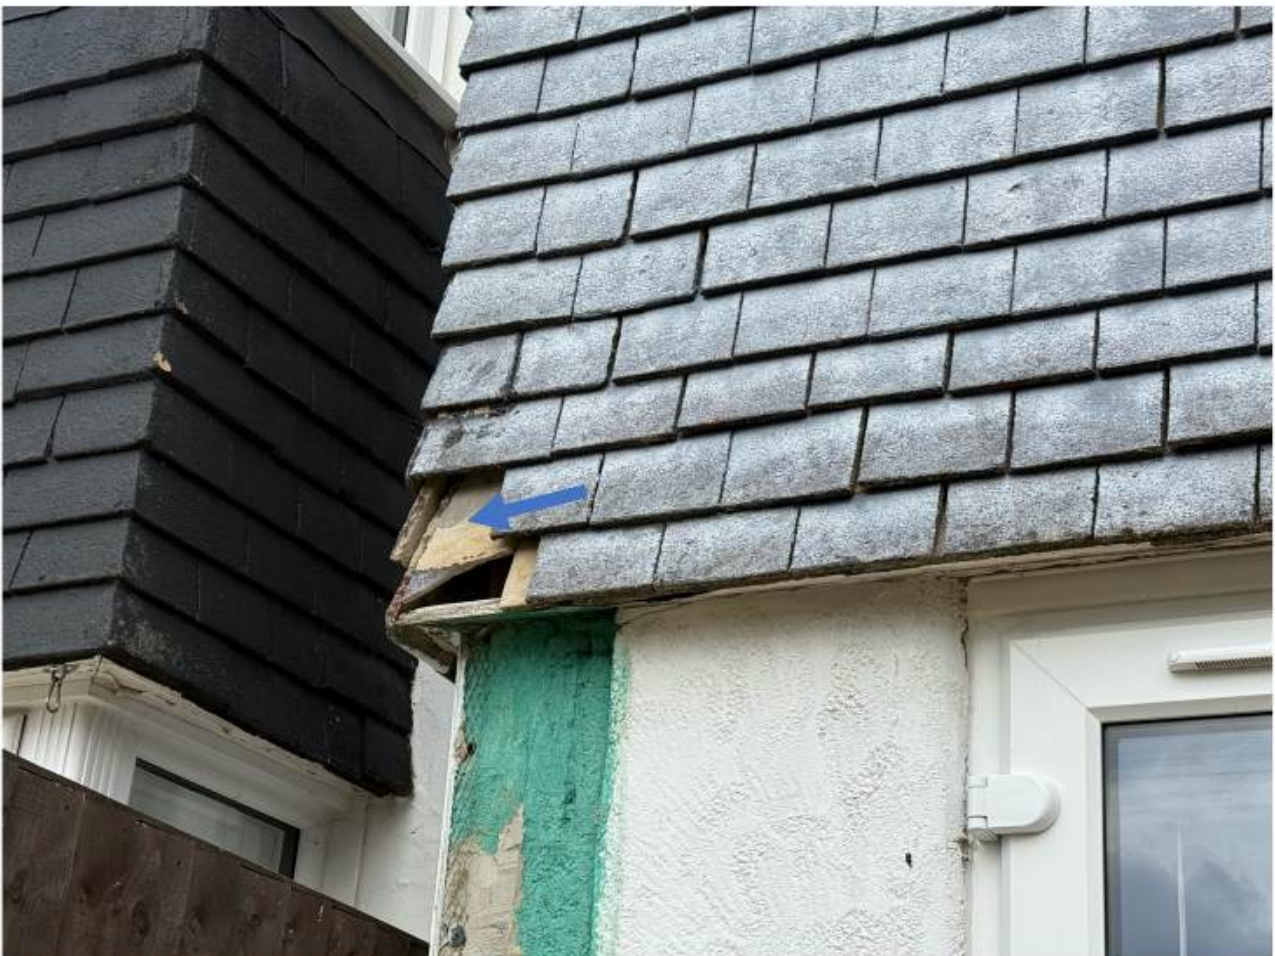
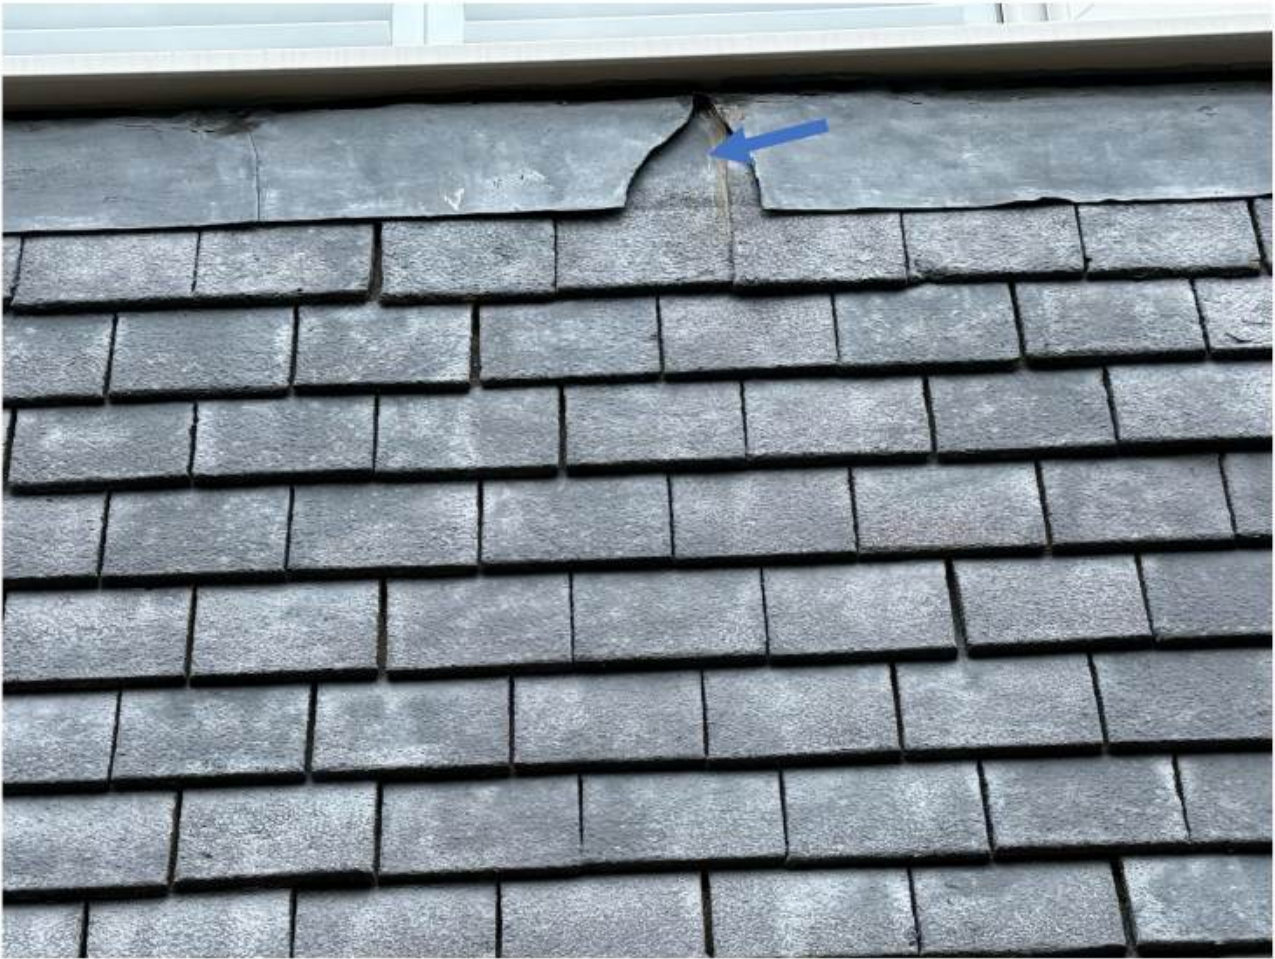
- The external render and masonry-paint finishes are in poor condition, with widespread delamination and localised sections of render already detached from the side elevation.
- Localised bricks are missing from the side wall and require reinstatement before the render is renewed.
- A poorly detailed former window opening to the rear elevation requires suitable infilling and rendering. Unfinished render adjoining the rear French doors should be completed at the same time.
- The tile-hung panels to the front and rear box-bay elevations are in poor condition and require renewal, including insulation and replacement tiles.
- Non-breathable coatings should not be applied across the lower brick courses, which should remain exposed to support natural drying.

*We estimate £15,000 to remove defective render, complete localised brick repairs, prepare the exposed masonry, apply new render coats and redecorate the elevations. We estimate a further £1,600 to renew the front and rear tile-hung panels, including insulation and replacement tiles, giving a total allowance of £16,600.*

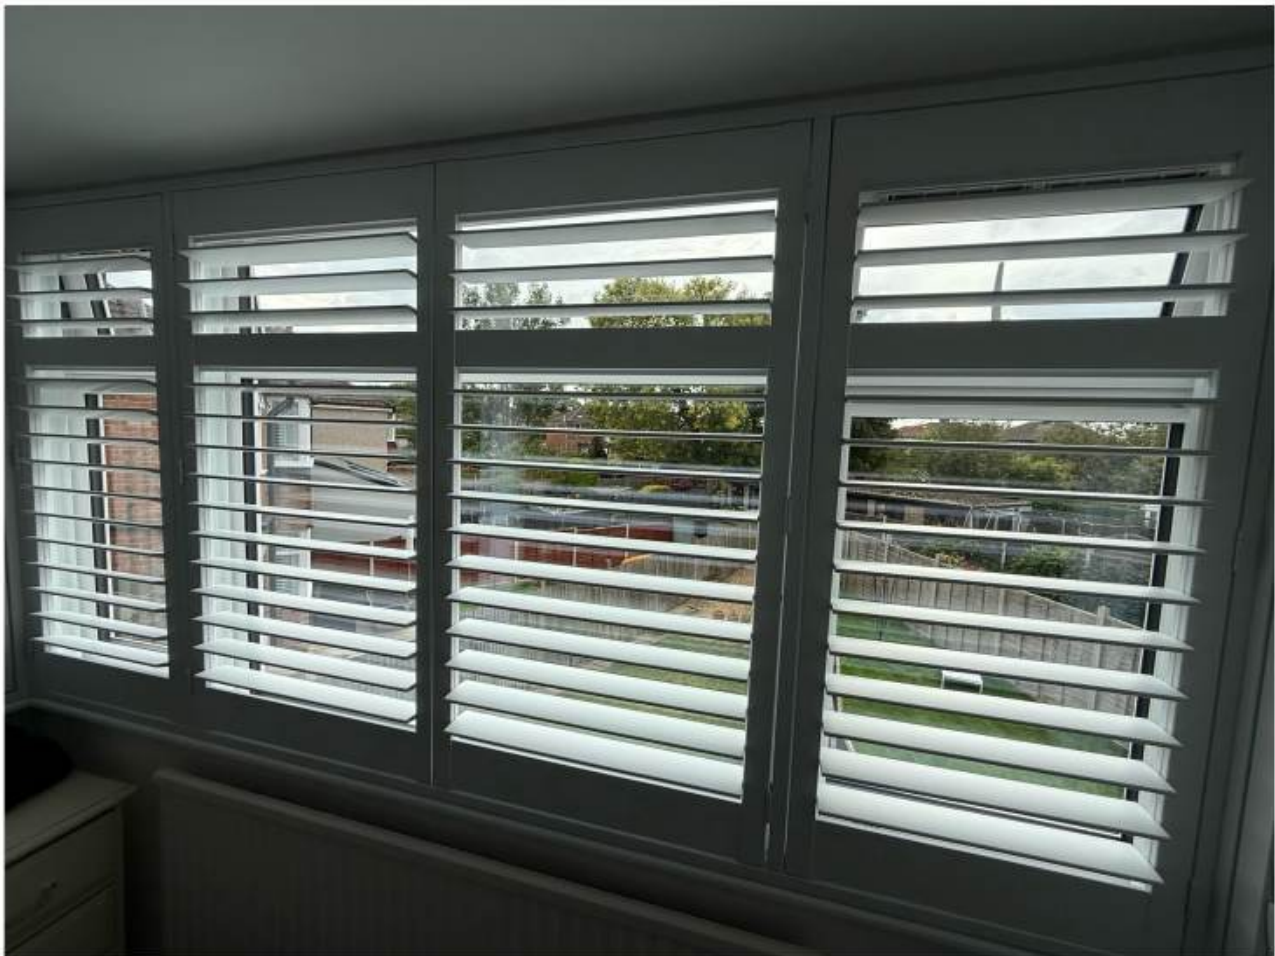
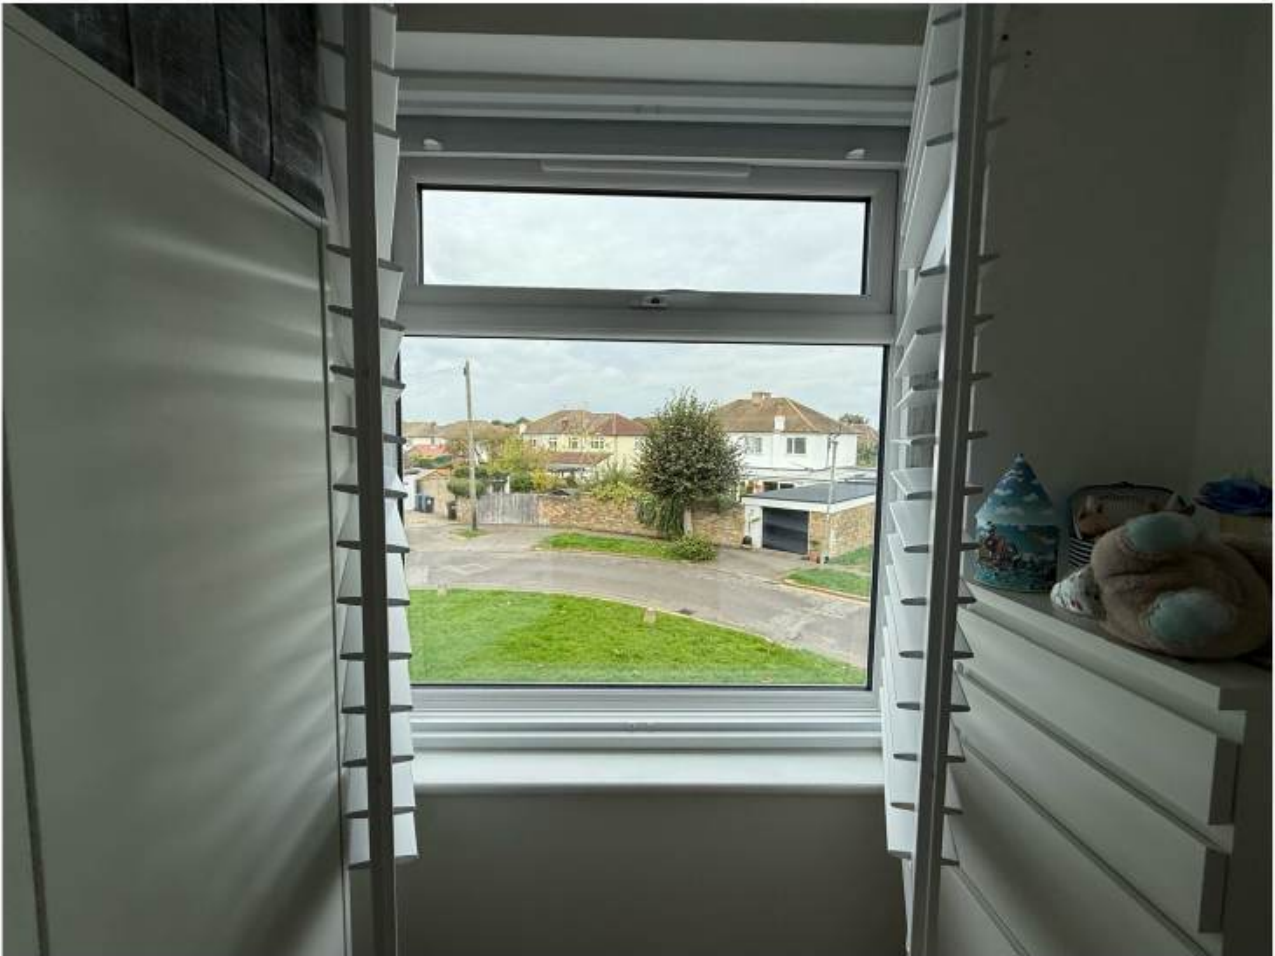
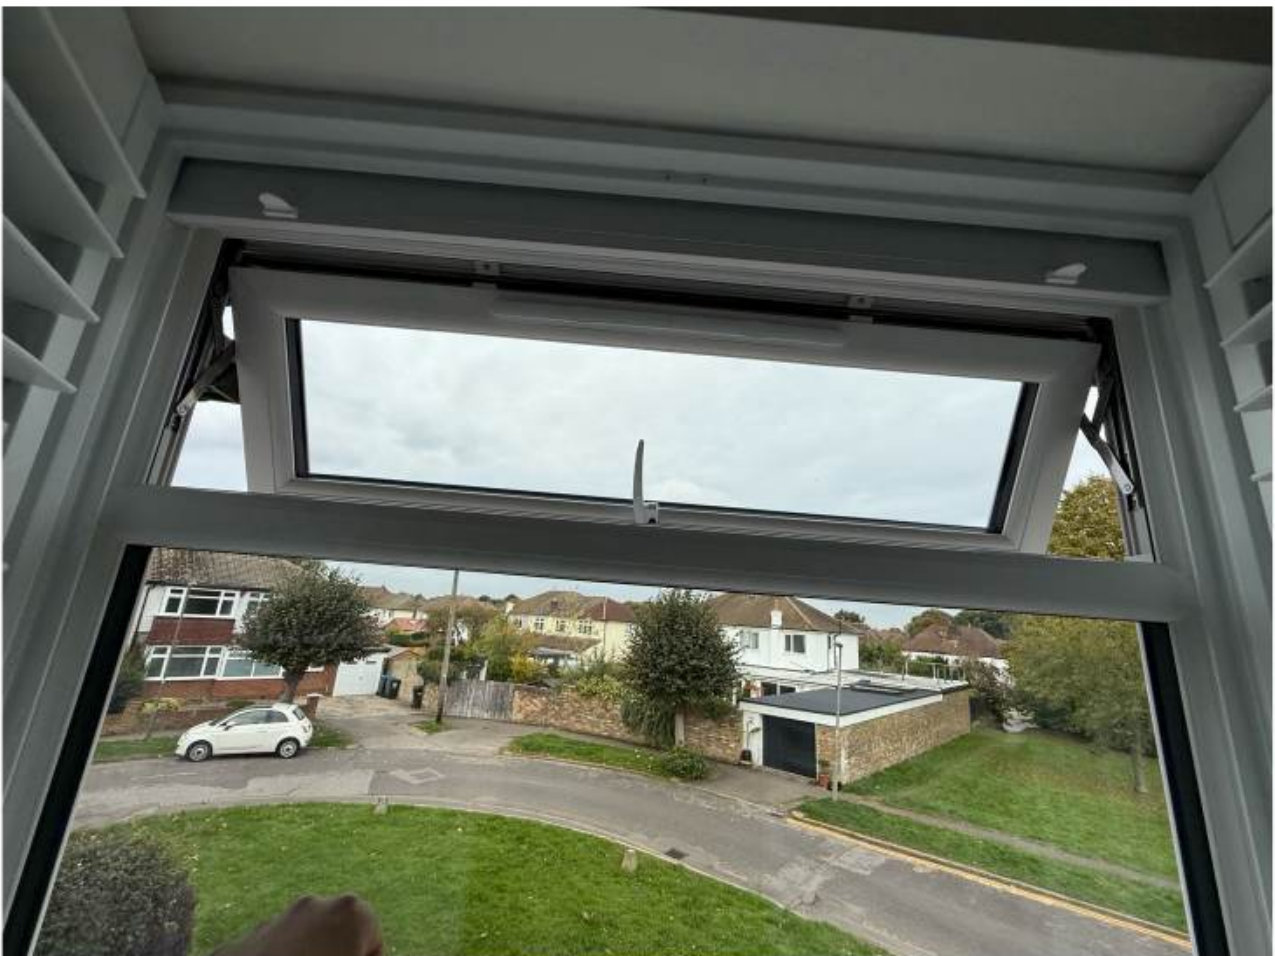
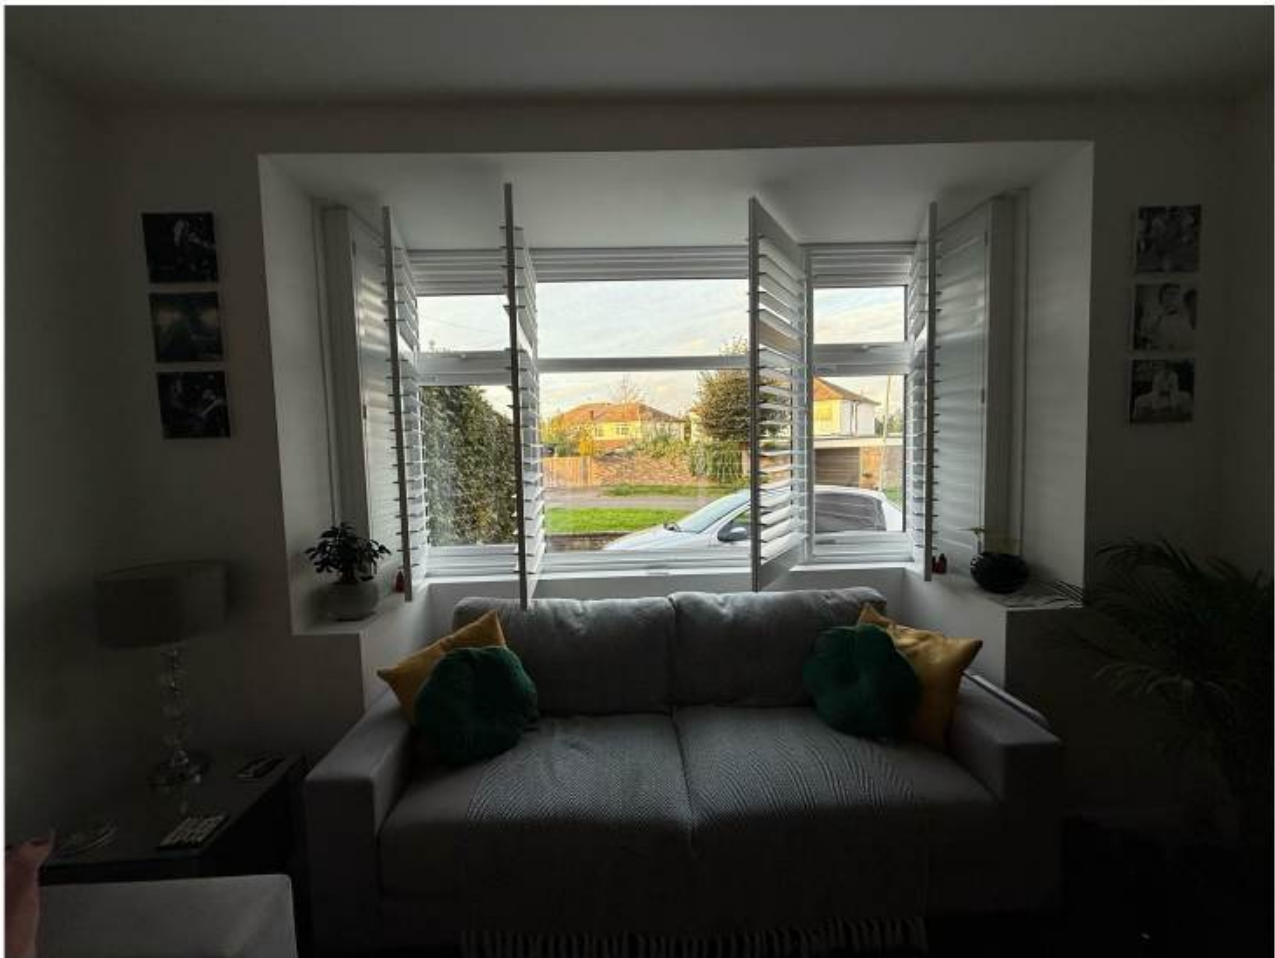
- No visible misting was identified between the panes, and no significant defects were noted to the accessible windows.
- Trickle vents, where fitted, should be kept open and the moving components cleaned and lubricated periodically.

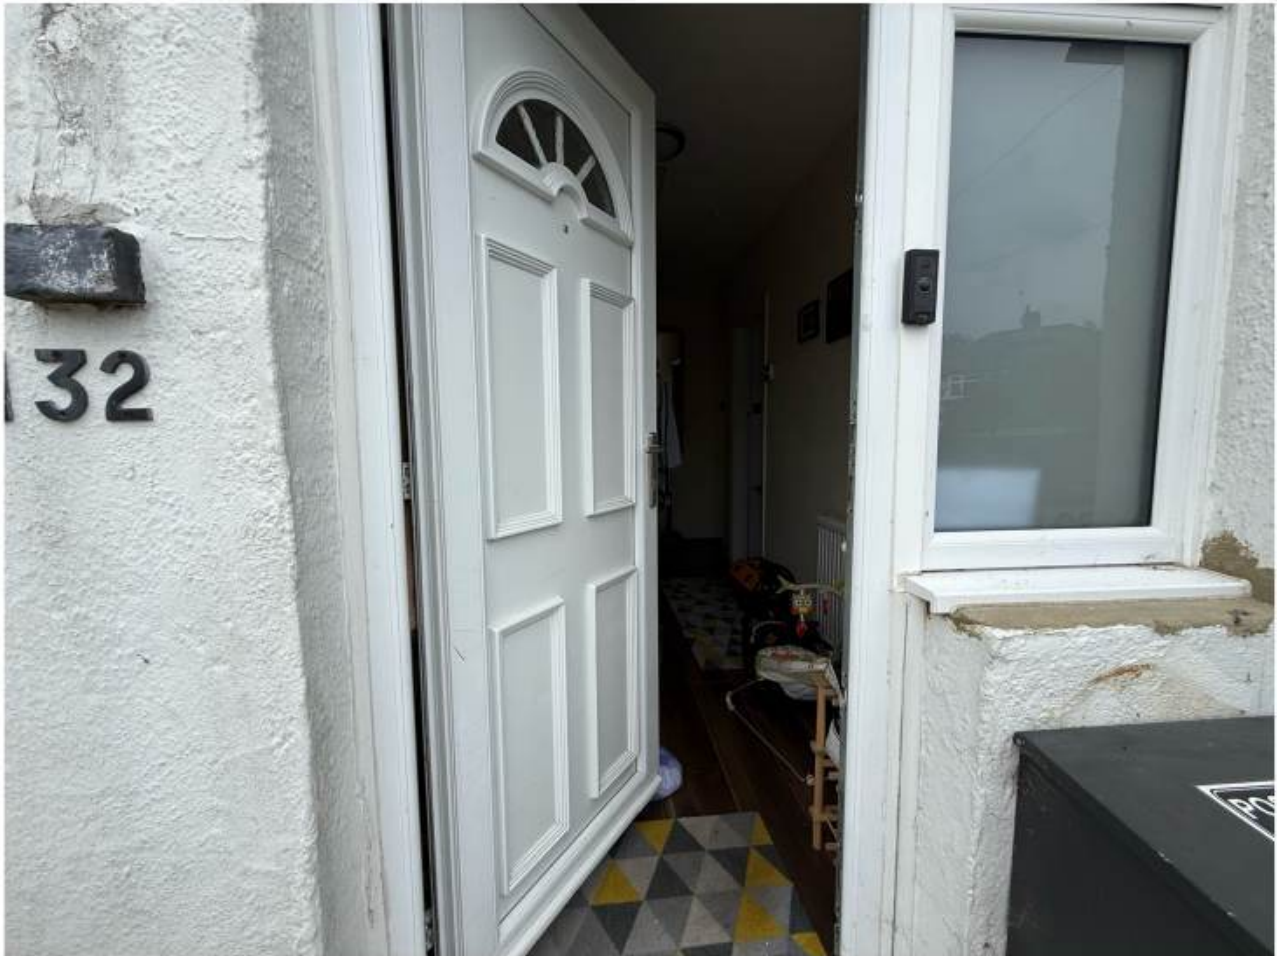
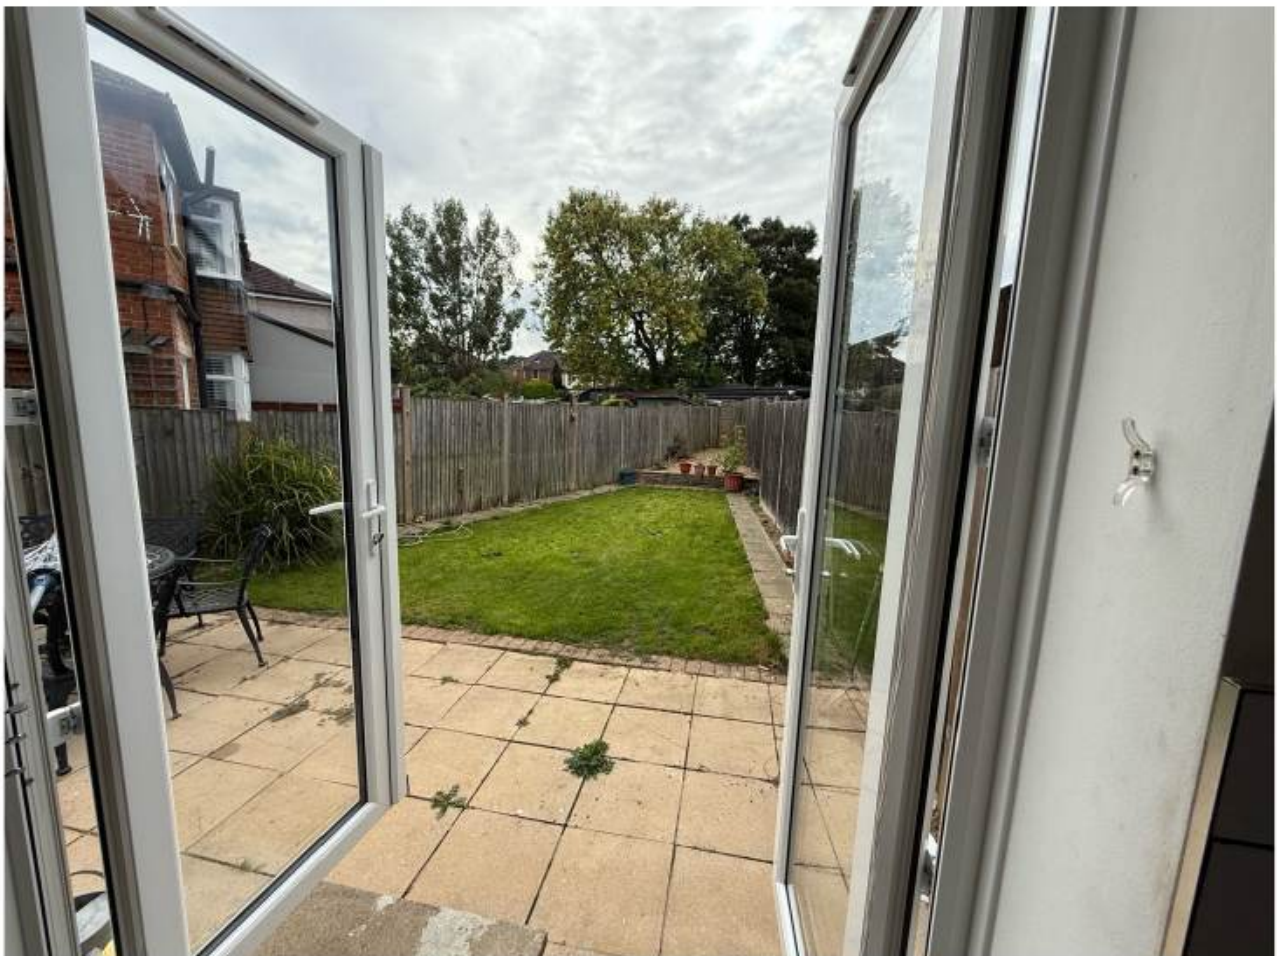
- No significant defects were identified during the visual inspection.
- Hinges, handles, locks and multi-point mechanisms should be cleaned, adjusted and lubricated as part of routine maintenance.

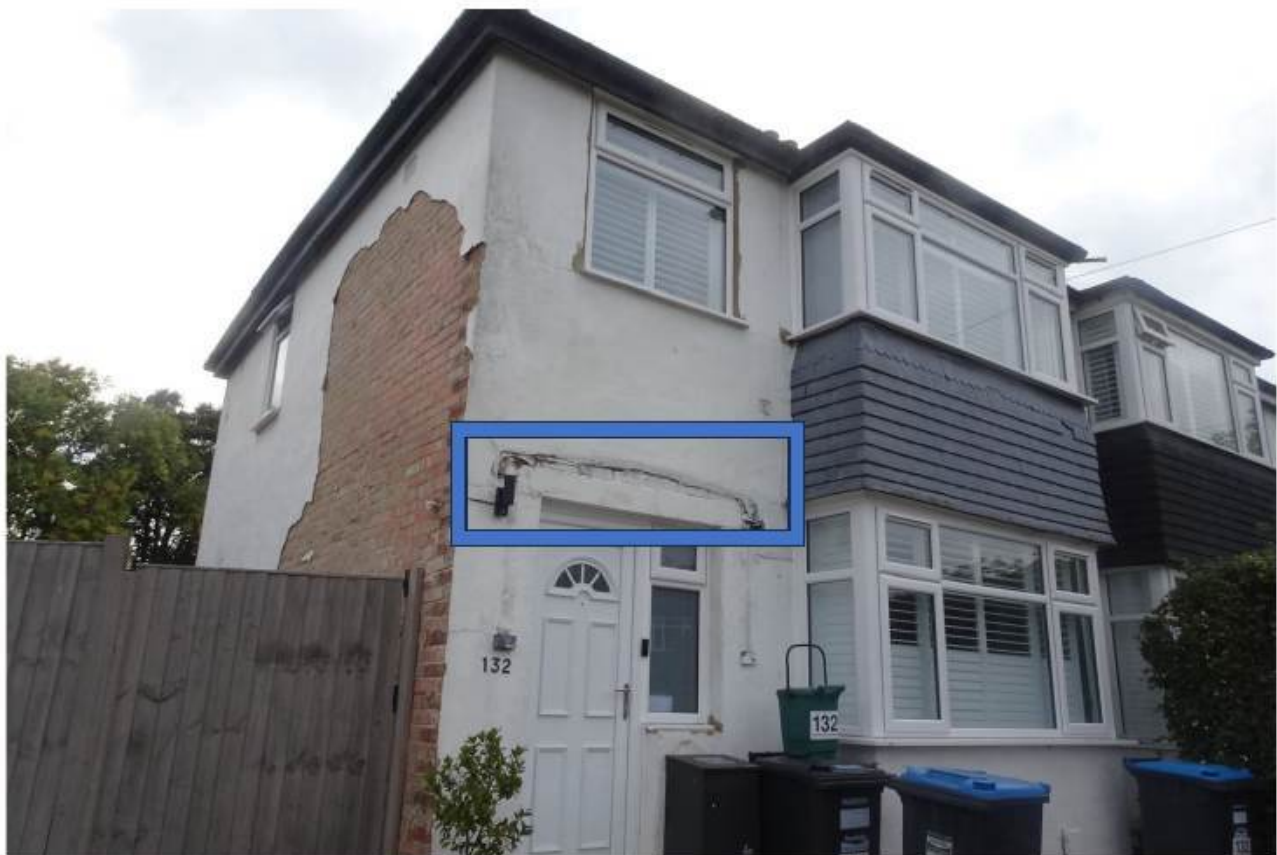
- The former porch is no longer present. Reinstatement would be discretionary rather than an essential repair.

We estimate £4,000 to construct a replacement porch of a similar form, if required.
