**VANGUARD**  
PROPERTY SURVEYORS

# LEVEL 3 Home Survey Report

Property Address:  
**Green Gardens, Wharlingham, CR8 9PQ**

Date of Inspection:  
**Wednesday 1<sup>st</sup> October 2025**

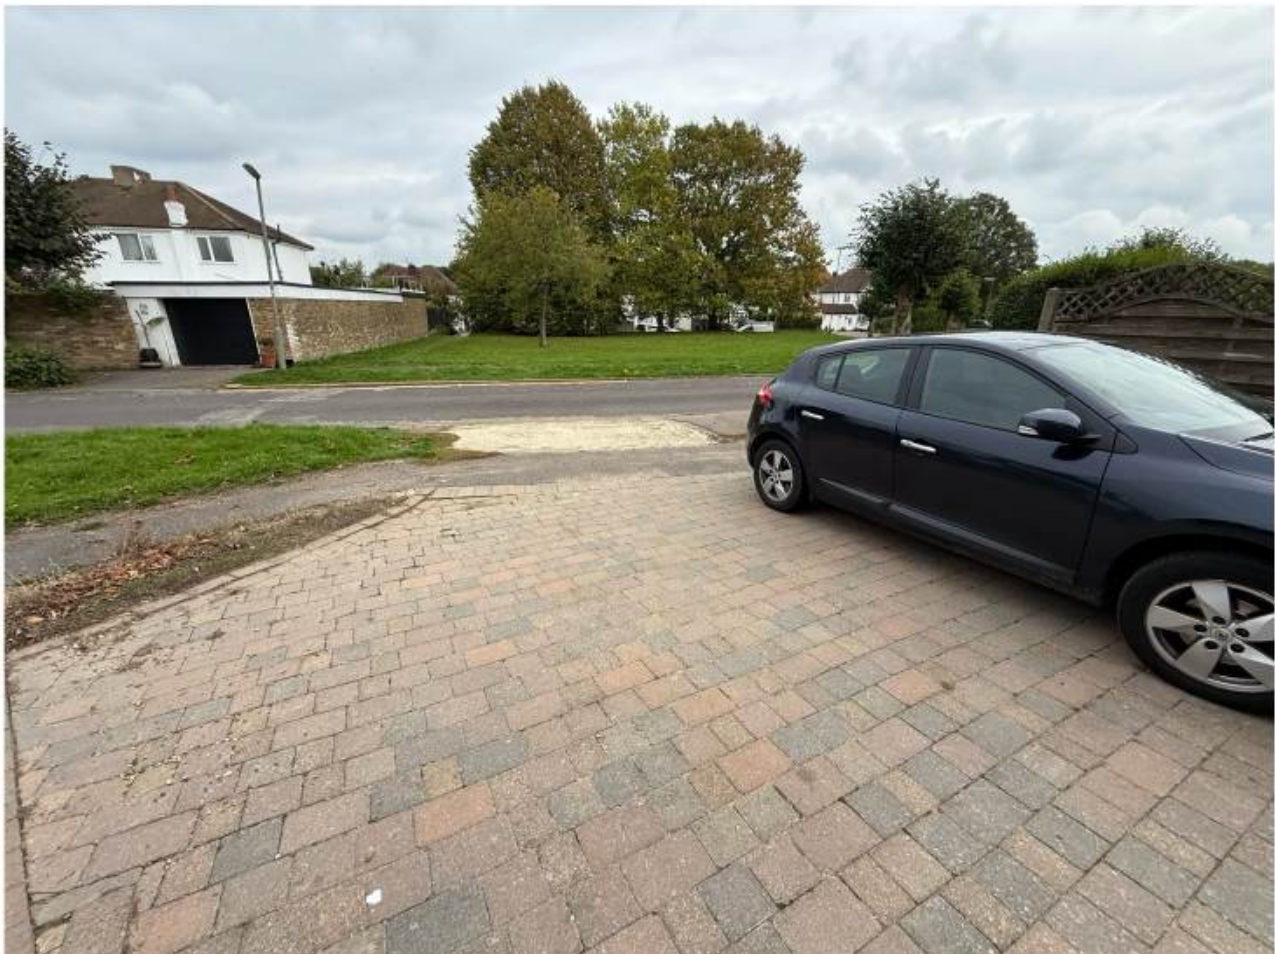
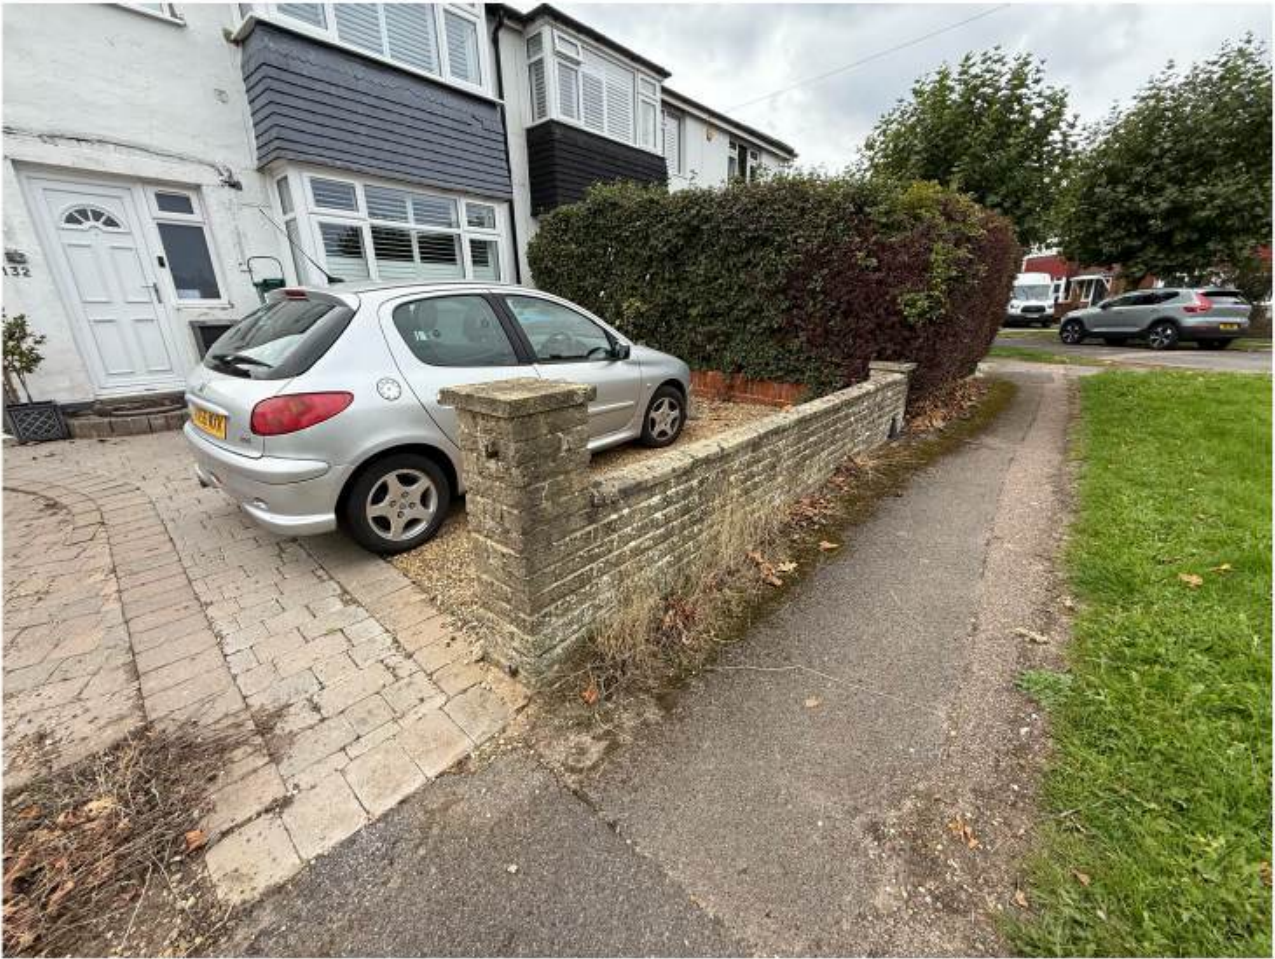
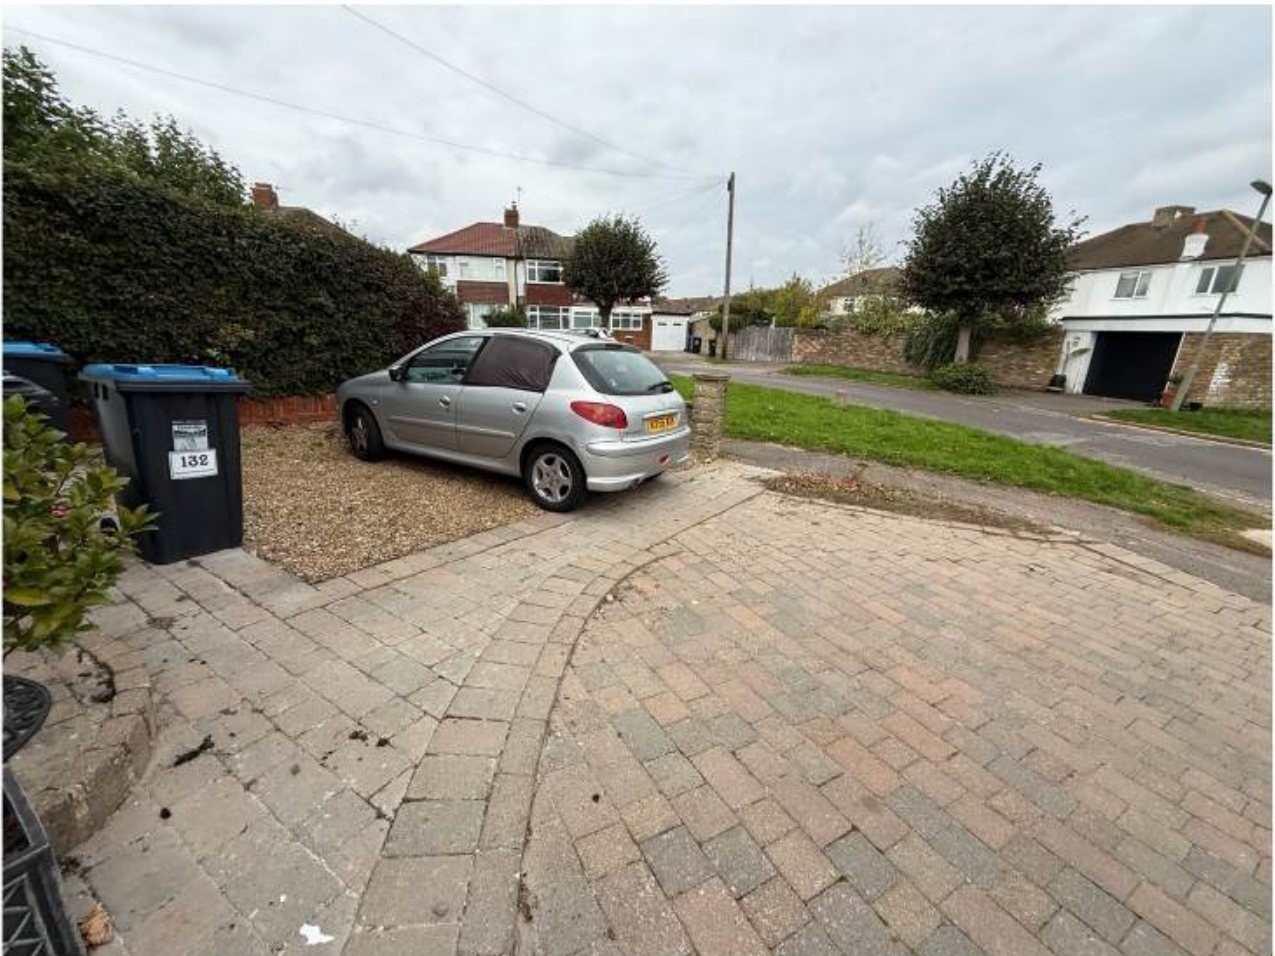
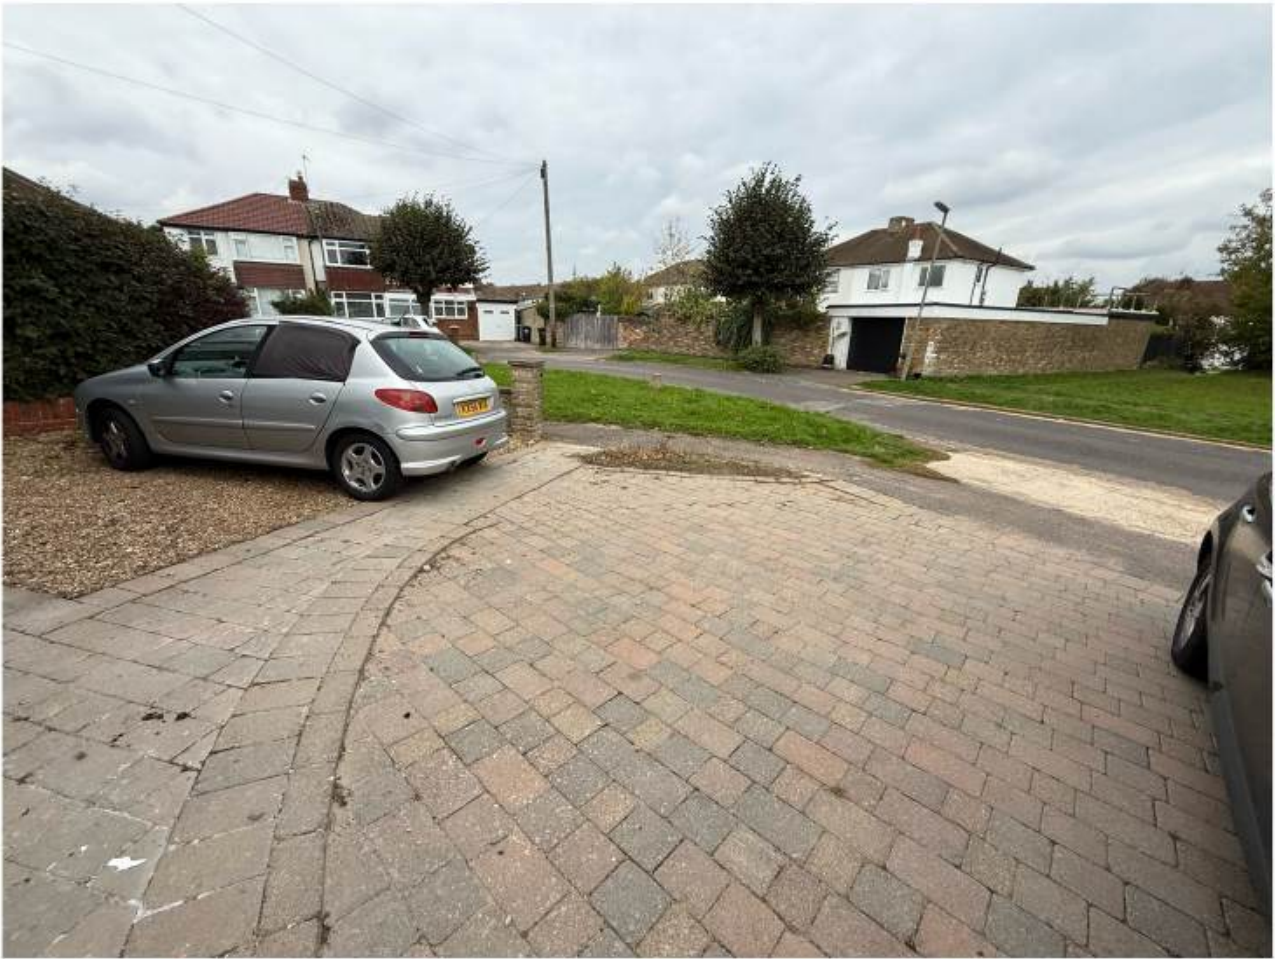
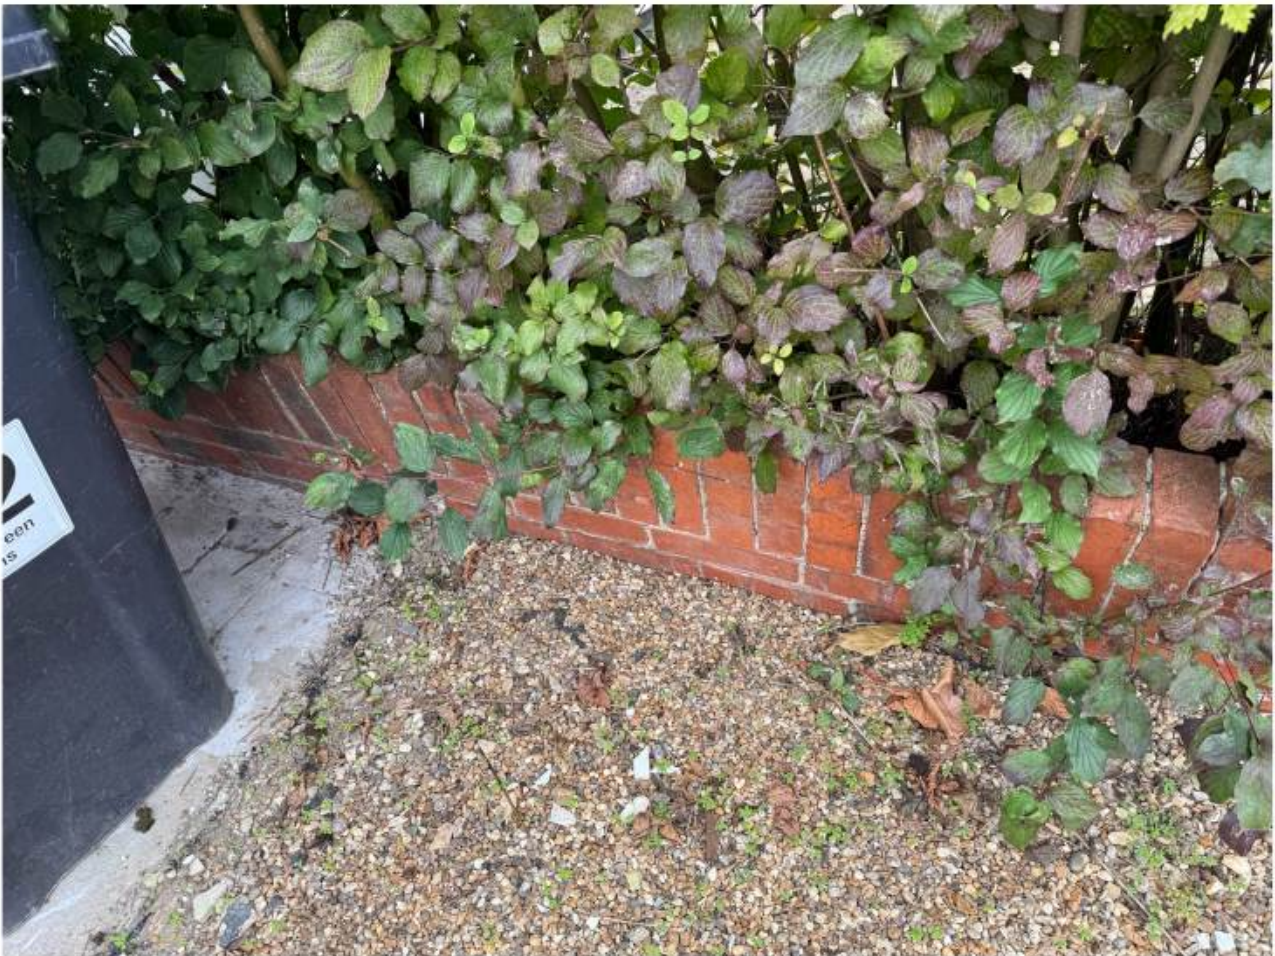
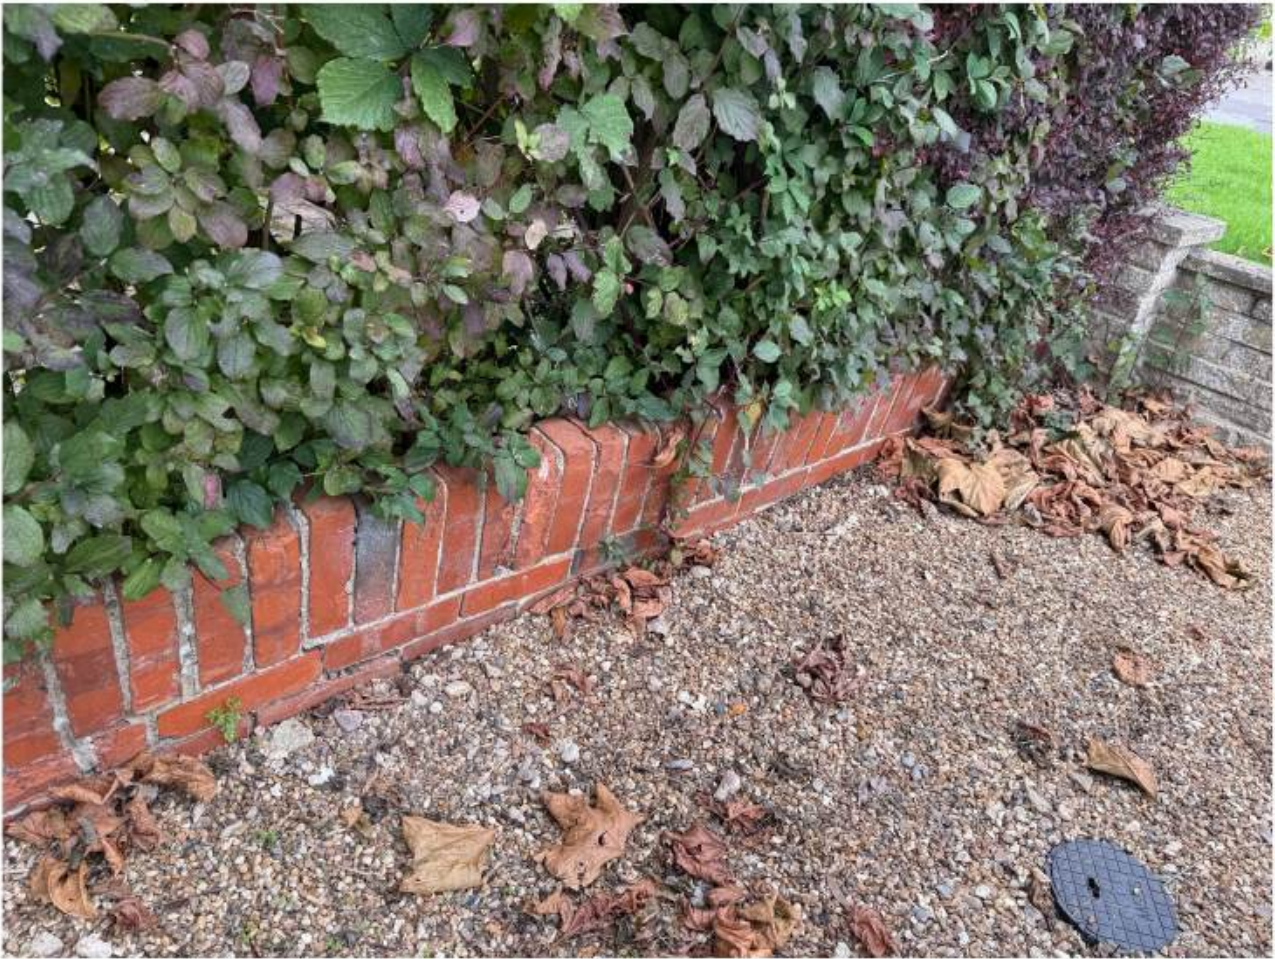
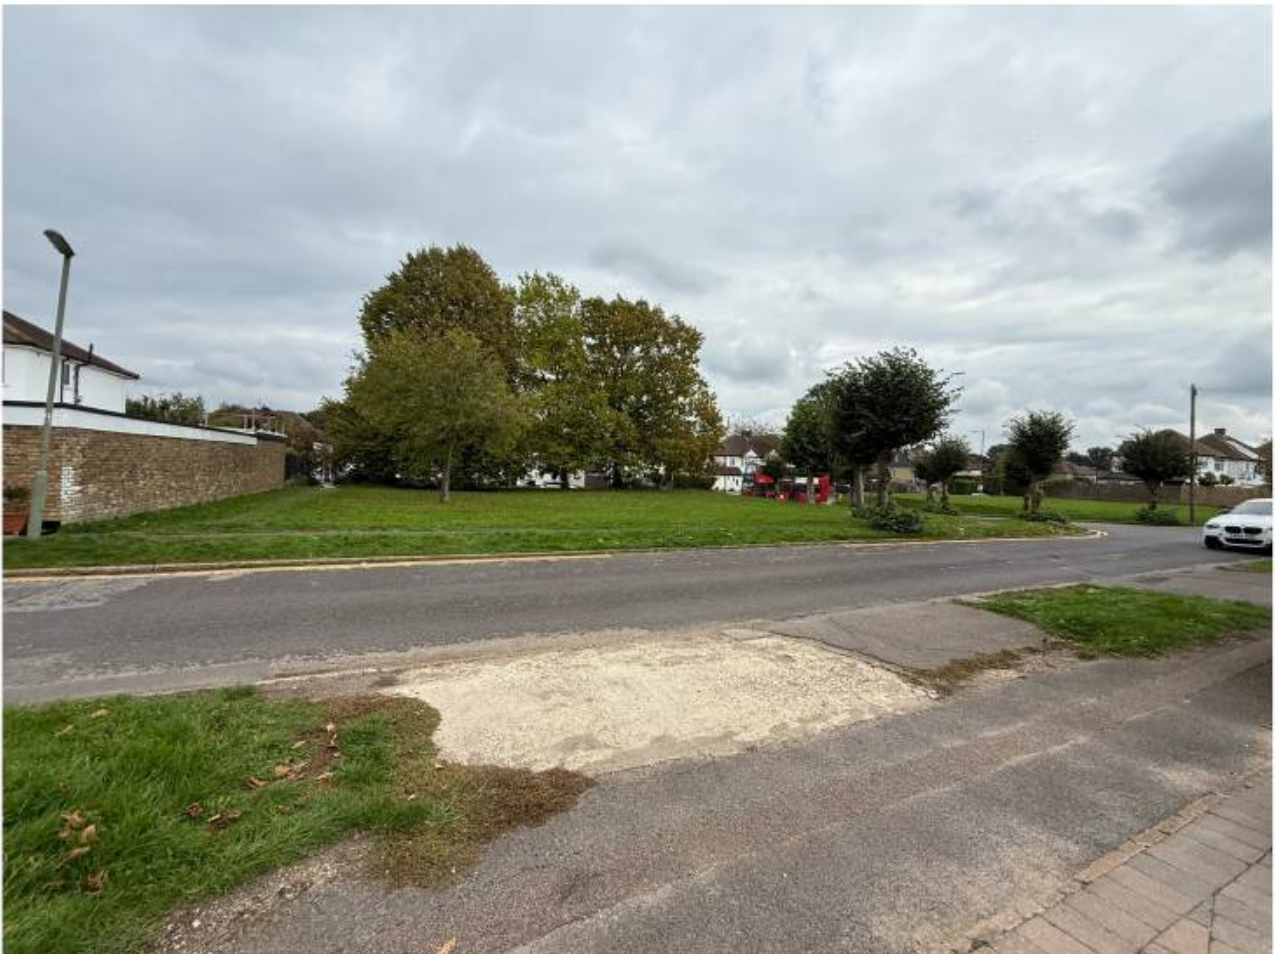
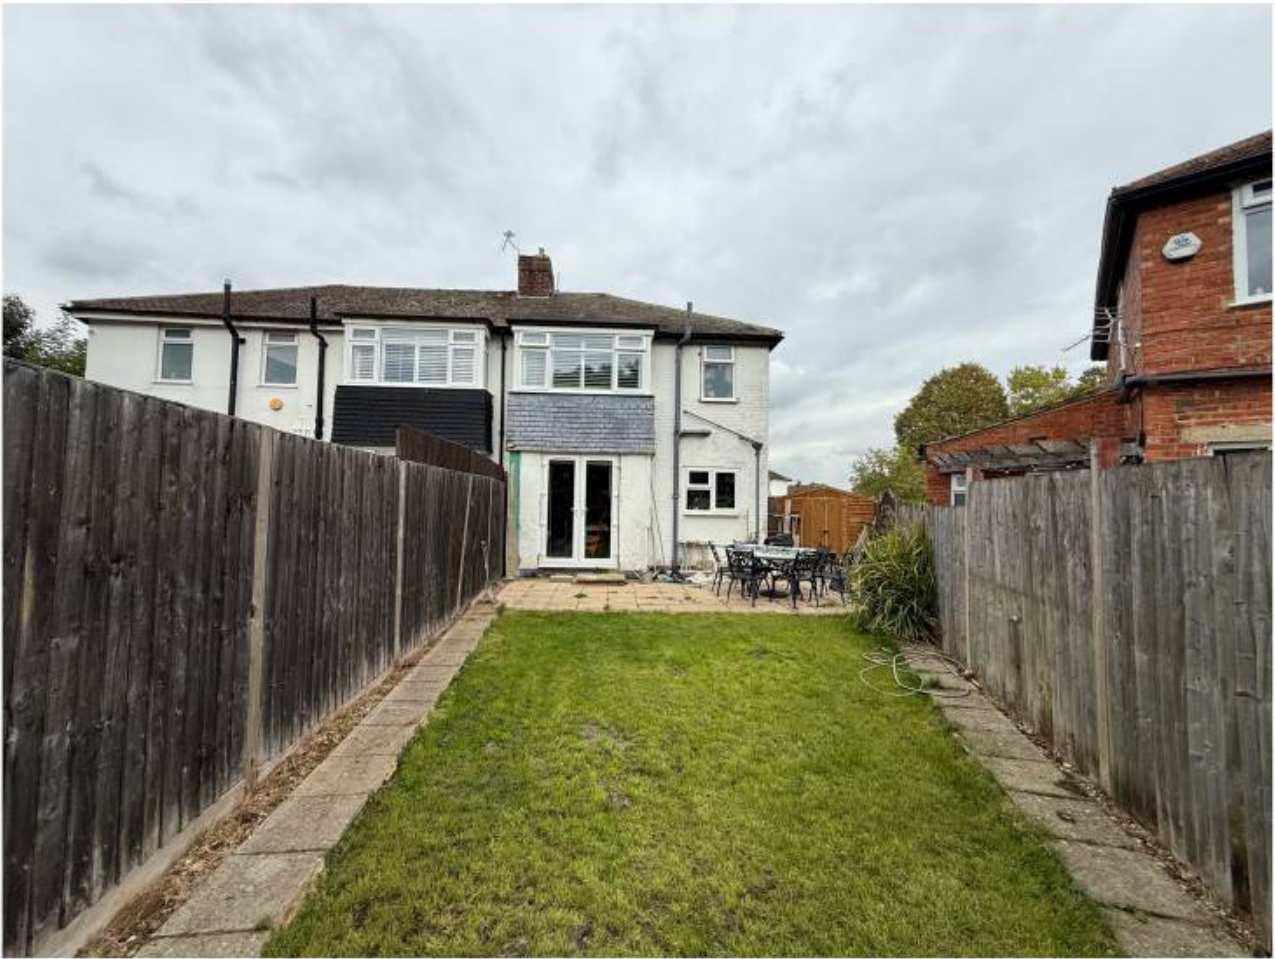
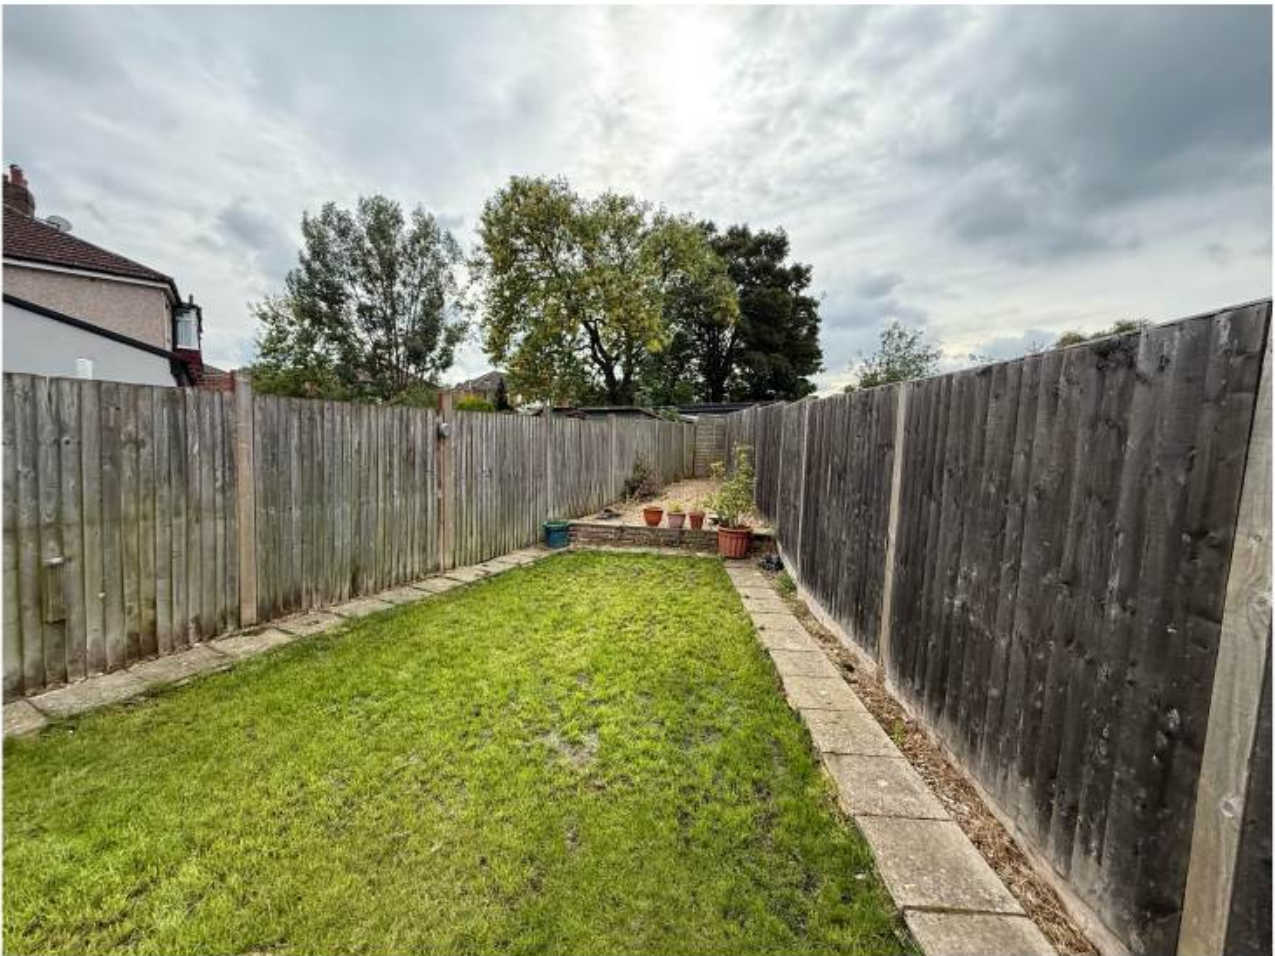
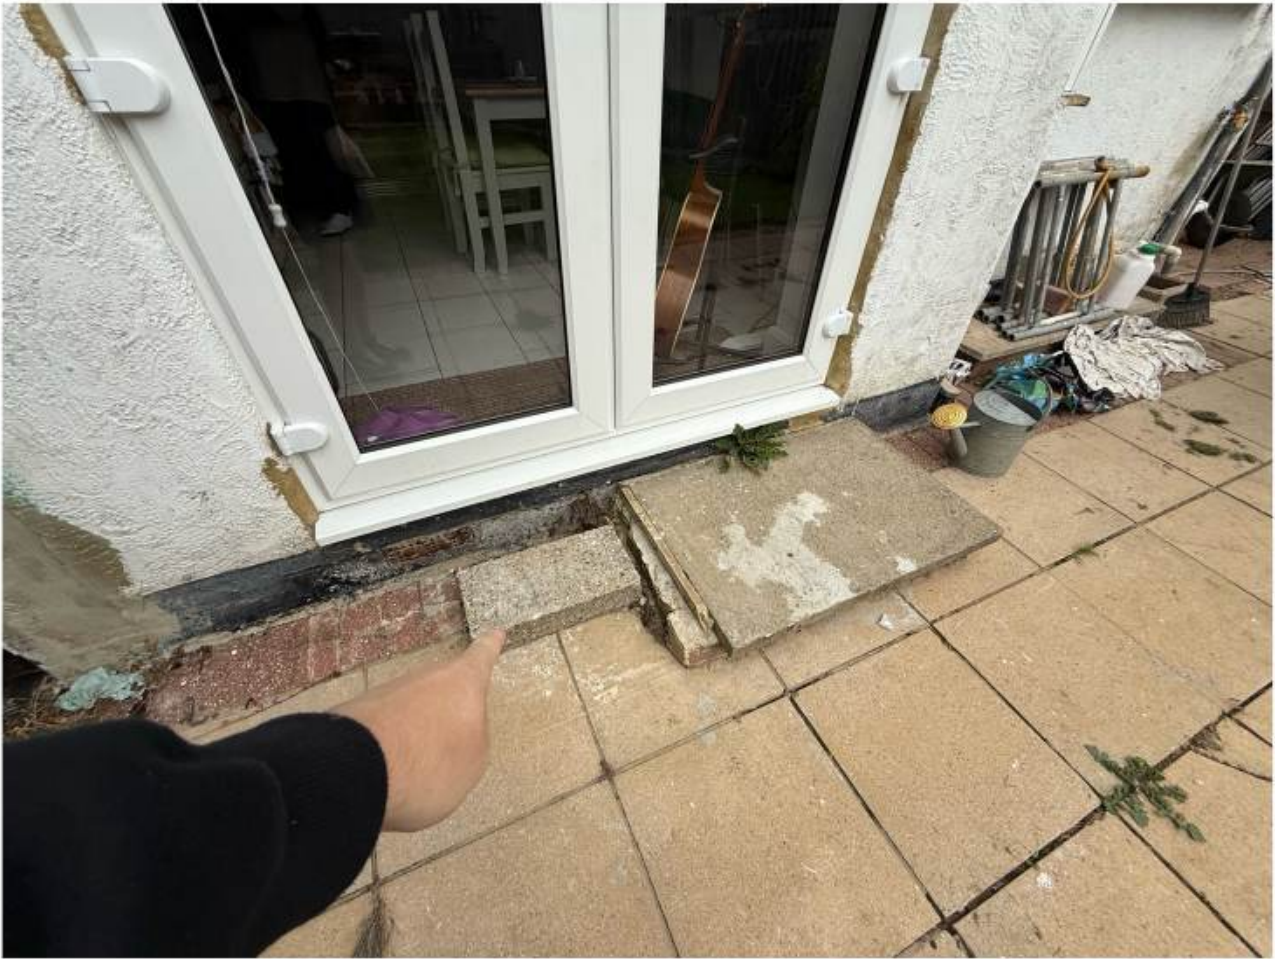
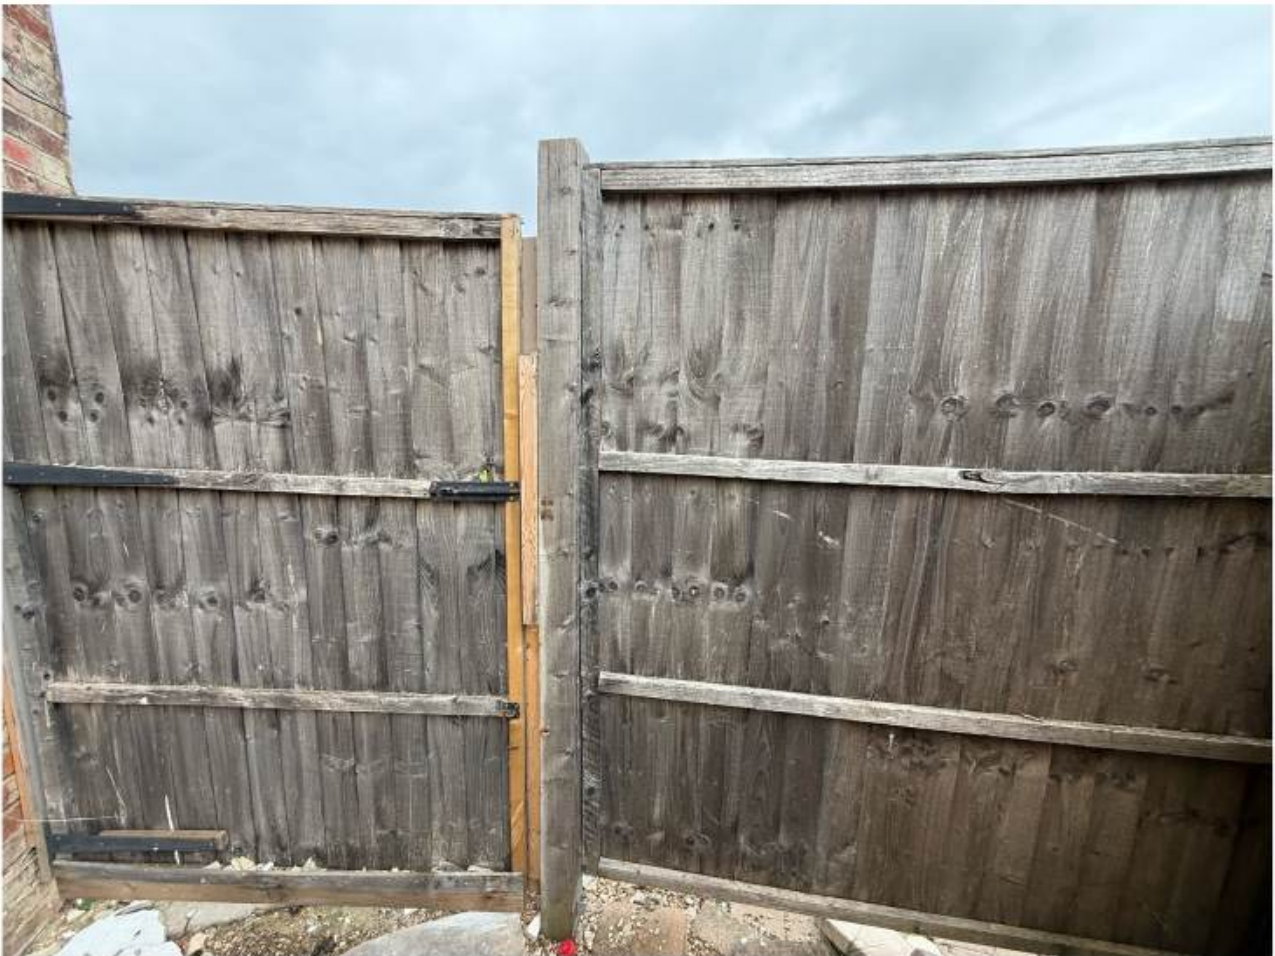
- The low red stock-brick wall to the right-hand front boundary is in poor condition and requires repair, renewal or removal.
- The former rear step has been removed, apparently to avoid obstructing the adjoining air bricks. A replacement step should incorporate suitable ventilation openings so that subfloor airflow is maintained.
- General wear is present to the rear boundaries and hard landscaping, although the remaining elements are serviceable.
- No visible Japanese knotweed, giant hogweed or other invasive plant growth was identified within the accessible grounds. This was a visual inspection only.

*We estimate £1,600 to repair or renew the defective front boundary wall and reinstate the rear step with suitable provision for subfloor ventilation.*

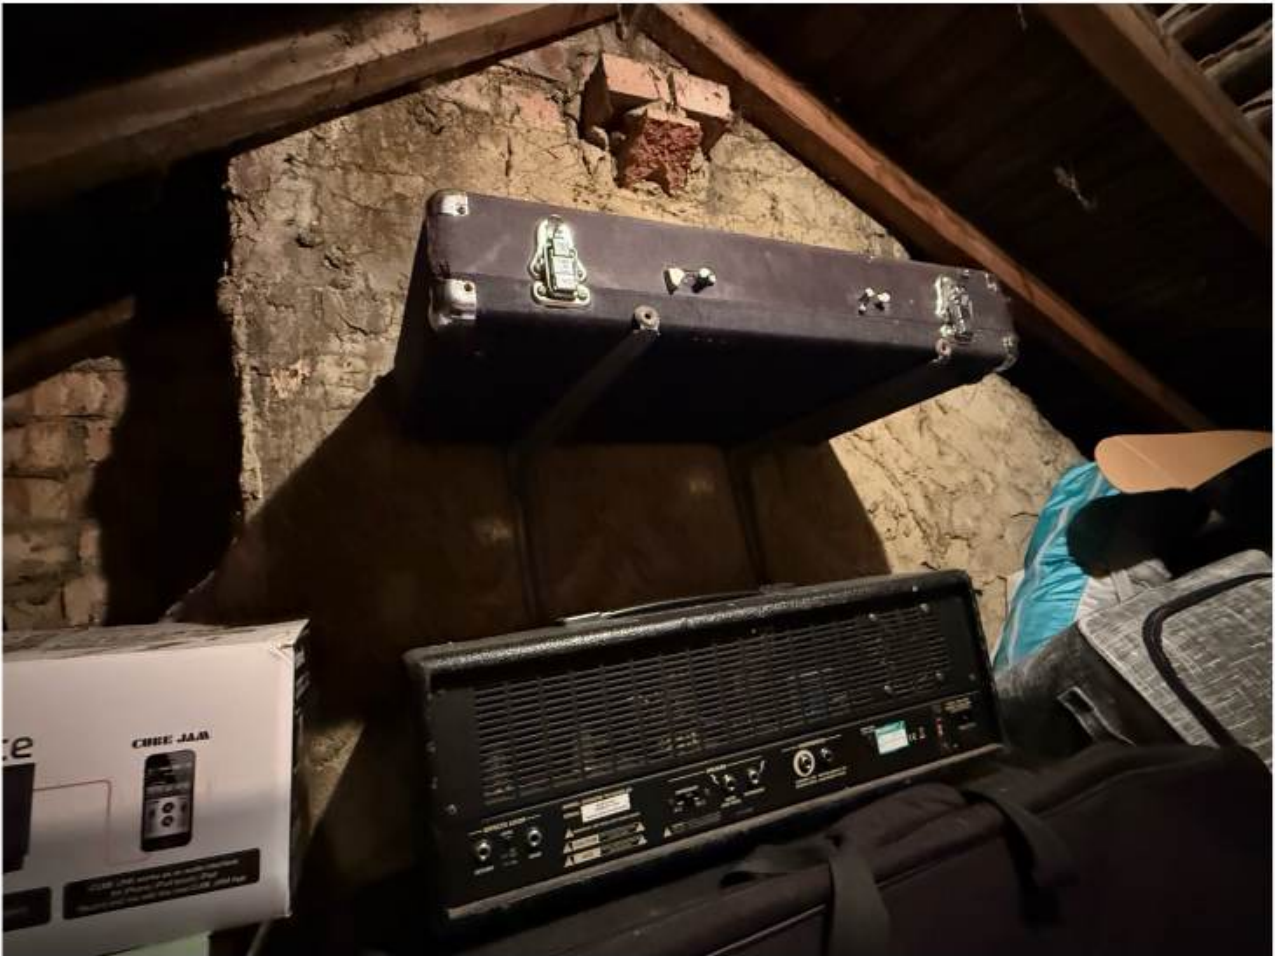
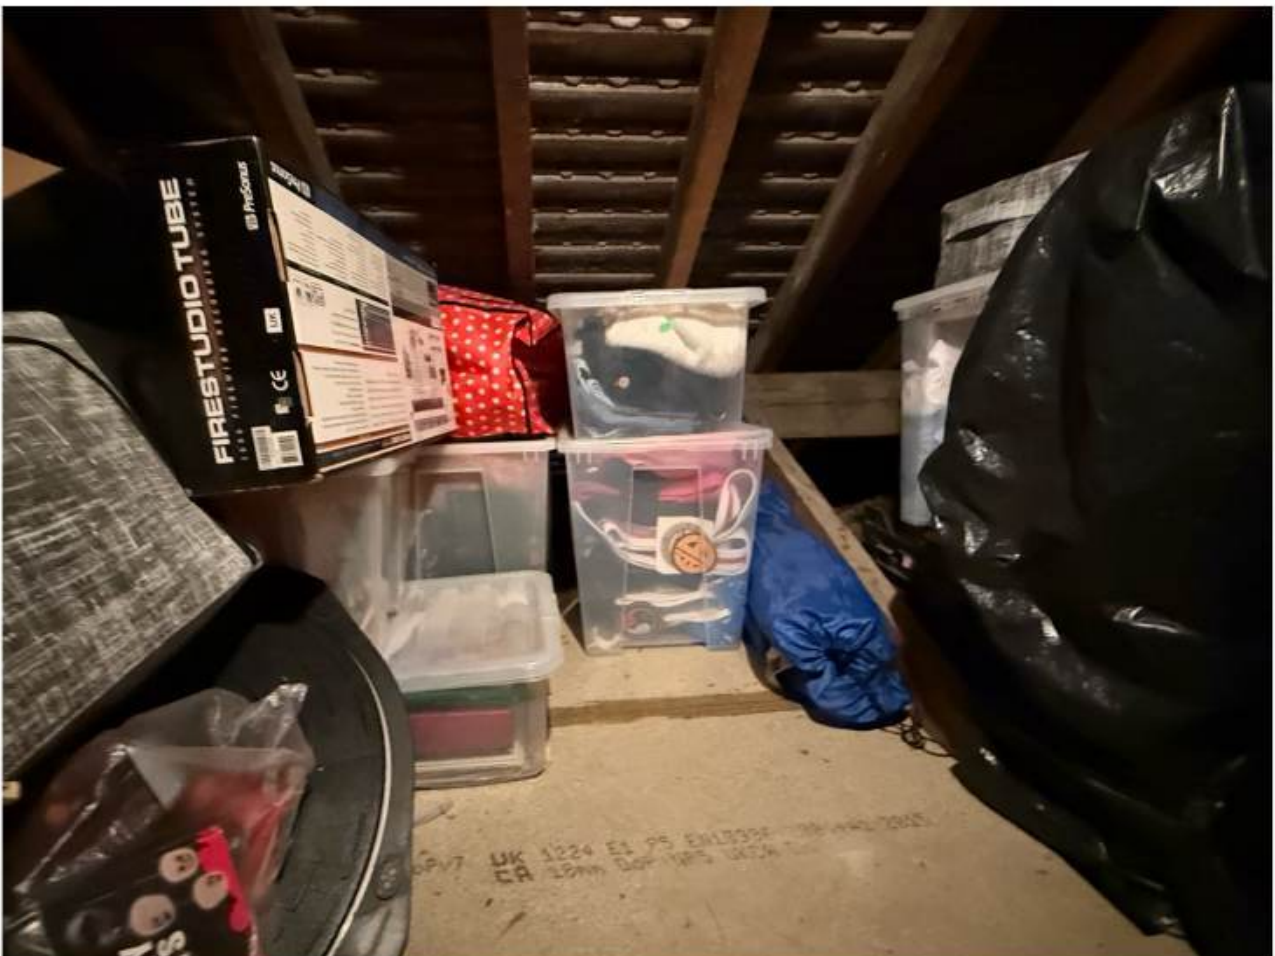
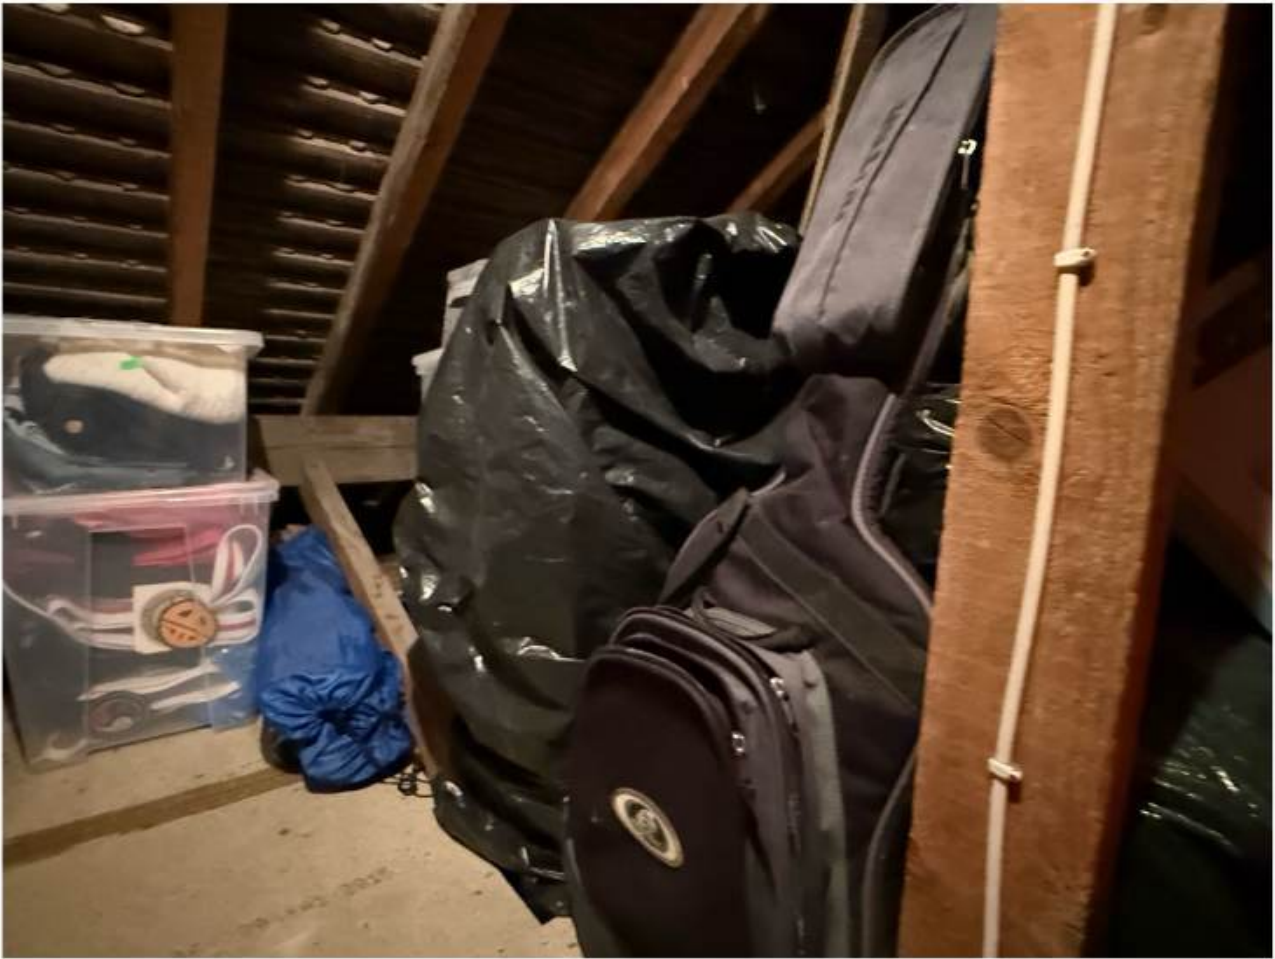
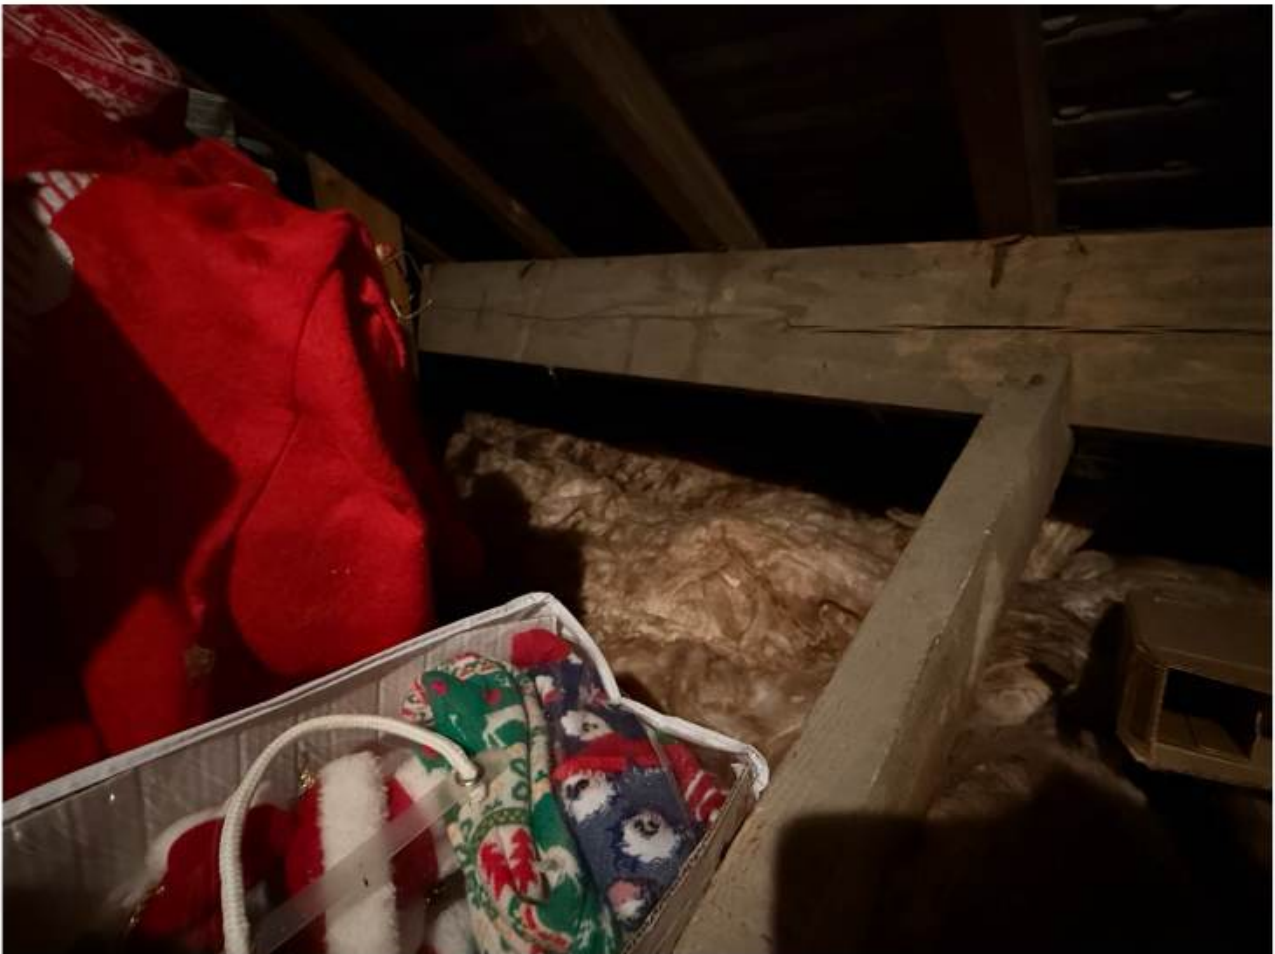
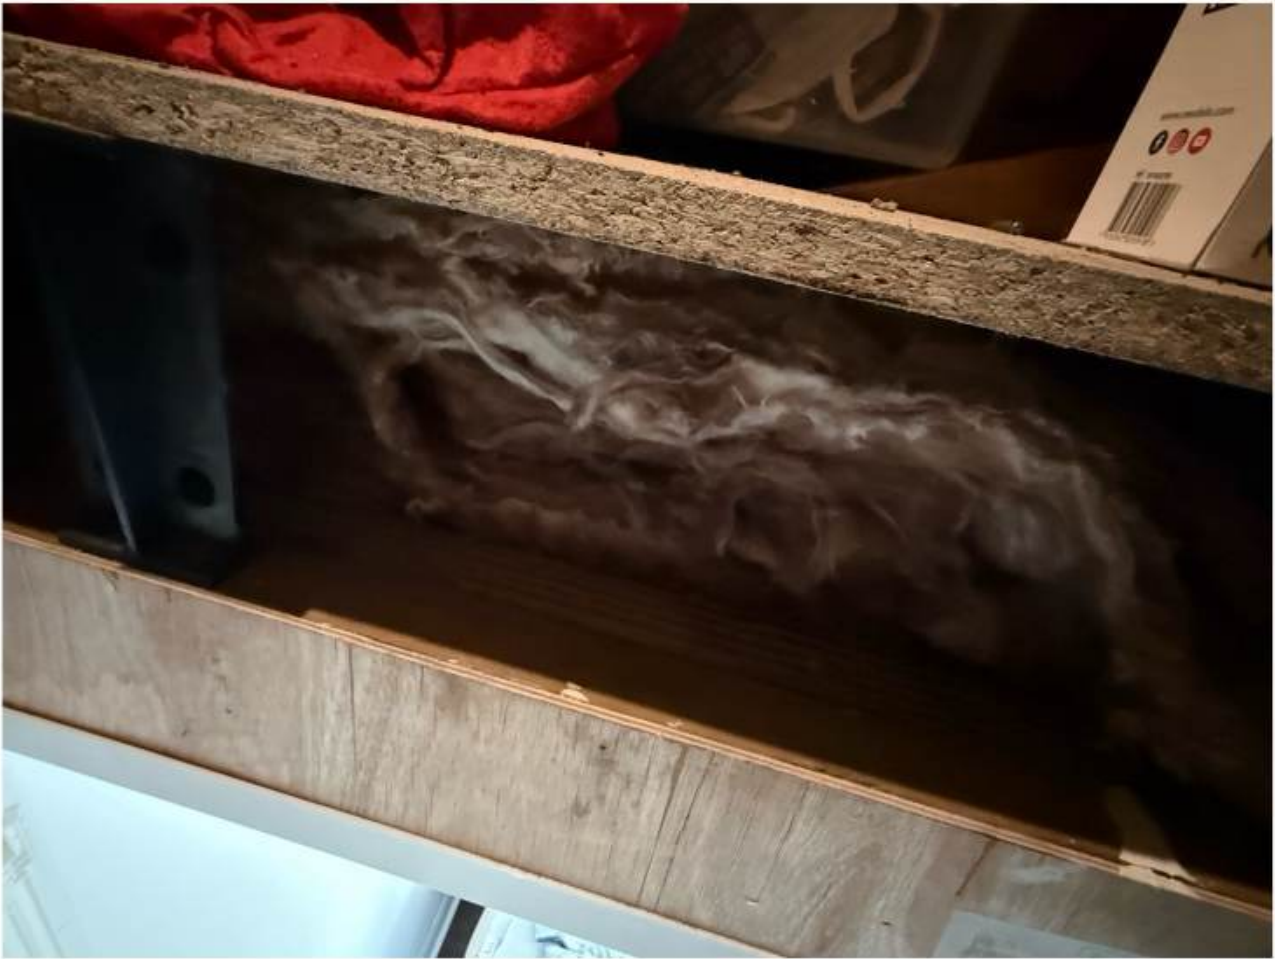
The loft contains approximately 270 mm of mineral-wool insulation supported by loft legs, which is consistent with the current recommended depth. Accessible timbers returned moisture readings within normal tolerances, and no significant condensation or mould growth was observed.

*We estimate £1,200 for a structural engineer's inspection, calculations and specification, together with £4,000 for the provisional installation of two gallows brackets and two concrete lintels. The total allowance is £5,200, subject to the engineer's design and the condition of concealed areas.*

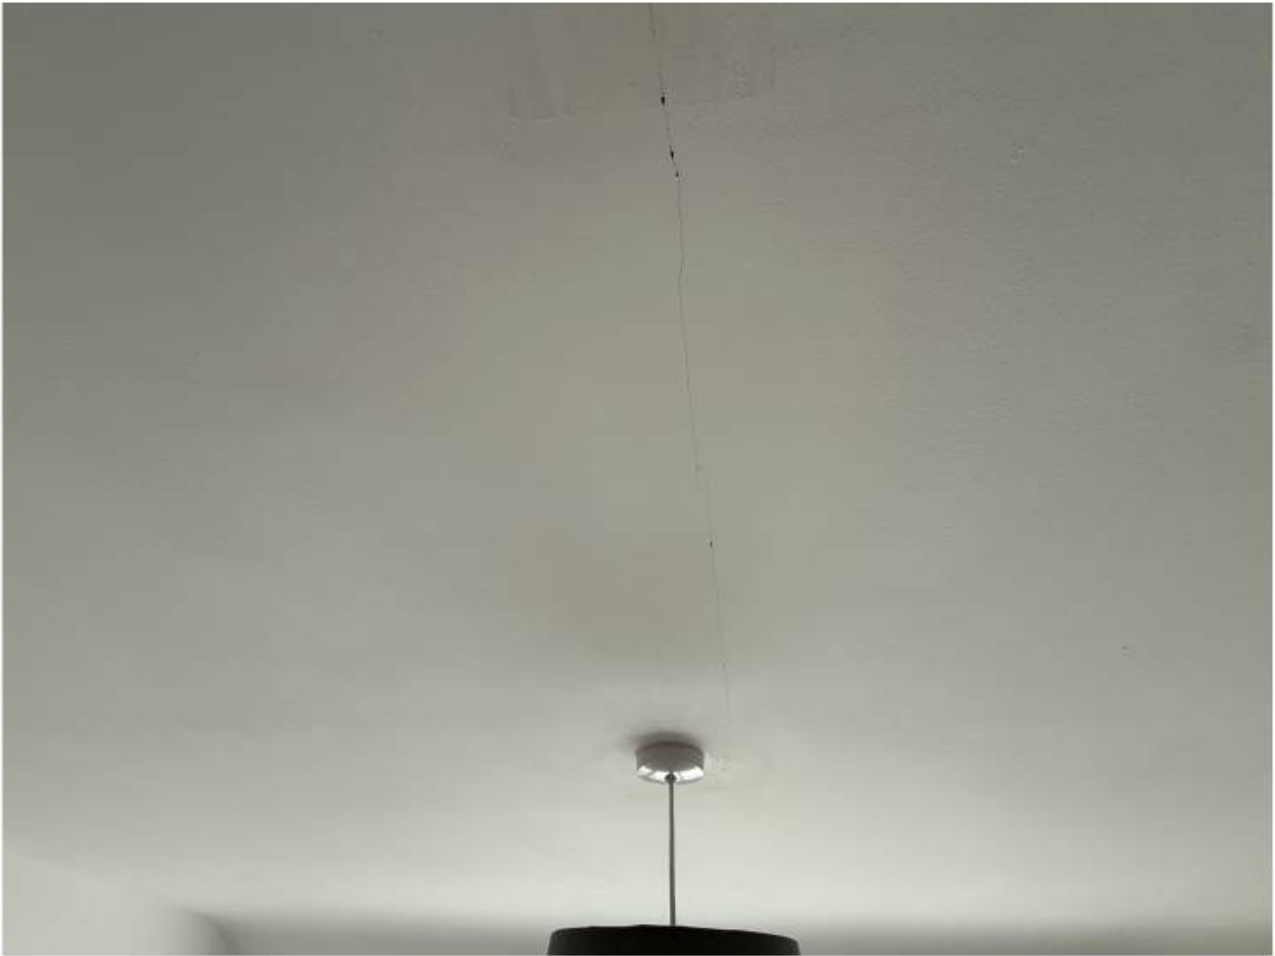
- Hairline cracking was noted to the principal-bedroom ceiling. Its form is consistent with thermal expansion and contraction of the plaster finish rather than structural movement.

*We estimate £200 to prepare the affected area, fill the crack with a suitable flexible filler and redecorate the ceiling.*
