# LEVEL 2 Home Survey Report

Client Name:  
**Mrs Jo Blogs**

Property Address:  
**Green Gardens, Wharlingham, CR8 9PQ**

Date of Inspection:  
**Wednesday 1<sup>st</sup> October 2025**

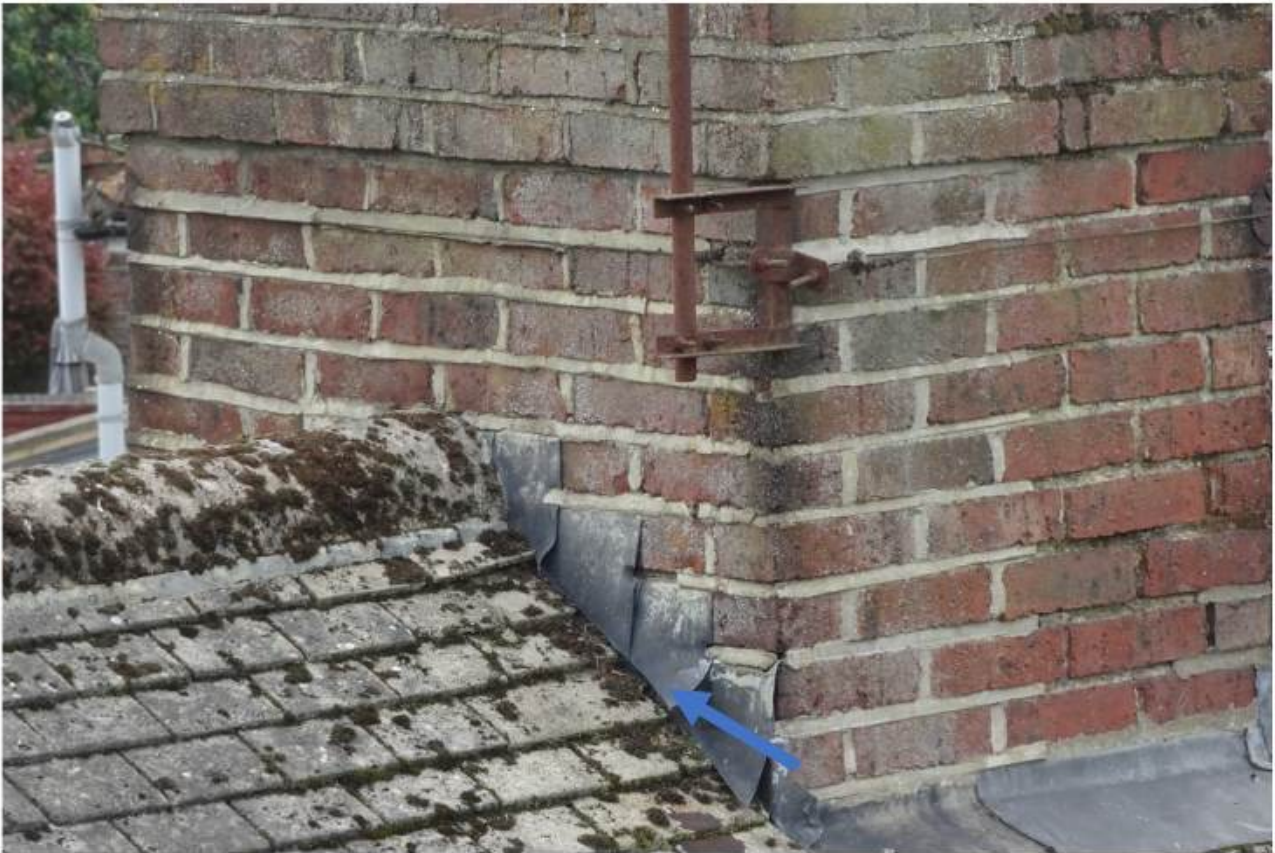
The main chimney was seen to be in a poor condition.

Television aerals are fitted to the stack. The front aerial appears redundant and exhibits corrosion and fatigue. The rear aerial appeared to remain in use and was in satisfactory condition.

- The mortar joints require repointing, and the flaunching to the crown is cracked, weathered and locally fractured.
- Not all chimney pots are fitted with suitable cowls. Appropriate cowls should be installed to reduce direct rainwater entry and deter nesting animals.
- The lead flashing is in poor condition and requires renewal to reinstate a weather-tight junction.
- The redundant front television aerial is corroded and should be removed.

A competent contractor should repoint the stack, renew the defective flaunching and lead flashing, install suitable cowls and remove the redundant aerial.

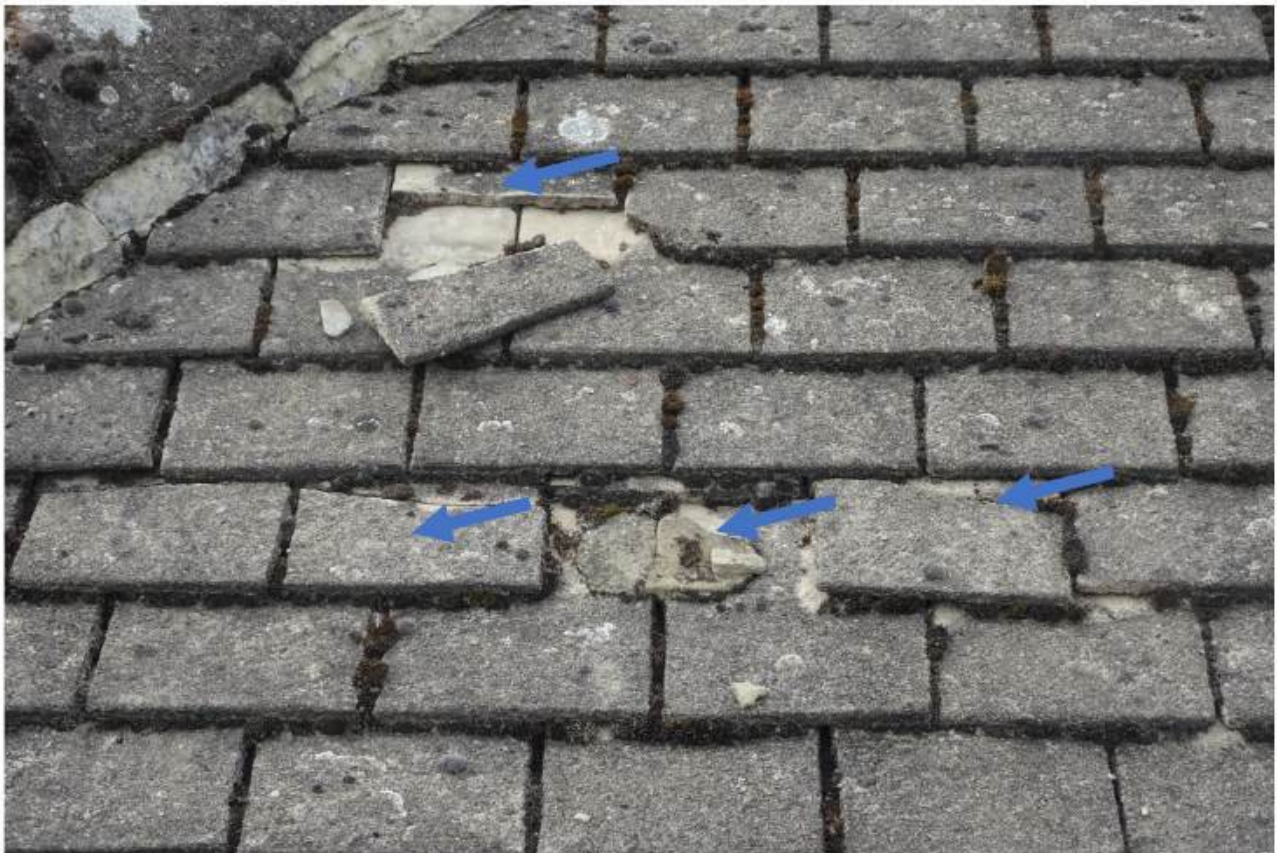
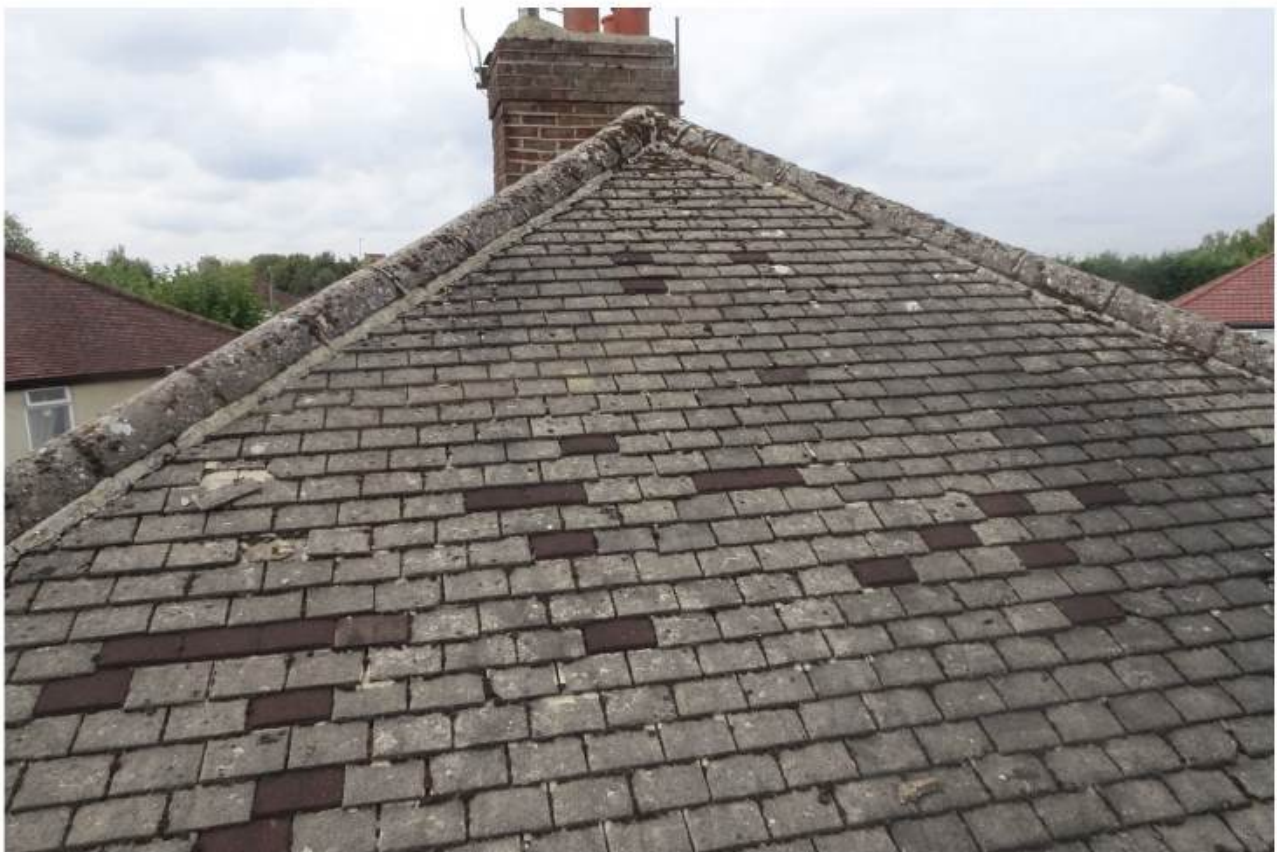
The front and rear box-bay roofs are formed with timber decking and weathered with a traditional three-layer bituminous felt system. The front covering was in satisfactory condition. The rear covering exhibits localised loss of the mineral finish and is likely to require renewal within the next three to five years.

- The main concrete-tile covering is at the end of its serviceable life. The tiles are weathered and thinned, with numerous historic patch repairs and several broken units.
- Deterioration is most pronounced along the apex and hips, where the mortar bedding and alignment are poor.
- No underfelt is present beneath the tiles. Defective or displaced tiles can therefore allow direct rainwater entry into the roof space.
- Heavy moss and lichen growth is present across the slopes and contributes debris to the rainwater goods.
- The rear box-bay felt covering is deteriorating and should be renewed within the short to medium term.

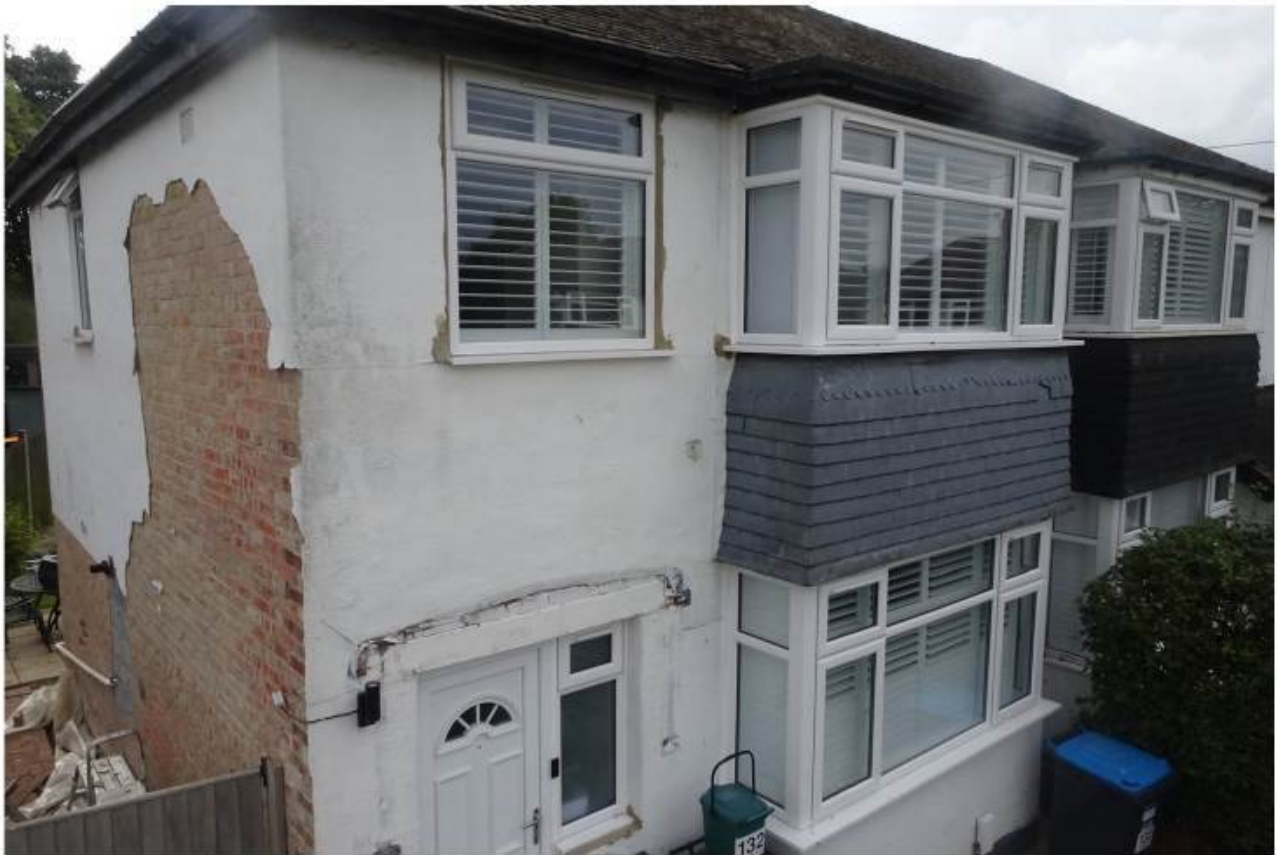
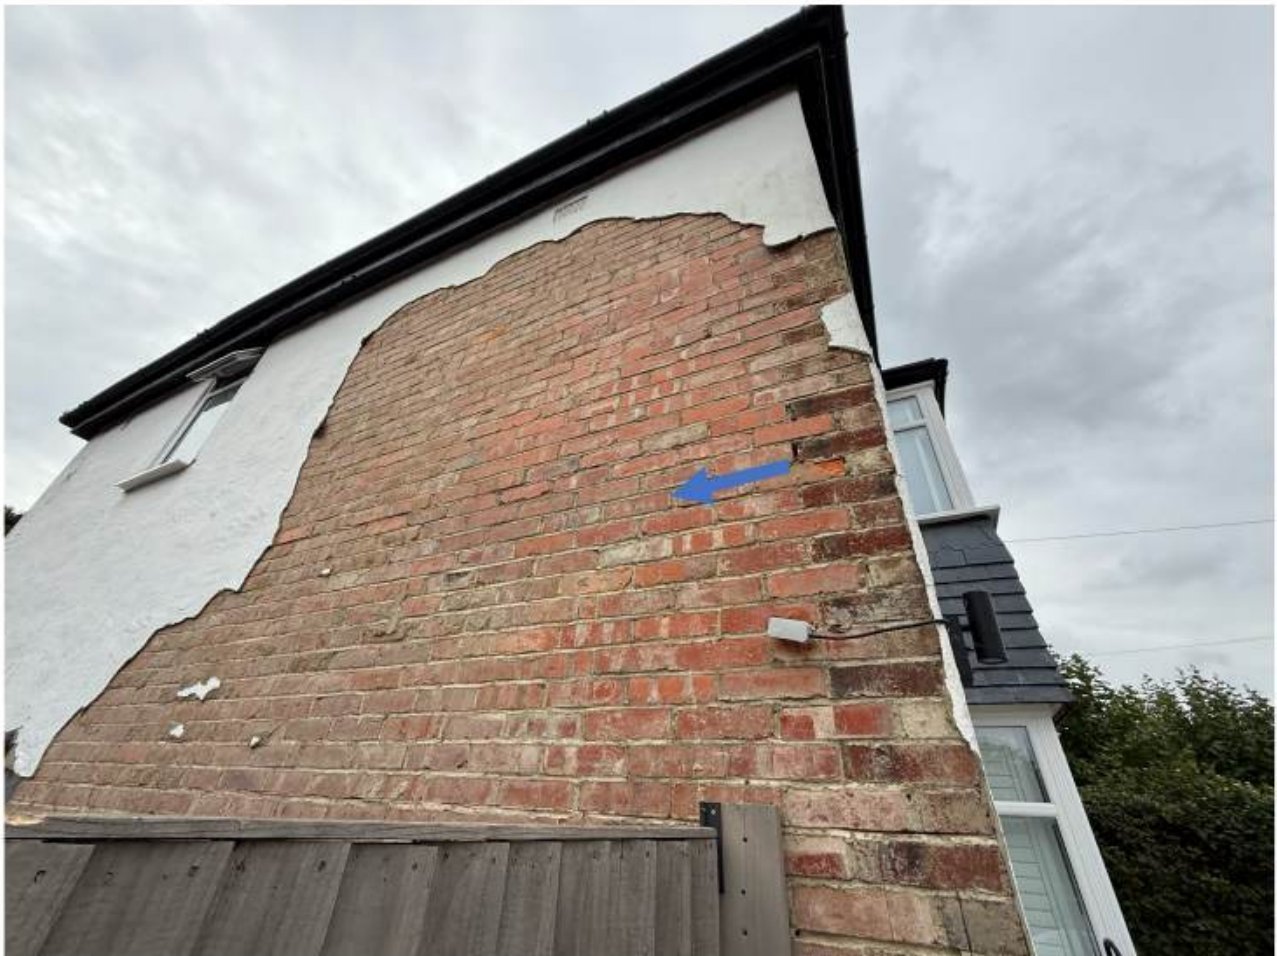
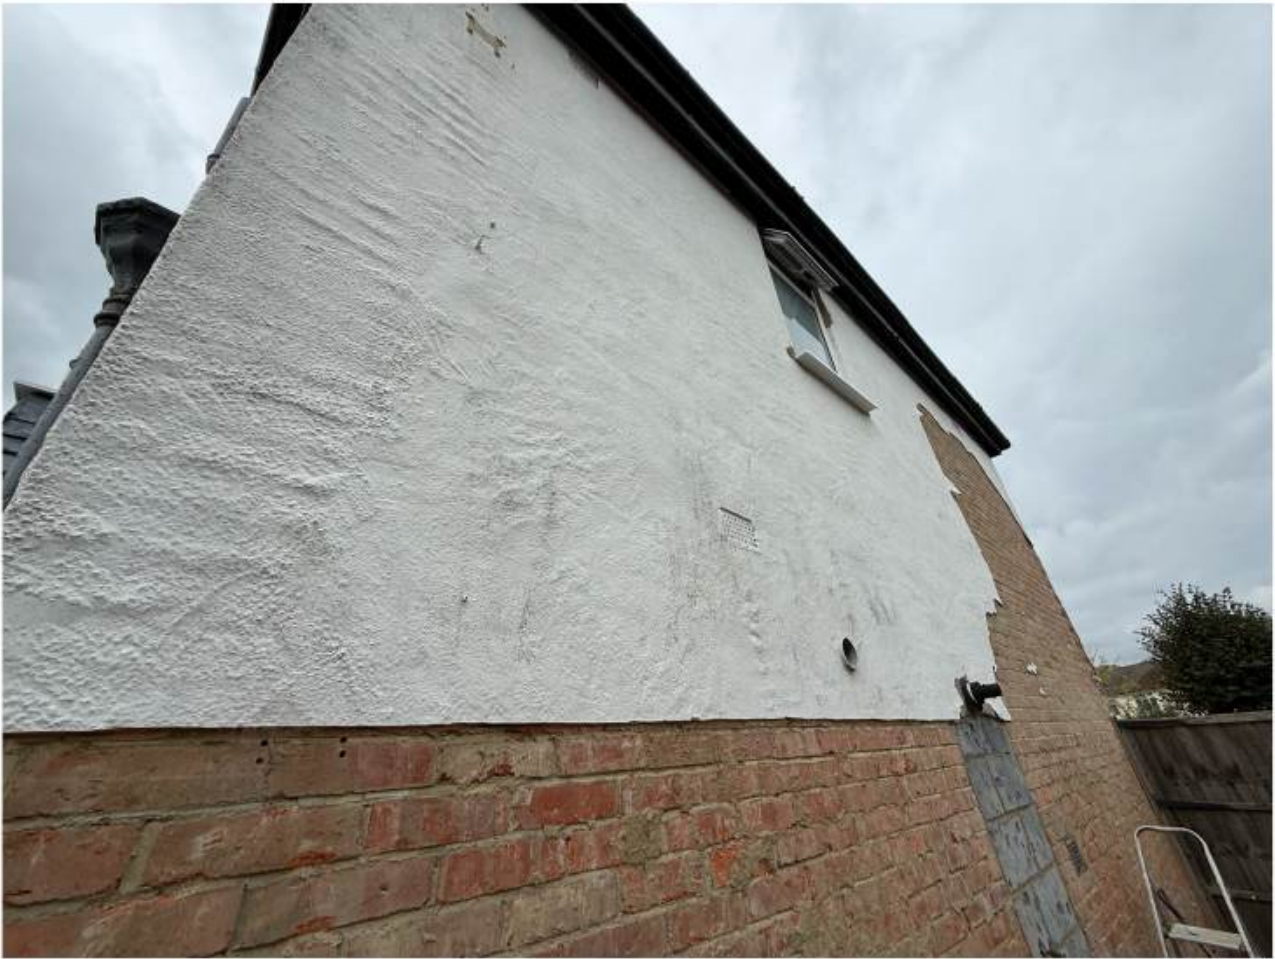
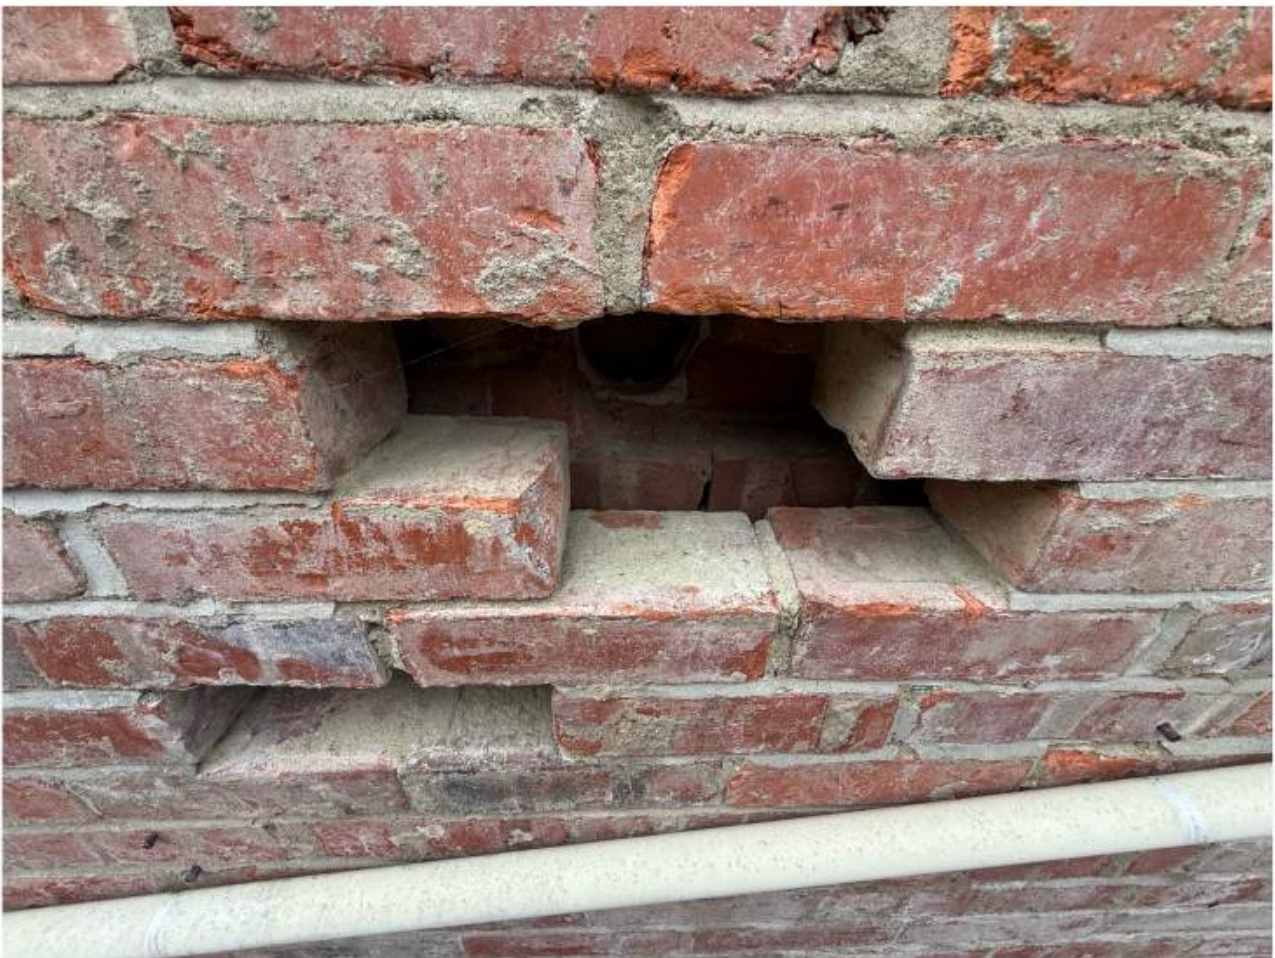
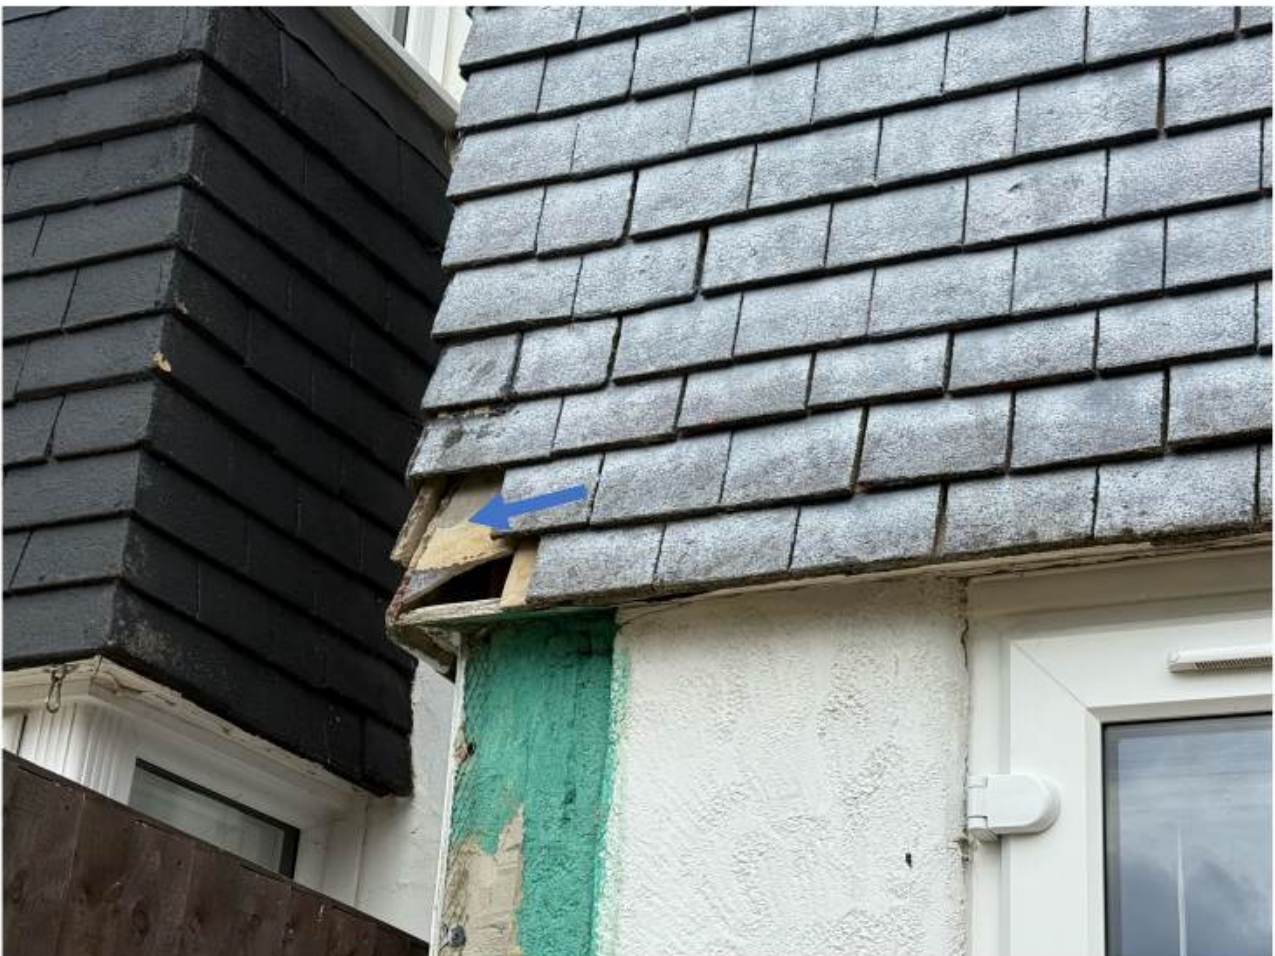
- The external render and masonry-paint finishes are in poor condition, with widespread delamination and localised sections of render already detached from the side elevation.
- Localised bricks are missing from the side wall and require reinstatement before the render is renewed.
- A poorly detailed former window opening to the rear elevation requires suitable infilling and rendering. Unfinished render adjoining the rear French doors should be completed at the same time.
- The tile-hung panels to the front and rear box-bay elevations are in poor condition and require renewal, including insulation and replacement tiles.
- Non-breathable coatings should not be applied across the lower brick courses, which should remain exposed to support natural drying.

A competent contractor should remove the defective render, complete localised brick repairs, prepare the masonry, apply new render coats and redecorate the elevations. The front and rear tile-hung panels should be repaired with suitable insulation and replacement tiles.

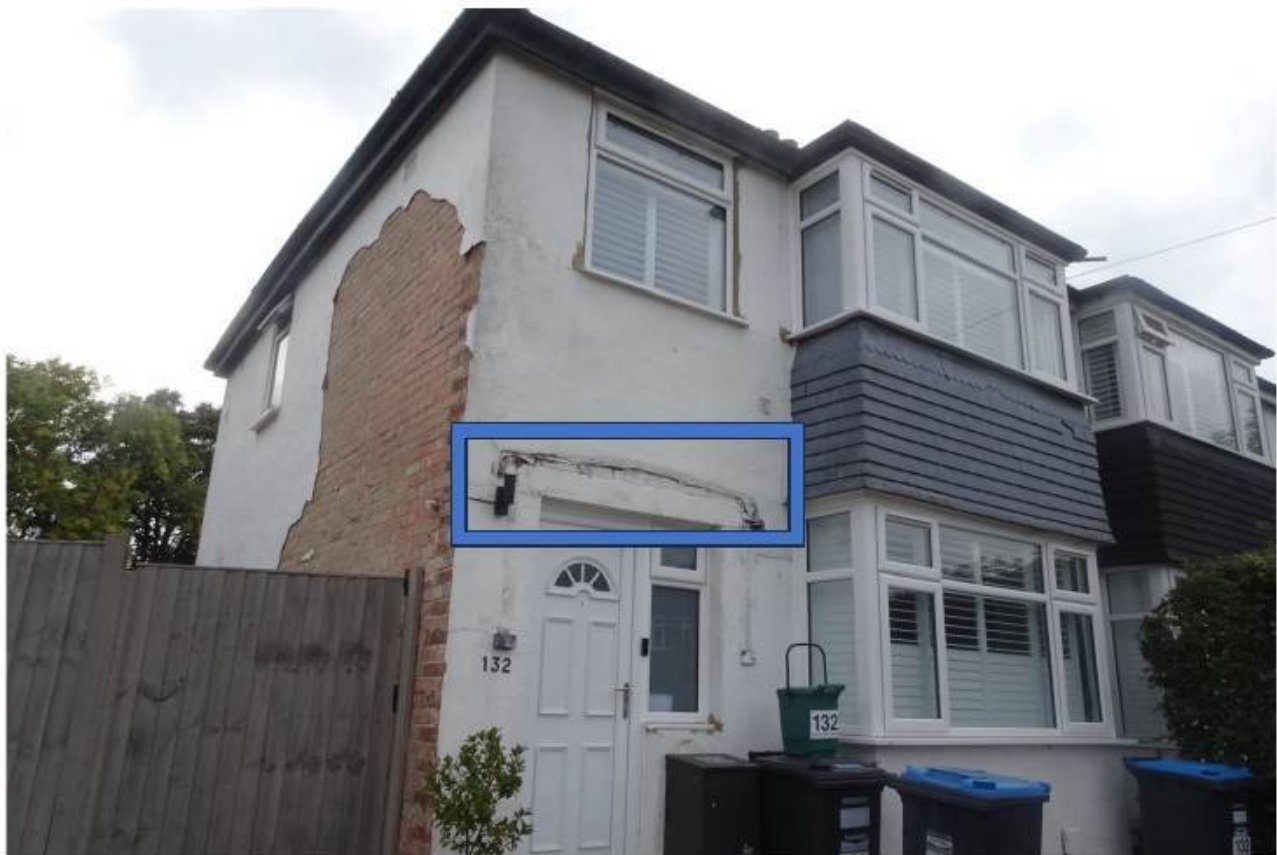
- The former porch is no longer present. Reinstatement would be discretionary rather than an essential repair.

Reinstatement of the former porch is discretionary. If a replacement porch is required, it should be designed and constructed by a competent contractor.

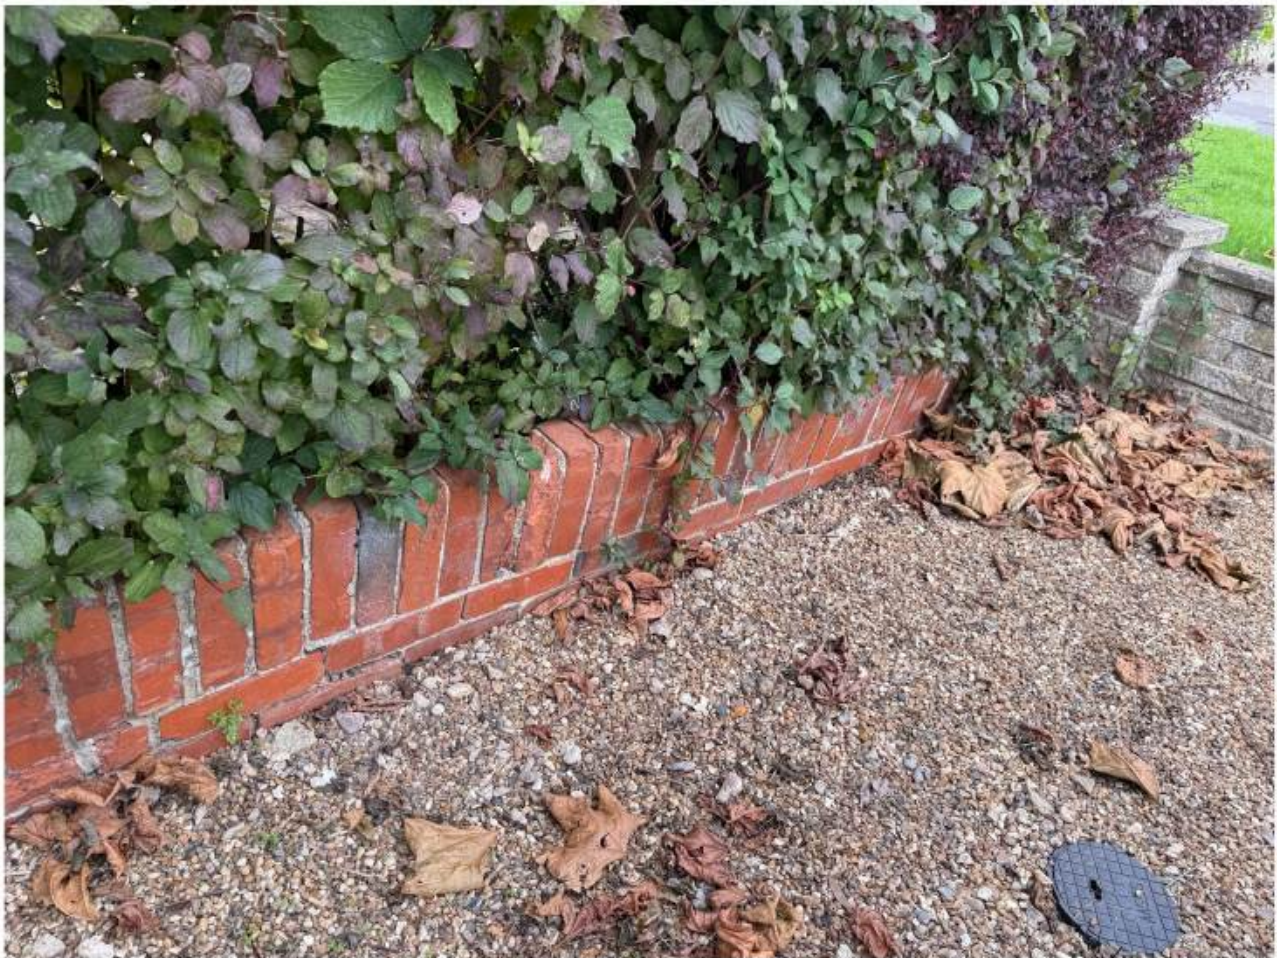
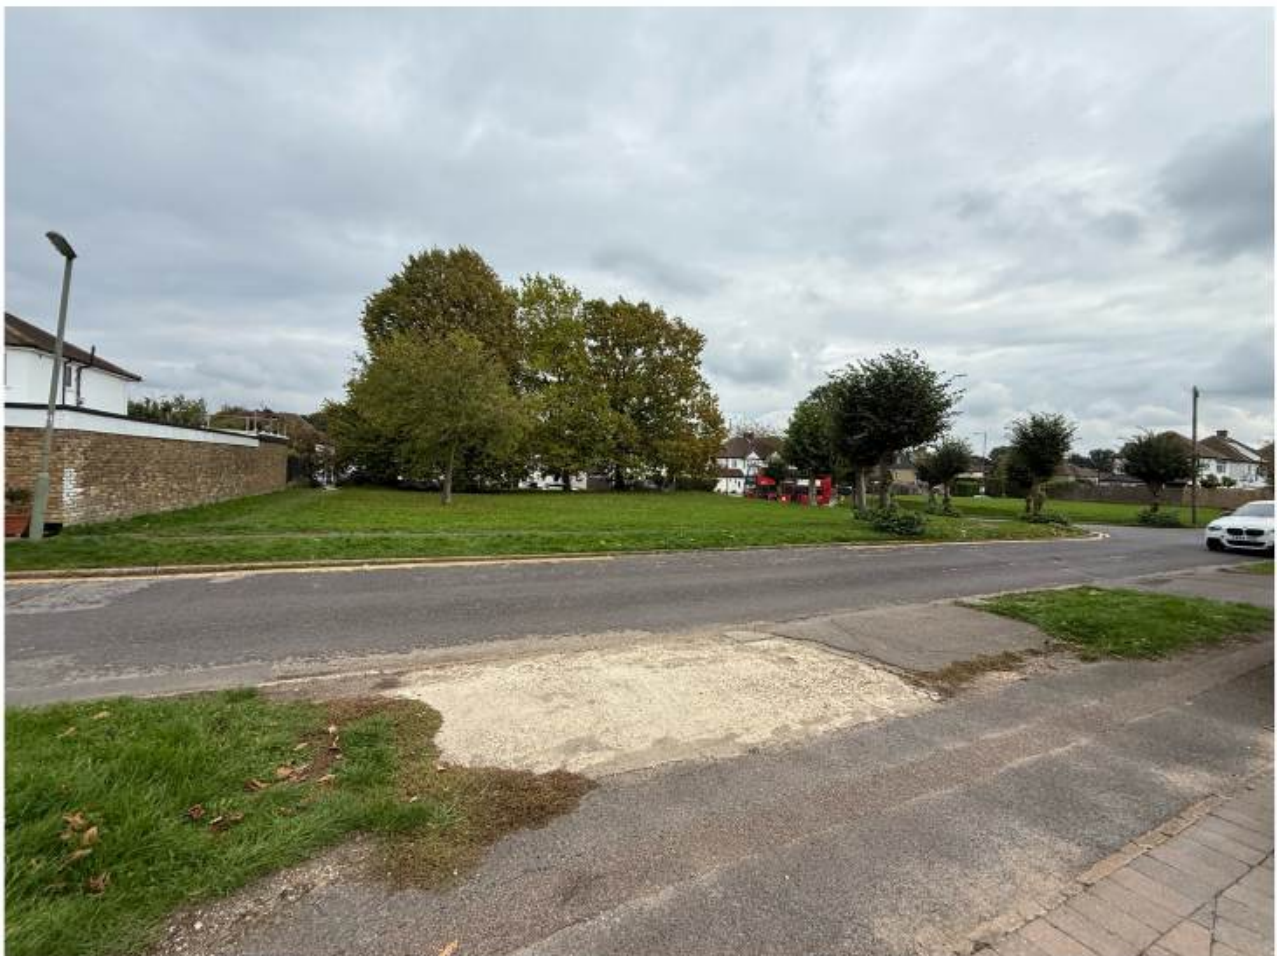
- The low red stock-brick wall to the right-hand front boundary is in poor condition and requires repair, renewal or removal.
- The former rear step has been removed, apparently to avoid obstructing the adjoining air bricks. A replacement step should incorporate suitable ventilation openings so that subfloor airflow is maintained.
- General wear is present to the rear boundaries and hard landscaping, although the remaining elements are serviceable.
- No visible Japanese knotweed, giant hogweed or other invasive plant growth was identified within the accessible grounds. This was a visual inspection only.

The defective front boundary wall should be repaired or renewed. The rear step should be reinstated with suitable provision for subfloor ventilation.
