Up Close Inspections LLC

EXAMPLE Home Inspection Report

EXAMPLE REPORT: 102 N This away
AZ

Prepared for John2 Doe2
Date of Inspection: 01/01/2024

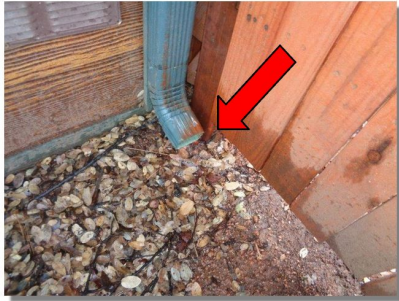
Location: West Right of Building

Comments: **DOWNSPOUT DRAINS NEXT TO BUILDING** - A splash block may be considered and placed so water is directed away from the building.

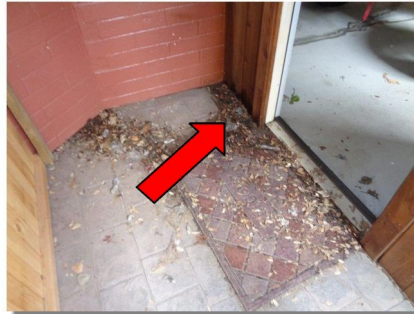
Location: Backside of garage

Comment: **MOISTURE NOTED:** at the back door from roof downspout and grading. Grading should fall 6" in 10 ft from the foundation. Recommend repair. This is causing water to enter the garage.

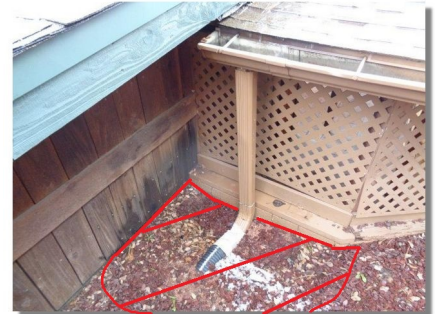
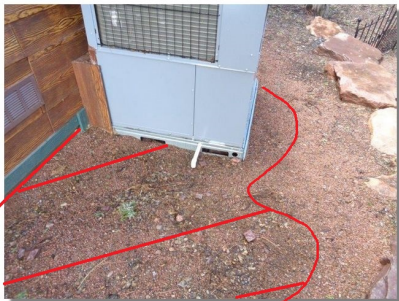
Location: West Right of Building. Next to HVAC system

Comments: **GRADE FAULTY, NEEDS TO SLOPE AWAY FROM FOUNDATION** - a minimum 6 inch fall within the first 10 feet. Arrows indicate water flow or points where grade is deficient. The use of a swale is allowed if physical barriers or lot lines prohibit the 6 inches fall in 10 feet.

Moisture found in crawlspace.

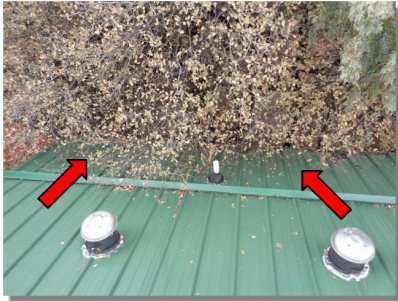
Location: Roof, Southwest Corner of Building

Comments: **BRANCHES TOUCHING BUILDING** - recommend cutting back so they do not touch the building. This can be bridge for pest or can damage siding and roof.

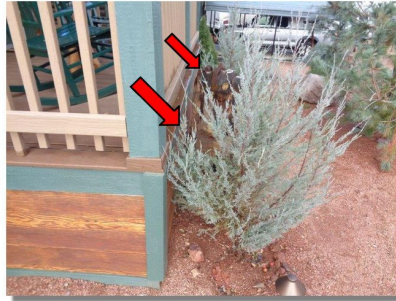
Location: North Front of Building

Comments: **BRANCHES TOUCHING BUILDING** - recommend cutting back so they do not touch the building. This can be bridge for pest or can damage siding and roof.

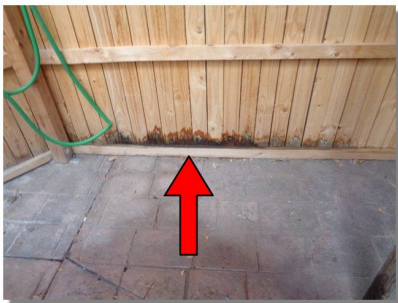
Location: South Rear of Garage

Comments: **STAINING ON FENCE** - from the neighbors hot tub drain.

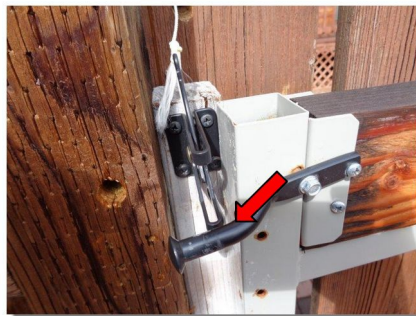
Location: North Front of Garage

Comments: **GATE LATCH** - does not latch to post

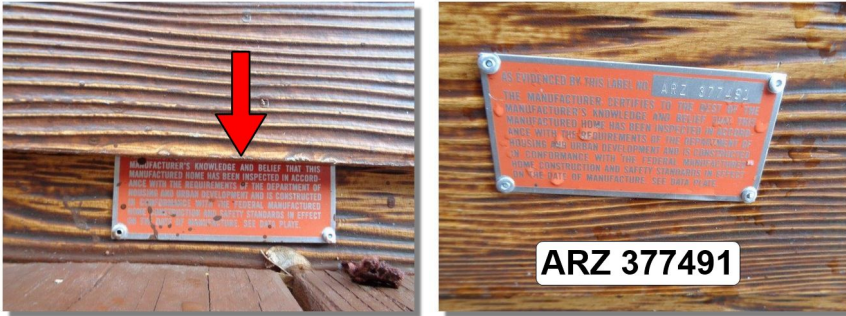
Location: South Rear of Building

HUD TAGS - one of them is covered up. These numbers are used by the state and insurance companies. Recommend revealing the one that is covered.

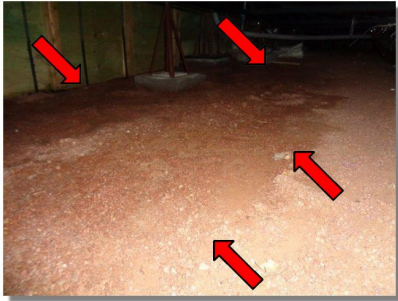
Comments: **MOISTURE IN CRAWLSPACE.** See "Lots and Grounds" for grade issues.

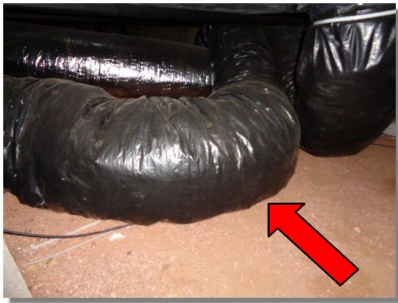
Comments: **DUCT TOUCHING THE GROUND** - this can cause the duct material to degrade faster. Recommend repair.

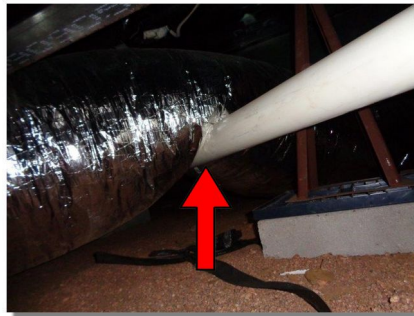
Comments: **DUCT WORK CREASED** - this restricts air flow. Recommend having an HVAC contractor do the repairs.

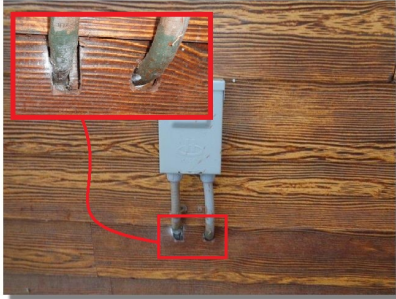
- Location: West Right of Building, disconnect for HVAC

Comments: **SIDING HOLED FOR PIPING** - should be sealed around the pipe so no moisture can enter the wall system, which can cause damage.

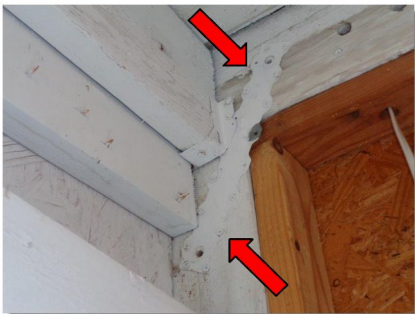
Garage top corners

BRACKET MISSING FASTENERS - recommend installation.

FASTENERS WRONG TYPE - wood screws are not strong enough.

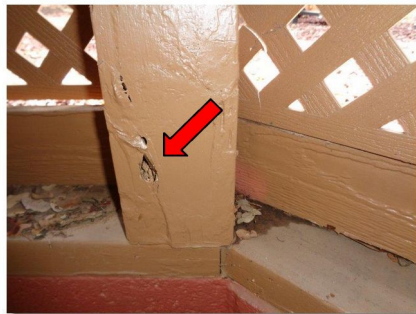
Back side of garage

POST DRY ROT - Recommend repair

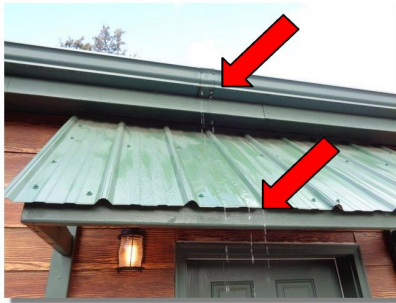
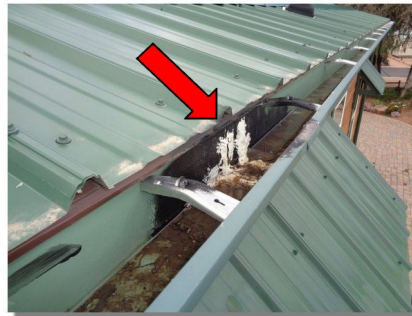
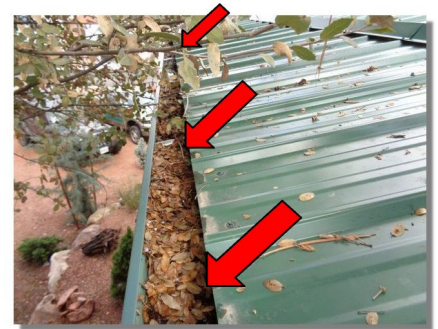
Location: East Left of Building

GUTTERS NEED CLEANING - The following are some possible problems

Comments: **GUTTERS LEAKING** - seams leaking over entry way. Recommend repair. Appears repairs were tried before, however its still leaking.. with clogged gutters .

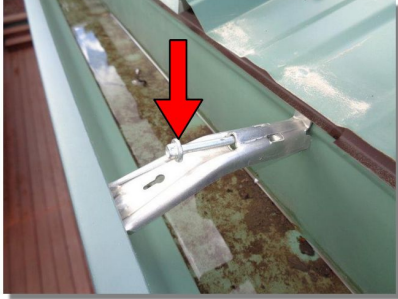
Location: Multiple areas

Comments: **GUTTER FASTENERS COMING LOOSE** - recommend repair.

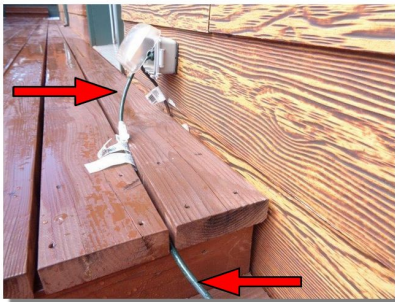
Location: East Left of Building

Comments: **Electrical extension cord on stairs. This can be a tripping hazard.**

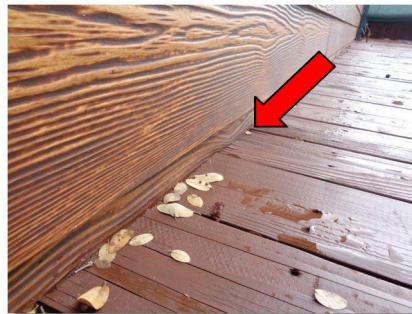
Comment: **FLASHING MISSING BETWEEN DECK AND SIDING** – this helps reduce dry rot.

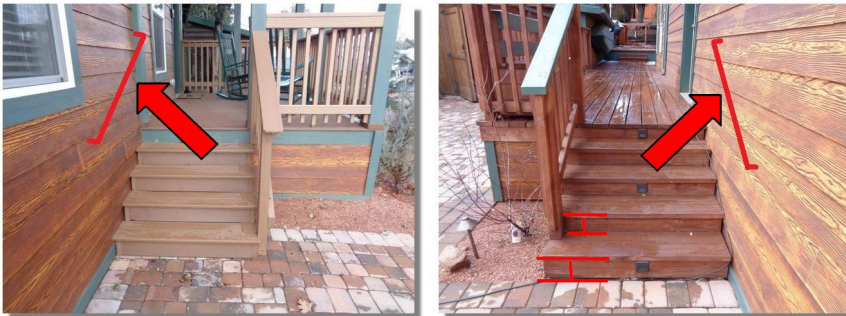
Location: North Front of Building, East Left of Building

Comments: **HANDRAIL MISSING** - Stairs with 4 or more risers require a graspable handrail. A guardrail is not considered a handrail. The key word is graspable. A handrail should be provided on at least one side of stairways. Handrail ends should be returned to the wall or into a newel post. These can be hazards.

RISERS NOT UNIFORMED - from the bottom step to the top step. Riser(s) should not exceed 3/8 inch difference from the tallest riser to the smallest risers. This is a hazard.

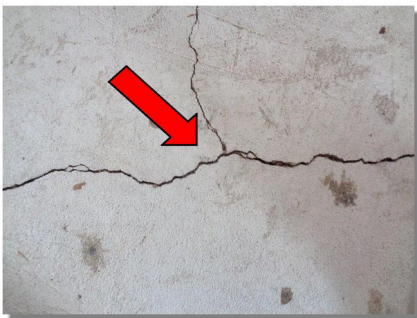
Location: Garage

Comments: **CONCRETE SLAB CRACKED** - recommend sealing cracks. Its possible the moisture going under the slab could have caused shifting in the ground there by cracking the slab.

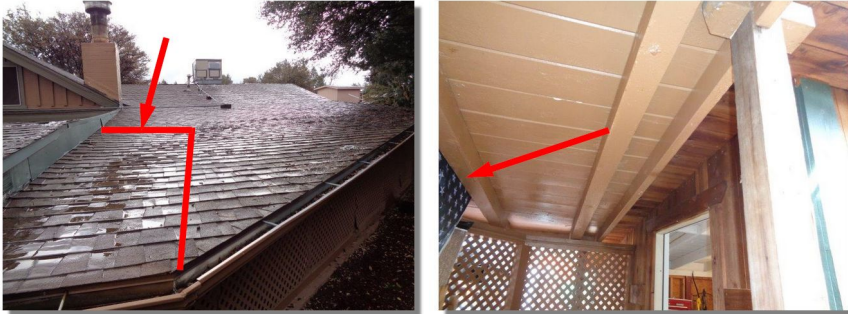
Location: South Rear of Garage

Comments: **FIRE SEPARATION MISSING** - missing 1/2" type x gypsum board which is required on walls between properties. This is a life safety issue."

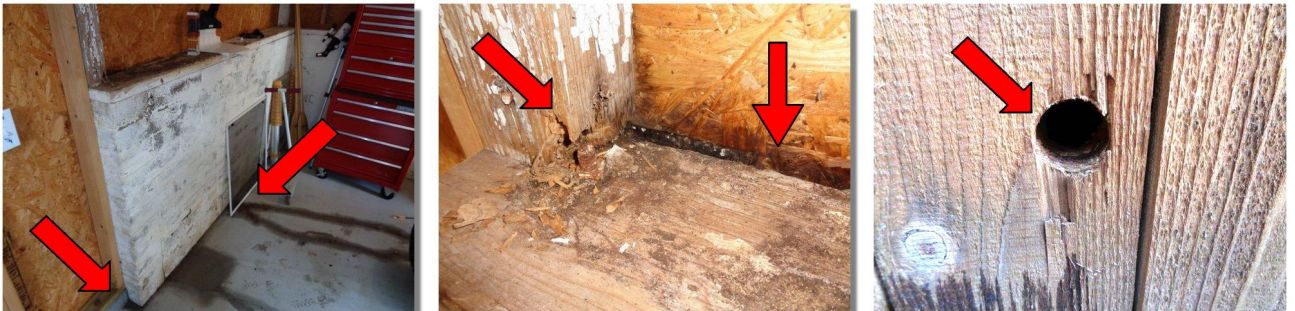
● Comments: South side of garage

MOISTURE COMING THROUGH WALL - to the point its running across the floor and out the other side of the garage. This should be repaired.

DRY ROT - noted at the bottom of siding. Recommend repair. Possible wood destroying insects. See Termite report.

SIDING HOLED - appears a hole was drilled into the siding; however, the siding should be sealed to prevent critters, insects, and moisture from entering the wall system.

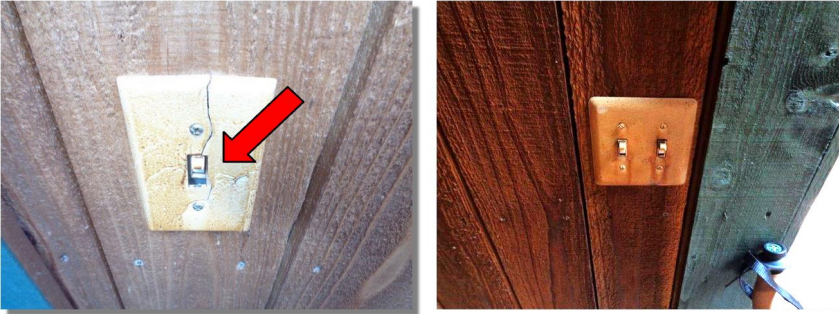
Location: Back side of garage. Switches outside

Comments: **UNKNOWN SWITCH USE** - recommend asking the seller or sellers agent what these switch(es) are used for.

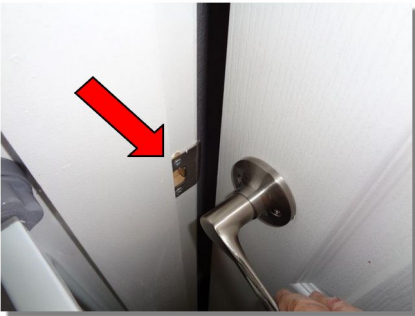
Location: Guest Bathroom

Comments: **DOOR LATCH DOES NOT CATCH PLUNGER** - Recommend repair.

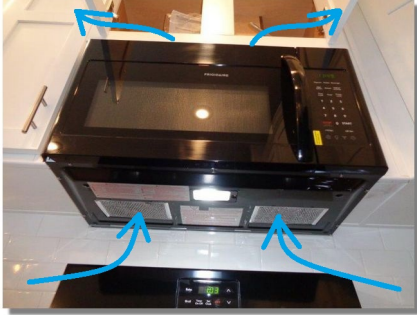
Comment: **VENTING PARTLY BLOCKED** - venting to the inside is ok. However, part of the vent is blocked by the cabinet above. It is designed to vent to the outside if desired.

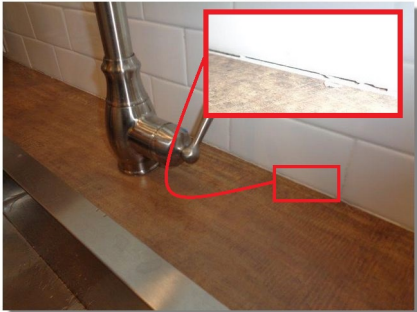
Comments: **SEALANT NEEDED** - where back splash and countertop meet.

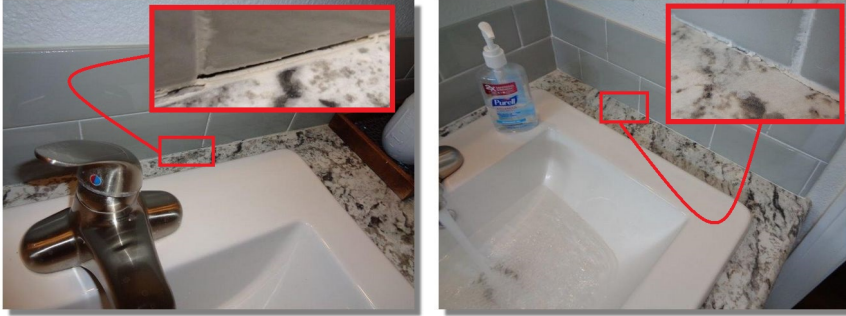
Location: Both bathrooms
Construction Material: Granite
Comments: **SEALANT NEEDED** - where back splash
and countertop meet.

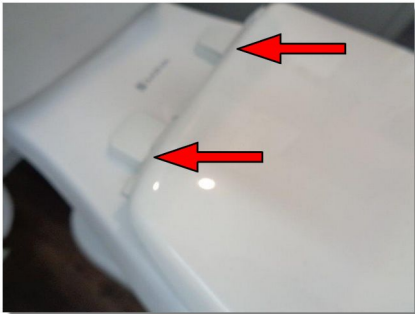
Location: Guest Bathroom
Comments: **TOILET LID LOOSE** - recommend repair.

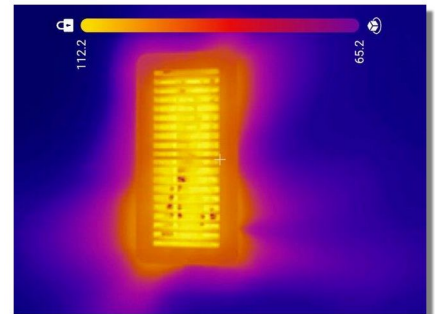
HEATING DIFFERENTIAL: noted at the time of inspection. Measurements are taken from the Return Air (intake air) to one of the registers (output). Heating should be close to 30 degrees higher than the return air and a cooling difference of 14 (older) to 20 (Newer) lower than the air return. Buyer may want to get an HVAC contractor if the differentials are far from the ideal. Measured differentials were:

Heating differential 44 degrees Fahrenheit

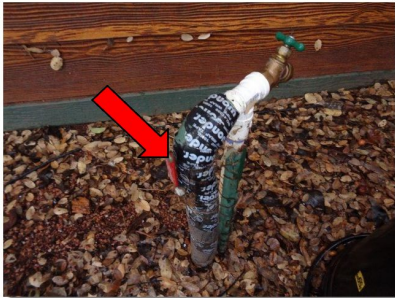
- Location: West Right of Building around the building.
- Faucet Type(s): Gate Valve

ANTI SIPHON DEVICE MISSING - This prevents water from siphoning back into the water supply in case of a water brake.

FAUCET EXPOSED TO COLD WEATHER - can freeze during winter months. This is not a frost free faucet. What works for some people is placing a frost free hydrant that is two feet under ground. Insulation does not keep it from freezing.

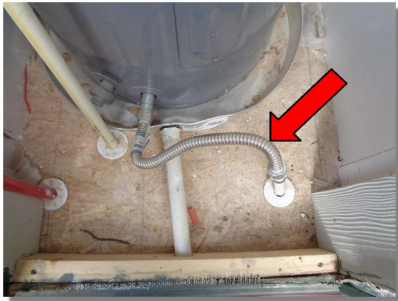
Location: Water heater closet

Comments: **COLD WATER VALVE MISSING** - from water heater. This helps when installing a new water heater.

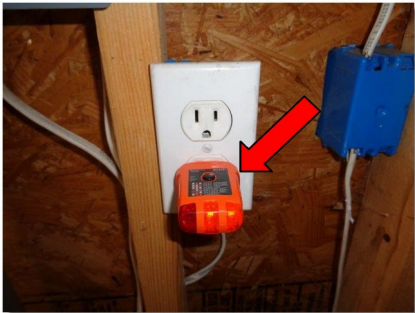
Location: Garage

Comments: **GFCI OUTLETS MISSING** - this is a hazard.
Recommend installation.

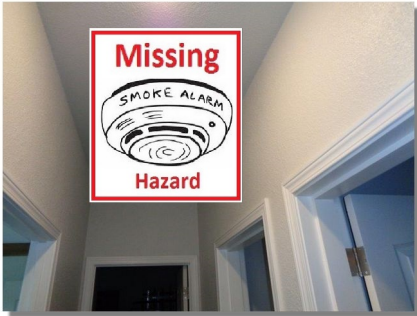
Location: Hallway

Comments: **SMOKE ALARM(S) MISSING** - should be in each bedroom and outside each bedroom. This is a life safety issue.

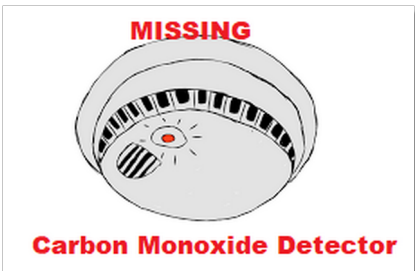
CARBON MONOXIDE LOCATIONS - required locations. Check marks means there is an issue, see comment below..

Comments: **CARBON MONOXIDE DETECTION MISSING** - recommend installation. This is a life safety issue.

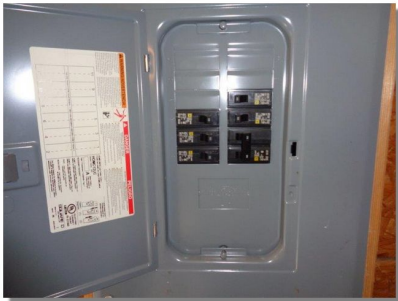
Location of Panel: Garage
Manufacture: Square D
Electrical wiring appears to be serviceable at the time of inspection.
There are 5 additional breaker slots left in the panel.
Thermal Scan shows no hot spots.

Comment: **LABELING INSUFFICIENT** - Panel not labeled to current standards, some or all breakers need labeling. This is a safety hazard.
