## KOEHLER KORNER

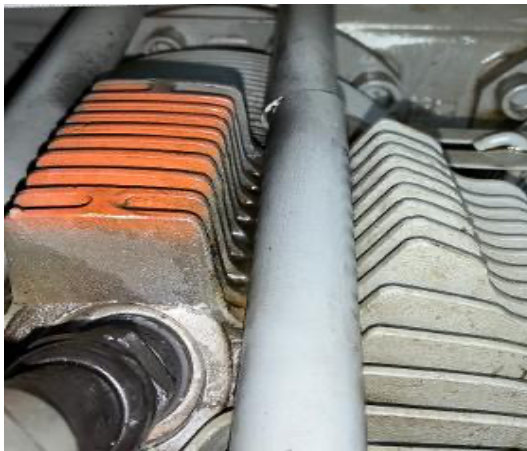
At 3.3 hours we landed at KFDY, taxied into the fuel stand and looked forward to one of their hot dogs offered to Oshkosh travelers. As I got out of the plane the lineman asked if my engine usually leaked that much oil upon shutdown. To my horror I found an expanding six inch puddle of oil on the ramp with a near steady stream of oil coming from the front left side of the cowl. Unfortunately, I forgot to take any pictures. We did remove the side cowl and examine the engine. The #2 cylinder exhaust pushrod shroud tube was broken in half, so all the cooling oil that normally lubricated and cooled the exhaust valve on #2 was bilging overboard. The left side of the engine, left fuselage side and entire belly were coated with oil. It turned out that I was only missing about a pint of oil, but that much can make a huge mess on the plane. Here is a view of the broken shroud tube:

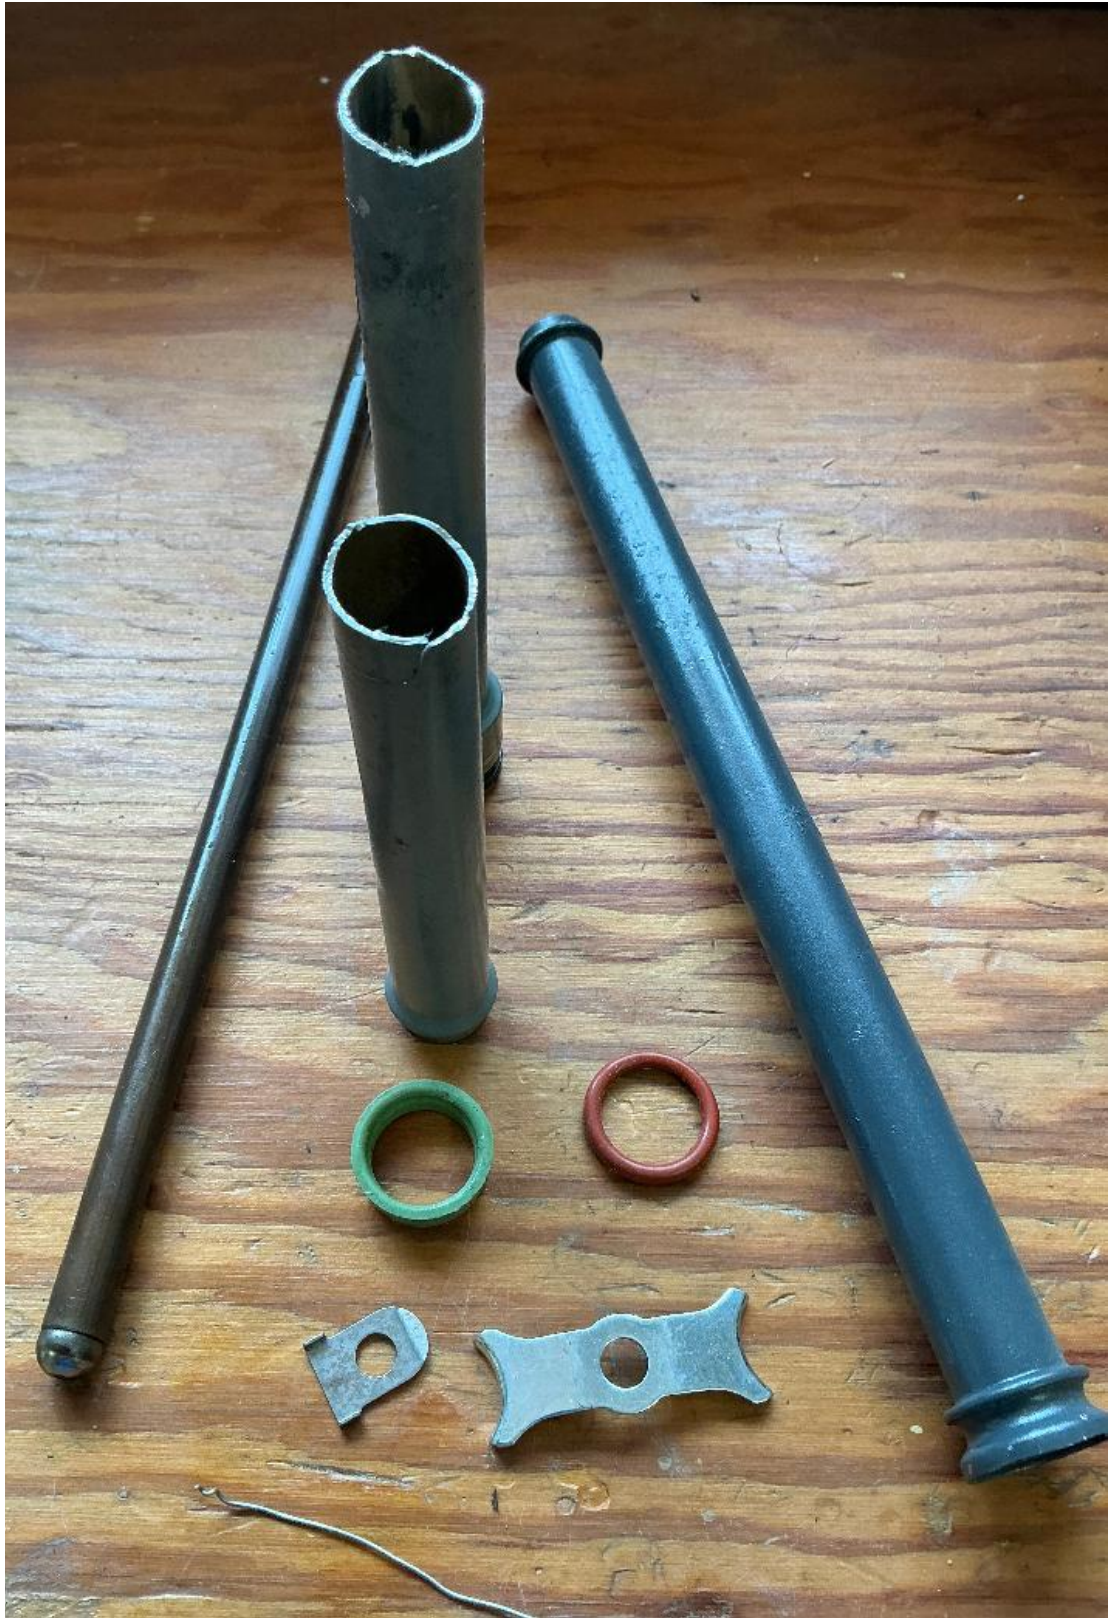
The two broken pieces are the old shroud tube and the new one is on the right. The piece of safety wire is to remove the hydraulic units from the tappet valves so that you can wash the oil out of them making them “dry” to get the dry tappet clearance of .028 to .080” for most Lycomings. We have reviewed this in past KKS, so I won’t redo it here. Remember that the pushrods come in various lengths to adjust that clearance within limits. Here is an example of the shortest pushrod used in the Lycoming O-360:

Now I had to track down the replacement parts. Obviously I needed a shroud tube, and it is usually necessary to replace the pushrod which is often bent. These parts are about \$45 and \$23 from Aircraft Spruce. The clips are about \$5 together, so for about \$75 I could replace all the parts. Remember, however, that it was Sunday and no supply shops were open. We spent the night in a motel, and Monday I called the nearest two parts shops and neither had the needed parts. Also, Dave had to get back to work. I called the guys at Aero Engines at Winchester VA and they had the parts in stock so, we rented a car and drove back to the Pax River area via Winchester VA, arriving about 8 pm. Bill and I had a bowl of soup and left at 5am to drive back to the plane, which took about 8 hours. These are the parts:

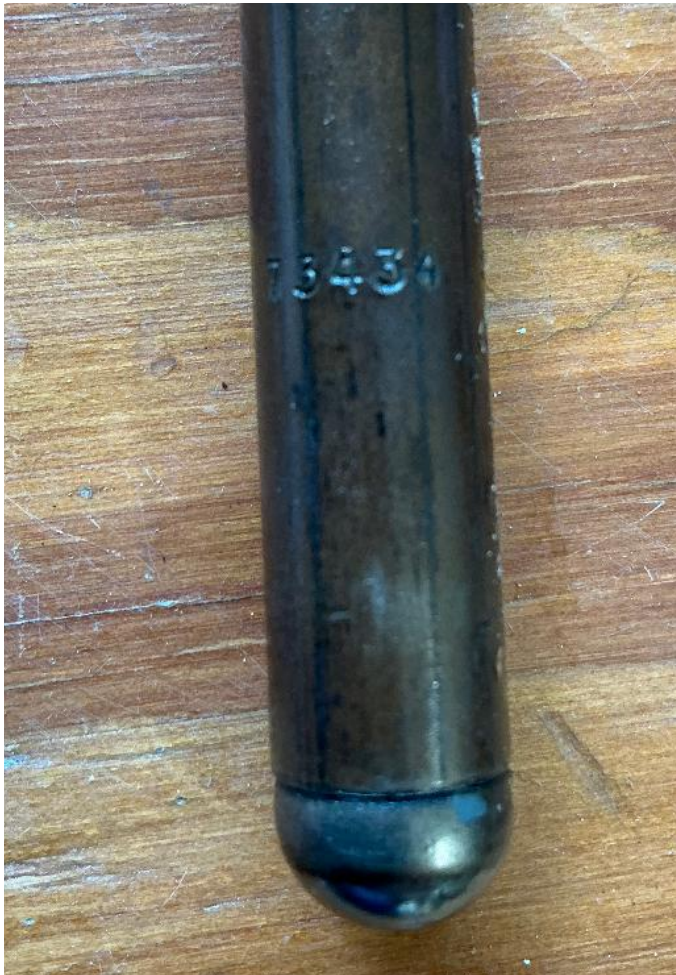
The part number is 73434. Next longer is 73435, etc. There is a more modern Lycoming part number, but it is followed with -34 or -35, etc. in a similar manner as the old numbers.
