KOEHLER KORNER

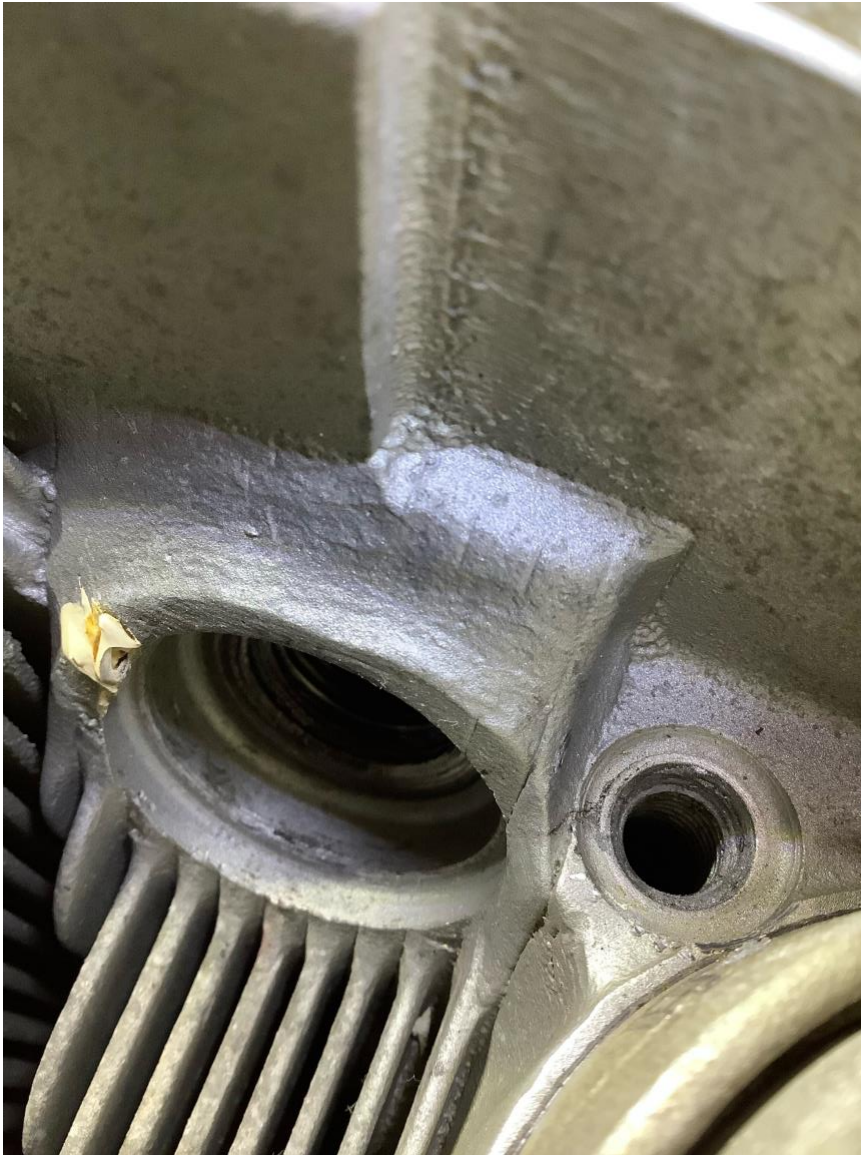
Note in the picture what appears to be a crack between the intake port and the smaller fuel injection port. The roughly horizontal crack runs across the roughly vertical web between the two ports. This type of crack is often caused by over tightening the fuel injector.

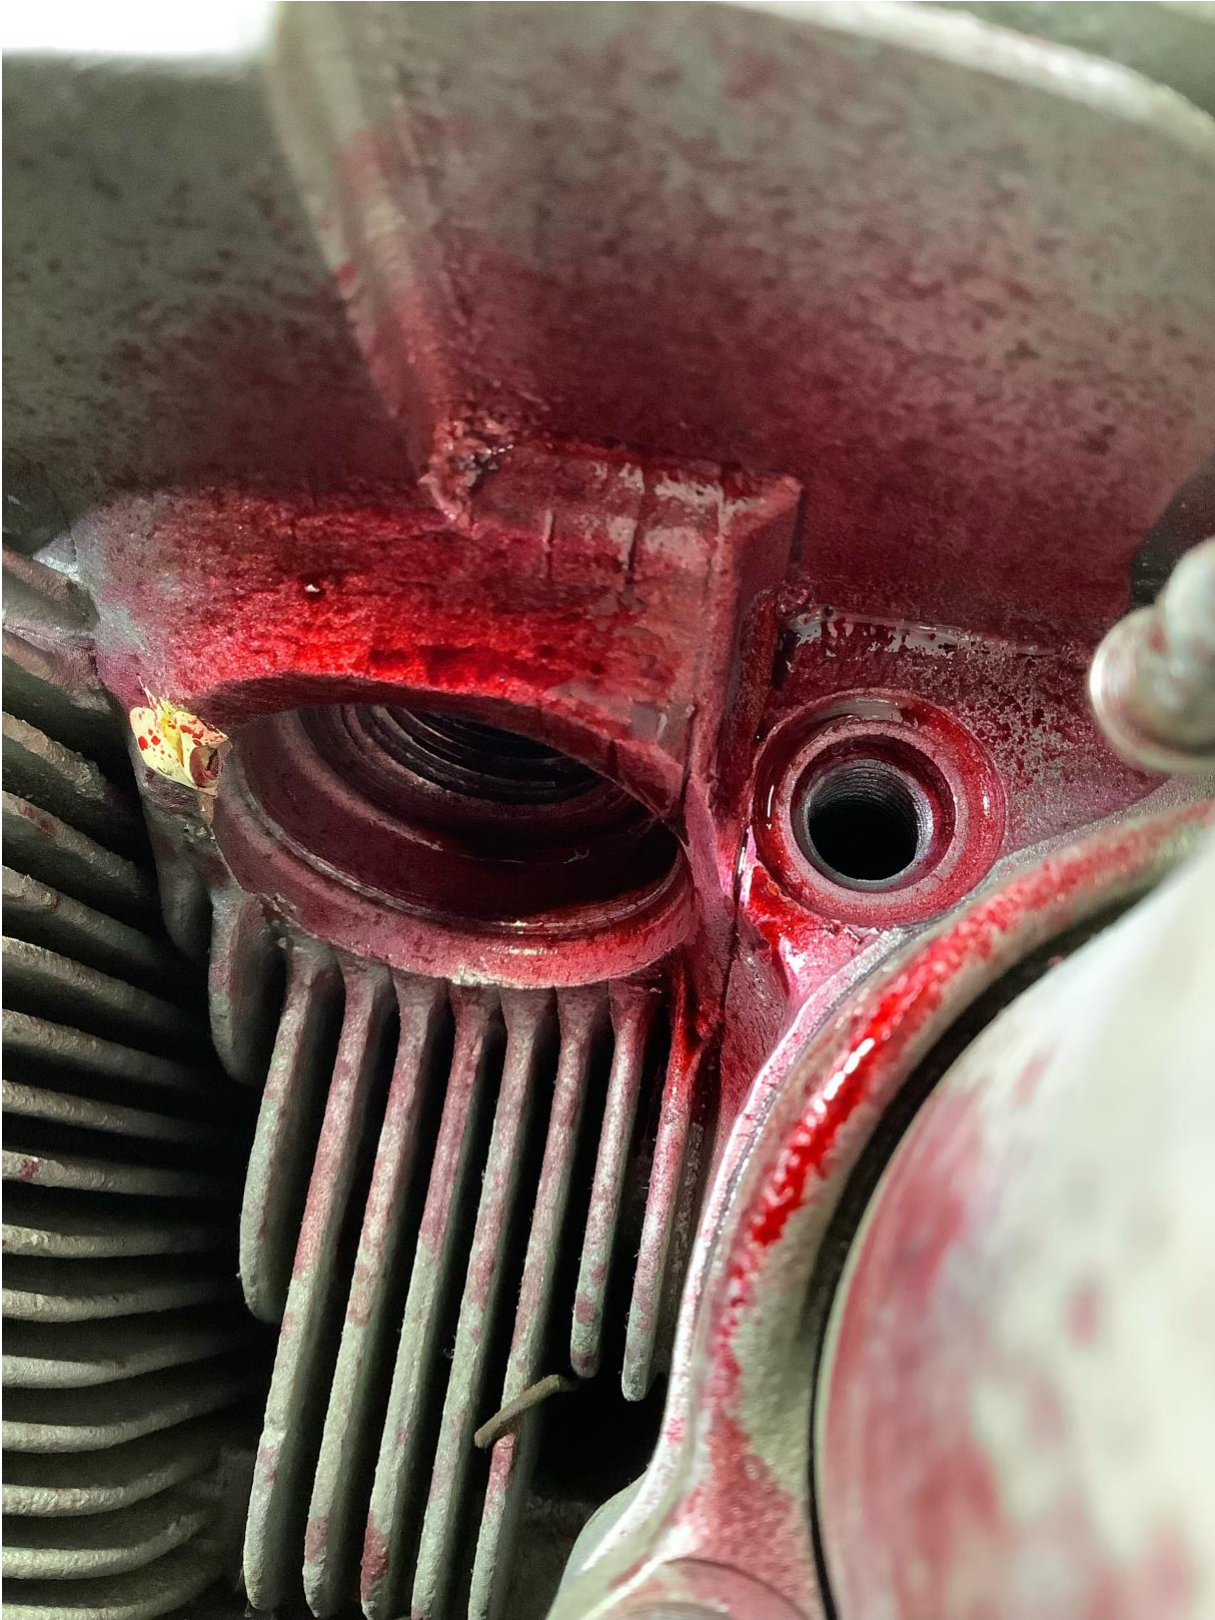
It is a messy step as shown here:

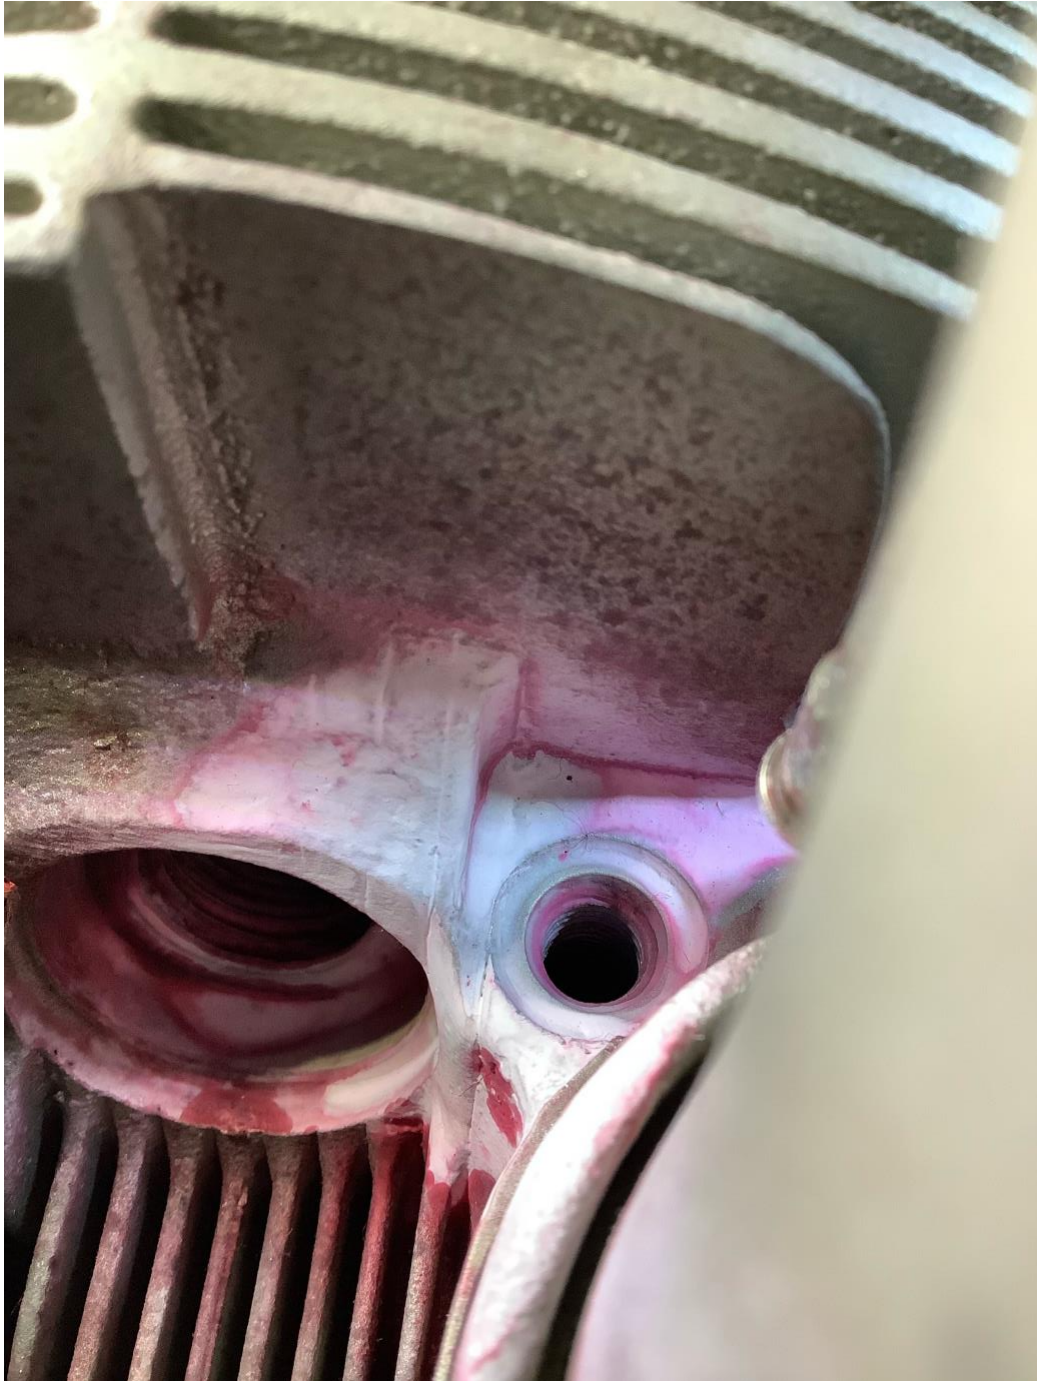
In this case it is obvious there is no dye color in the area of the suspected crack. The cylinder head was not cracked! I could hear the owner sigh in relief a block away. As a bit of a quality control, note the area just below the injector port in the face of the cylinder where there is a red reaction area. This appears to be a porous spot in the casting. It is not a structural issue, but being there, shows up in the process, indicating we probably did it right.

So, what caused the original issue of an apparent crack on the cylinder. I don't know for sure, but it appears to have been just dirt and/or grease smeared in a line. The line was in an area where cracks can occur, so it was easy to assume a crack. Based on the article by Mike Busch it may be an issue on Cirrus aircraft. Something in the cowling/baffling may cause an airflow that deposits the dirt/stain in a location and orientation that looks like a crack.

Moral of the story is to do your homework before jumping into pulling cylinders. Wipe down a suspect crack area to clean it and monitor at regular intervals. Cracks do not go away. They do grow, so do not wait too long to recheck.

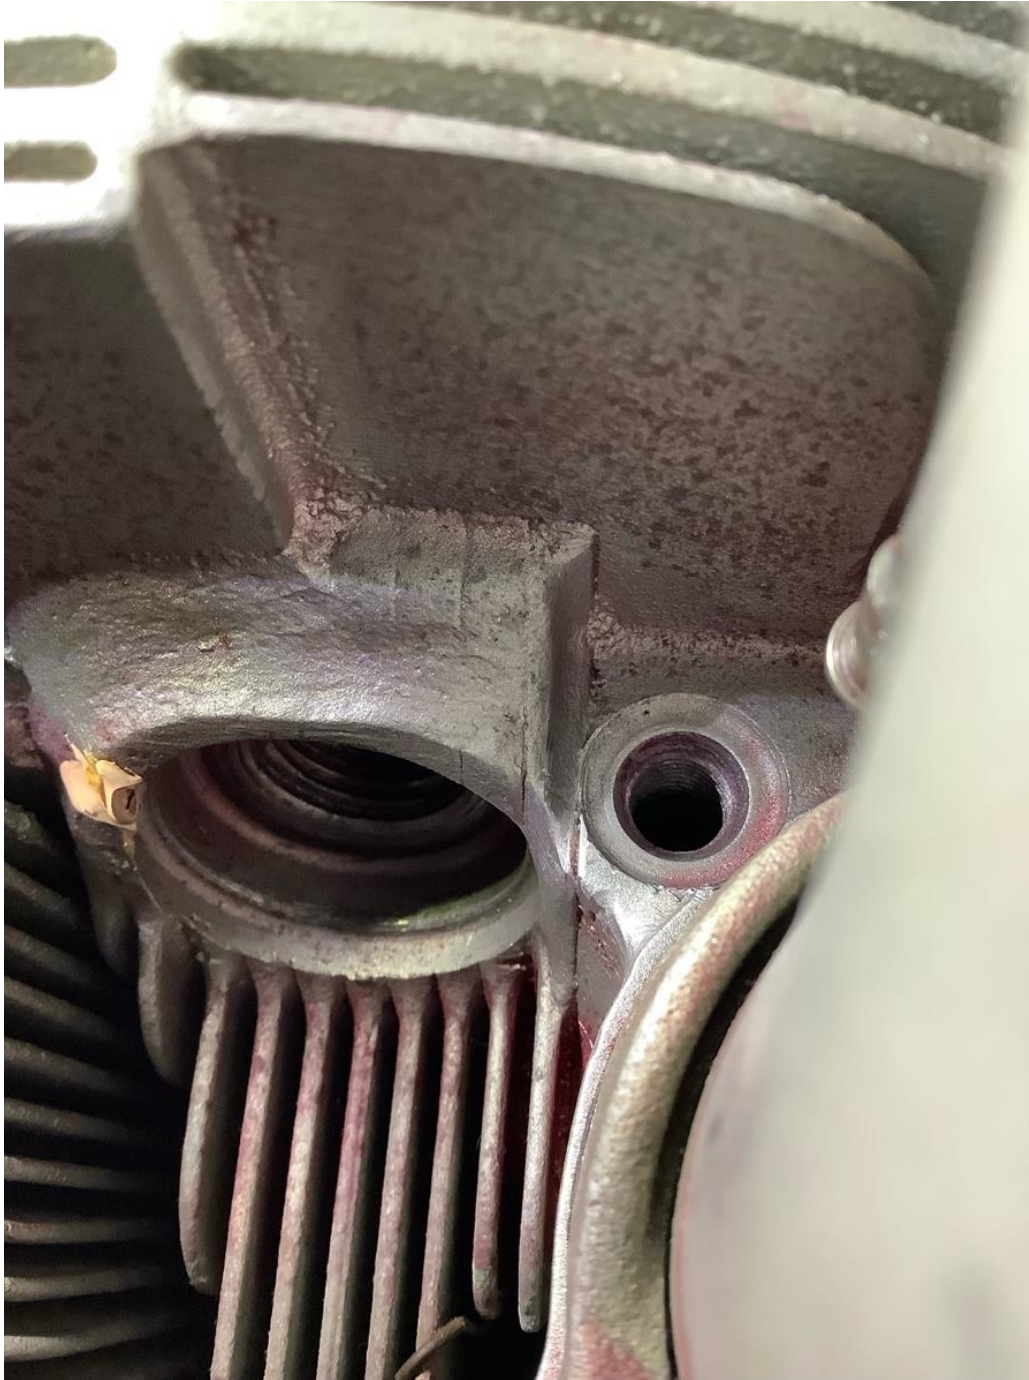
I then super cleaned the area and left the cylinder clean for the IA to reinstall the parts.
