KOEHLER KORNER

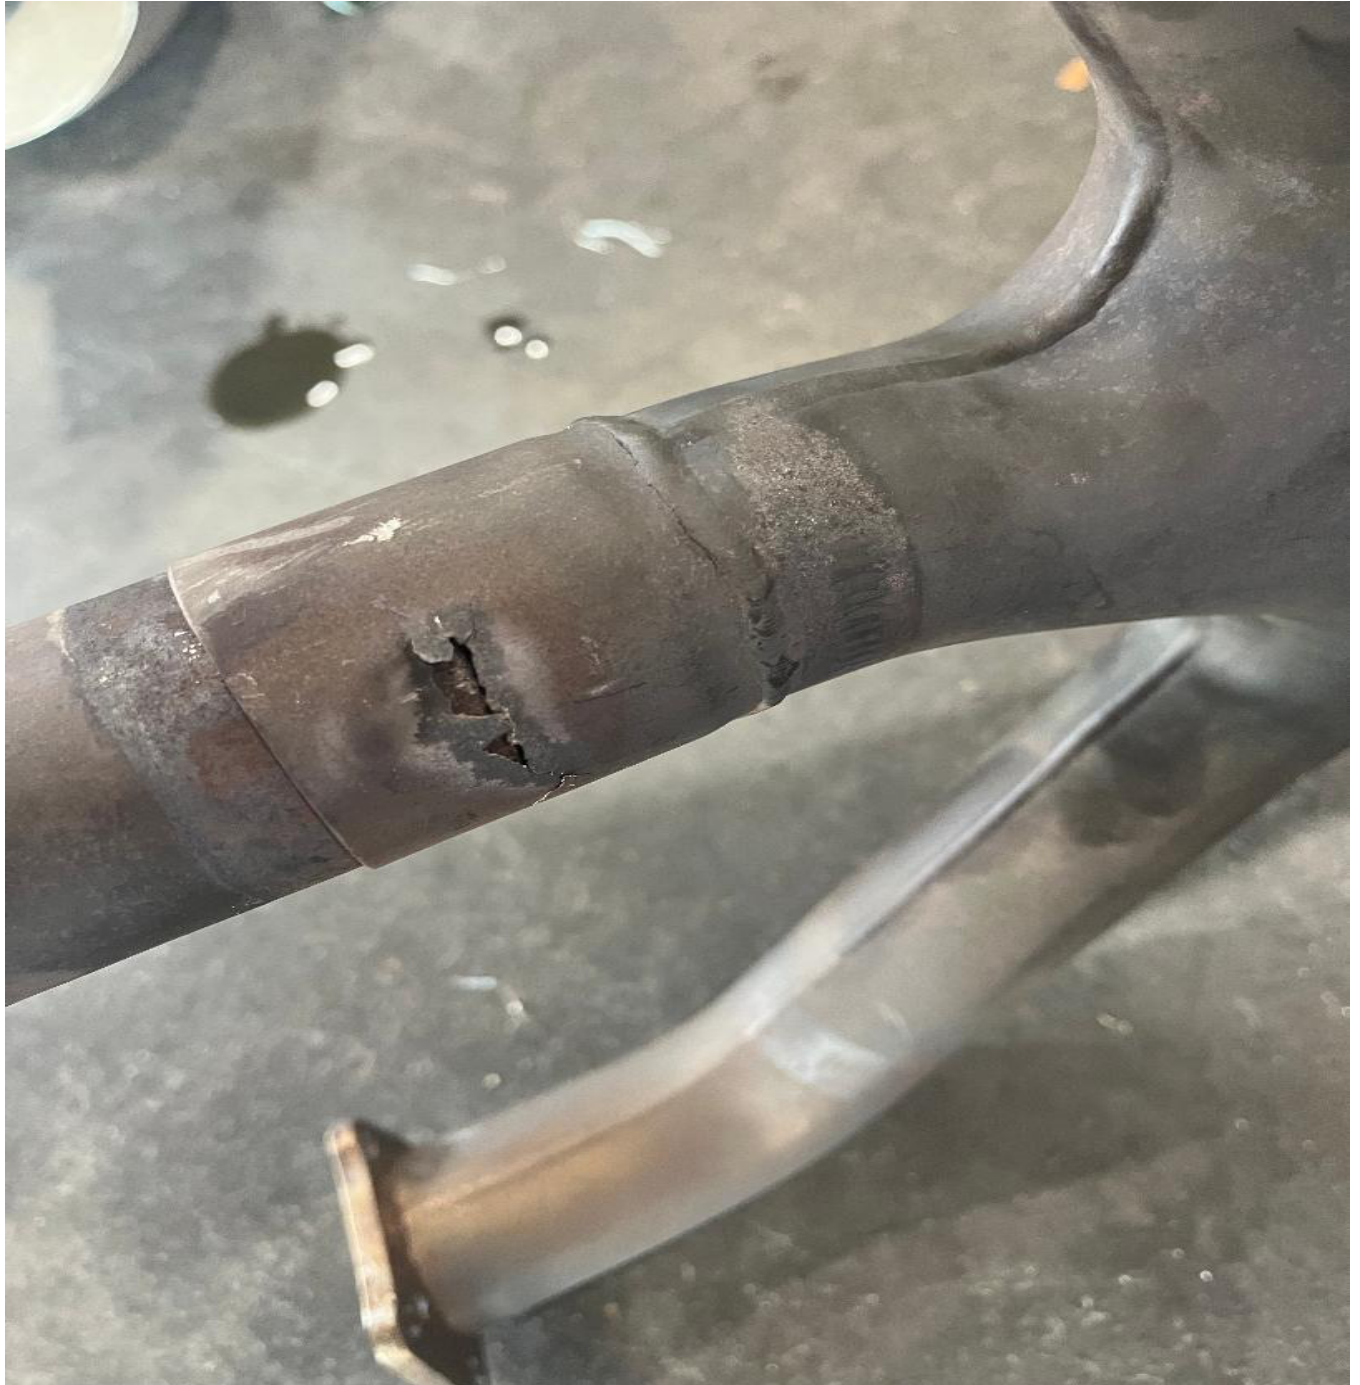
We all agreed that the earlier problem with the missing plug in the injection port had nothing to do with the break-in issue. After another visit to Aero Services, they decided to remove the cylinder (a third time) and replace it with new. To do so, they first removed the exhaust system and discovered the following:

It turns out that the exhaust system developed a leak on the backside at a slip joint and the leak was directly impinging on the CHT sensor probe. This was giving an artificially high indication of the cylinder's CHT on the display in the cockpit. This solution completely explains why we had the high CHT indication and no other indication of cylinder distress, such as high oil consumption or temperature. A weld repair and this engine/plane should be happily flying again. When this happens, we can hopefully verify that the cylinder has broken in successfully. The

relatively small leak was hard to detect because it left no trace gas markings on the cylinder, and was on the backside where it was not clearly visible.
