KOEHLER KORNER

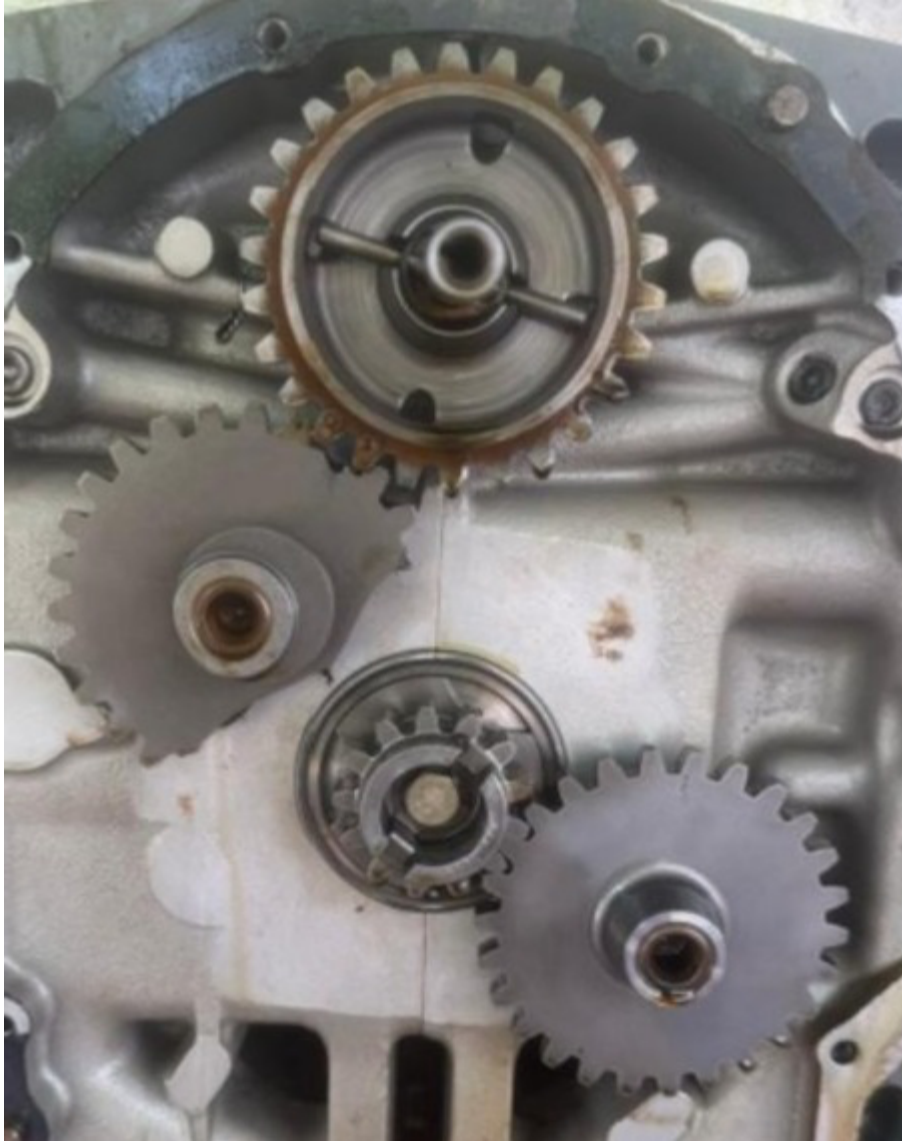
Inside the sump about a 160° segment of the left idler was found in one piece! When the accessory case cover came off, the rest of the gear was found. Here is a picture of the gears as found:

Oh, what caused this? Turns out the owner had the left mag come loose about 20 hours ago and fall out of the case. It appears that as the mag gear tipped it jammed one of the teeth on the left idler gear breaking it off. There was enough gear mesh for the idler gear to keep the gear timing correct, but the gears were probably not meshing smoothly and eventually this bad meshing resulted in a structural overload that broke the gear! It is perhaps sobering to consider that this aircraft within the past year had made a major over water flight.

All of the gears were removed, except the one at the very top. It is the cam gear and is forged integral with the cam. To remove it would require splitting the case. The owner chose to not remove it. All of the intact removed gears were magnafluxed and no cracks or other damage were found. A replacement gear was found for well north of \$500 and the bolt (\$50!) and locking plate in the center of the small crank drive gear were replaced. New gaskets were purchased along with new engine mounts (it was time) and a new fuel pump (precautionary).

sudden stoppage due to a prop strike. I invite you to look up the AD and review its unique definitions that require the inspection/replacement. The Lycoming associated Mandatory Service Bulletin is MSB No. 475C. Again, I invite you to read this SB. The owner elected to follow its guidance and have everything inspected and/or replaced. All items passed. The new 5/16" bolt that is just one inch long costs \$50! It is STD-2246 and no suitable alternative is available or authorized.

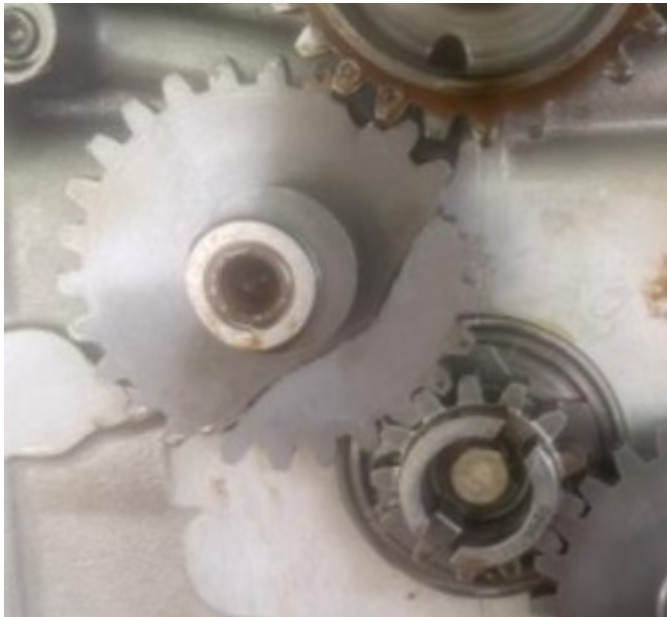
I can't resist adding another picture that shows the broken piece in place and the missing tooth. You can see the timing alignment dots on the broken part of the gear, just above the crank drive gear.
