## KOEHLER KORNER

I recently was asked to look at a Piper Arrow (PA-28R-200) which was marking its territory by leaving a puddle of liquid under the engine area. Yes, I know, you assume it is an oil leak, and most airplane engines leak a little oil. However, this puddle was red, meaning it was from 5606 hydraulic fluid. The only thing in the engine area that had hydraulic fluid in it was the landing gear retraction system. The nose gear actuator on an Arrow is at the back right side of the nose wheel well. I checked it and found red fluid all over.

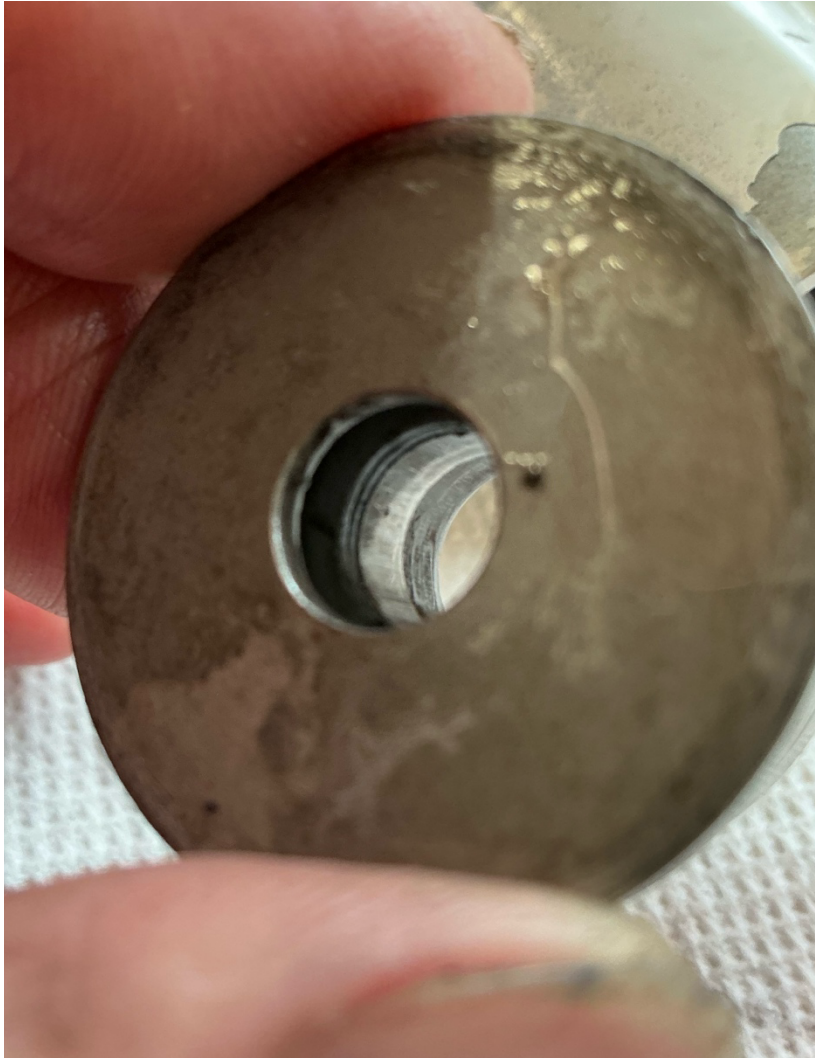
The picture below is of the end plate on the actuator. It is held in the actuator barrel by a circlip and has a sealing O-ring on the outside and the shaft seal O-ring on the inside. The outer sealing O-ring almost never fails, if it is installed correctly since it is in a static environment, but the inner O-ring takes the rubbing wear of the shaft. It is not installed in this pic:

The O-rings are removed and inserted most easily with a dental pick, taking care to not scratch the surfaces of the aluminum end plate.

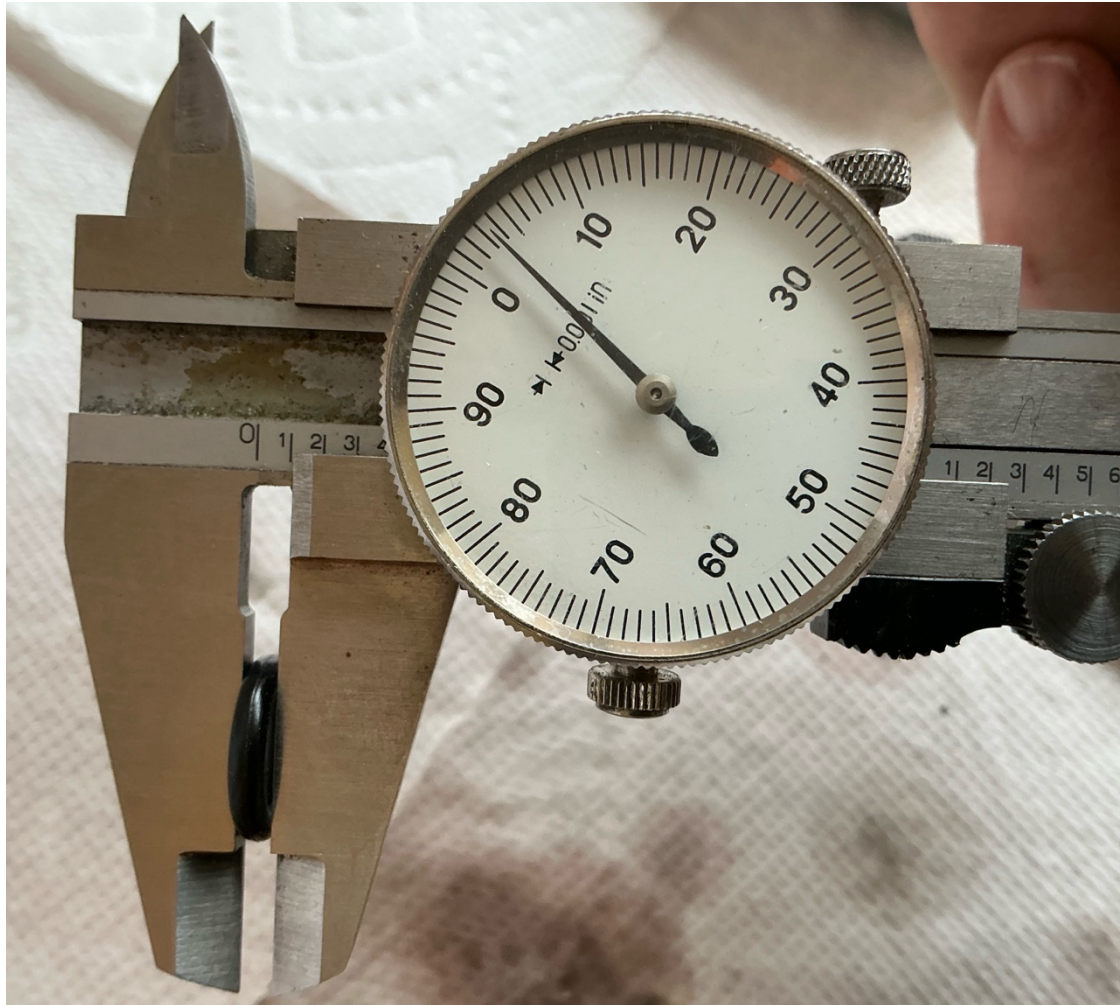
I measured the thickness of the O-ring in the unworn direction as shown in the picture below at .1035”:

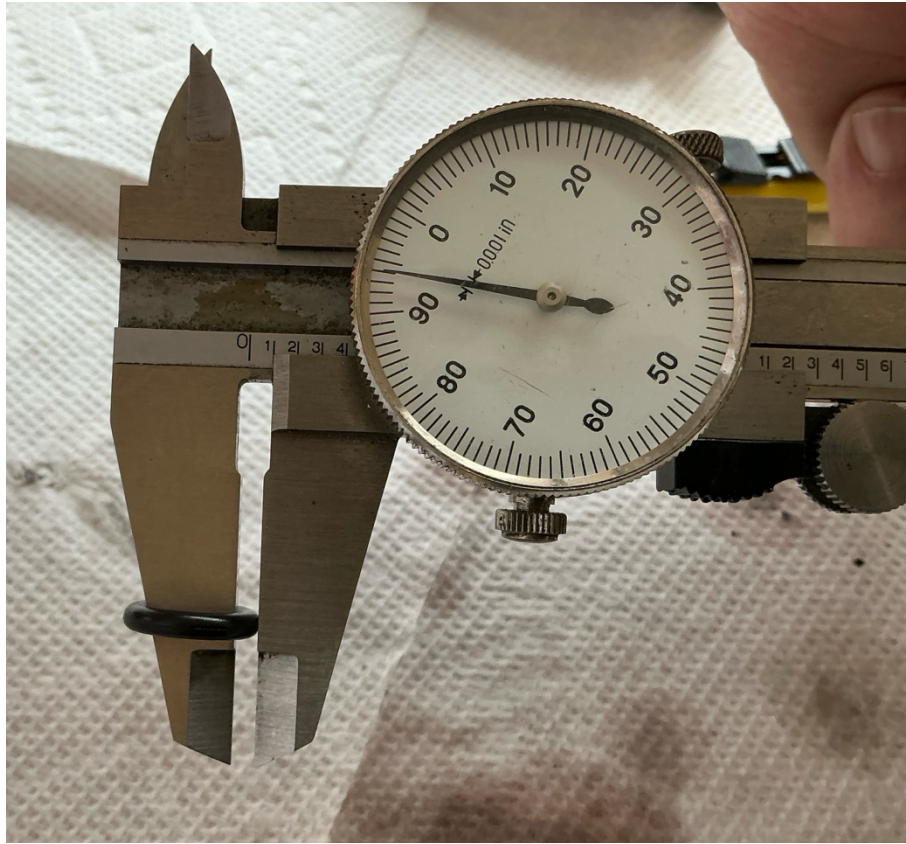
Looking specifically at the worn side of the O-ring, I also used the vernier micrometer to measure the distance from the inner to outer surface as in the picture below at .0940”.

So, the inner edge of the O-ring wore at least .0095". You could definitely see a flattened and worn face on the inside diameter with the naked eye, but I was unsuccessful in catching it in a photo. Also, the old O-ring was noticeably hard and non-pliable compared to the new O-ring.

We put in the new O-ring, prelubing it with a dab of 5606, reassembled the actuator, and reinstalled it on the plane. Since we had introduced air into the gear retraction system, we did multiple retractions and extensions until the operation of the system was smooth and even. With a double-acting hydraulic system like this, it tends to be self bleeding, as opposed to brake systems that almost always need bleeding after changing out a component.
