VAN'S AIRCRAFT
TOTAL PERFORMANCE

SERVICE BULLETIN 00036 - REV 3

Subject: Cracking in horizontal stabilizer rear spar at outboard elevator hinge brackets

Affected Models: RV-3, RV-4, RV-6/6A, RV-9/9A, RV-10, RV-14/14A

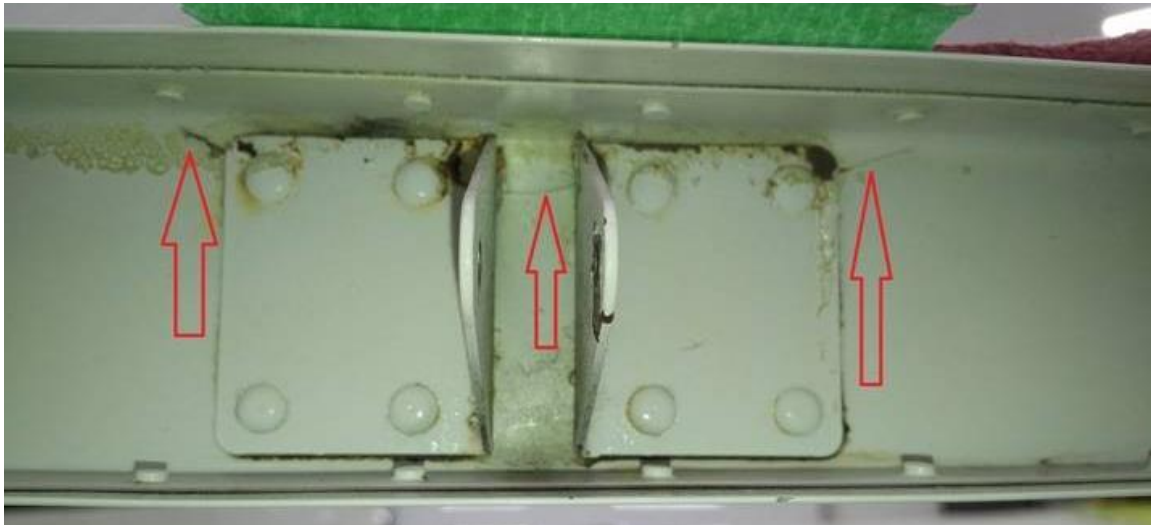
Van's Aircraft has received reports of cracks forming in the outboard elevator hinge bracket areas of the horizontal stabilizer rear spar. See Figures 1 through 4 below for visual examples of cracks.

Formation of these cracks is caused by loads from the elevator hinge pushing and pulling on the web of the rear spar. This has been observed and reported on multiple RV-3, RV-4, RV-6, RV-7 and RV-8 aircraft, in many cases where aerobatics were performed and the airframe total times were near 2,000 hours, although cracks have since been reported on aircraft with a variety of total times and operations.

FIGURE 1: EXAMPLE 1 - CRACK LOCATIONS – AFT SIDE OF SPAR

Cracks that do not meet the spar replacement criteria must be stop-drilled using a #40 hole at the extreme end of the crack. This hole must be at least .098 from the edge of any rivet hole and may not extend into the bend of the spar. If you cannot meet these minimum distance requirements when drilling, replace the rear spar.

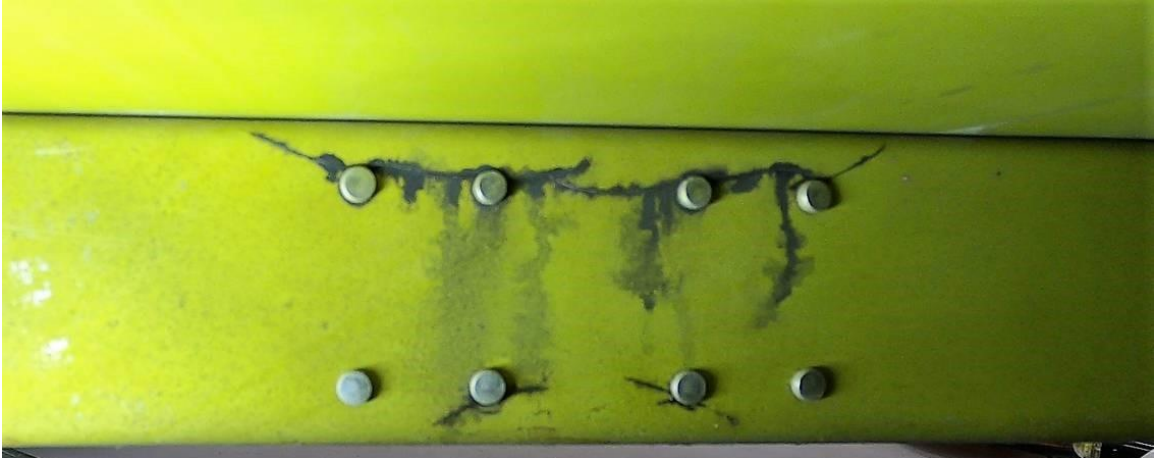
FIGURE 2: EXAMPLE 1 - CRACK LOCATIONS - FWD SIDE OF SPAR

NOTE: Cracks may be present, but not visible from the aft side of the spar. It is imperative that the forward side of the spar is inspected.
