## SERVICE BULLETIN 00036 - REV 1

<b>Date Released:</b>	February 2, 2023 (Revision 1) January 23, 2023 (Initial release)
<b>Date Effective:</b>	January 23, 2023
<b>Subject:</b>	Inspect outboard elevator hinge on the horizontal stabilizer rear spar, replace if cracks found
<b>Affected Models:</b>	RV-3, RV-4, RV-6/6A, RV-9/9A, RV-10, RV-14/14A  RV-7/7A and RV-8/8A Empennage Kits shipped prior to November 2022
<b>Required Action:</b>	Inspect outboard elevator hinge bracket area on the rear spar of the horizontal stabilizer for cracks
<b>Time of Compliance:</b>	For the initial inspection, within 25 hours or at the next annual inspection, whichever is earlier  After the initial inspection, inspect every 12 months; continue this schedule until replacement of the outer hinge brackets is completed
<b>Supersedes Notice:</b>	N/A
<b>Labor Required / SLSA Warranty Allowance:</b>	N/A
<b>Level of Certification:</b>	Check the rules of the local controlling agency and the operating limitations for your aircraft

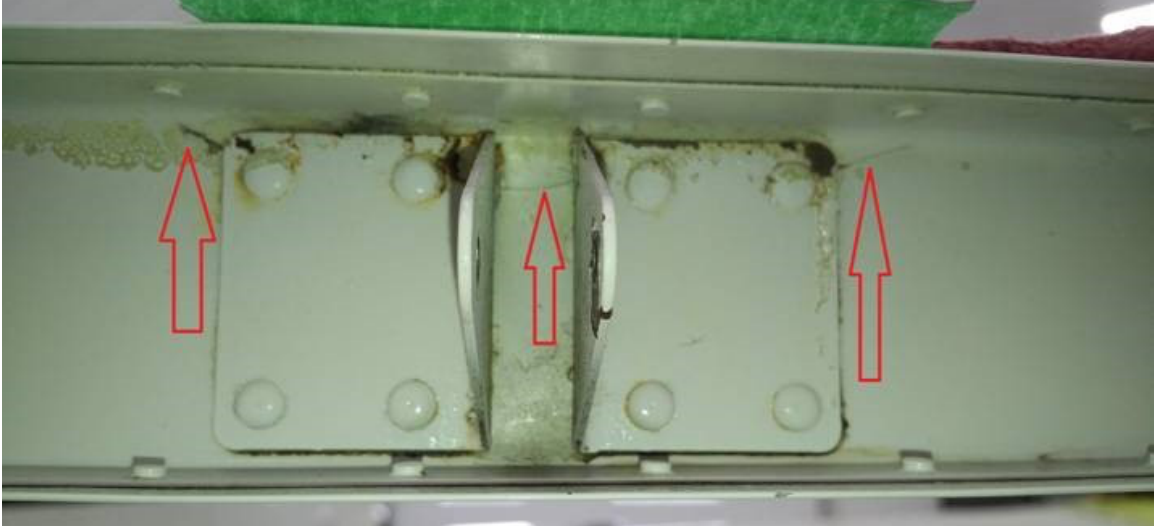
Van's Aircraft has received a small number of reports of similar cracks forming in the outboard elevator hinge bracket areas of the rear horizontal stabilizer spar web. See Figures 1 through 4 below for visual examples of cracks.

Formation of these cracks may be caused by loads from the elevator hinge pushing and pulling on the web of the rear spar. This was observed on aircraft where aerobatics were performed and the airframe total times were near 2,000 hours. Additional potential causes may include misalignment of the elevator hinge brackets and/or the interaction of airframe vibrations and the elevator, which can result from failure to dynamically balance the propeller.

**FIGURE 1 – EXAMPLE 1 - CRACK LOCATIONS – AFT SIDE OF SPAR**

If cracks are found, it is important to determine the severity of the cracks. To do so you will need to remove the outer hinge brackets to fully inspect the cracks.

Cracks that have propagated into the bend of the spar or span across holes will require the spar to be replaced. Otherwise, cracks can be stop drilled using a 3/32" hole at the extreme end of the crack.

These cracks must be monitored for further propagation that would require spar replacement.

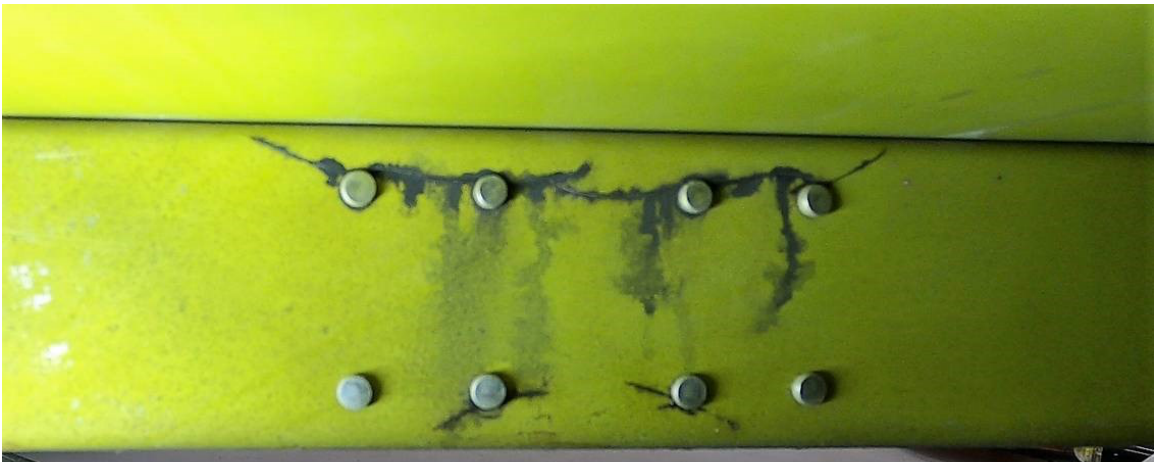
**FIGURE 2 - EXAMPLE 1 - CRACK LOCATIONS - FWD SIDE OF SPAR**

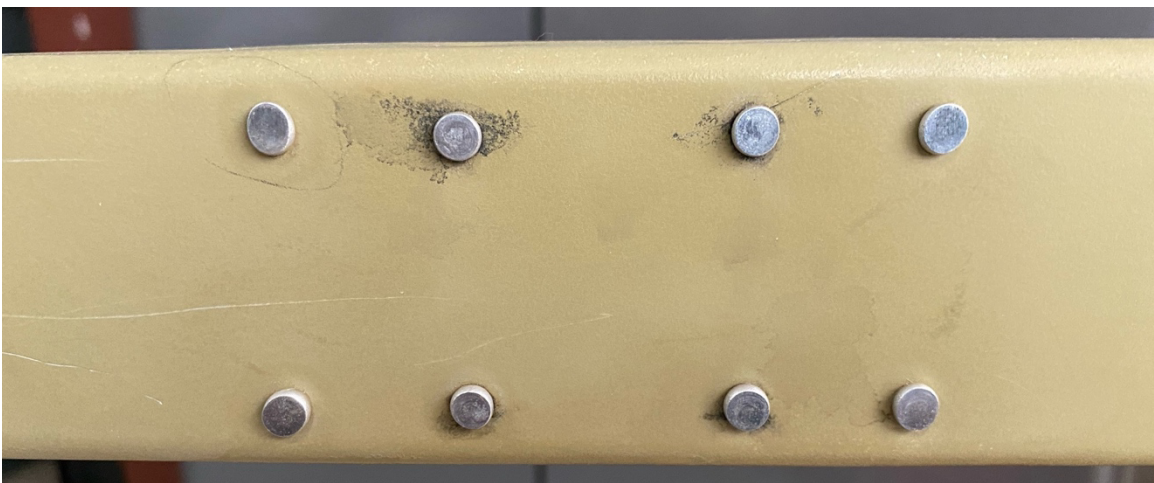
**FIGURE 3 - EXAMPLE 2 - CRACK LOCATIONS - FWD SIDE OF SPAR**

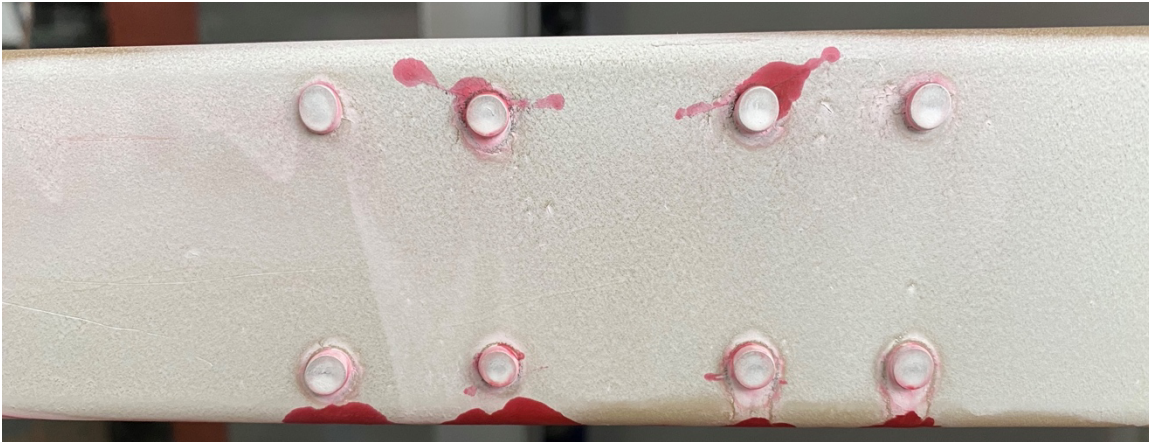
**FIGURE 4 - EXAMPLE 2 - CRACK LOCATIONS - FWD SIDE OF SPAR**
