# Inspection Report

1122 Sunshine Street, Hometown, Florida 123456

**Inspection Date** March 23, 2020  
**Inspector** Matt Durst  
561-350-8125  
[mdurst@sunshinestatesbhi.com](mailto:mdurst@sunshinestatesbhi.com)

Sunshine State's Best Home Inspection

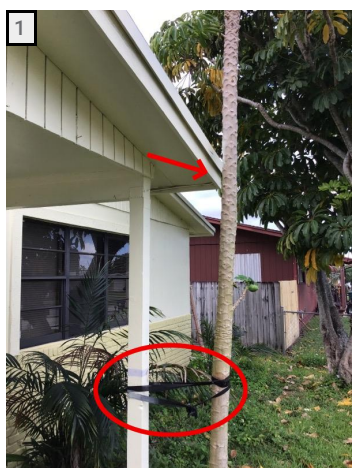
#### Trees being held in place with cabling

**Location** Exterior: Ground View

**Impact** Tree will gradually increase tension on cable. In a strong wind could potentially become free and damage the house structure.

**Suggested Action** Monitor cable periodically for deterioration and slippage.

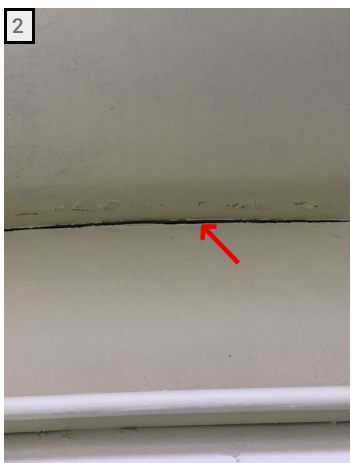
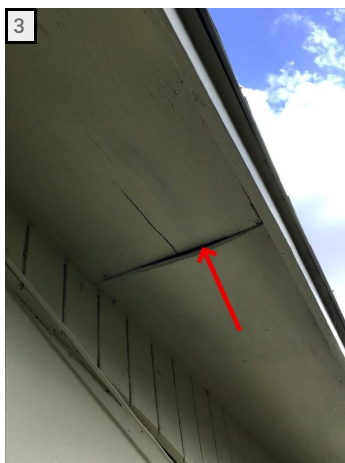
##### Gaps in soffit

<b>Location</b>	Exterior: Ground View
<b>Impact</b>	The gap provides an environment for Pest and Moisture intrusion
<b>Suggested Action</b>	Paint, stain and/or seal with a weatherproof product

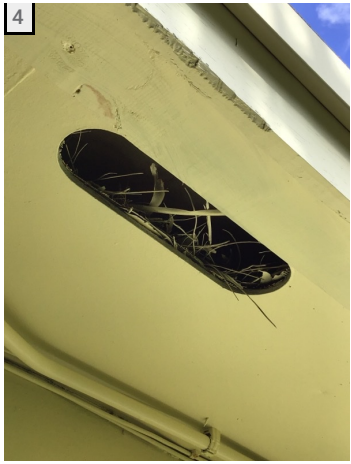
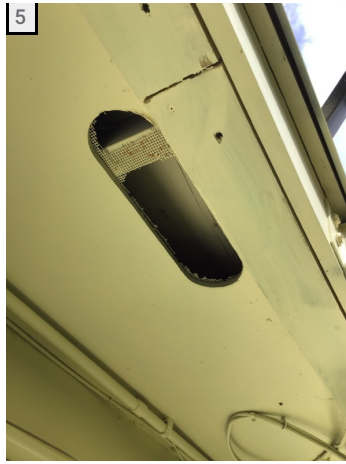
##### Missing Soffit vent screen

<b>Location</b>	Exterior: Ground View
<b>Impact</b>	Most soffits are vulnerable to animal entry, and given the architecture of a house, the eave leads right into the attic, where animals like to live.
<b>Suggested Action</b>	Replace Screen

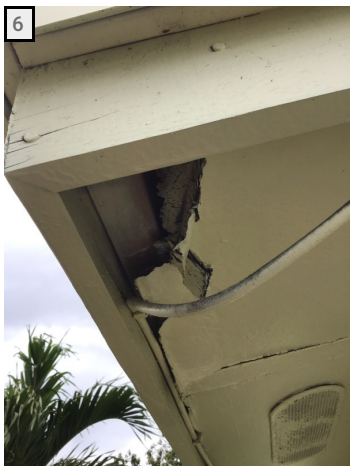
#### Soffit wood is rotted

<b>Location</b>	Exterior: Ground View
<b>Impact</b>	The rotted areas lacks protection from insects, animals and the elements
<b>Suggested Action</b>	Replace the damaged area

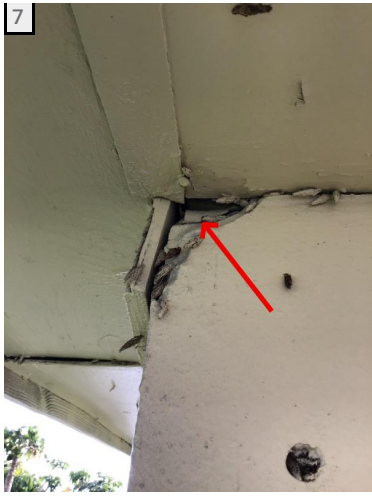
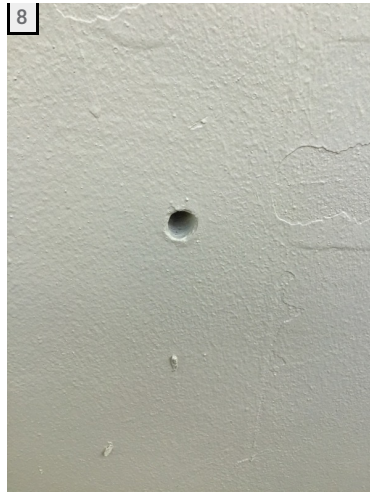
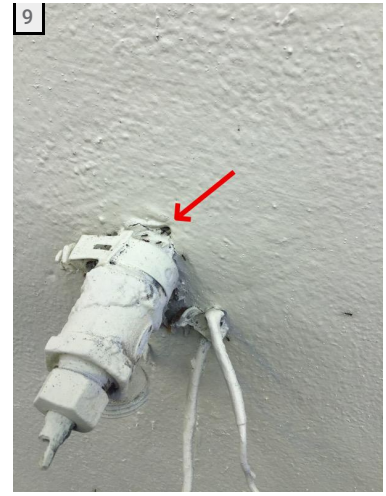
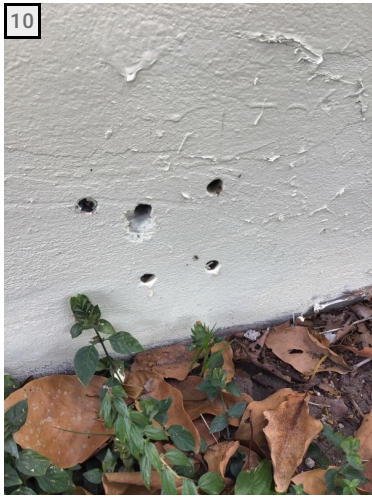
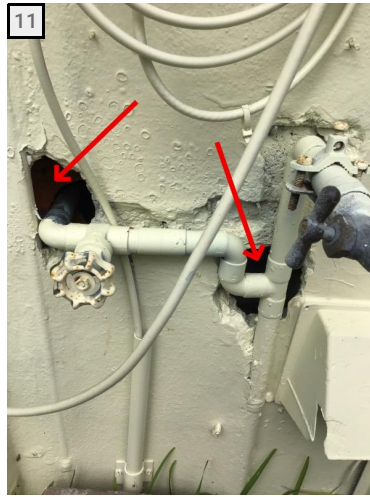
#### Holes in Stucco

<b>Location</b>	Exterior: Ground View
<b>Impact</b>	Moisture intrusion from weather and sprinkler heads could cause damage to interior walls.
<b>Suggested Action</b>	Paint, stain and/or seal with a weatherproof product

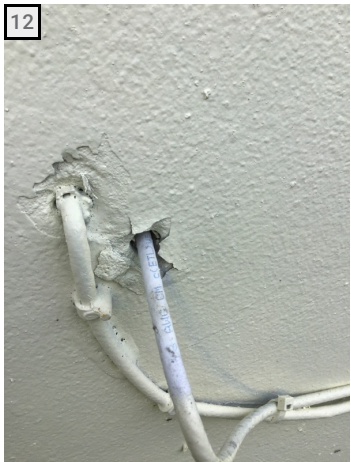
**Siding has coaxial cables that are unsealed**

<b>Location</b>	Exterior: Ground View
<b>Impact</b>	Any gaps in the siding can invite moisture and pest intrusion
<b>Suggested Action</b>	Fill and seal with weather proof caulk

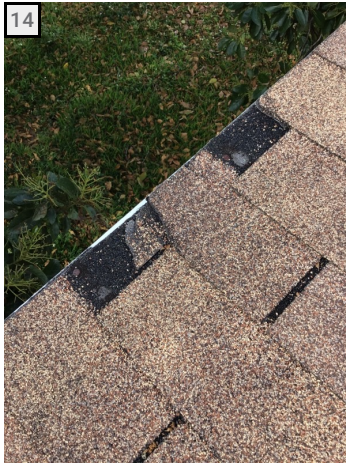
#### Cracked or Broken Shingles

**Location** Exterior: Roof View

**Impact** Any breach in the roof material will expose the underlying wood to the elements and may cause roof leaking

**Suggested Action** Have the damaged roof material replaced by a tile roofing professional

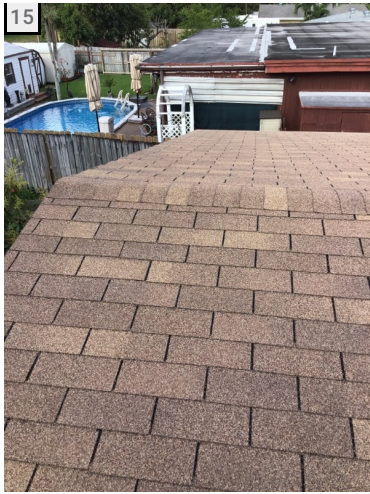
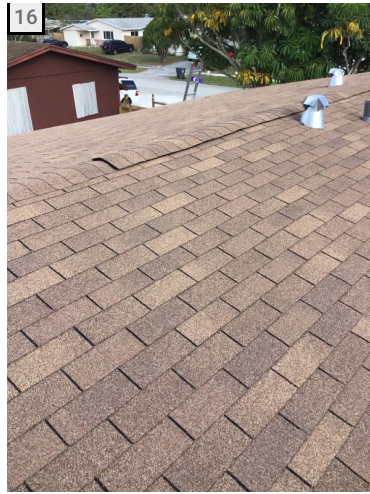
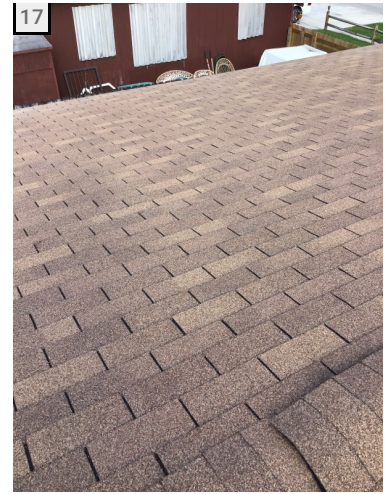
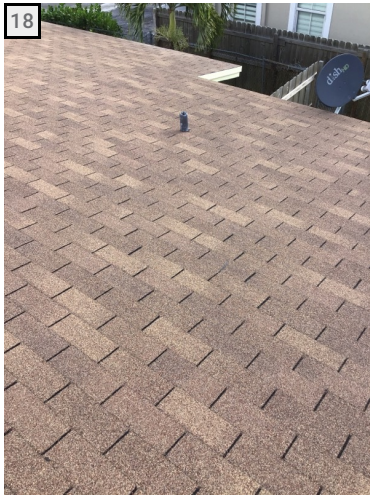
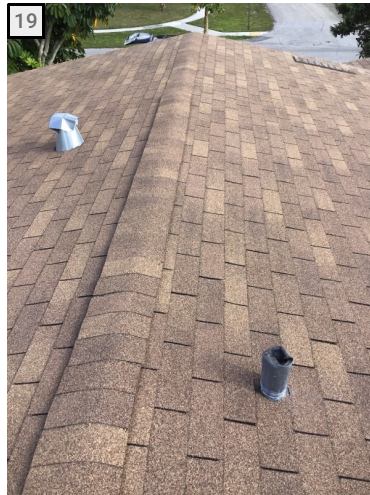
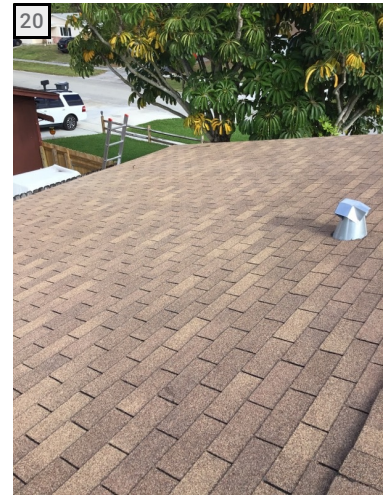
**3 Tab Asphalt Shingles covering the roof of this home exhibited moderate general deterioration commensurate with the age of the roof. They appeared to be adequately protecting the underlying home structure at the time of the inspection. Roof is 5 Years old at time of inspection**

**Location** Exterior: Roof View

**Impact** The expected lifespan of a 3-tab asphalt shingle roof, often called a 20-year shingle roof, is 15 to 18 years in Florida. The 15 to 18 year average lifespan estimate is based on "average" conditions.

**Suggested Action** Recommend having the roof inspected periodically by a Qualified Roofing Contractor and have the damaged roof material repaired or replaced as needed

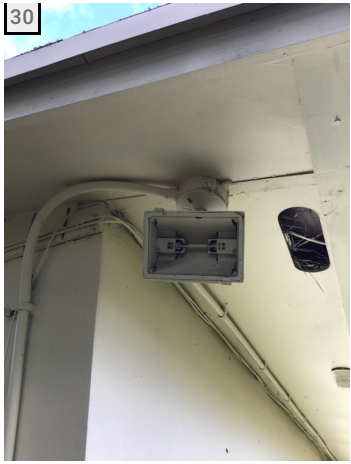
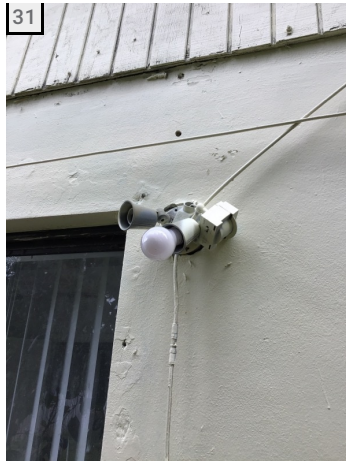
### A light fixture did not respond to the switch.

<b>Location</b>	Exterior: Ground View
<b>Impact</b>	Light fixture not working
<b>Suggested Action</b>	The bulb may need to be replaced or there may be a problem with the switch, wiring or light fixture. If after the bulb is replaced this light still fails to respond to the switch, the Inspector recommends that an evaluation and any necessary repairs be made by a qualified electrical contractor.

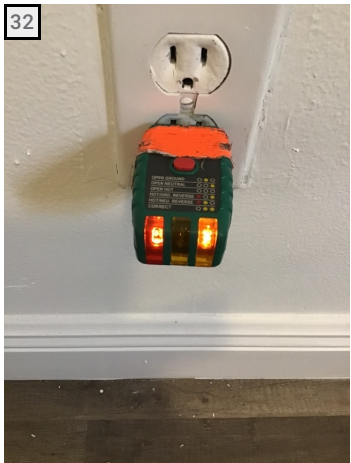
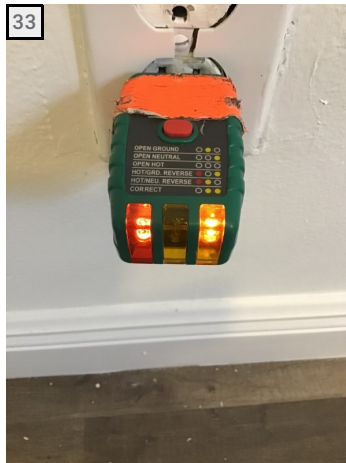
**Tester shows hot ground reverse**

<b>Location</b>	3rd Bedroom- Master
<b>Impact</b>	A hot ground reverse outlet can cause electrical shock through an appliance
<b>Suggested Action</b>	Have repaired by qualified electrician

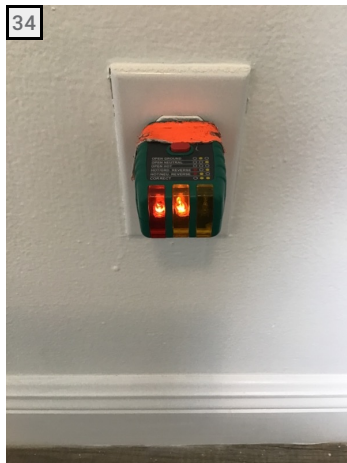
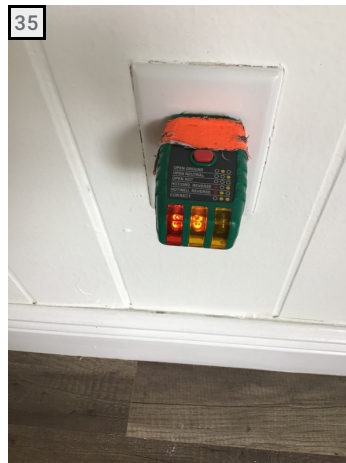
### Tester shows hot neutral reverse

<b>Location</b>	1st Bedroom- Guest front
<b>Impact</b>	A hot neutral reverse outlet can cause electrical shock or damage an appliance
<b>Suggested Action</b>	Have repaired by qualified electrician
<b>Other Information</b>	Reversed polarity is when the hot and neutral connections at a receptacle are wired "backwards." Home wiring is color-coded, and the black wire is "hot," meaning that it is electrically charged or, as it is sometimes called, the "live" wire. It's the one that will shock you if you come in contact with it in a way that will complete a circuit to the earth. The white is called the "neutral." It completes a circuit when connected with the hot wire through a switch, providing electric power to an appliance, and will not shock you. The screws at wire terminals on the sides of receptacles are also color-coded, with brass-colored screw being for the black hot wire and the silver screw for the white neutral connection. Also, the the two blades at the end of an appliance cord are size-coded: the smaller blade is hot and larger one is neutral. Receptacles have a small and large slot, so that the cord cannot be installed backwards. So, between the color-coding of the wiring and the terminals, plus the different sizes of the blades and receptacle slots so that the neutral cannot go into the hot slot of a receptacle, it's obvious that getting the hot and neutral connection right is a big deal. The reason is that reversed polarity can create a shock hazard in certain situations. Because the switch is positioned before the hot wire side enters the appliance and the neutral is connected to the other end of the appliance circuitry, when the polarity is reversed the appliance circuitry is electrically charged all the time, but only functional when a switch closes the neutral wire connection and the current begins flowing. So, the heating element wires in a toaster (the ones that turn red) would shock you if you stuck a knife in the toaster with reversed polarity to prod a piece of toast loose. Also, the metal shell of the light bulb socket in a lamp would cause a shock if touched when the polarity is reversed. Both of them are harmless if the wiring is correct. Although reversed polarity is usually caused by incorrect connections at the receptacle, it can also be due to wiring reversal in the electric panel or at wire connections between the panel and the receptacle.

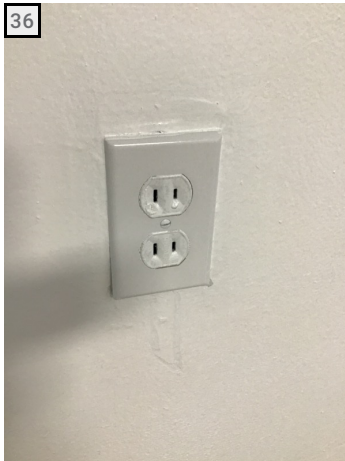
### 2 Prong Outlets Are Not up to Code

Prior to closing recommend having the entire electrical system inspected by a Qualified Electrical Contractor Upgrade your outlets to a ground fault circuit interrupter, or GFCI. According to the National Electrical Code, the outlet must be tamper-resistant if installed 5.5 feet above the floor or lower and you must label the outlet as "GFCI protected" and "no equipment ground."

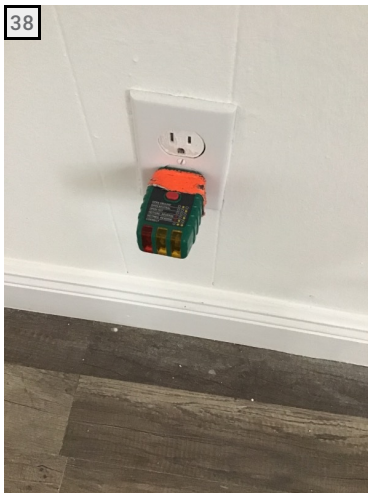
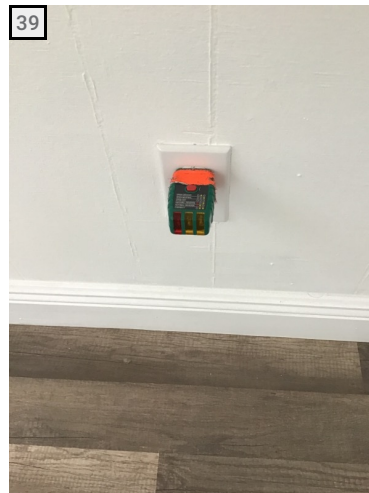
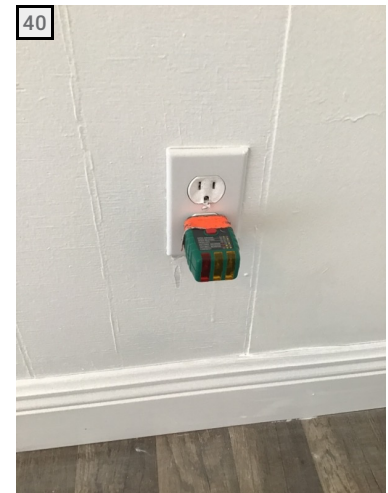
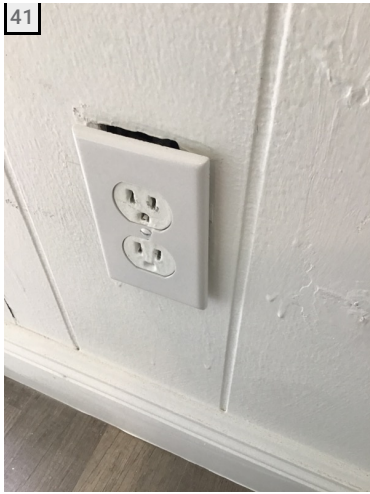
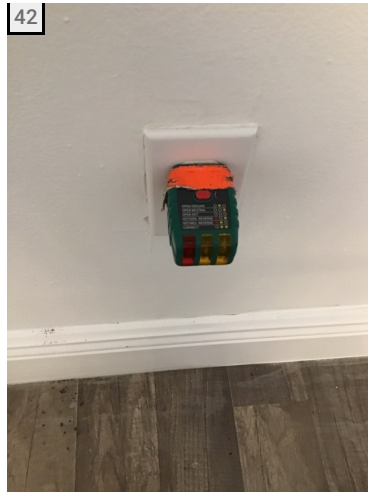
### Appears to have no power

**Impact** Tested with multiple switches

**Suggested Action** Have repaired or replaced by a licensed electrical technician

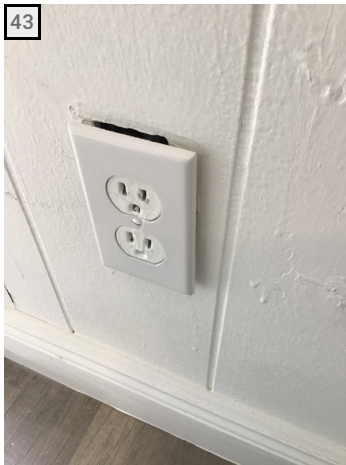
#### Cover plate is loose to outlet

<b>Location</b>	2nd Bedroom- Guest back
<b>Impact</b>	Refasten or replace cover
<b>Suggested Action</b>	Replace the screw

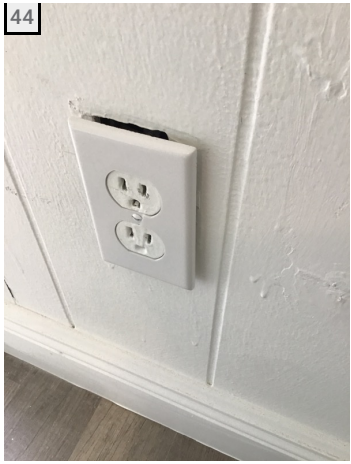
#### Receptacle is painted shut

<b>Location</b>	2nd Bedroom- Guest back
<b>Impact</b>	Paint may prevent a full electrical contact between the plug and outlet. If this happens, heat builds up, and increases the risk of a fire.
<b>Suggested Action</b>	Replace outlet by a Qualified Electrical Contractor

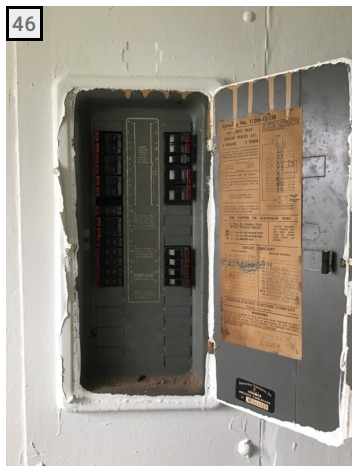
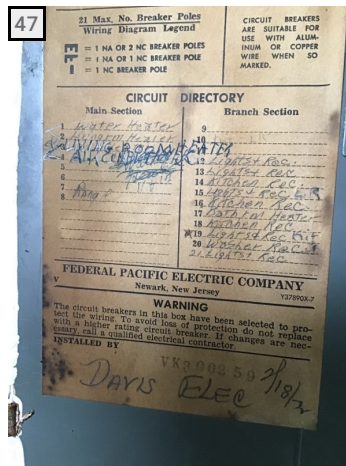
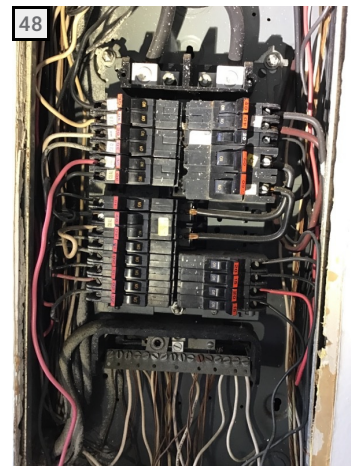
### A Federal Pacific Electrical Panel

<b>Location</b>	Laundry Room / Mudroom
<b>Impact</b>	While showing no active defects at the time of inspection, the panel could overheat and catch fire
<b>Suggested Action</b>	Simply replacing the circuit breakers is not a reliable repair. The panel should be inspected by a licensed electrician
<b>Other Information</b>	Federal Pacific Electrical panels have been the subject of class action lawsuits because their circuit breakers have been known to fail to trip at a higher rate than standard panels. When a breaker fails to trip, an extreme amount of power from the outside electrical supply surges into the panel and circuits. Once that happens, it cannot be stopped or shut off manually. Electricity will burn until it runs out of fuel or the wires melt. Many Federal Pacific Electric panels and breakers can operate properly for years, but they can malfunction unexpectedly

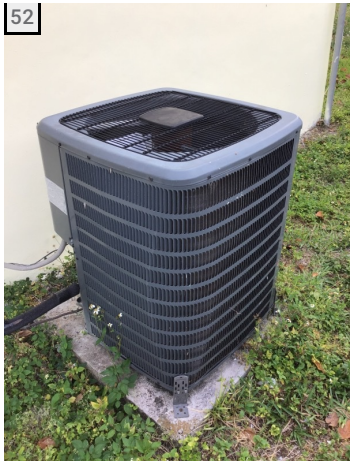
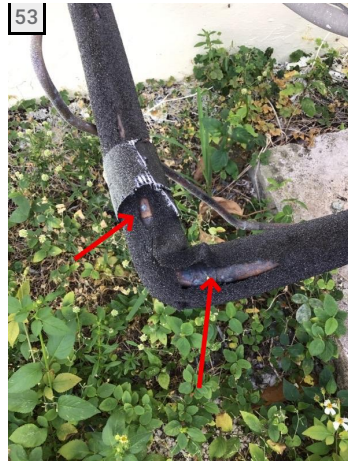
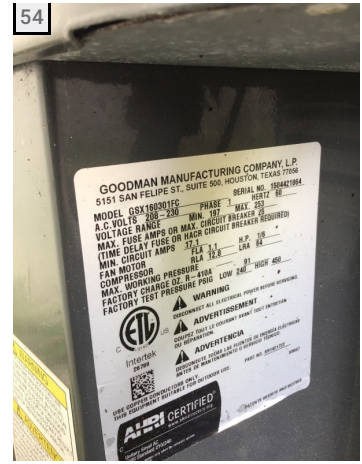
#### Insulation is damaged

**Impact** Over time insulation on exterior HVAC lines can degrade from weathering, UV rays and poor installation causing a loss of effectiveness. When insulation loses its ability to insulate, energy is lost and the equipment must work harder to maintain the desired indoor comfort level. The large-diameter line (suction line or gas line) should be insulated along its entire length. The insulation has two functions: To prevent the suction line from sweating and dripping water inside the house. To prevent the suction line from heating up outdoors on its way to the compressor. We are trying to take heat out of the house and dump it outside. We do not want to collect more outdoor heat in the suction line before it goes into the compressor.

**Suggested Action** Replace the insulation with 3/4 to 1 inch vapor-proof insulation

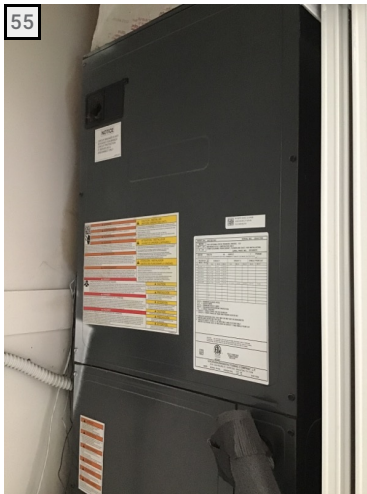
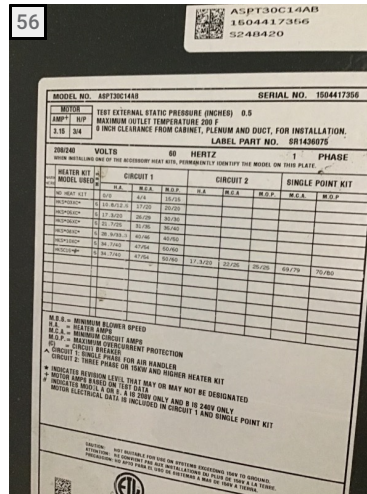
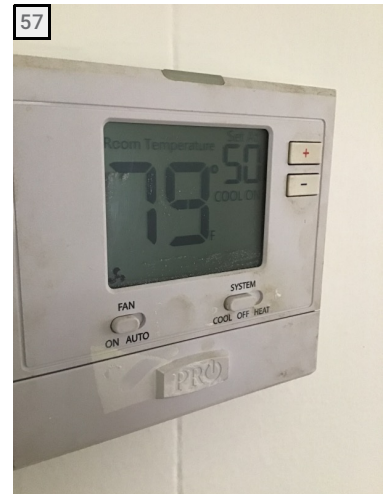
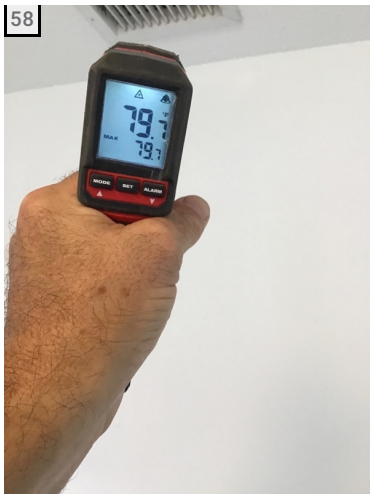
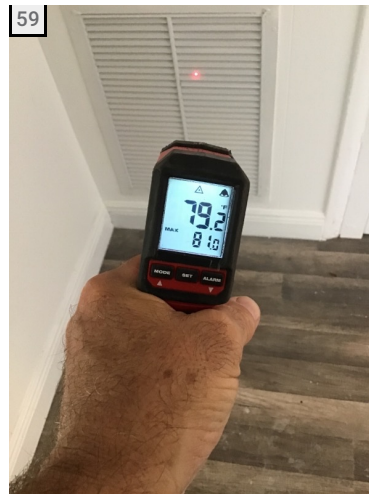
**Location** 2nd Bedroom- Guest back  
**Impact** For ideal temperature, you do want a 16°–22° F difference from the supply air and return air. Professionals call this temperature difference the evaporator Delta T. When evaporator Delta T is between 16°–22° F, that means your system is working properly. But if temperatures fall outside of that range, it means your AC has some issues. Not working at the time of inspection

**Suggested Action** Prior to closing, have the entire HVAC system serviced by an HVAC service professional. Secure a quote on repair/ replacement costs.

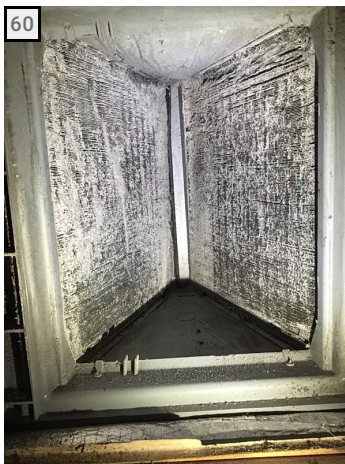
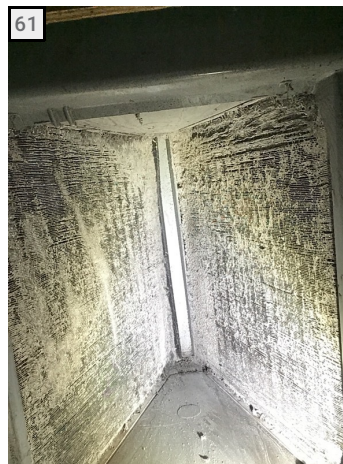
### Evaporator coils are dirty

Drop in cooling efficiency: Dirt along a coil creates a layer of insulation between the air and the refrigerant in the coil. This makes it much harder for the refrigerant to absorb heat from the air, and this will result in a rise in temperatures. An air conditioner won't be able to handle the cooling expected from it with a dirty coil. Development of ice on the coil: If the restriction of heat absorption along the coil becomes restricted enough, the refrigerant in it won't warm up past freezing. Water moisture along the coil will then freeze. This ice further impedes the evaporator coil from doing its job. The ice will continue to build-up until heat absorption is completely blocked. The ice can also cause damage to the fins and coil from warping. Clogged condensate drain: As the evaporator coil absorbs heat, it also causes moisture to condense along it. This excess water drips down from the coil and into a pan, where a drain removes it into the wastewater system. But if the water dripping from the coil contains dirt, this will become lodged in the drain, eventually creating a complete clog. Water will overflow from the condensate drain, creating water damage, high humidity, unpleasant moldy odors, and even health hazards from toxic mold spores.

Proper cleaning of a coil requires special chemicals. And cleaning the coil may be only the beginning of service; professionals may need to fix a deeper problem with the AC or repair issues that have started because of the coil, such as cleaning out a dirty condensate drain. Recommend immediate service by a qualified HVAC contractor

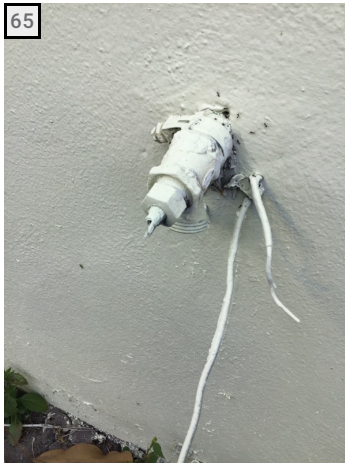
#### Handle broken

<b>Location</b>	Exterior: Ground View
<b>Suggested Action</b>	Replace handle

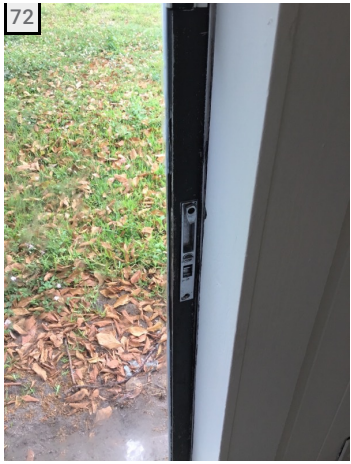
**Location** 2nd Bedroom- Guest back

**Suggested Action** Replace the latch

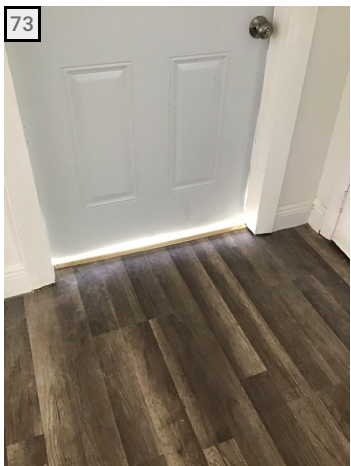
#### Not weather sealed

<b>Location</b>	Living Room
<b>Impact</b>	Without proper protection, the door is not protected from the elements
<b>Suggested Action</b>	Protect with weather-resistant seal, stain or paint

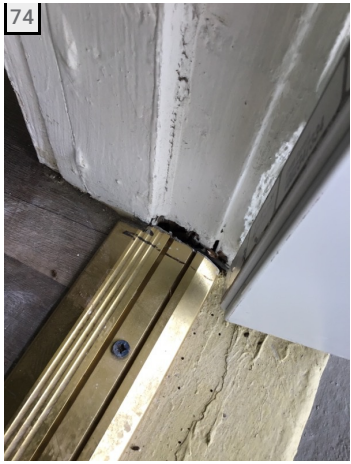
#### Wood rot at Exterior Door Jamb

<b>Location</b>	Exterior: Ground View
<b>Impact</b>	Door frames commonly rot at the bottom corner where it meets the door sill. The wood jamb rotted because the caulk seam failed allowing rain water intrusion
<b>Suggested Action</b>	Repair or replace Exterior door

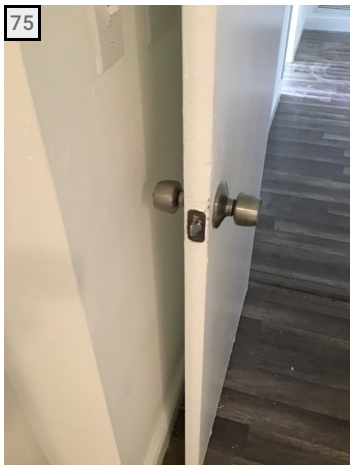
#### No Door Stopper

<b>Location</b>	3rd Bedroom- Master
<b>Impact</b>	Potential damage to walls
<b>Suggested Action</b>	Add a stopper

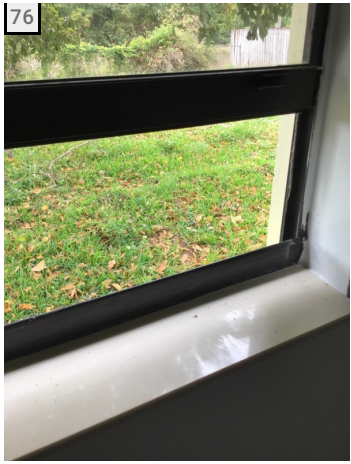
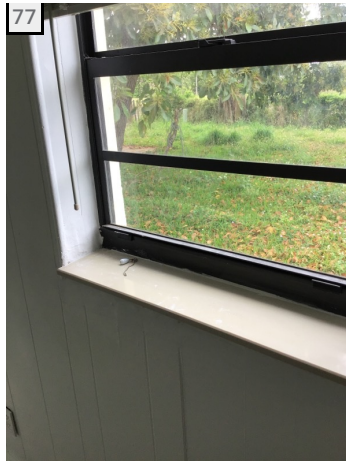
#### Screen missing

<b>Location</b>	3rd Bedroom- Master, 2nd Bedroom- Guest back
<b>Impact</b>	Should the window be open, lacks protection from insects
<b>Suggested Action</b>	Consult with seller to identify if screens exist. If they do not, install screens as needed

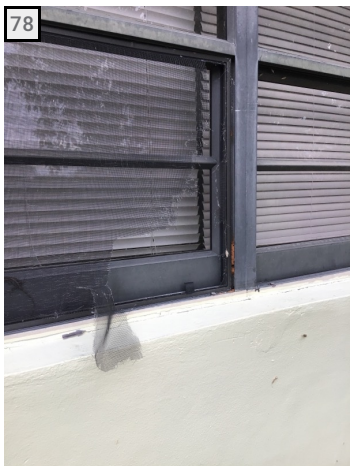
#### Torn or damaged

**Location** Exterior: Ground View  
**Impact** lacks protection from insects  
**Suggested Action** Replace the screen

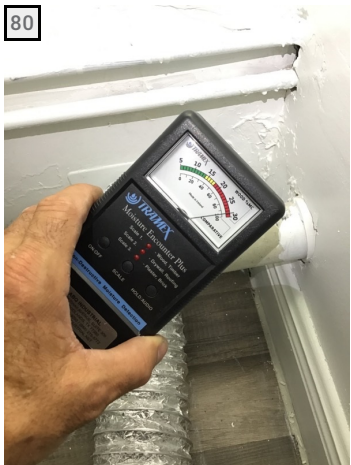
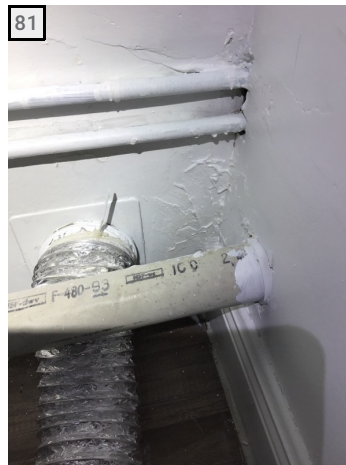
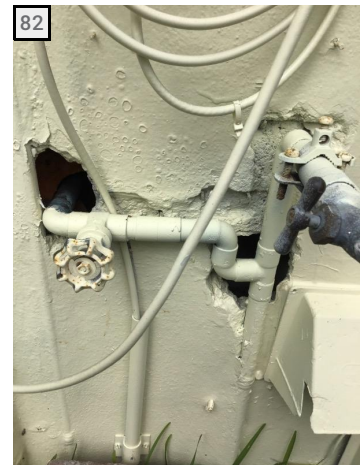
#### Moisture Meter indicates a level of moisture on wall.

<b>Location</b>	Laundry Room / Mudroom
<b>Impact</b>	Potential interior wall damage.
<b>Suggested Action</b>	Recommend sealing exterior gaps in siding

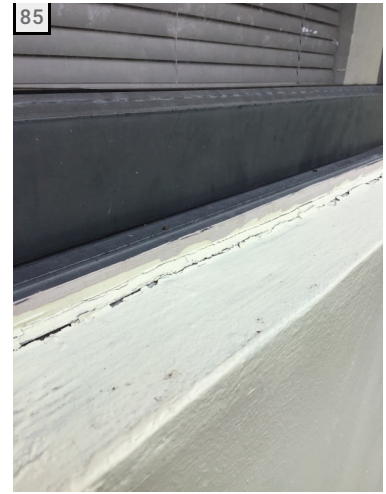
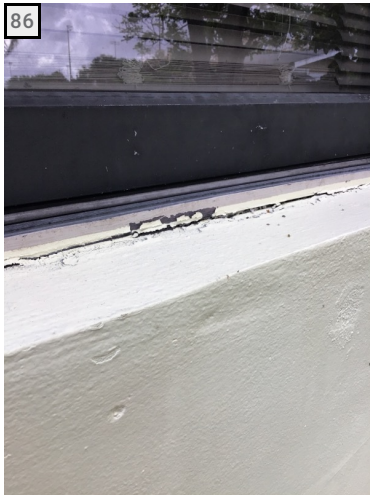
#### Caulking or sealant is deteriorated

<b>Location</b>	Exterior: Ground View
<b>Impact</b>	Without proper caulking, air, moisture and/or insect intrusion may occur. Often, water leaks at a window result from a breakdown in the connection between the window frame and the wall.
<b>Suggested Action</b>	Re-caulk all windows and doors where caulking has deteriorated. To prevent leaks, caulk the window where it meets the exterior siding. If the window is surrounded by trim, use a high-grade polyurethane caulk to seal all gaps between the trim and the siding (and the trim and the window).

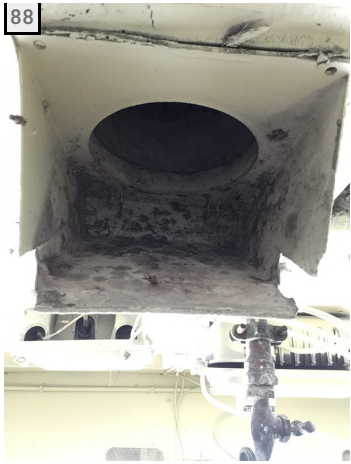
##### Dryer Vent has no damper

<b>Location</b>	Exterior: Ground View
<b>Impact</b>	While neither a dryer vent nor a dryer exhaust backdraft damper is absolutely necessary to the function of a clothes dryer, both may be considered valuable and important.
<b>Suggested Action</b>	If you want to keep insects (such as bees and wasps), dirt, dust, rain, and even mice from entering your dryer vent and possibly your dryer, you will find a back draft damper to be an essential addition to your dryer accessories.

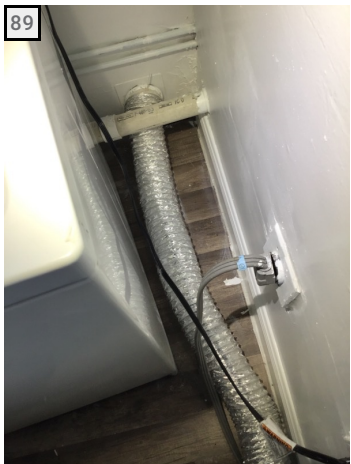
### Improper dryer vent hose is Mylar Foil Tubing.

Dryers should use approved exhaust ducts. Ducts made of vinyl, nylon or foil are not recommended. If used, they will void the warranty of most dryers. Spiral-duct designs often trap lint, which can clog the duct, requiring the dryer to work harder and longer to dry clothes and causing it to increase the dryer's temperature. Not only is a poorly exhausting dryer less efficient, it can also be a fire hazard due to the flammability of the accumulated lint.

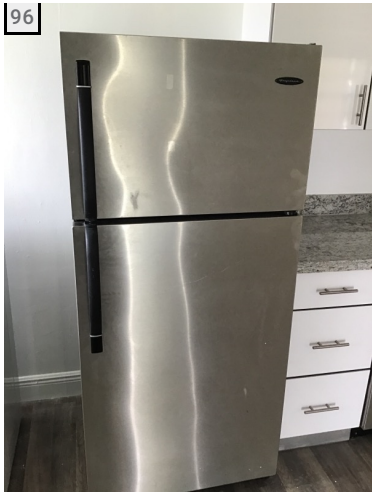
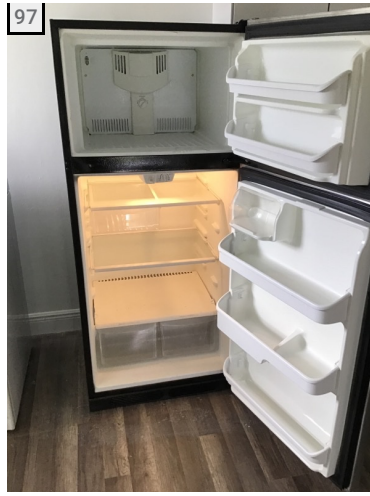
**Refrigerator was off prior to beginning of inspection. After 2 hours of operation, freezer was cooling properly but refrigerator side was not**

**Location** Kitchen  
**Suggested Action** Repair or replace the unit

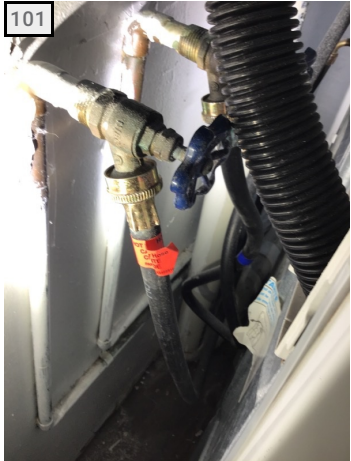
**Location** Laundry Room / Mudroom  
**Impact** For a washing machine inside the house, these washing machine hoses made of reinforced rubber hoses are not recommended because they are the most likely to burst.

**Suggested Action** Rubber washing machine hoses should be replaced with stainless steel braided hoses. A stainless steel braided hose is the minimum recommended for indoor use. The braided stainless steel encases a rubber hose and provides a burst-resistant measure. These washing machine hoses have a lower failure rate than rubber hoses when properly installed

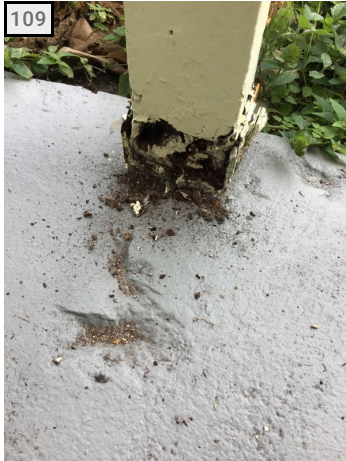
### Support posts are significantly deteriorated

**Impact** Without sufficient support posts, the structural integrity of the railing is compromised

**Suggested Action** Have repaired by qualified carpenter

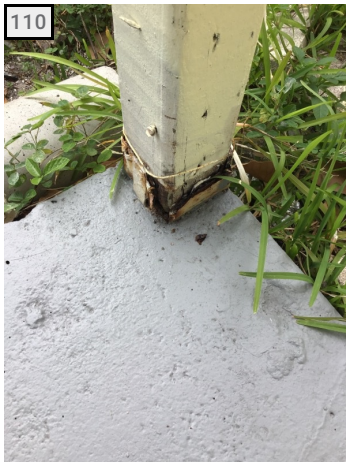
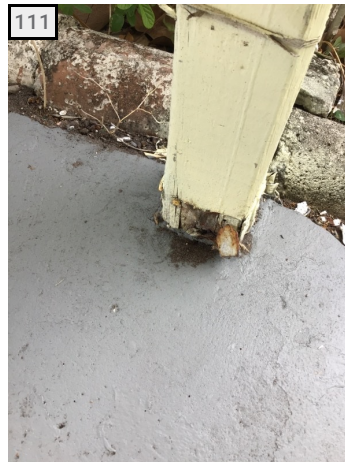
### Support posts are showing wear

**Impact** If not addressed, the post may dry or rot

**Suggested Action** Paint, stain and/or seal with a weatherproof product
