All-Star Inspection Report
1001 Sample Drive
Parma, OH 44130

Inspected By: Joe Sanzone

Prepared For: Sample Report
Inspected On Thu, Jul 11, 2024 at 2:00 PM

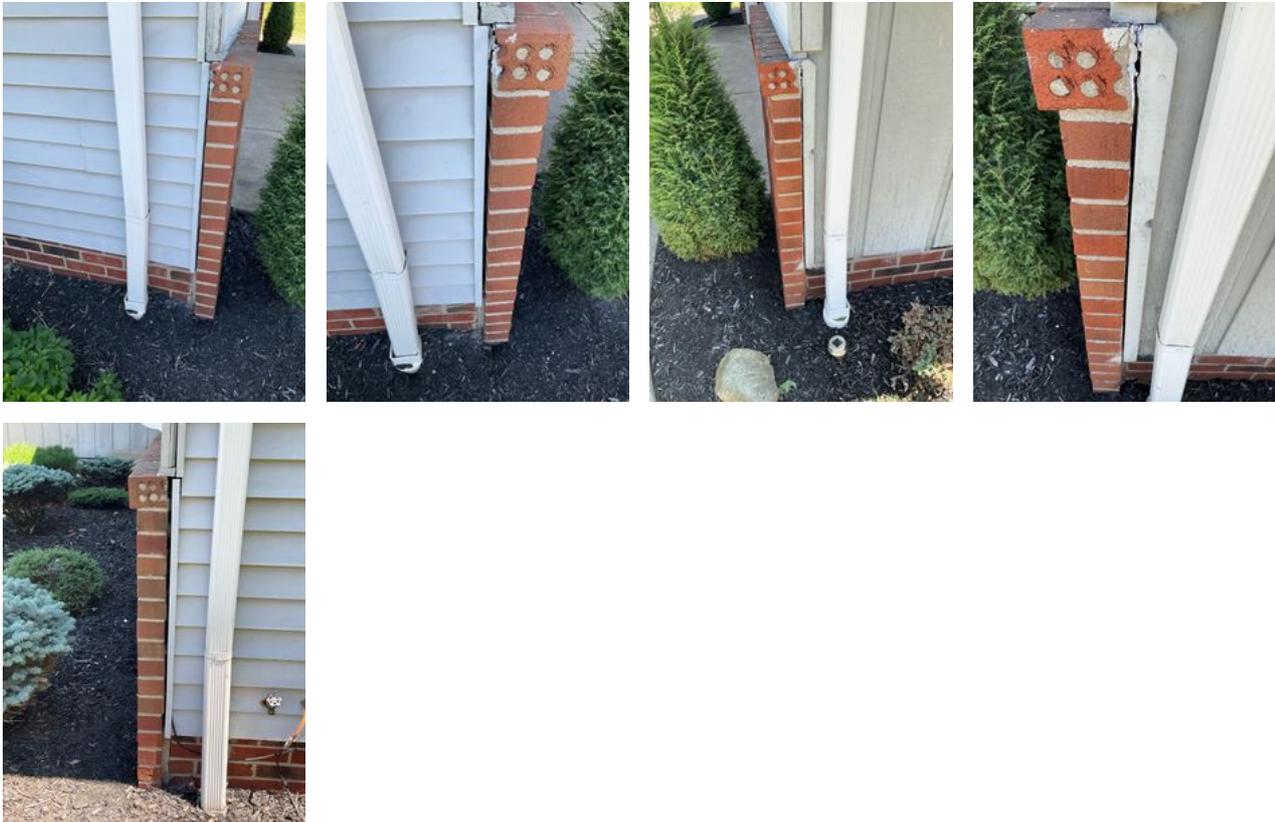
Comment 3
Maintenance Item

Recommend sealing gaps where brick veneer and siding join to prevent moisture and/or pest intrusion.

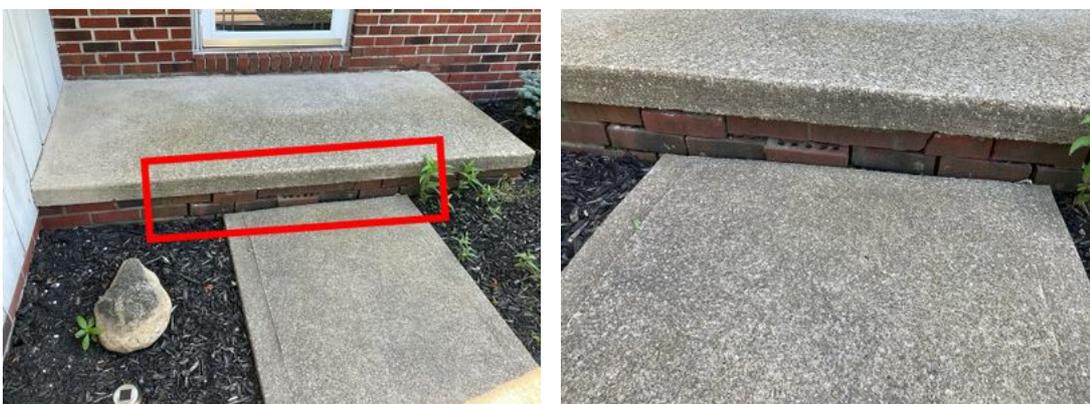
Comment 4
Deficiency

Deteriorated/missing mortar joints and loose bricks present at the front stoop. Recommend tuck pointing repairs.

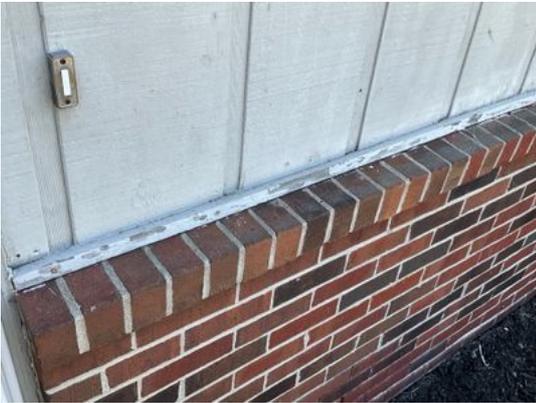
Comment 5

Flaking paint and exposed wood present at the wood trim at front of house. Recommend prepping and painting to prevent premature deterioration.

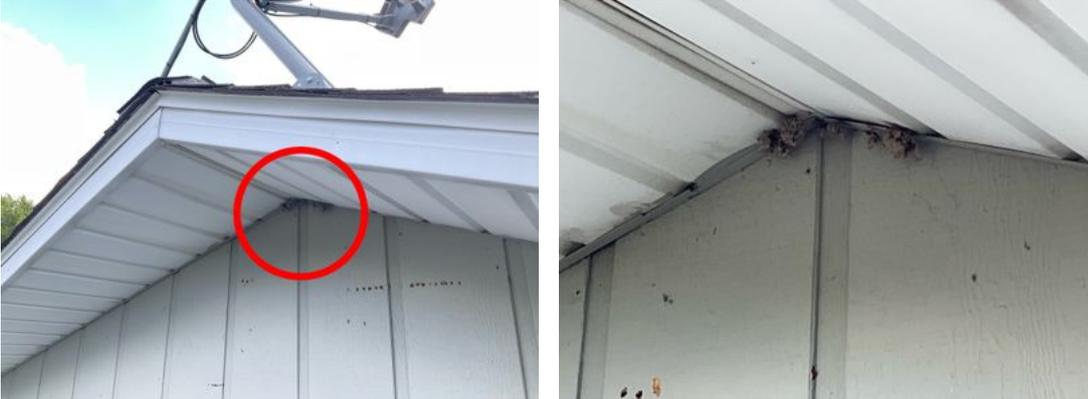
Comment 7
Deficiency

Stinging insect hives present at front of house. Hives appear to be dormant at time of inspection. Recommend removing.

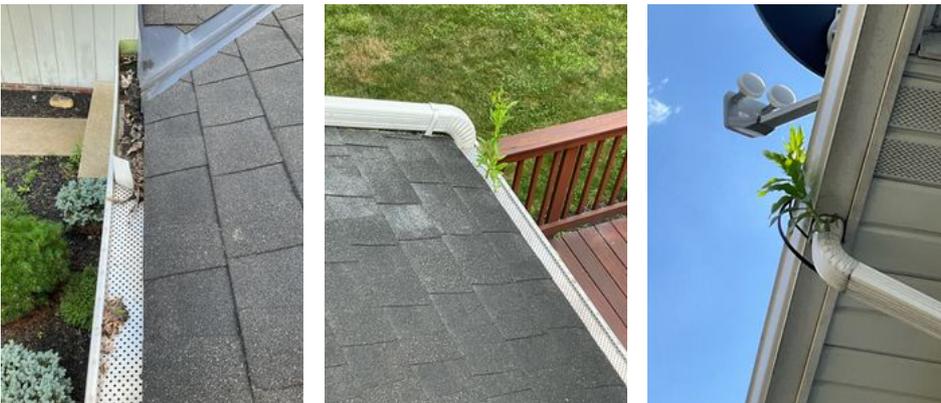
Comment 8
Maintenance Item

Gutters need cleaned out. Recommend cleaning out gutters and gutter screens to ensure proper water drainage.

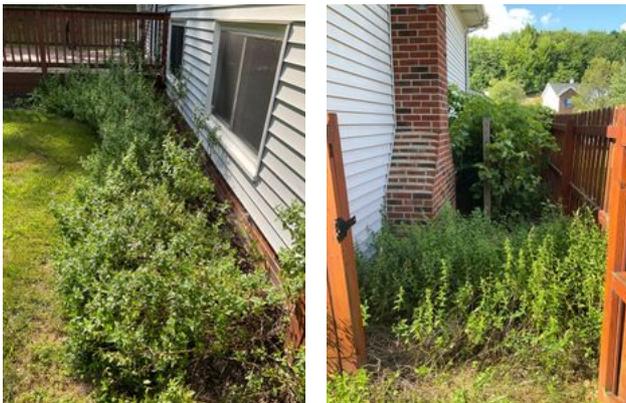
Comment 11
Maintenance Item

Recommend trimming any shrubs/bushes away from the house.

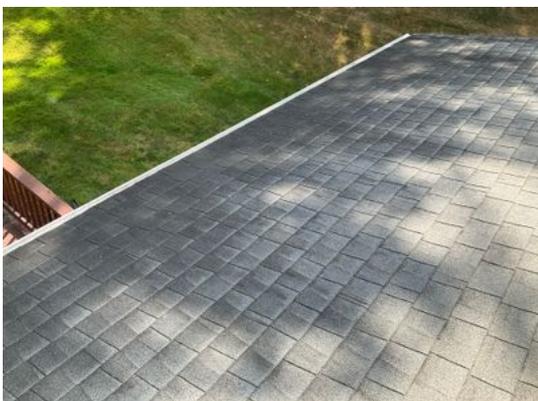
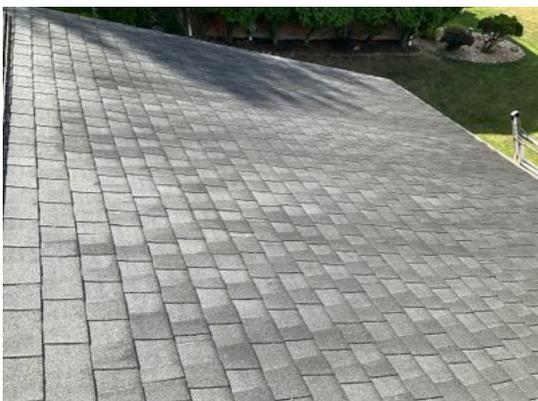
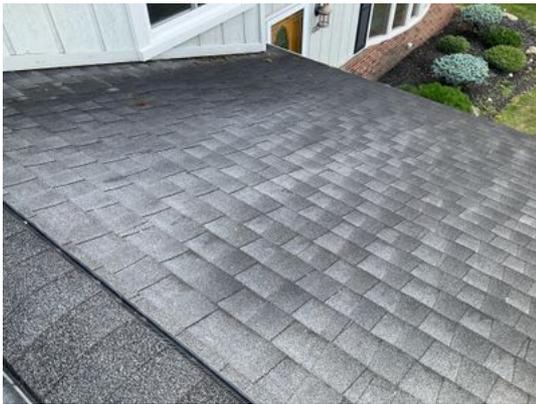
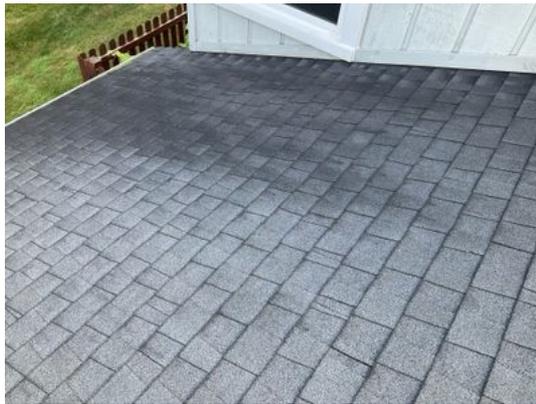
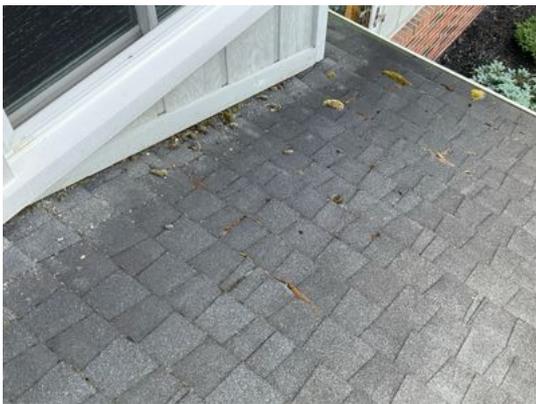
Comment 16
Deficiency

Algae staining (black streaks) present in multiple areas of the house and garage roof. Moss developing at the garage roof.

Recommend having a professional roof cleaning company perform a low pressure roof cleaning to remove any algae and moss from the shingles.

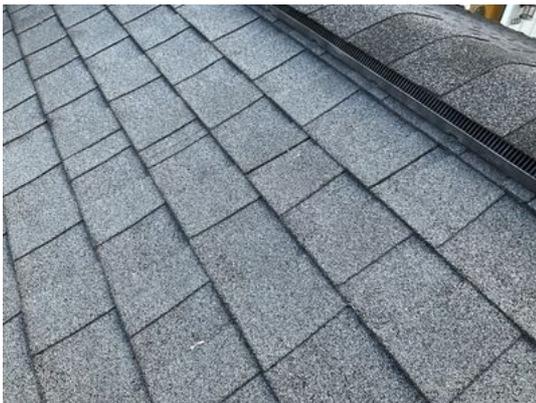
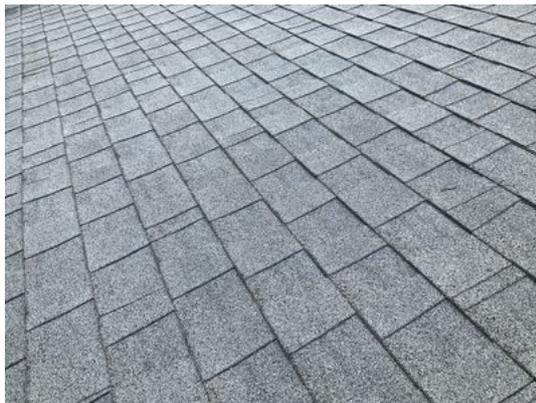
Comment 17
Deficiency

Deterioration and granule loss present at roof shingles. No active leaks or evidence of roof leaks at time of inspection. Recommend monitoring and repairing or replacing the roof when needed.

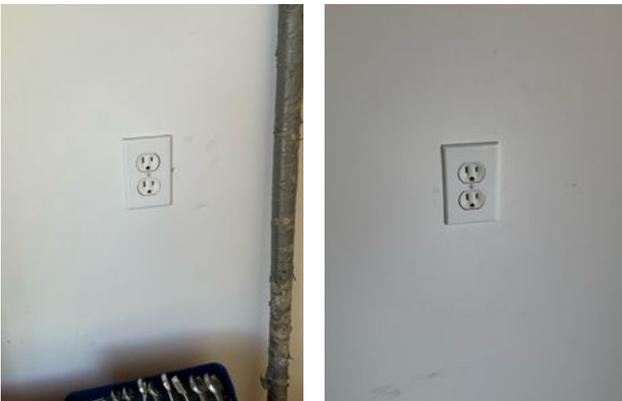
Comment 20
Safety Hazard

Garage outlets are not GFCI protected. Safety Hazard. Recommend upgrading to GFCI protected outlets.

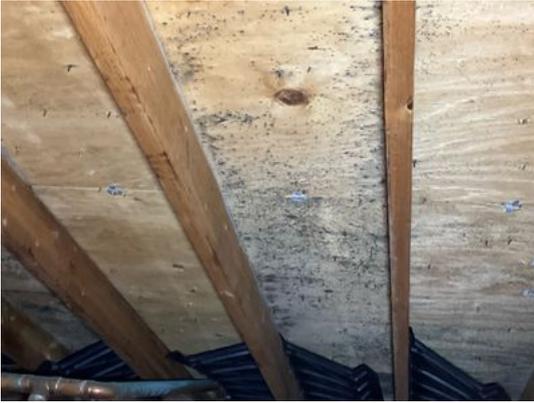
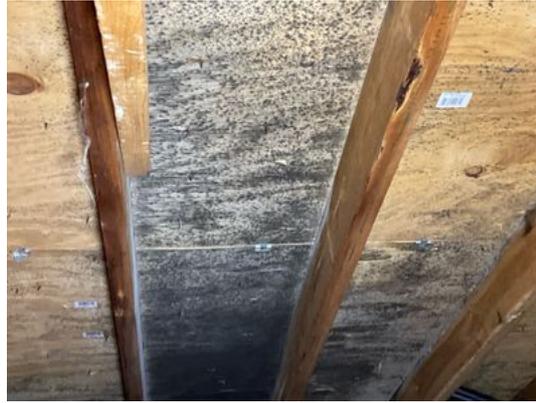
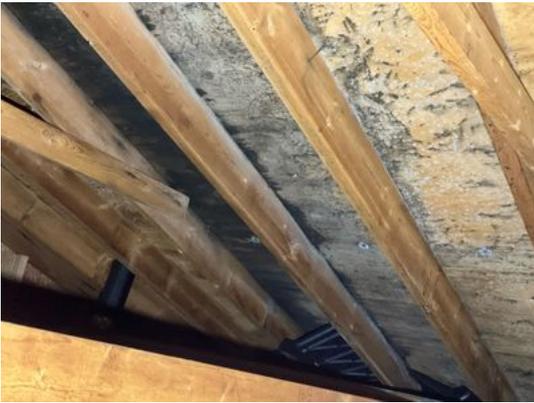
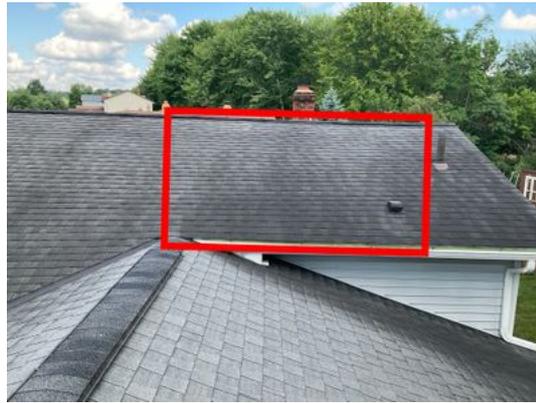
Comment 24
Deficiency

Evidence of potential microbial growth/mold present at roof sheathing in several areas. Recommend mold remediation by a qualified mold remediation contractor.

The staining appears to be isolated to the West facing side of the upper tier roof.

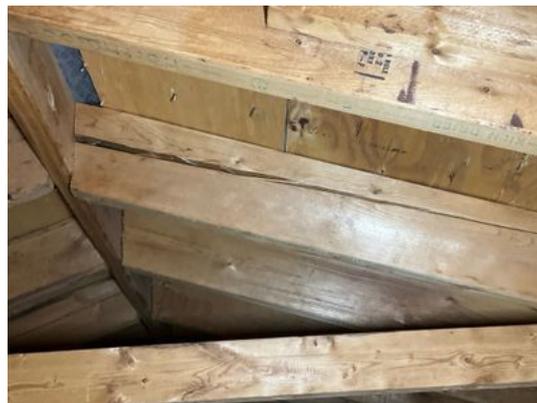
Comment 25

Cracked rafter at the roof. Recommend repairing.

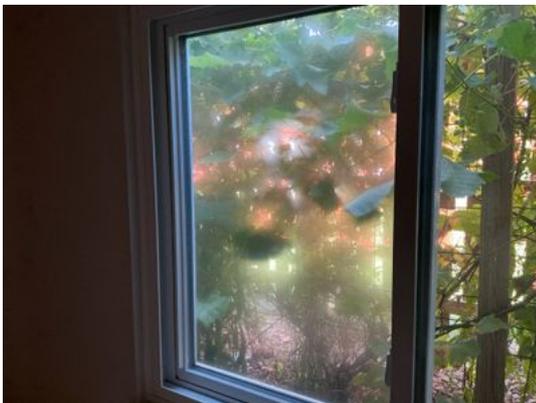
**Comment 31
Deficiency**

Evidence of insulated glass seal failure at window. Recommend replacing as needed.

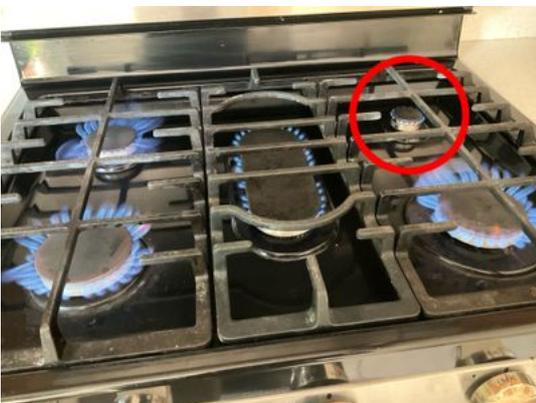
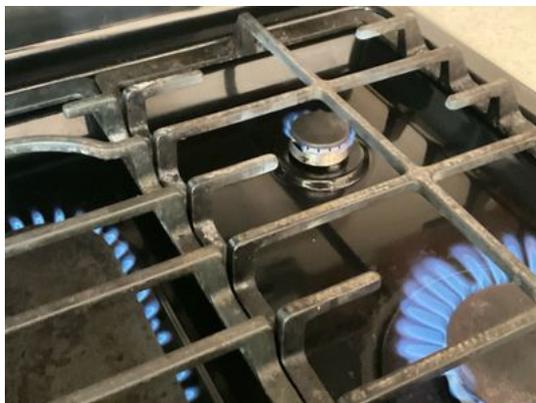
Comment 42
Deficiency

Low flame output at the right rear burner. Recommend repairing as needed.

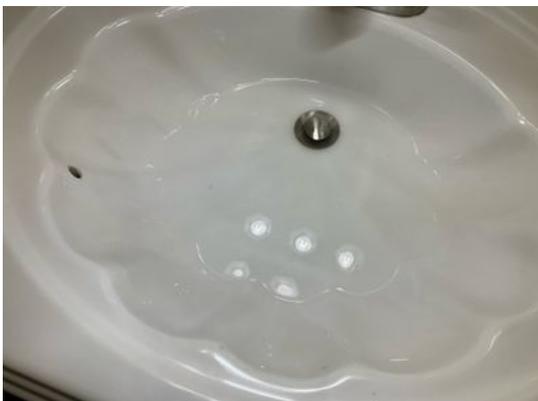
Comment 45
Deficiency

Slow drain at the sink. Recommend cleaning the drain.

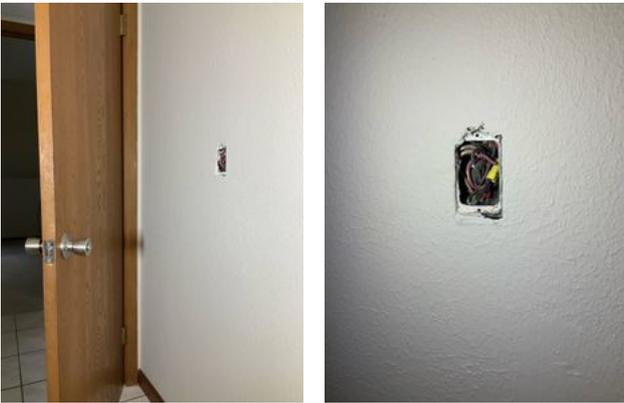
Missing plate cover with exposed live wires at the top of the basement stairs. Safety Hazard. Recommend repairing.

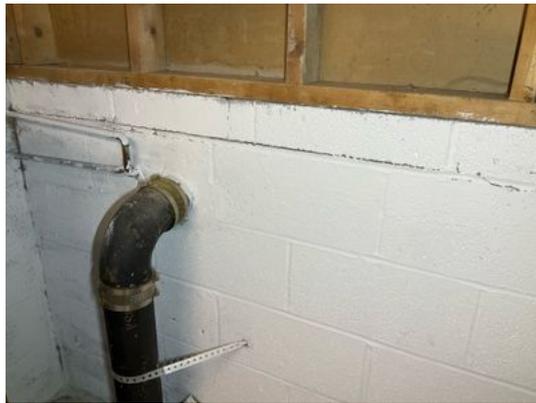
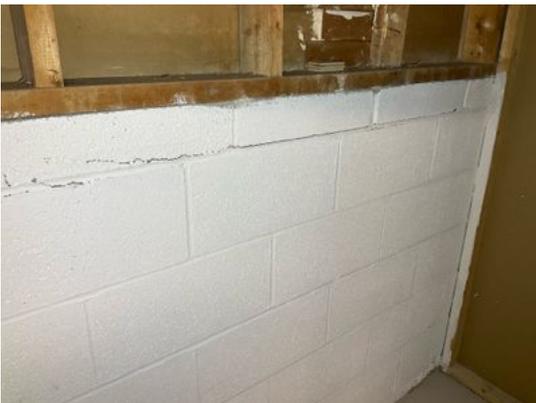
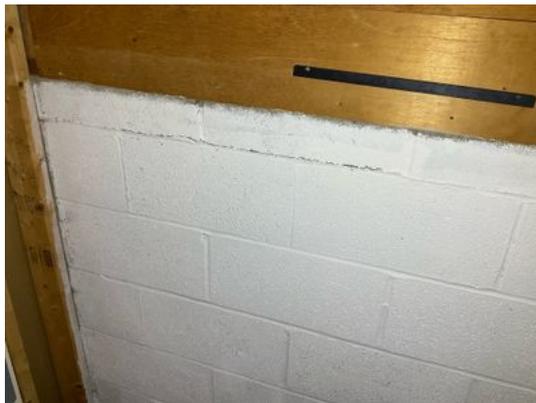
Comment 51

Vertical and horizontal settling cracks present at the visible foundation walls. No structural deficiencies or concerns observed. Recommend monitoring and repairing as needed.

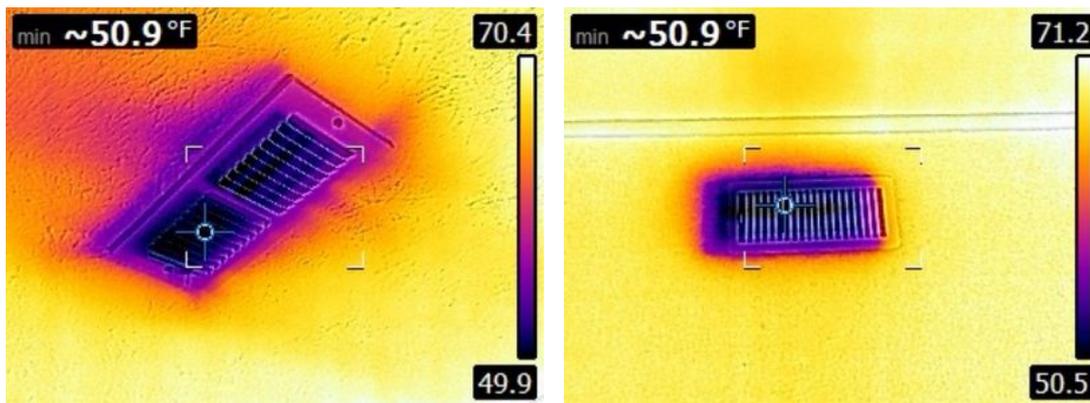
Air conditioning was blowing below 60 degrees at the vents.

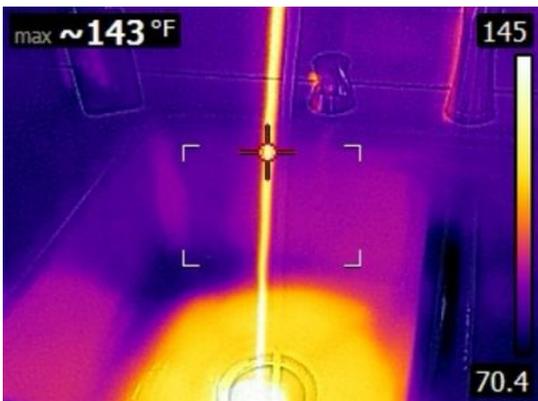
**Comment 65
Safety Hazard**

Hot water at the sink was measured at 140+ degrees. Potential Safety Hazard. Recommend turning down the water heater thermostat to obtain hot water closer to 120-125 degrees.

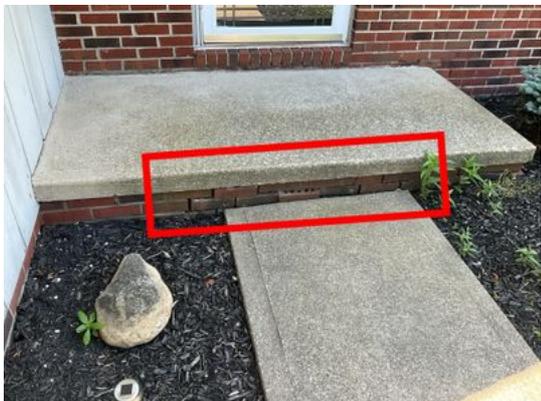
Deteriorated/missing mortar joints and loose bricks present at the front stoop. Recommend tuck pointing repairs.

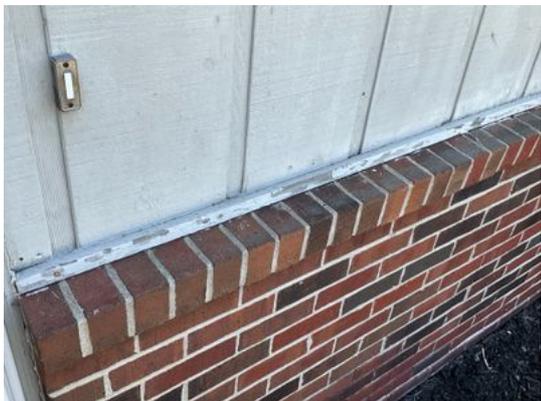
Flaking paint and exposed wood present at the wood trim at front of house. Recommend prepping and painting to prevent premature deterioration.

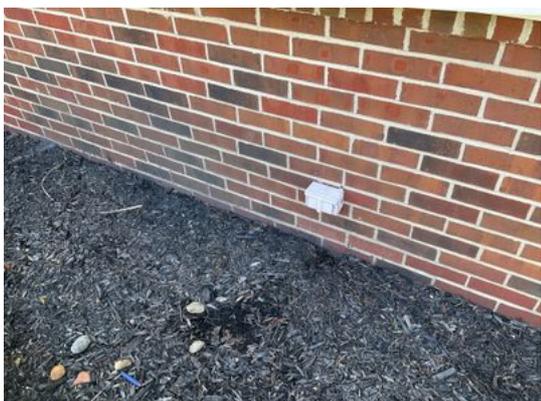
No power at this exterior GFCI protected outlet at front of house. Recommend repairing or replacing as needed.

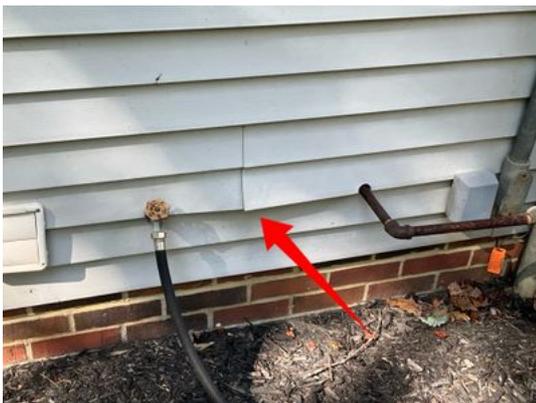
Loose section of vinyl siding at rear of house. Recommend repairing.

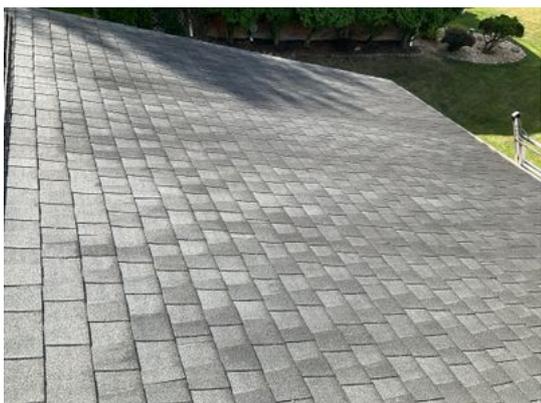
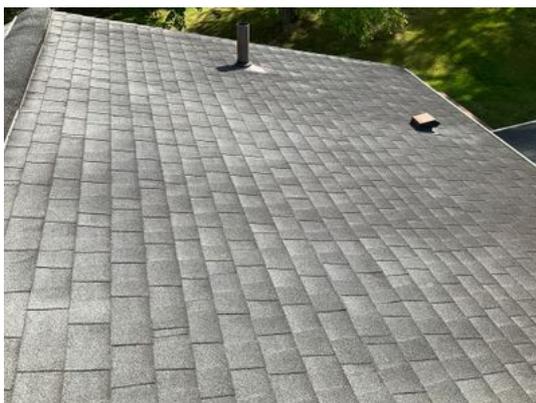
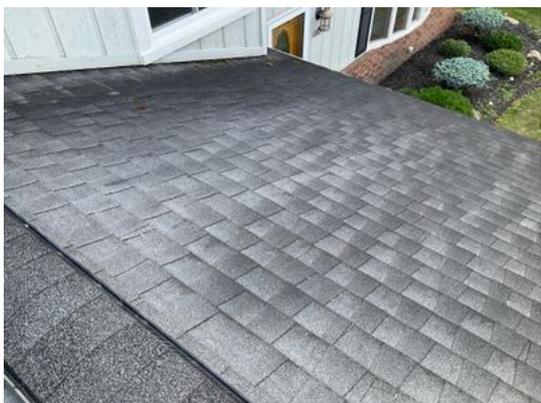
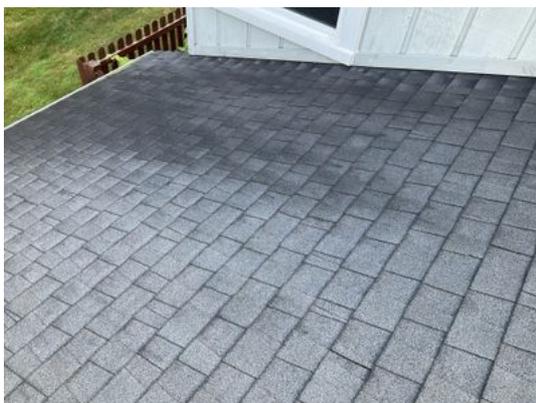
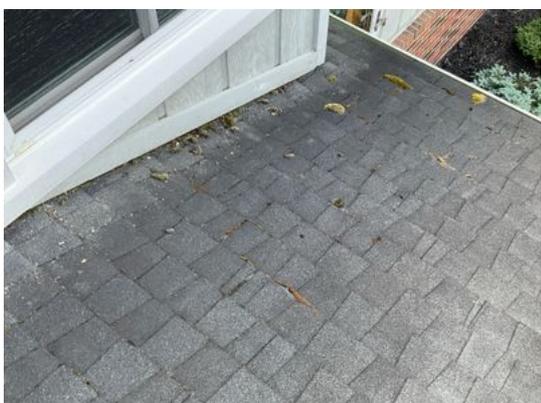
Algae staining (black streaks) present in multiple areas of the house and garage roof. Moss developing at the garage roof.

Recommend having a professional roof cleaning company perform a low pressure roof cleaning to remove any algae and moss from the shingles.

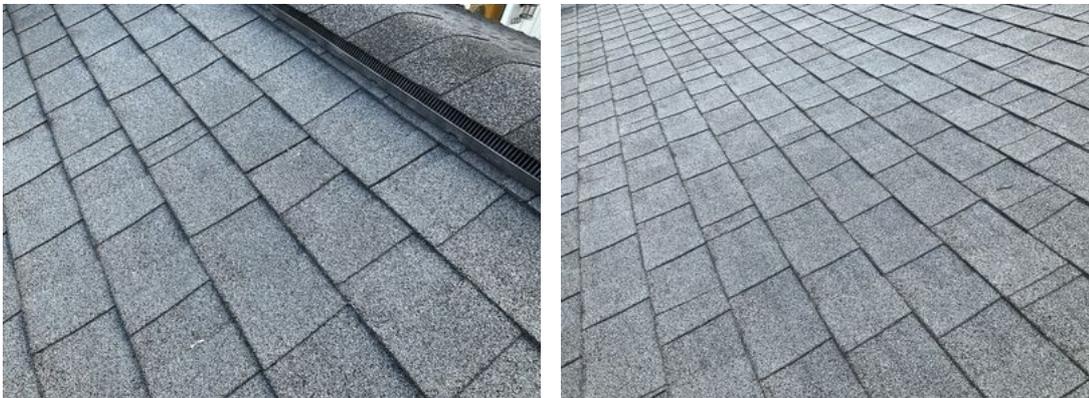
Deterioration and granule loss present at roof shingles. No active leaks or evidence of roof leaks at time of inspection. Recommend monitoring and repairing or replacing the roof when needed.

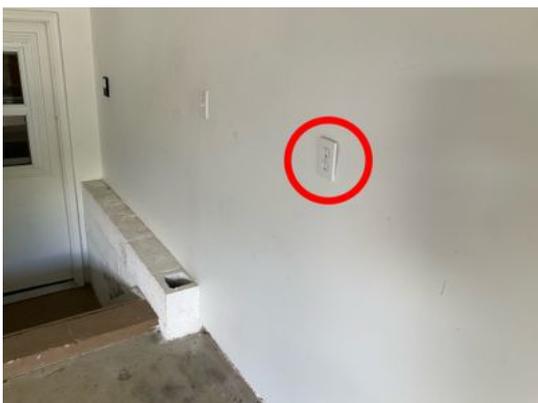
Loose electrical outlet. Recommend repairing.

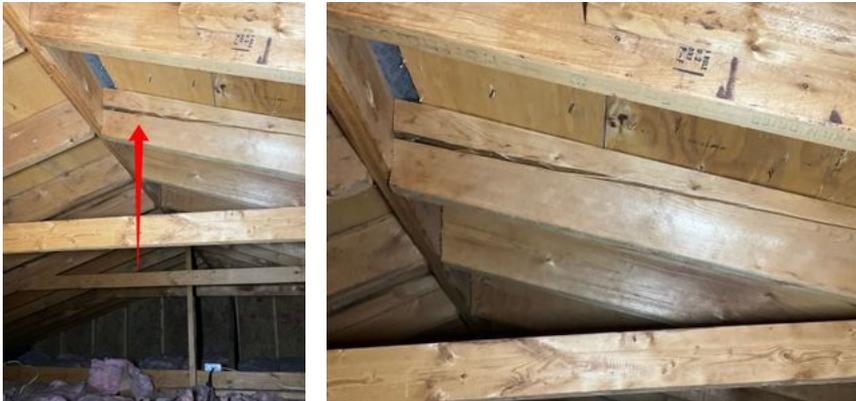
Cracked rafter at the roof. Recommend repairing.

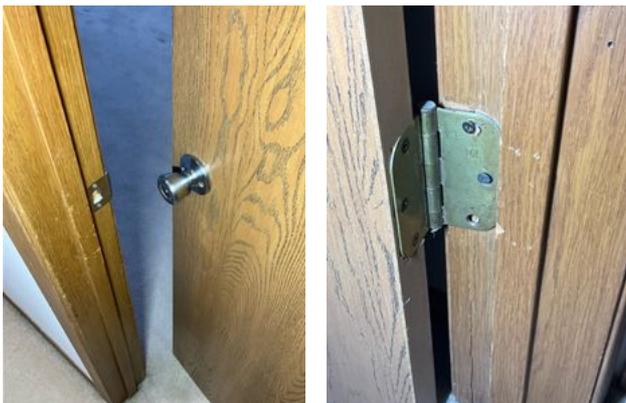
Entry door does not properly latch and the bottom hinge is loose and missing a screw. Recommend repairs.

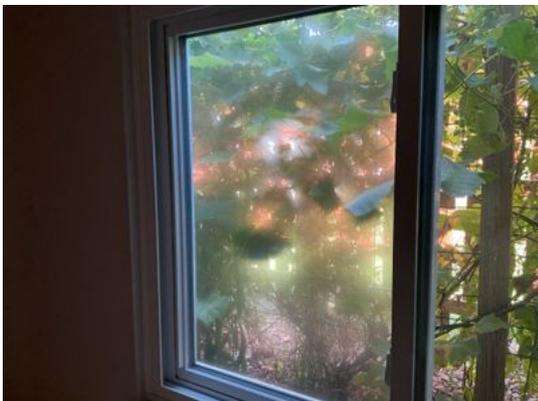
Evidence of insulated glass seal failure at window. Recommend replacing as needed.

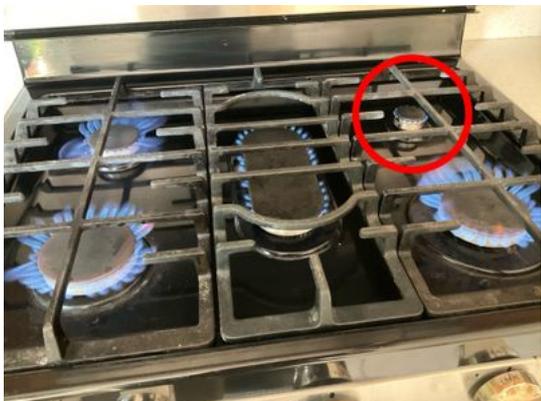
Low flame output at the right rear burner. Recommend repairing as needed.

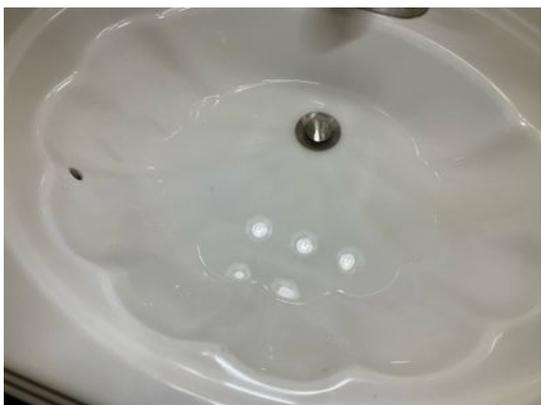
Slow drain at the sink. Recommend cleaning the drain.

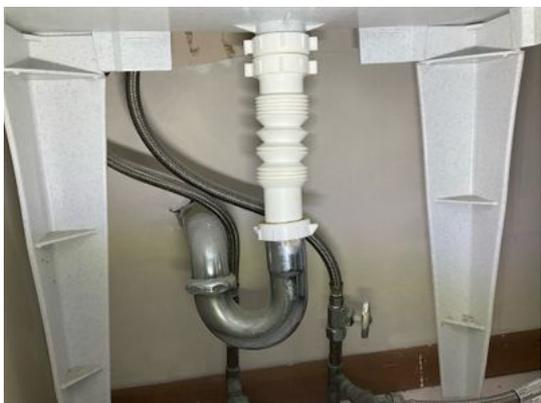
Improper drain line present at utility sink. Corrugated flexible drain lines are prone to clogging and leaking. No active leaks at time of inspection. Recommend replacing with a solid PVC drain line.

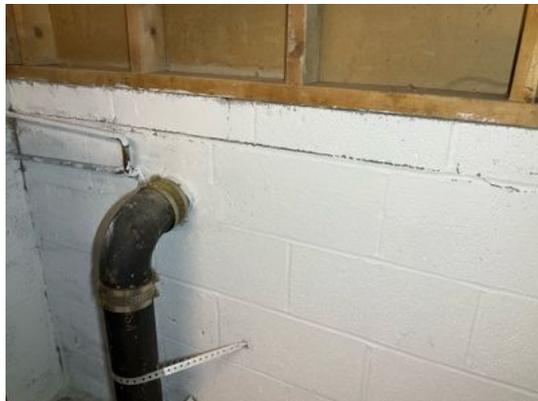
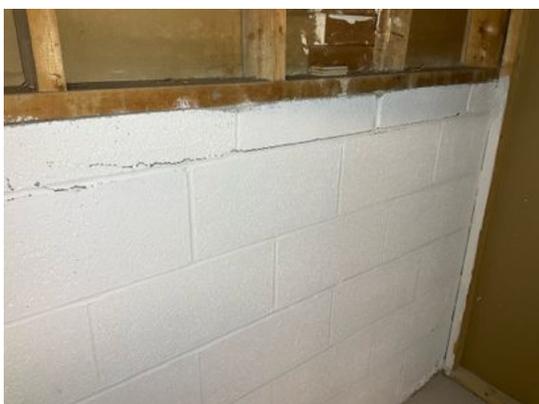
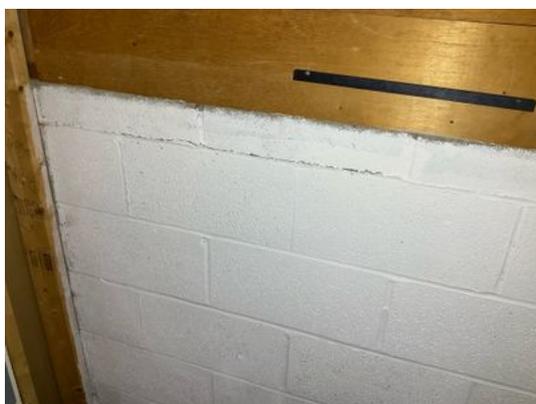
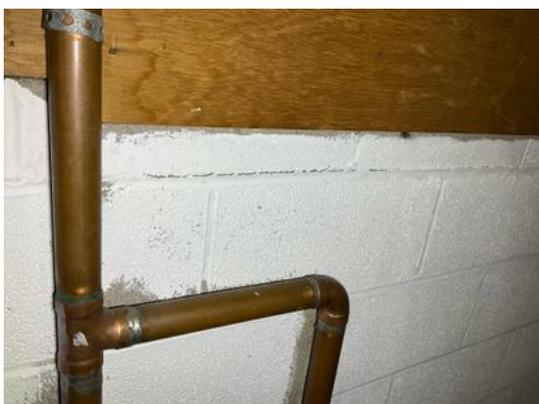
Vertical and horizontal settling cracks present at the visible foundation walls. No structural deficiencies or concerns observed. Recommend monitoring and repairing as needed.

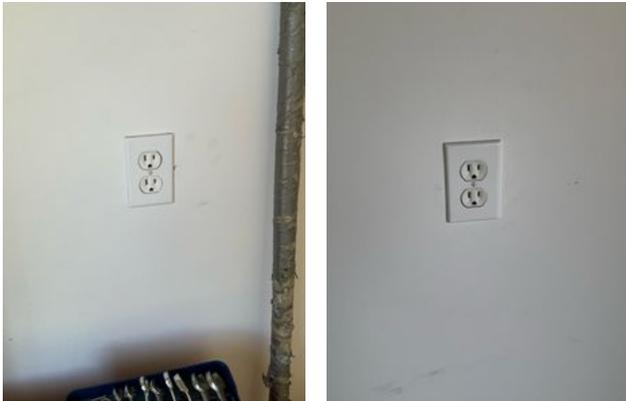
Garage outlets are not GFCI protected. Safety Hazard. Recommend upgrading to GFCI protected outlets.

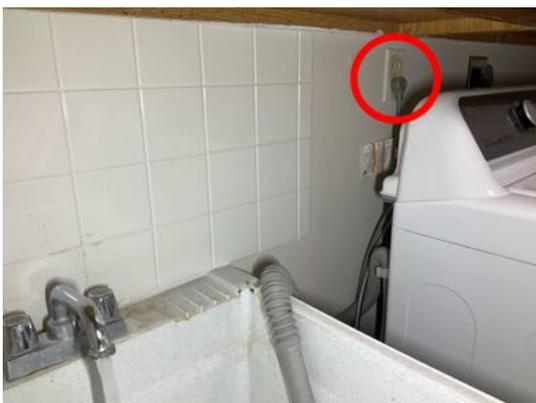
Laundry area outlet within 6 feet of a water source is not GFCI protected. Safety Hazard. Recommend upgrading to a GFCI protected outlet.

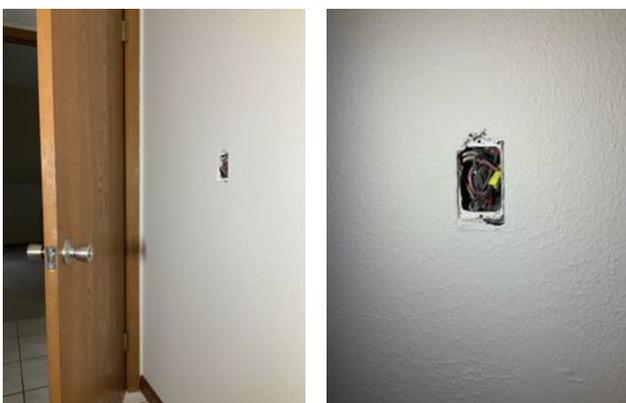
Missing plate cover with exposed live wires at the top of the basement stairs. Safety Hazard. Recommend repairing.

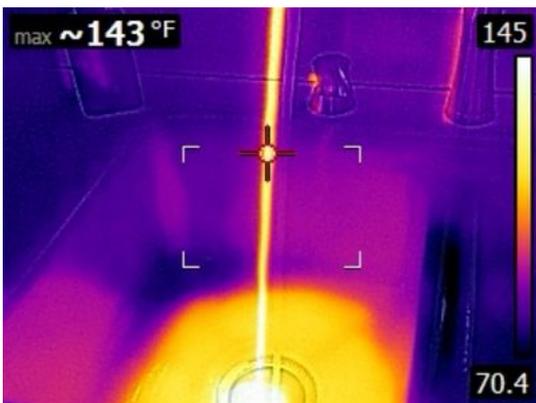
Hot water at the sink was measured at 140+ degrees. Potential Safety Hazard. Recommend turning down the water heater thermostat to obtain hot water closer to 120-125 degrees.

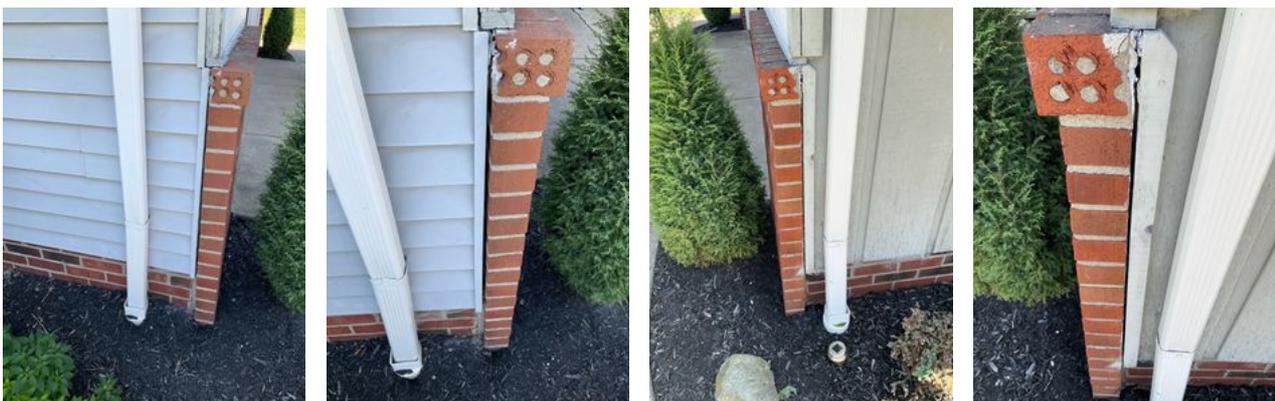
Recommend sealing gaps where brick veneer and siding join to prevent moisture and/or pest intrusion.

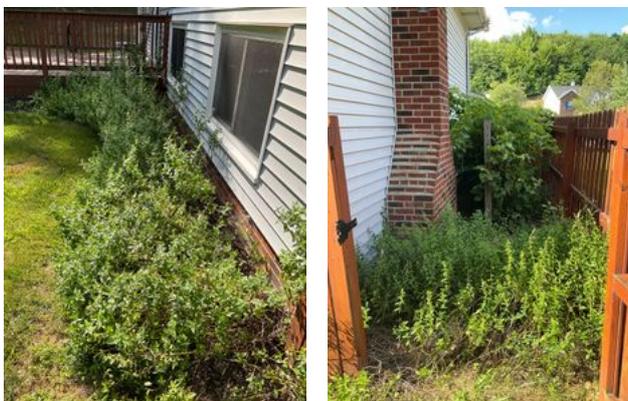
Recommend trimming any shrubs/bushes away from the house.

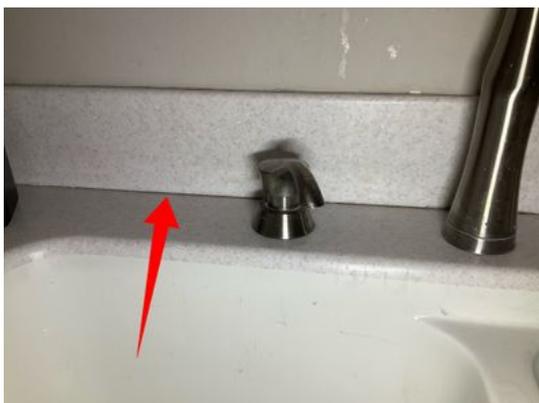
Countertop backsplash seam needs sealed to prevent water intrusion. Recommend sealing.
