Asbestos Refurbishment/Demolition Survey for

Upwell Village Hall

Project Number: ECB/4715

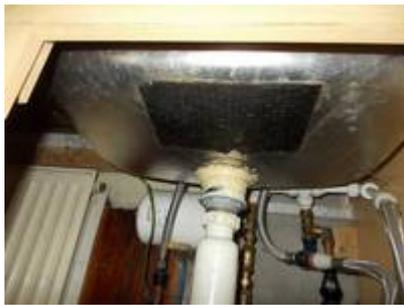
Location ID: 25984 Location Ref: 1 Product Type: NADIS

Area/ Floor/ Room/ Product: Main: Ground floor: Bar: Bitumen pad

Material Comments: Non asbestos bitumastic pad under sink.

Action: No Action Required

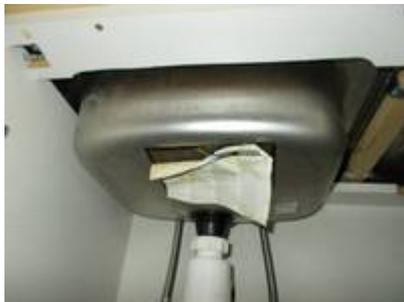
Location ID: 25985 Location Ref: 2 Product Type: NADIS

Area/ Floor/ Room/ Product: Main: Ground floor: Kitchen: Bitumen pad

Material Comments: Non asbestos bitumastic pad under sink.

Action: No Action Required

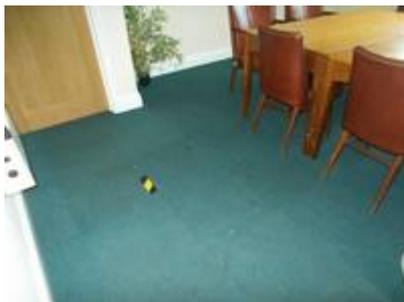
Location ID: 25986 Location Ref: 3 Product Type: NADIS

Area/ Floor/ Room/ Product: Main: Ground floor: Meeting Room: Boarding

Material Comments: Non asbestos board under carpet.

Action: No Action Required

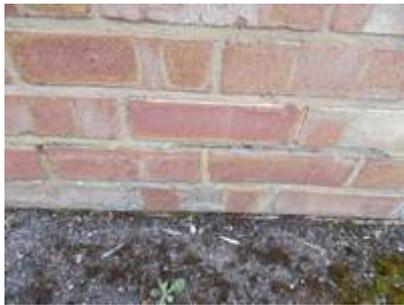
Location Ref: 4

Area/ Floor/ Room/ Product: Main: Ground floor: External: Bitumen

Damage: No visible damage

Asbestos bitumastic damp proof course. Annual inspection or remove if affected by works.

Asbestos Type: Chrysotile

Material Risk Score: 2

Material Risk Band: Very Low Risk

Action:
Remove during demolition. Not Licenceable

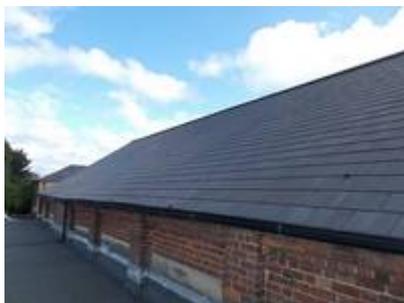
Location Ref: 5

Area/ Floor/ Room/ Product: Main: Ground floor: External: Roof Tiles

Non asbestos cement roof tiles on main roof.

Action:
No Action Required

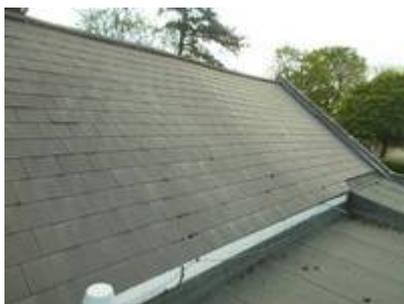
Location Ref: 6

Area/ Floor/ Room/ Product: Main: Ground floor: External: Roof Tiles

Non asbestos cement roof tiles on lower roof.

Action:
No Action Required

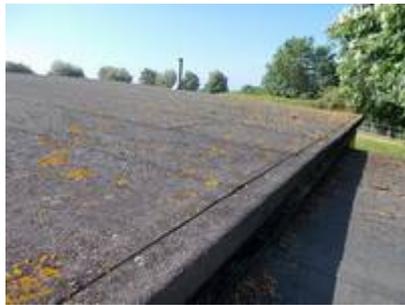
7

Main: Ground floor: External: Roofing felt

Non asbestos bitumastic roof felts.

No Action Required
