**Triangle Pond Management**  
 405 S Rogers Ln  
 Raleigh, NC 27610  
 (919)398-3221  
 Office@TrianglePondManagement.com  
 www.TrianglePondManagement.com  
**Maintenance Service Report**

| Chandler Woods MOA | | 10/18/2024 | |
| BMP 1, BMP 2, BMP 3 | | | |

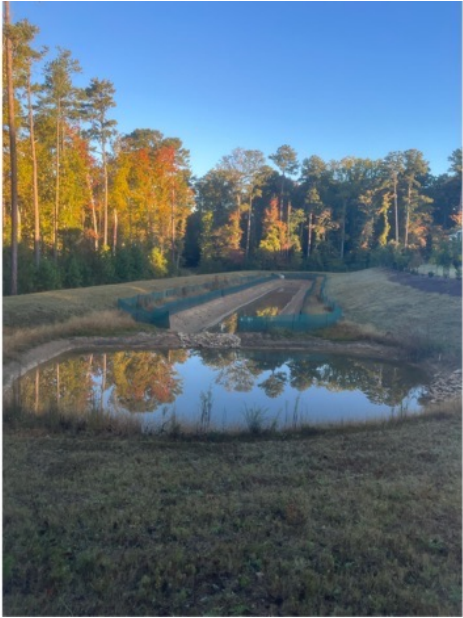
| Photo 1: | Photo 2: |

| Photo 1: | Photo 2: |
|---|---|
| BMP 1 overview | Overview |

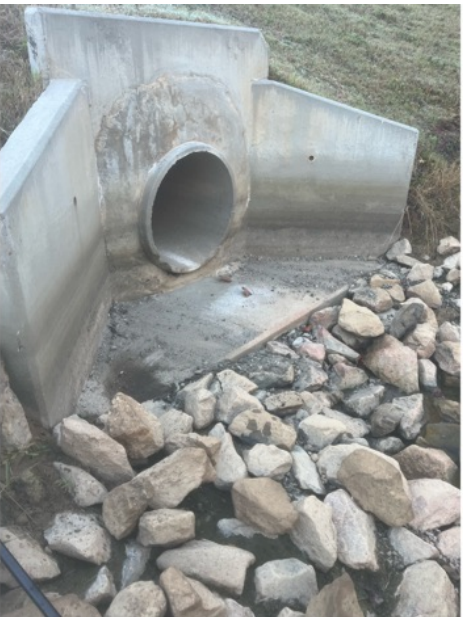
| Photo 1: | Photo 2: |
|---|---|
| Photo 3: | Photo 4: |

| Photo 1: | Photo 2: |
|---|---|
| Inlet | Outlet |

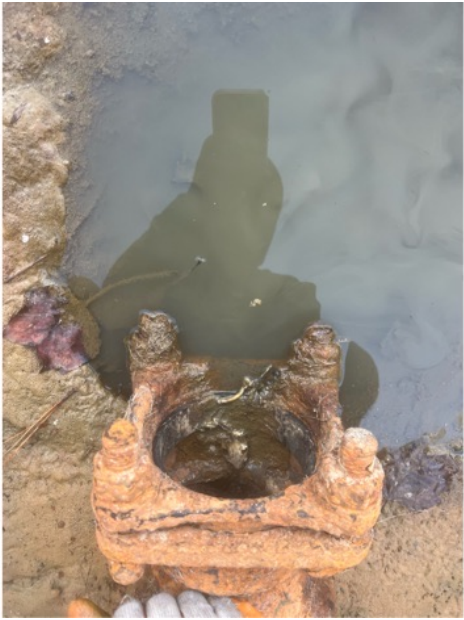
| Photo 5: | Photo 6: |
|---|---|
| Photo 7: | Photo 8: |

| Additional Notes: |
|---|
| <p>Each device was walked and all trash and debris within device perimeters was removed. Woody vegetation throughout each device was controlled or hand pulled.</p> <p>The water level in BMP 1 is very low, likely due to a defective or leaking drain valve. The drain valve in BMP 1 does not function (wheel will not turn).</p> <p>Riprap in BMP 1 has lost position, recommend repairs.</p> <p>Beneficial vegetation in BMP 1 looks stressed, likely from being newly planted and the low water level.</p> <p>Overall BMP 1 is deficient, will send a deficiency report to our office.</p> <p>The drain valve in BMP 2 does not function.</p> <p>BMP 3 has areas lacking mulch, recommend re-mulching in the coming months.</p> <p>BMP 3 outlet has minor accumulated sediment, will continue to monitor.</p> <p>All other components were functioning properly.</p> <p>Please contact our office with any additional questions, concerns, or to schedule repairs.</p> |

| Photo 5: | Photo 6: |
|---|---|
| Drain valve intake | Low water level |

| Repairs? | Comment: |
|---|---|
| Are repairs required? Yes | BMP 1, drain valve BMP 2 |

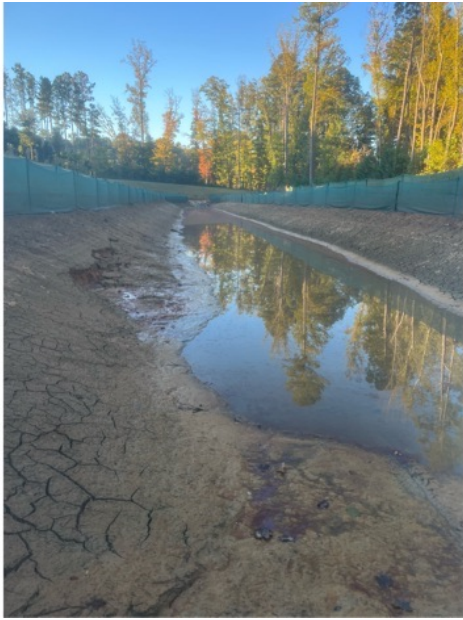
| General Inspection: | | Comment: |
|---|---|---|
| Was the water at the proper elevation? | No | BMP 1, see notes |

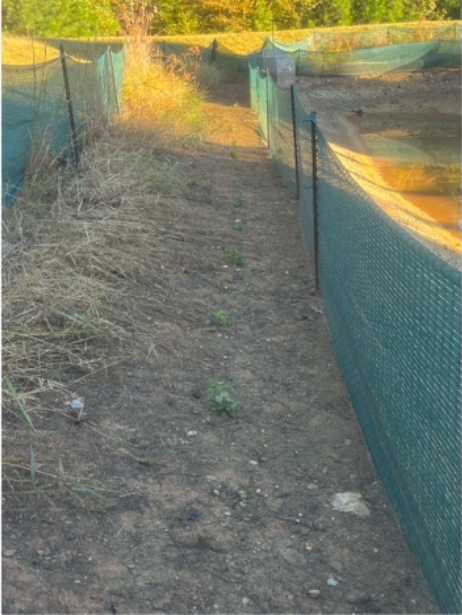
| Photo 9: | Photo 10: |

| General Inspection: | | Comment: |
|---|---|---|
| Was the required beneficial vegetation healthy and flourishing? | No | BMP 1, see notes |

| Photo 9: | Photo 10: |
|---|---|
| Beneficial vegetation | Displaced riprap |

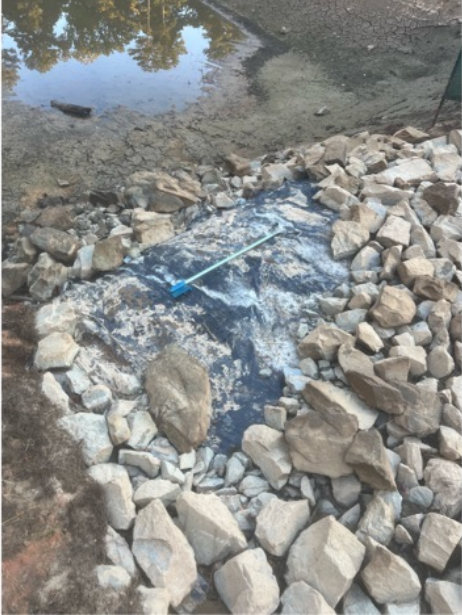
| Optional Services: | | Comment: |
|---|---|---|
| Was the Rip Rap in the correct position? | No | BMP 1, see notes |
