Triangle Pond Management
 405 S Rogers Ln
 Raleigh, NC 27610
 (919)398-3221
 Office@TrianglePondManagement.com
 www.TrianglePondManagement.com
Maintenance Service Report

Customer Name:		Date:	
Chandler Woods MOA		3/26/2024	
Address:			
214 Abbot Pl			
Aquatic Technician:			
Trevor Davis / Doug Ogle			
Time of Arrival:	Time of Departure:	Drive Time:	
11:57 AM	1:45 PM	19 min	
Type of Device(s) Maintained:			
BMP 1, BMP 2, BMP 3

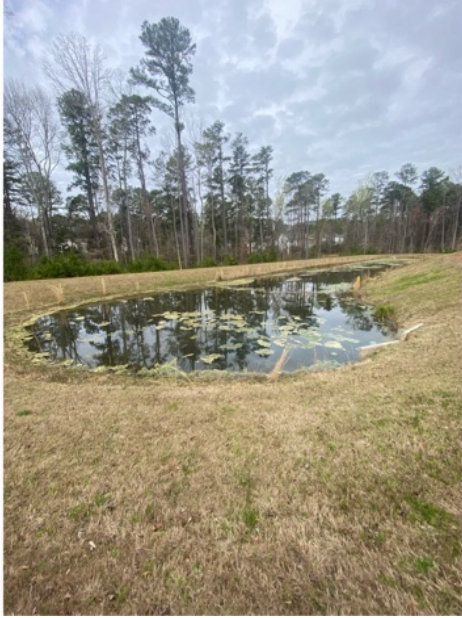
Photo 1:	Photo 2:

BMP1 overview	BMP1 backside of dam
Photo 3:	Photo 4:

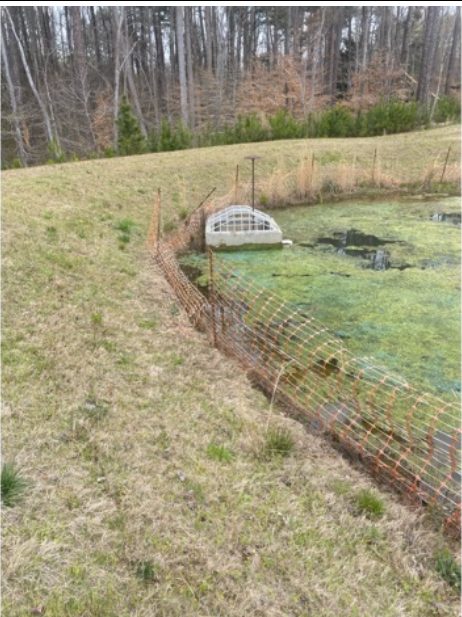
BMP1 riser	BMP1 outlet

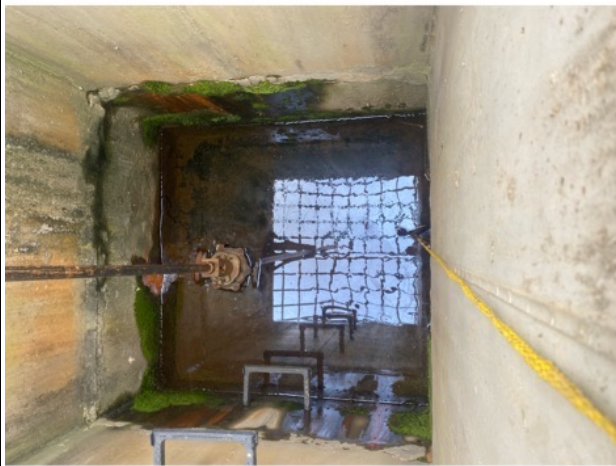
Photo 5:

BMP1 inside riser

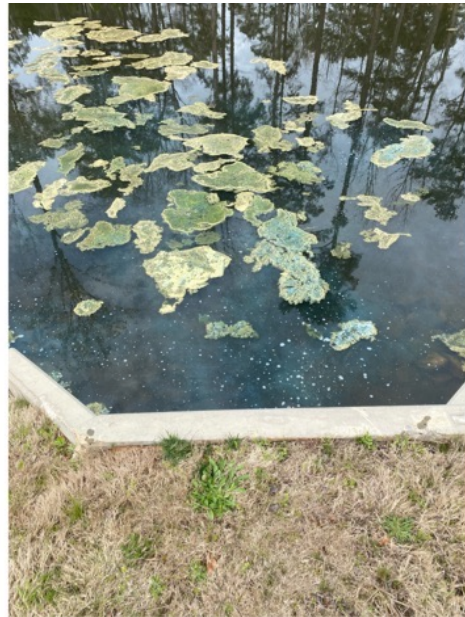
Photo 6:

BMP1 inlet

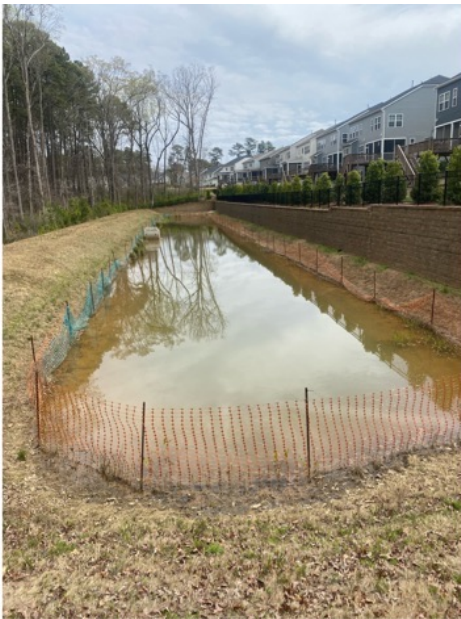
Photo 7:

BMP2 overview

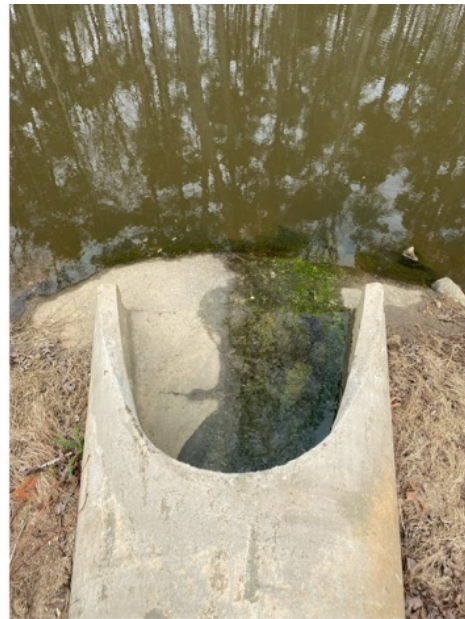
Photo 8:

BMP2 inlet

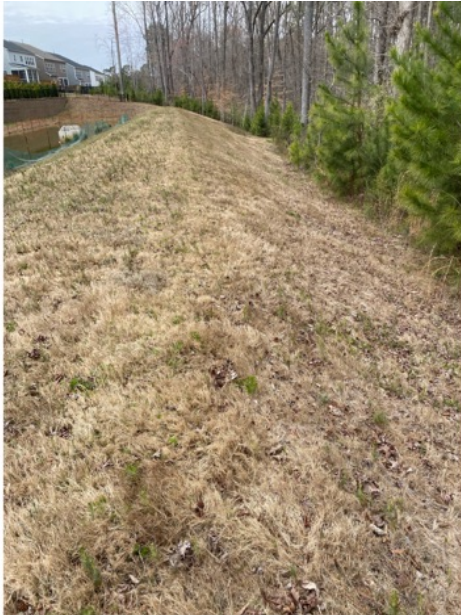
Photo 9:

BMP2 backside of dam

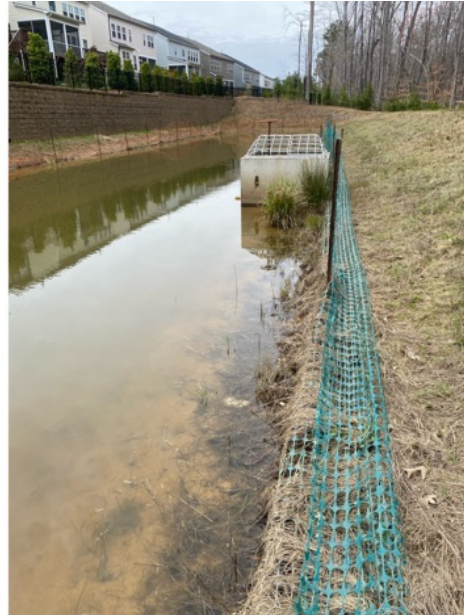
Photo 10:

BMP2 riser

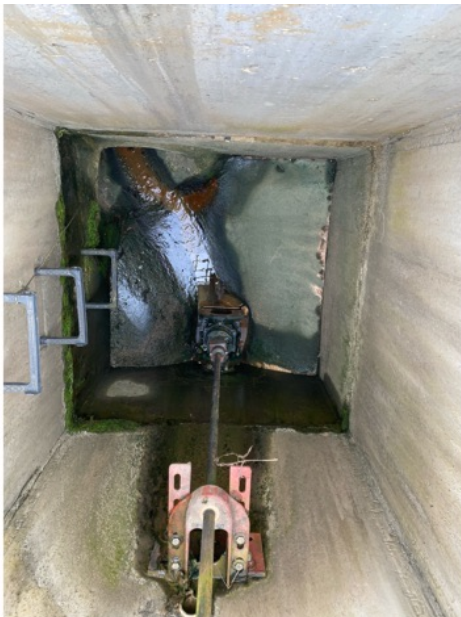
Photo 11:

BMP2 inside riser

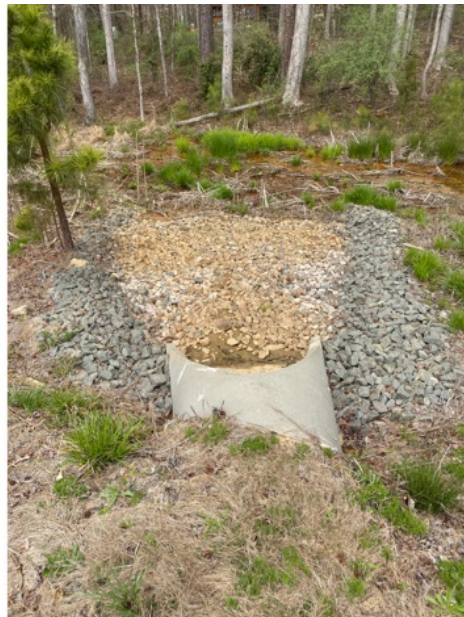
Photo 12:

BMP2 outlet

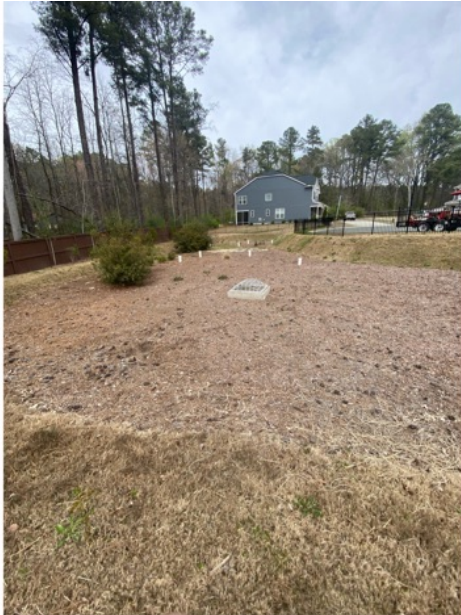
Photo 13:

BMP3 overview

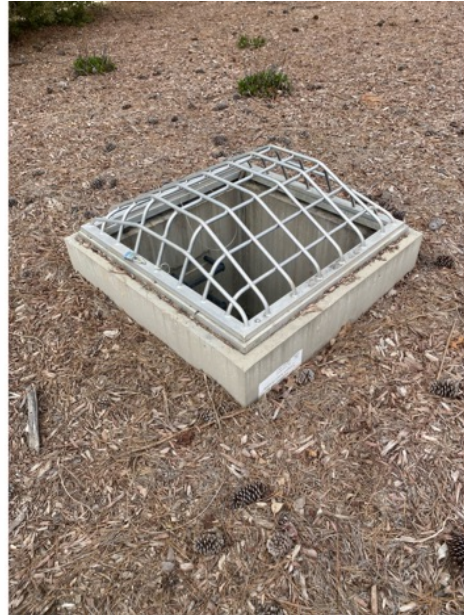
Photo 14:

BMP3 riser

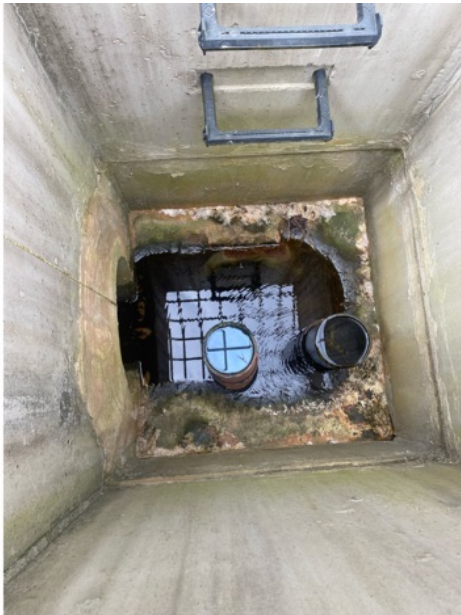
Photo 15:

BMP3 inside riser

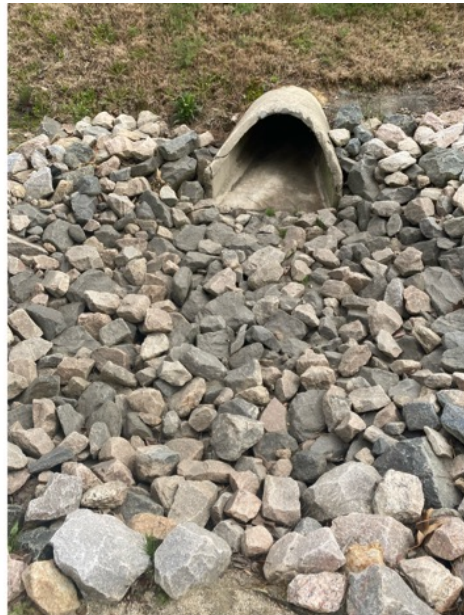
Photo 16:

BMP3 inlet

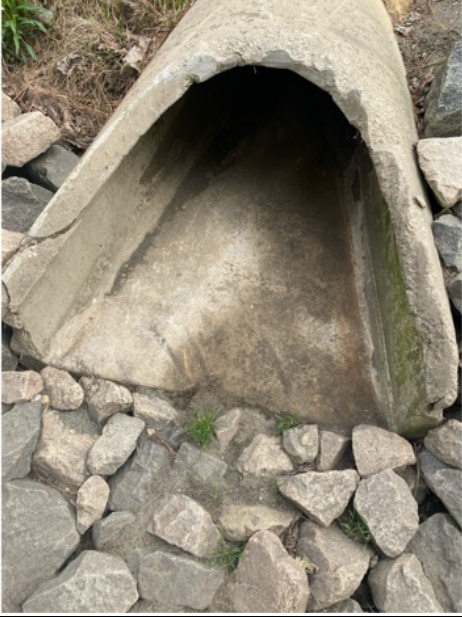
Photo 17:	Photo 18:

BMP3 inlet cleared of sediment	BMP3 bare areas
Photo 19:	Photo 20:
